DAMAGE CAUSED BY A WHEELED HARVESTER TO THE RESIDUAL TREES OF A PINUS STAND IN THE FIRST MECHANIZED MIXED THINNING

Carlos Cezar Cavassin Diniz^{1*}, Felipe Martins de Oliveira², Romano Timofeiczky Junior¹, Renato Cesar Gonçalves Robert³, Miguel Pesch Tramontini¹, Fabio Cordeiro de Brito¹

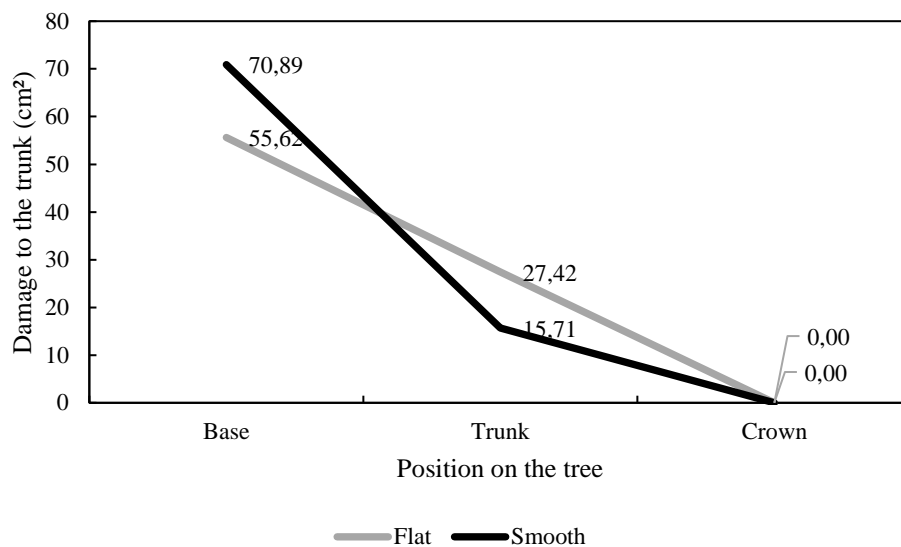
Figure 5. Mean size of damage caused by the harvester to different positions on the tree considering two land types.

It is possible to verify that the felling operation conducted on the different terrains did not present a statistical difference in the variable amount of damage by the Parallelism test ($T_2 = 2.912^{ns}$). This result indicates that the type of terrain does not affect the behavior of the curves for the conditions studied. It is important to note that the main damage was found at the base of the trees, followed by the trunk, without crown damage.

Although the terrain type did not show differences between the damage size averages, the greatest difference between damage at the base and trunk/shaft ($a = -0.0016$) and lower between the trunk/shaft and the crown ($a = 0.0009$) was observed after applying the level test (base, trunk and crown). Regarding the third applied statistical test which aimed to verify whether the levels (base, trunk and crown) presented flat or inclined curves, it was found that they are not flat and that the levels affect the behavior of the curves (Flat = 147.5102^* ; Smooth = 87.5663^*).

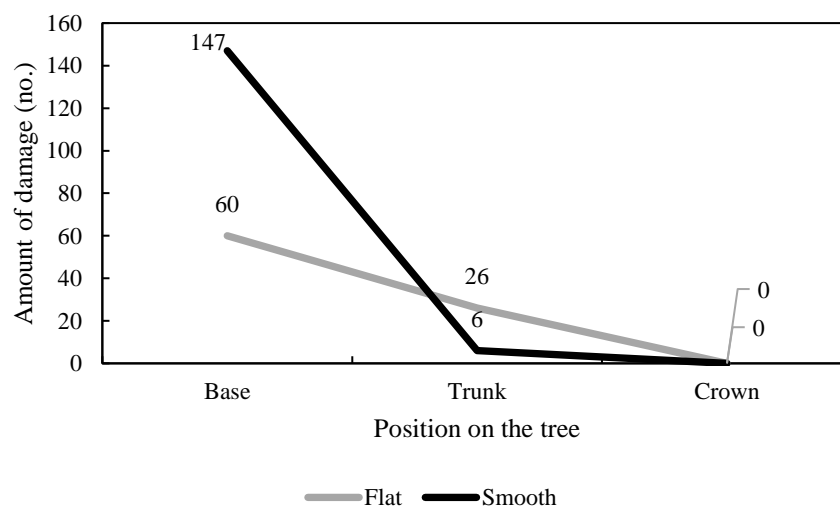
Figure 6. Distribution of the amount of damage caused by the harvester in thinning on the remaining trees of pine plantations.

Of the 239 damage spots found, 86% were located at the base of the trees and 14% on the trunk/shaft. According to the type of terrain, 64% remained on smooth terrain and 36% on flat terrain, with a statistical difference by the Parallelism test. Although there is no difference between the average damage sizes, this result alerts us to the performance of forest cutting operations on land with a slope greater than 6°.

There is a higher incidence of damage at the base of the trees, which is the section with the highest commercial value. Thus, the results demonstrate the need for improvements in the operational forest cutting procedures with harvesters in conducting the thinning operation, avoiding the occurrence of damage to the trees and future losses. The location of the damage to the tree is shown in Table 2.
