Upstream Tailings Dam - Liquefaction

**Problem report submitted to the
Benjamin M. Statler College of Engineering and Mineral Resources
At West Virginia University
in partial fulfillment of the requirements
for the degree of**

**Master of Science
In
Mining Engineering**

Morgantown, West Virginia 2020

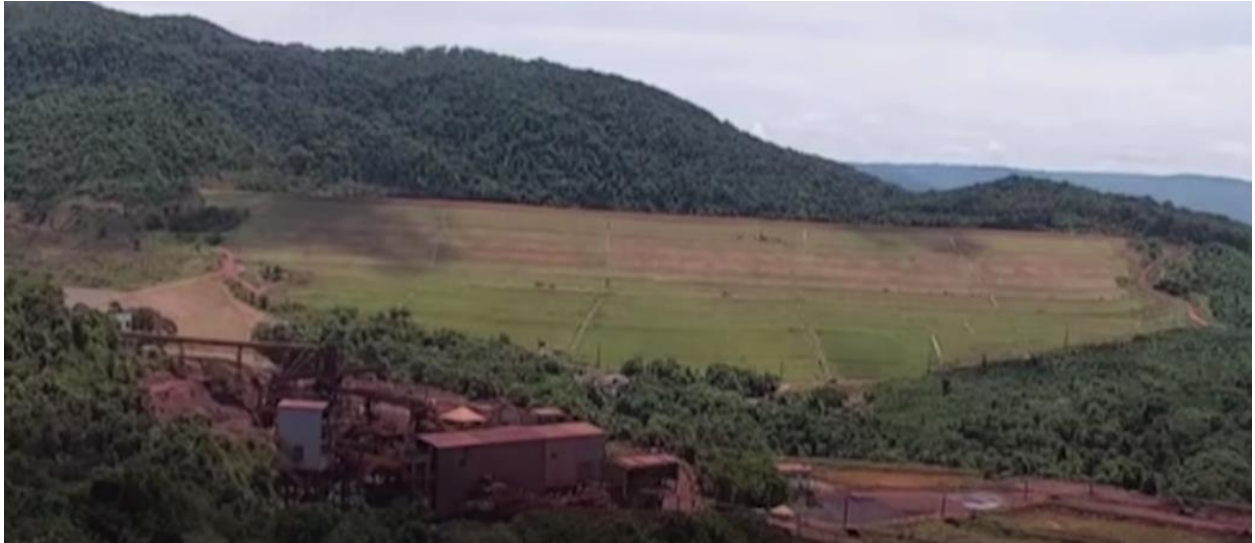
Figure 1 – Dam I before the collapse (Guardian News, 2019)

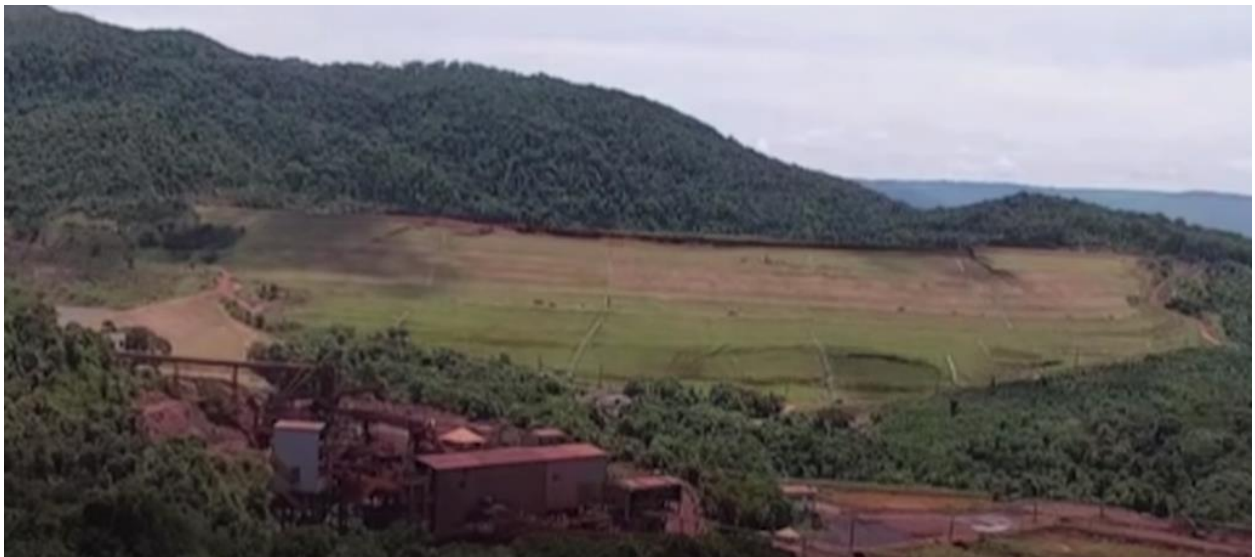
Figure 2 – Dam I when collapse started (Guardian News, 2019)

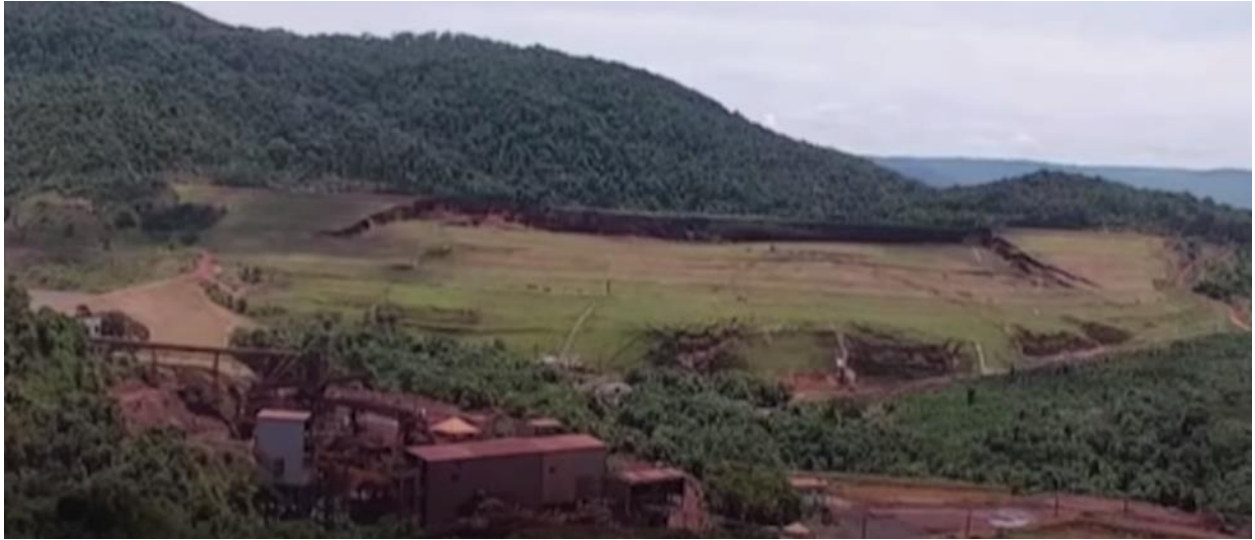
Figure 3 – A few seconds after the collapse started (Guardian News, 2019)

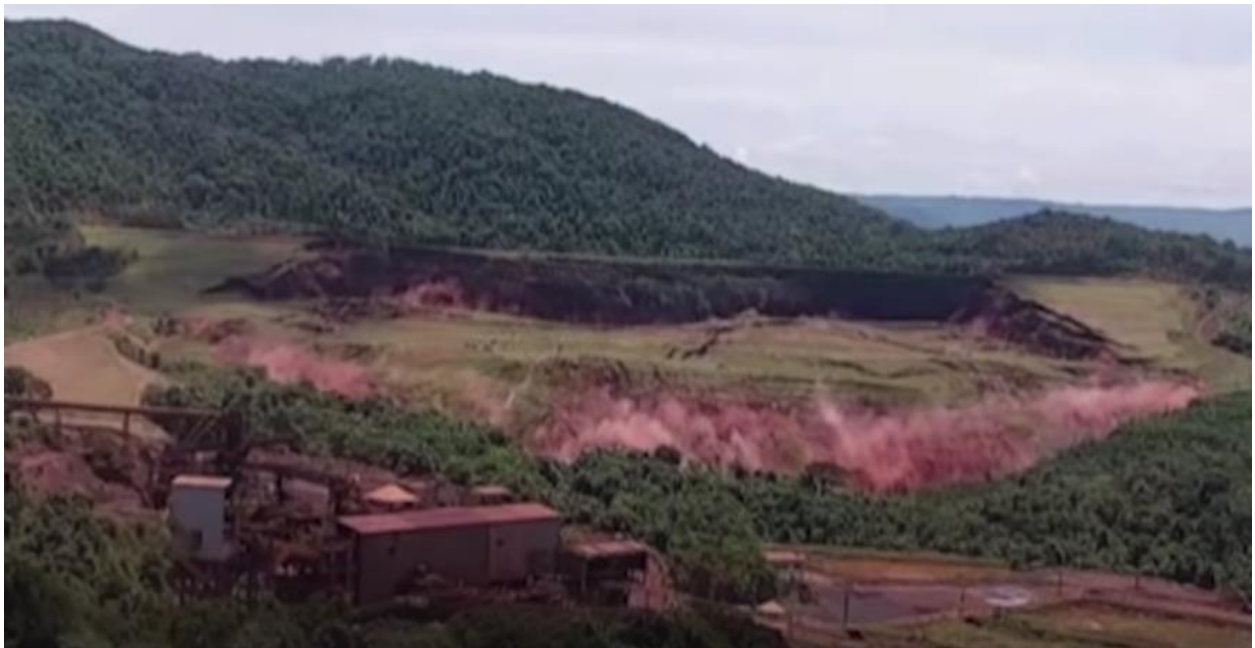
Figure 4 – The direction of the mudflow a few seconds after the collapse of the dam (Guardian News, 2019)

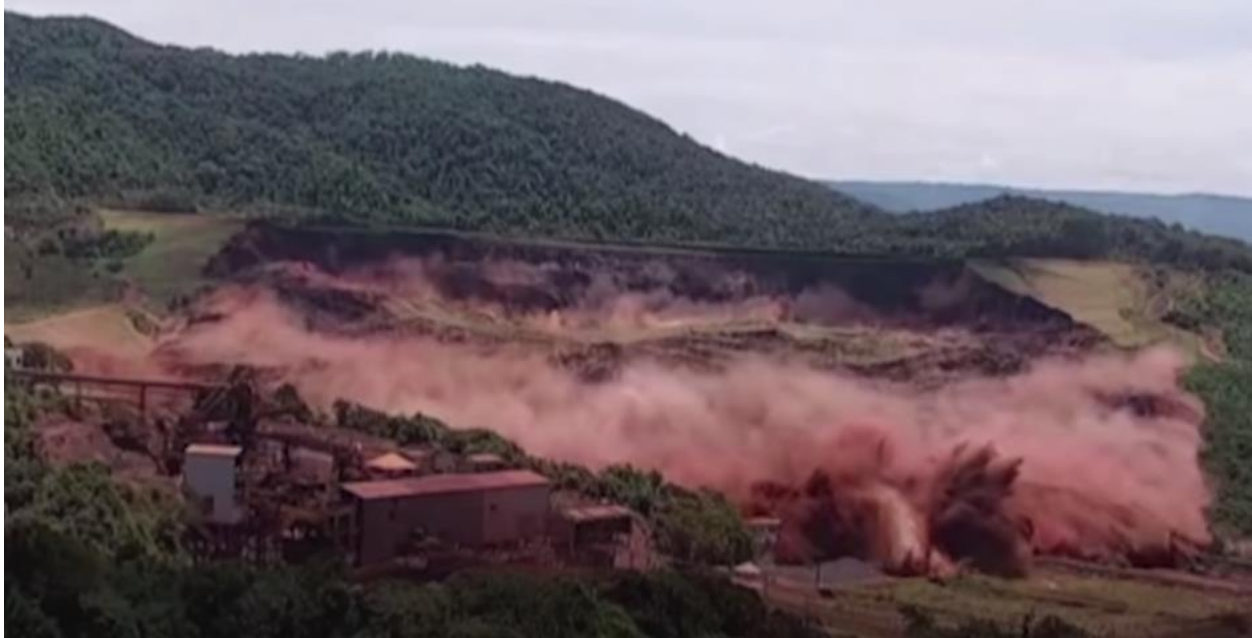
Figure 5 – The wave of the mud flowing downhill (Guardian News, 2019)

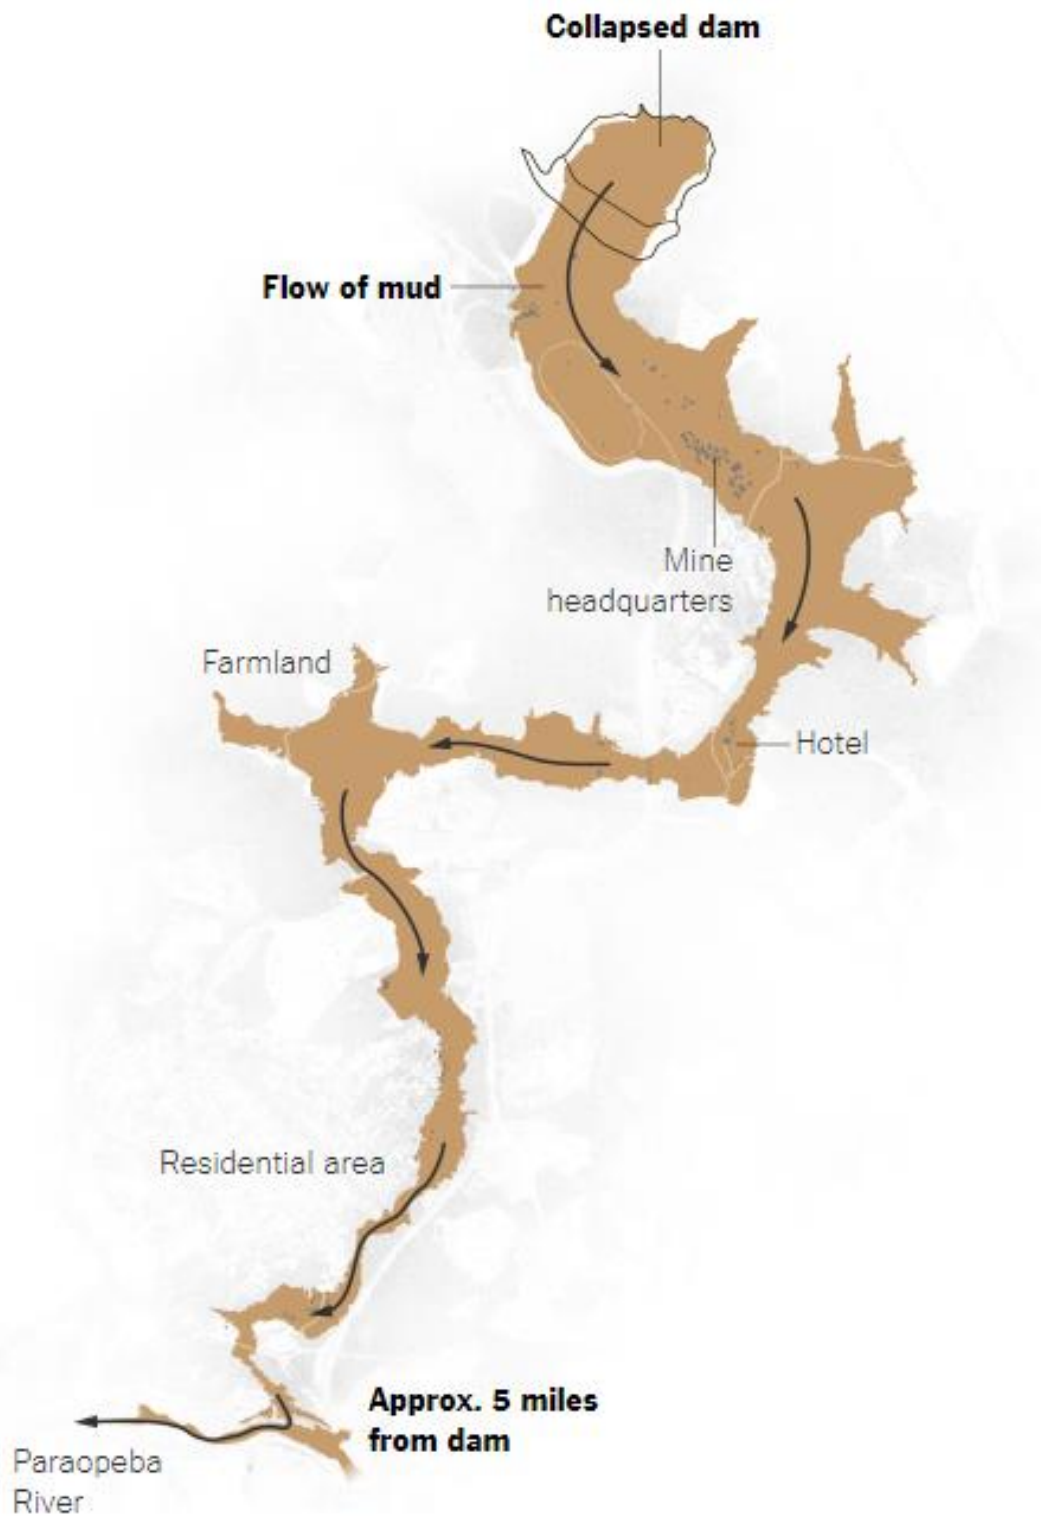
According to Robertson et al., (2019) the height of the dam was approximately 80 meters with a crest of approximately 700 meters. The evidence from the video footage and the unexpected mudslide flow distance shows that the failure was the result of flow liquefaction within the materials of the tailings dam.

Figure 6 - Tailing's mudflow down the hill (Darlington et al., 2019)

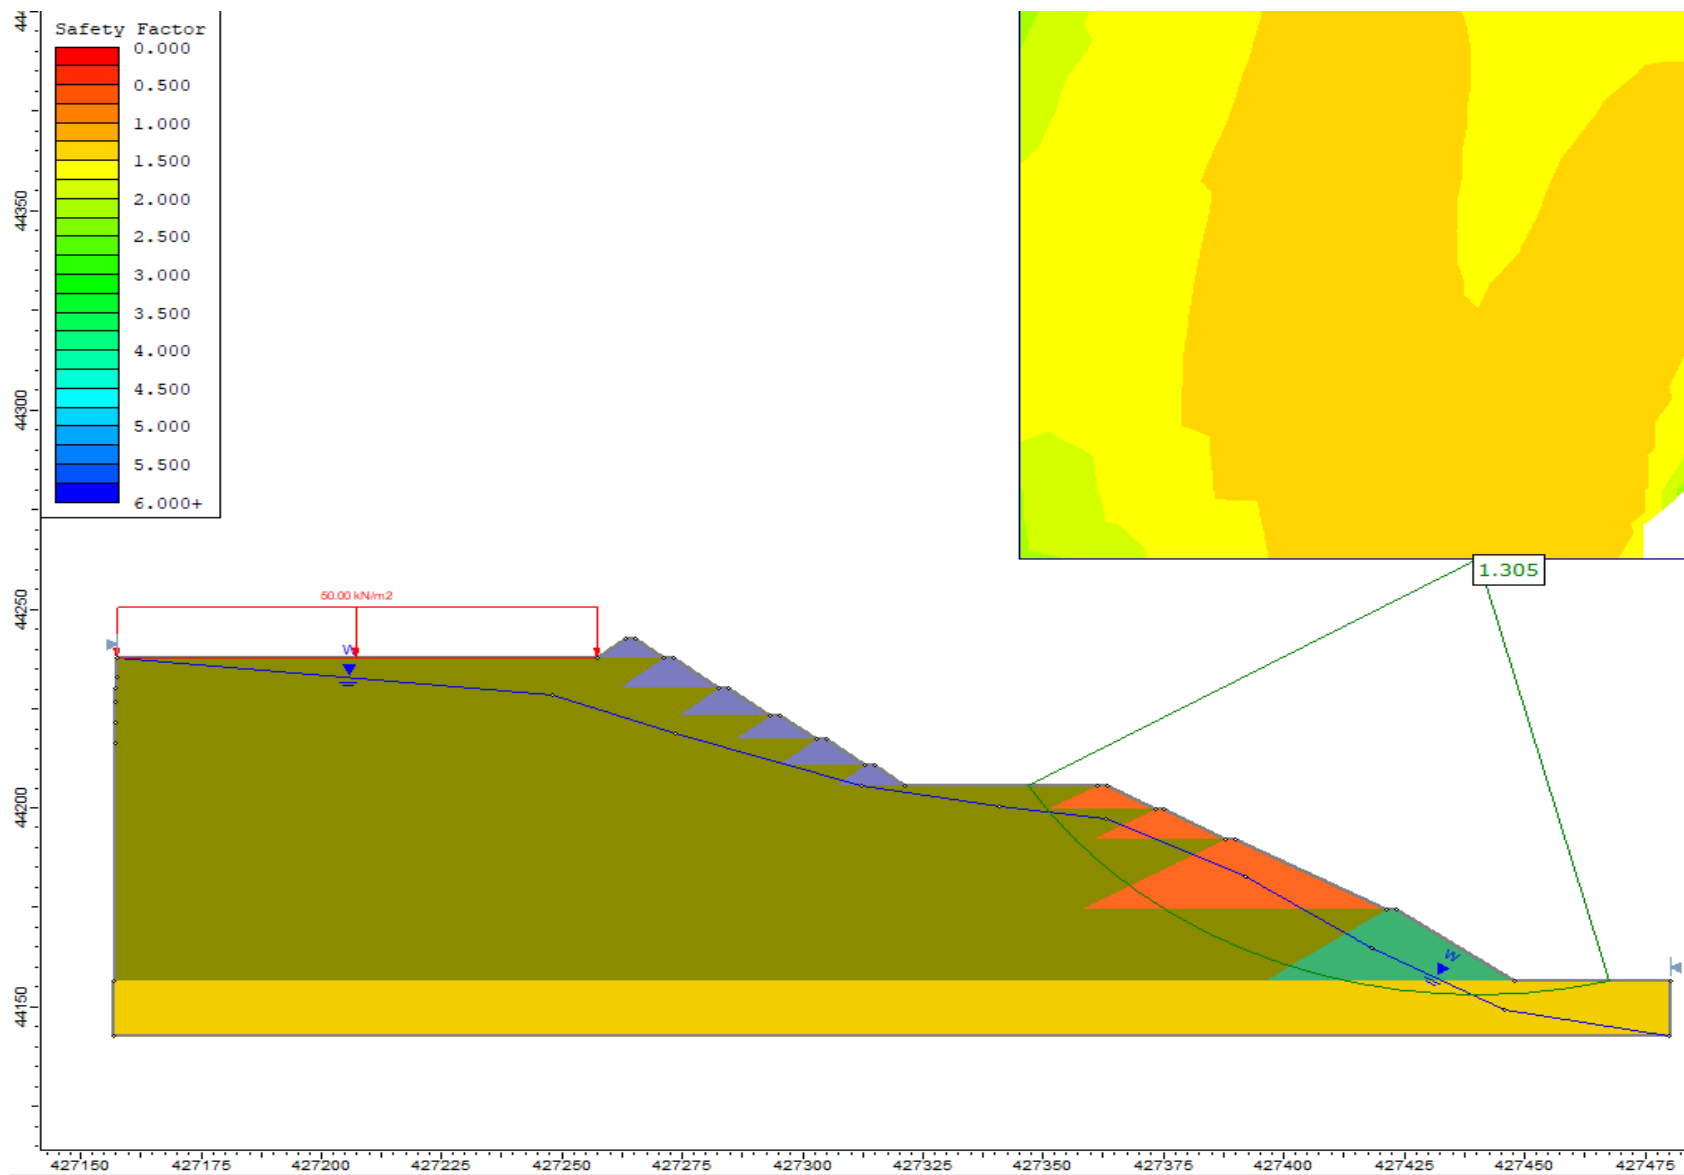
Therefore, the resulting safety factor of 1.305 goes to “Low” flow failure potential, which is very serious because the upstream tailing methods are very sensitive. Additional inspections, repair, and support should be done.

Figure 13 - Slope stability under the water pressure

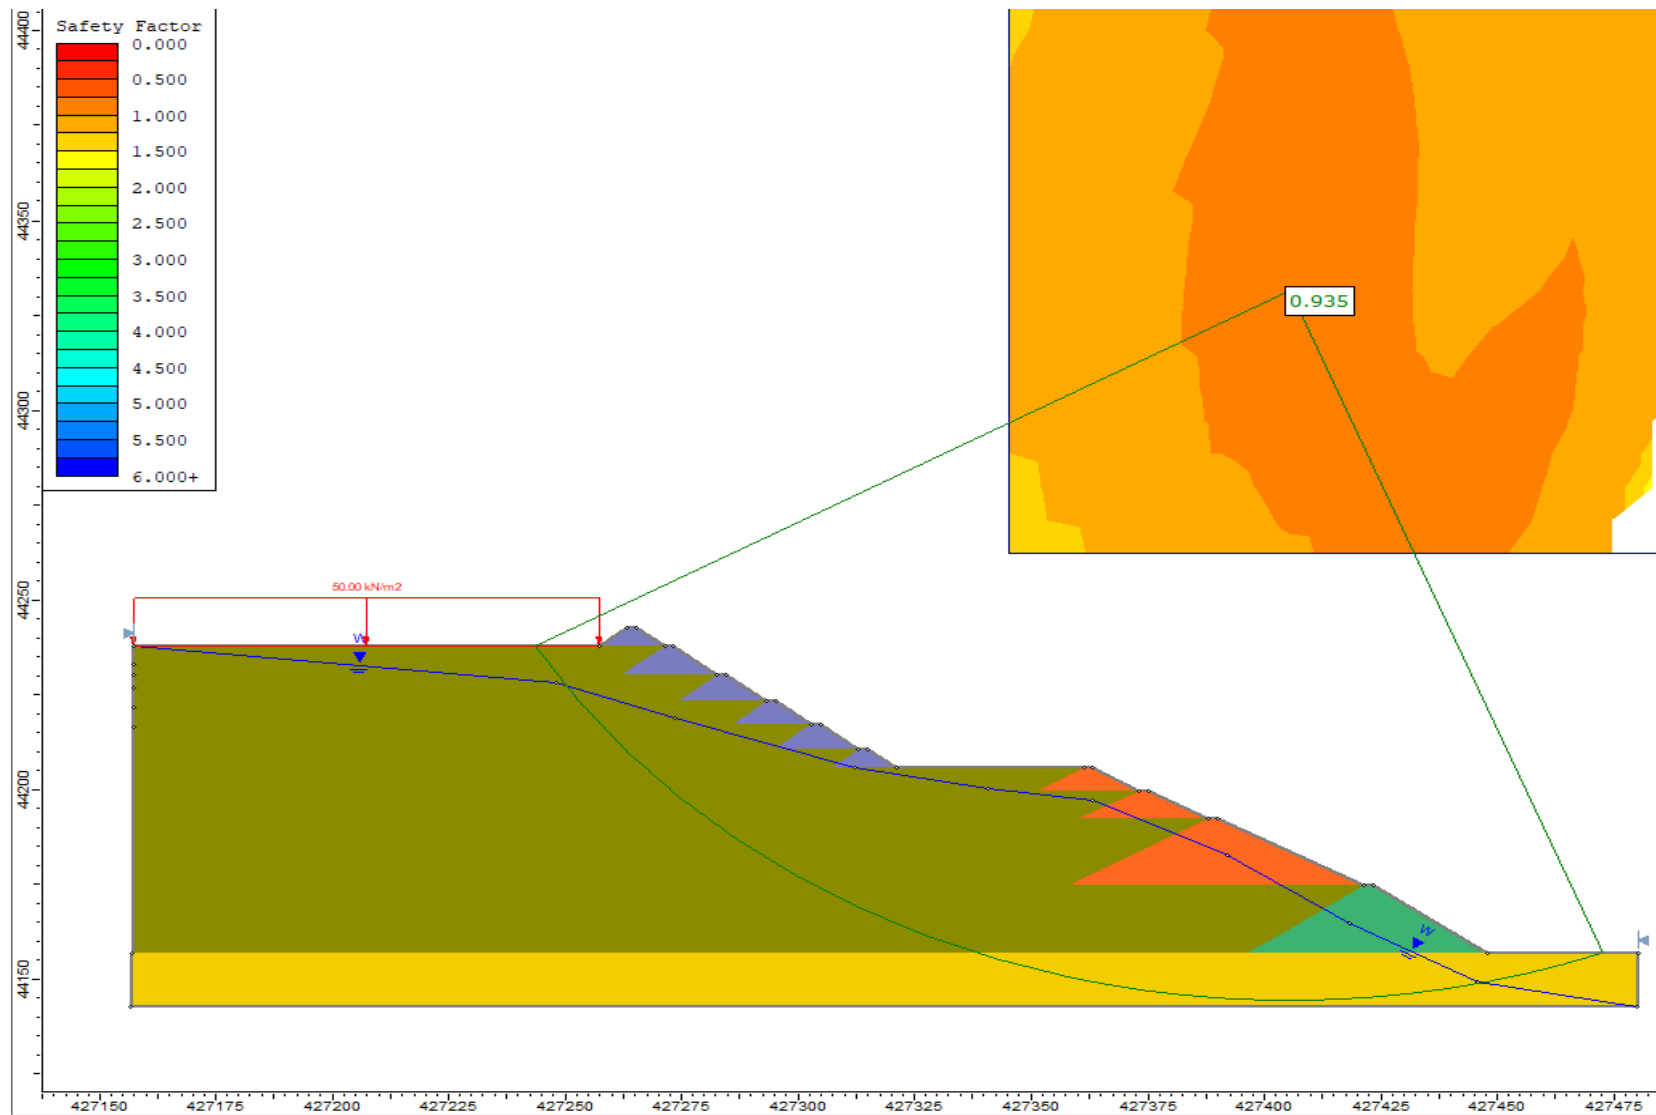
Analyzing this situation, the conclusion was that the safety of the dam is jeopardized because the factor of safety is 0.935 (Figure 14).

If an earthquake or any other major seismic activity occurred, the slope would fail because the safety factor is below 1.

Figure 14 – Critical part under the seismic activity

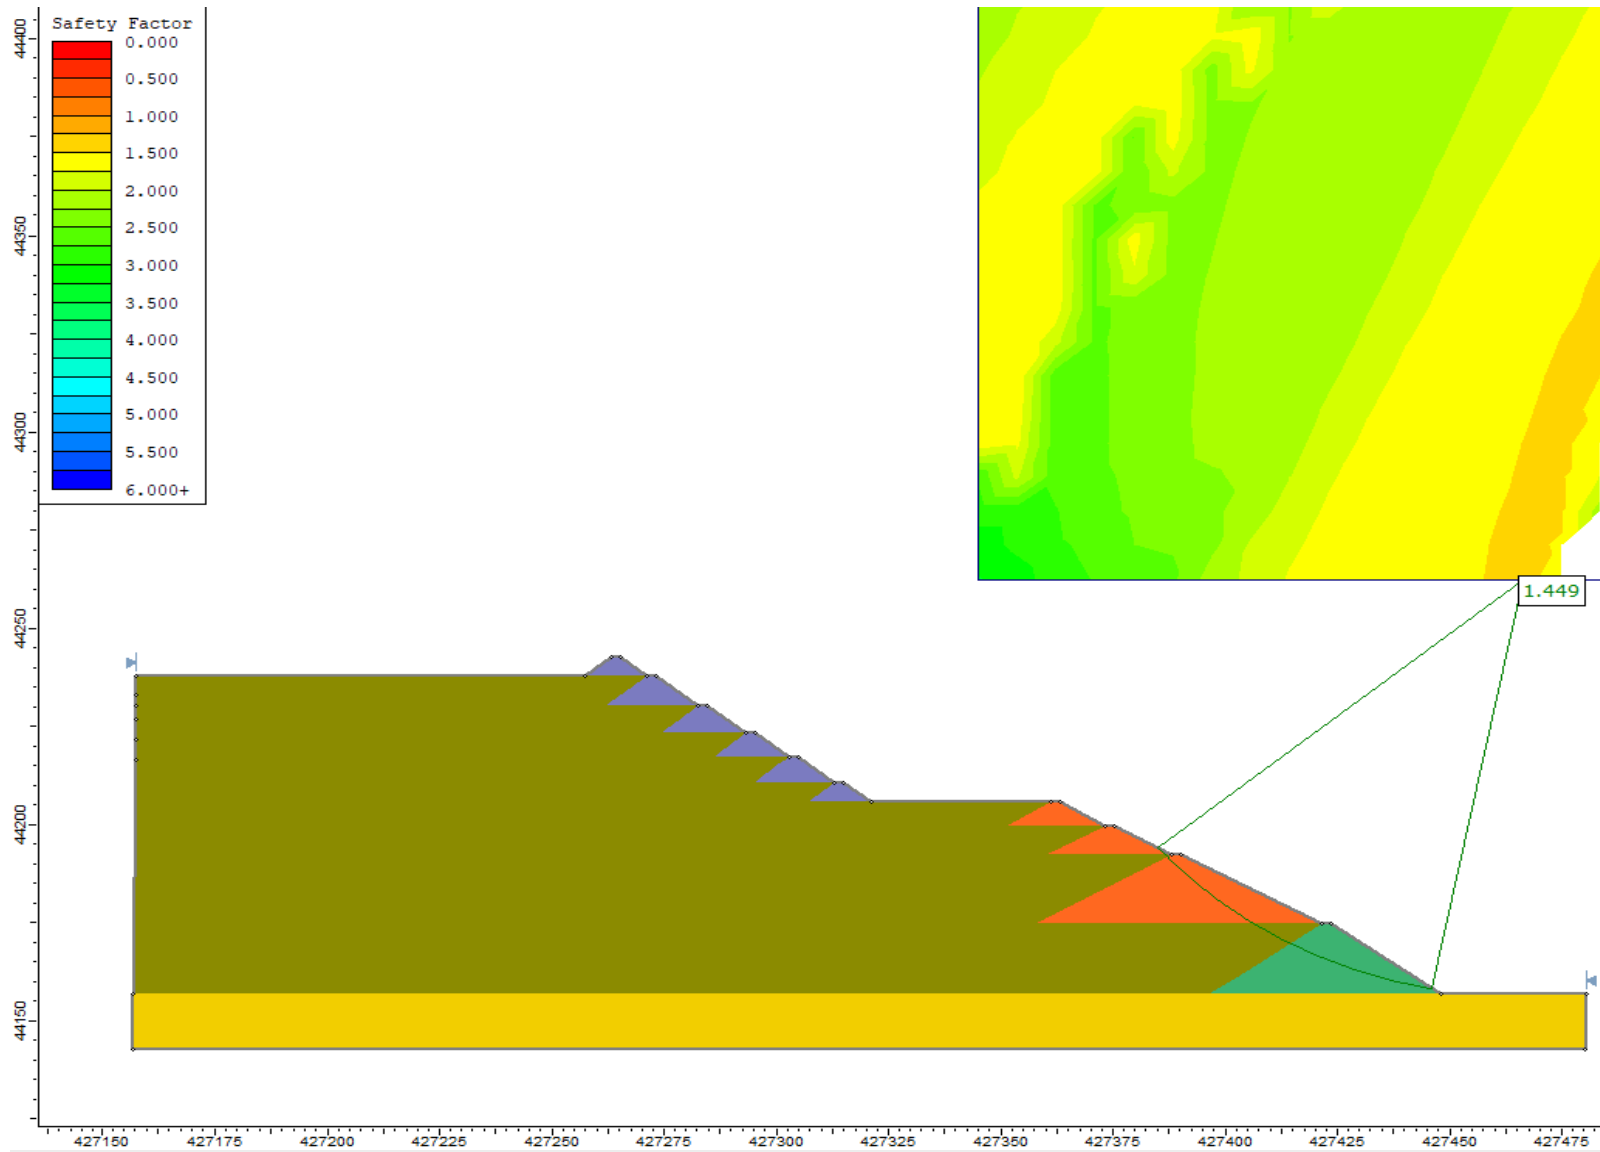
As a result of this simulation method, the factor of safety is 1.449 (Figure 16), which is satisfying, and the dam is safe when the dam is completely dry.

Figure 16 – Completely dry tailings dam

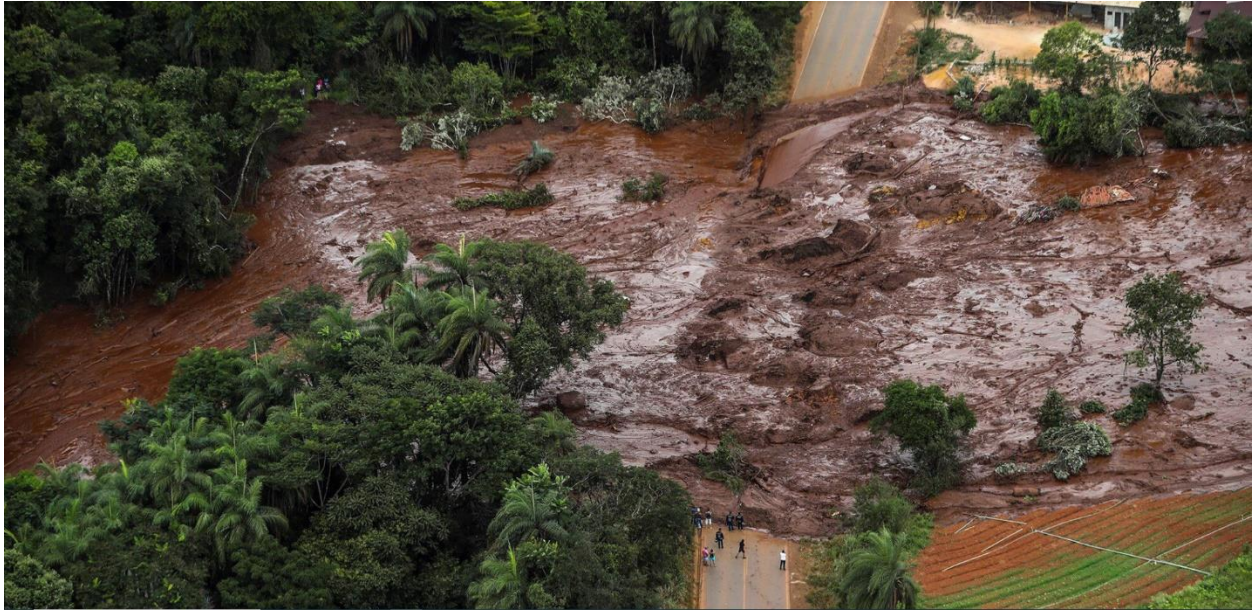
Toxic mud flowed for five miles, destroying homes, and offices, and killing people. The Brazilians had not seen a catastrophe like this before.

The slurry traveled downhill to the Rio Paraopeba River, killing most of the animals and contaminating the drinking water along the river.

Figure 17 - Tailings' mudflow (Darlington et al., 2019)

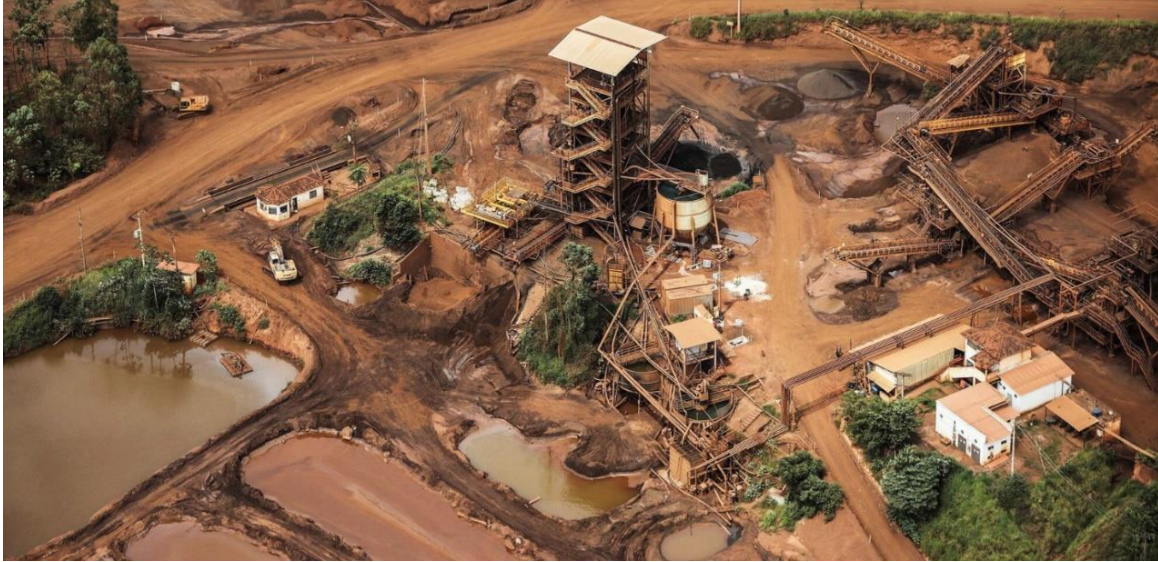
Figure 18 - Reparations to a plant after the incident (Darlington et al., 2019)
