## **Repair of Major Road Embankment Failure Using Reinforced Earth (re) wall**

Assoc. Prof. Ir. Damanhuri Jamalludin  
Ir. Dr. Mohd Farid Ahmad  
Samsuri Mohd Salleh  
Ahmad Kamal Md. Issa

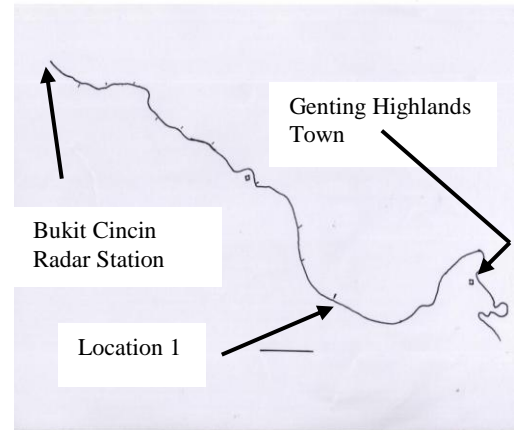
**Fig. 2 : Location of road failure at Location 1**

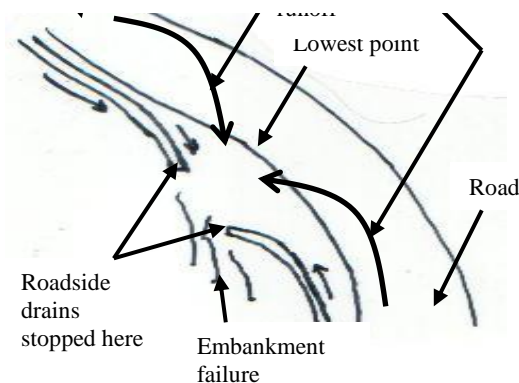
The causes of failure for this embankment were predominantly due to (a) soil erosion since roadside drains were not connected to cascading drain to lead rain water and surface runoff to the toe of slope and (b) improper compaction of the fill material resulting in critical battering of the slope. Erosion caused the toe of slope to progressively fail. Figure 3 shows erosion causing the major road failure while Figure 4 shows the failure at Location 1.

**Fig. 3 : No cascading drains causing erosion which lead to embankment failure.**

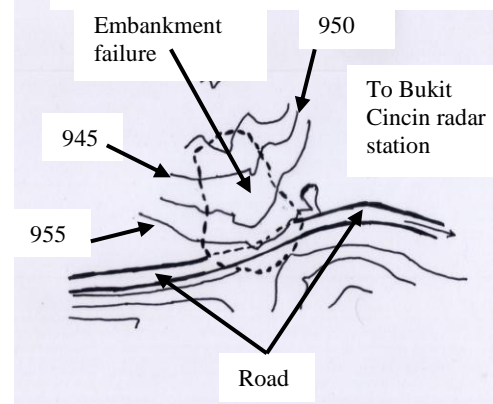
**Fig. 4 : Road embankment failure at Location 1.**

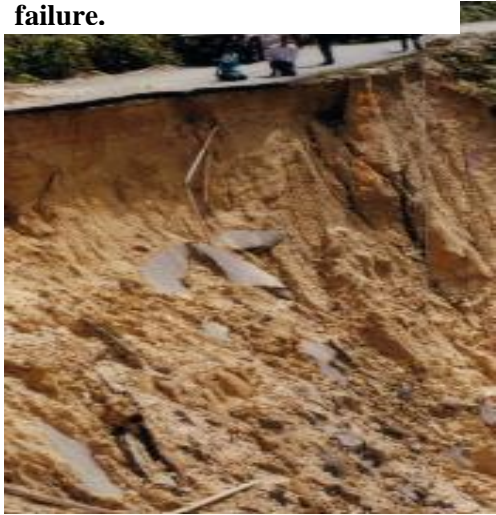
The shallow slips retrogressively moved towards the crest of the embankment created instability to the embankment. As this phenomena proceed, slumping of soil mass occurred and forming a vertical scarp at the crest of the embankment as described by Bumi Hiway (1998). Figures 5 and 6 show the road embankment failure.

**Fig. 5 : Major road embankment failure.**

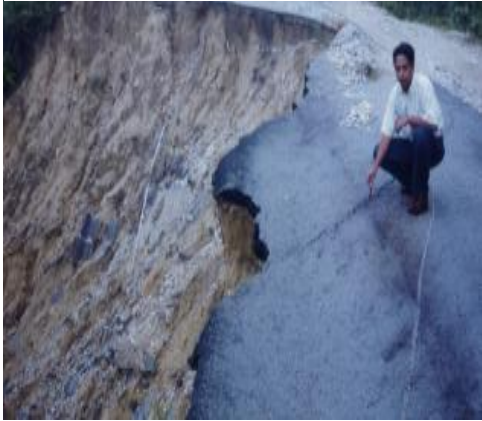
**Fig. 6 : Another view of the road embankment failure. The road was totally impassable to vehicles.**

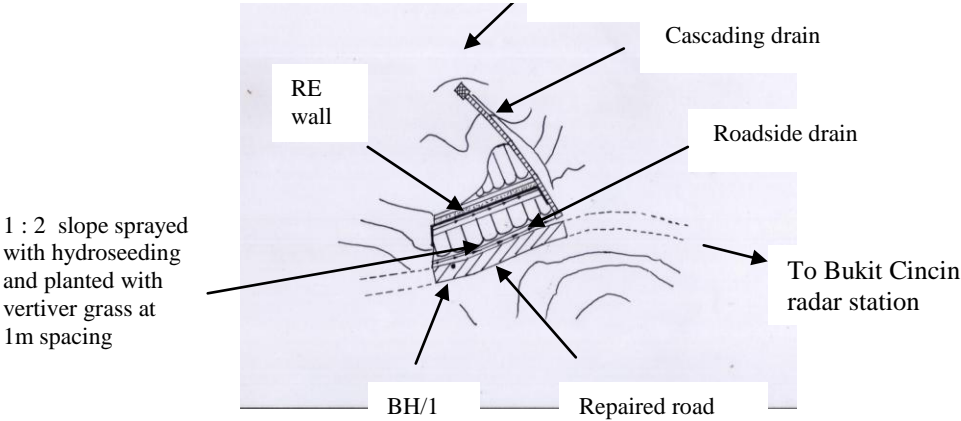
**Fig. 7 : The plan view of the repaired zone**

The wall height was 5.5m by 5.9m wide and about 29m long. Figure 7 shows the plan view of the repaired zone while the typical cross section of the repair works and the results of BH/1 are shown in Figure 8.

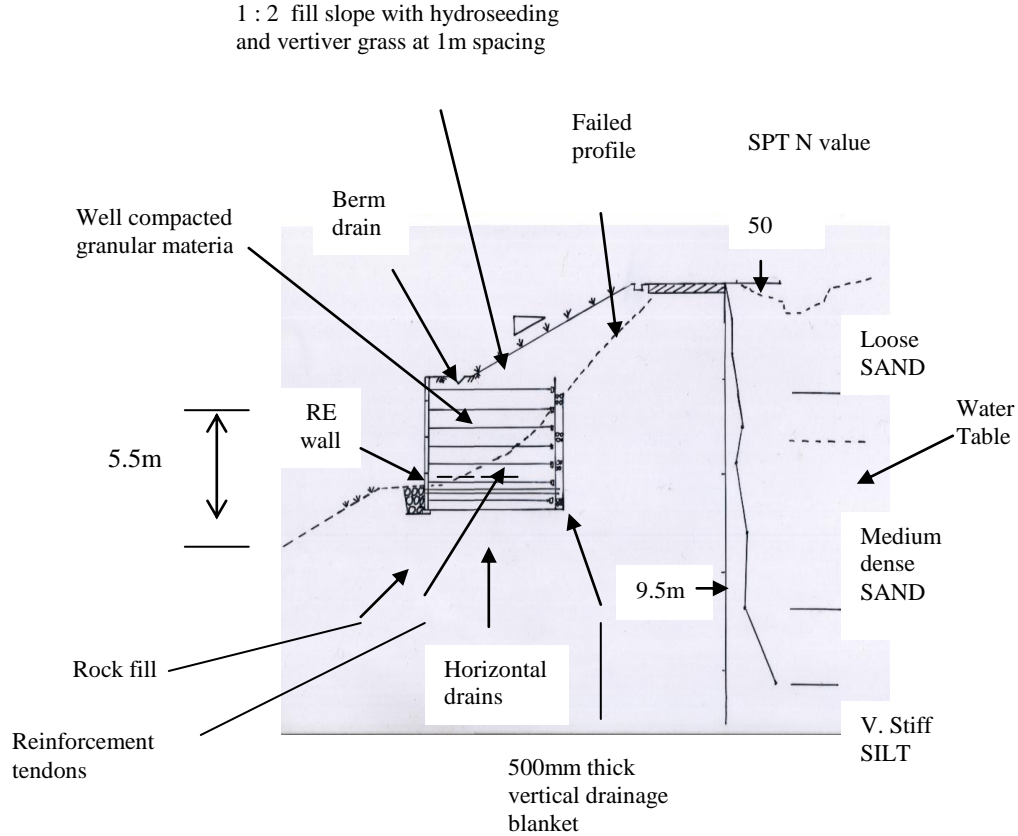
**Fig. 8 : Typical cross section of the repair works and the results of BH/1.**

Reinforced earth wall was suitable and used as the repair works for the failed embankment since the soil to place the wall was strong and also enough space was available to place the wall safely as recommended by Neoh et al. (1997). The base of the wall was decided at 9.5m below the existing road level. From BH/1, at this level, the soil type was medium dense clayey SAND with SPT N value of 9.

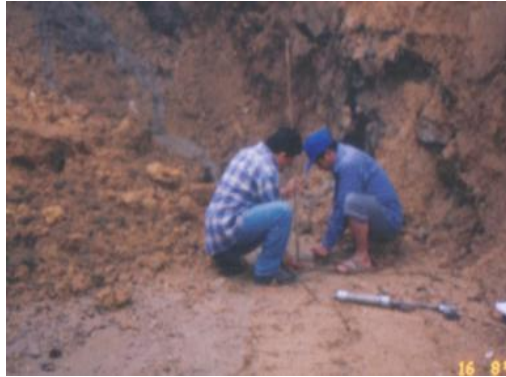
Precast anchor blocks were placed at the end of the trench. **Fig. 9 : Conducting JKR probe at the base level.**

A minimum horizontal distance of 2m was provided between the toe of the reinforced earth wall and top edge of down slope. Weak and failed materials were removed and the base was placed on firm ground. JKR probe tests were carried out to confirm the allowable bearing capacity of the base. Figure 9 shows JKR probe test is in the progress of being carried out.

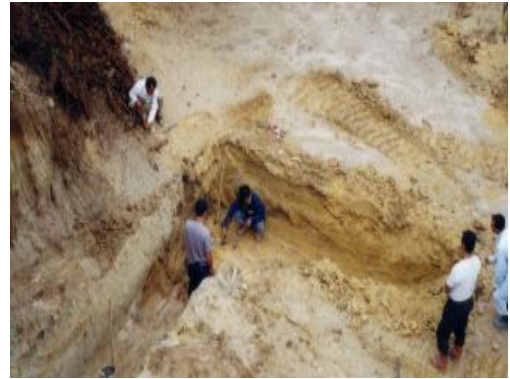
**Fig. 10 : Trench is excavated at the toe of RE Wall to construct the Rock Fill.**

A vertical drainage blanket 500mm thick was constructed between the reinforced earth wall and the existing embankment. It consisted of gravel wrapped with filter geotextile material. Rock fill 300mm by 600mm wrapped with geotextile TS20 was placed at the front toe of the reinforced earth wall as shown in Figures 10 and 11. Horizontal PVC drains 150mm diameter with spacing of 6000mm were placed almost at the base of the reinforced earth wall to drain groundwater collected in the vertical drainage blanket to the rock fill. Good external and internal drainage must be provided as recommended by Jones (1985) since large catchment area and also water table was found at 6.5m below road level. Drainage was provided by rock fill at toe, berm drain and shoulder drain in which all were connected to a cascading drain. Stone filled gabion mattress was constructed at the toe of the cascading drain to prevent toe erosion as shown in Figure 7.

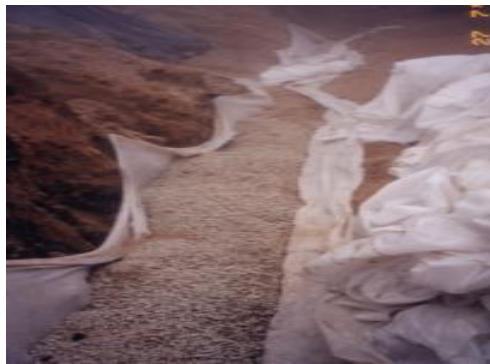
**Fig. 11: Gravel wrapped with geotextile is placed into the excavated trench to form Rock Fill.**

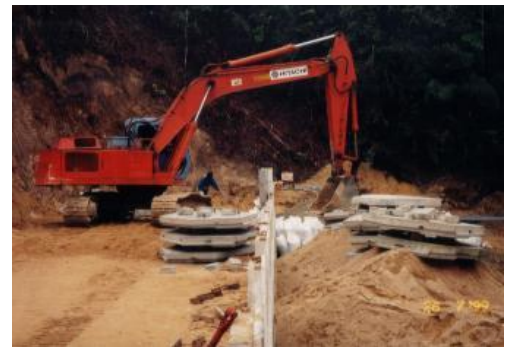
**Fig. 12 : Erecting the RE Wall.**

The reinforced earth wall consisted of hexagonal shaped precast concrete panel connected to hot dipped galvanised reinforcing tendons as shown in Figures 12 and 13.

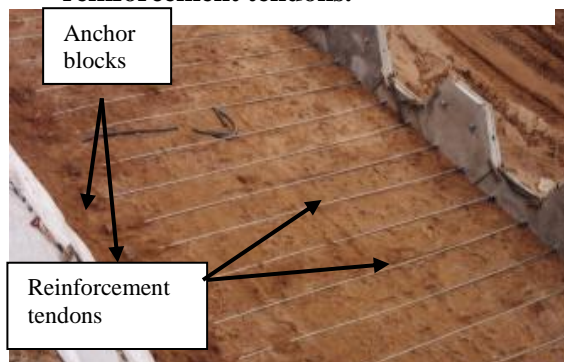
**Fig. 13 : Laying of the galvanised reinforcement tendons.**

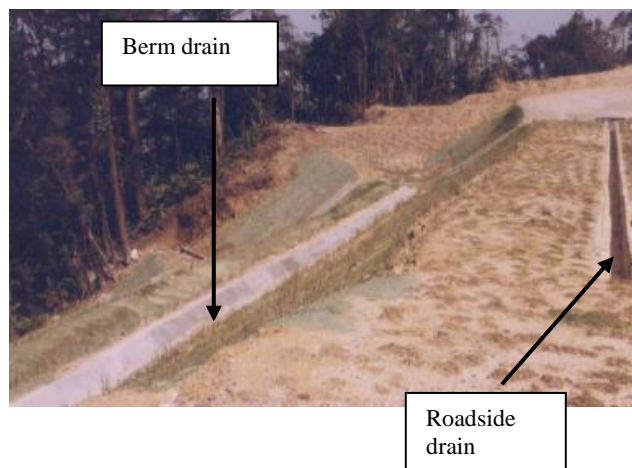
**Fig. 15 : New roadside drain is constructed. Road shoulder is turfed.**

Hydroseeding grass was sprayed and vertiver grass at 1m spacing was planted on the reconstructed slope while at downslope, 3 rows of vertiver grass at 1m spacing were also planted. Berm drain and roadside drain were connected to a cascading drain with stone filled gabion mattress at its toe. Figure 15 shows the berm and roadside drains. The damaged road was also reconstructed on the pile embankment. Partially completed repair works are shown in Figure 14 while the fully completed repair works are shown in Figure 16.

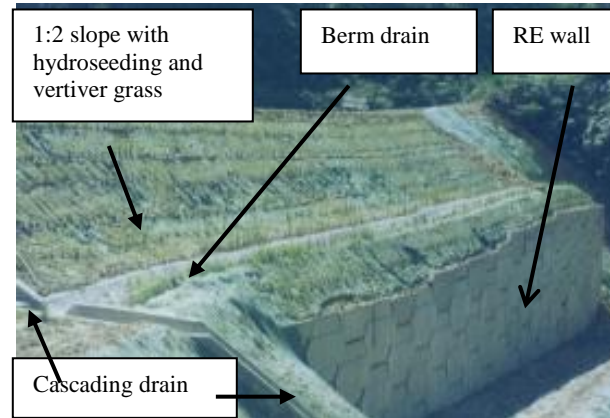
**Fig. 16 : Completed RE wall with berm drain and cascading drain.**
