Safety Investigation and Guidance for Work-Zone Devices in Freight Transportation Systems Subjected to Passenger Car and Truck Impacts with New Crash Standards

Report # MATC-UNL: 100

Final Report

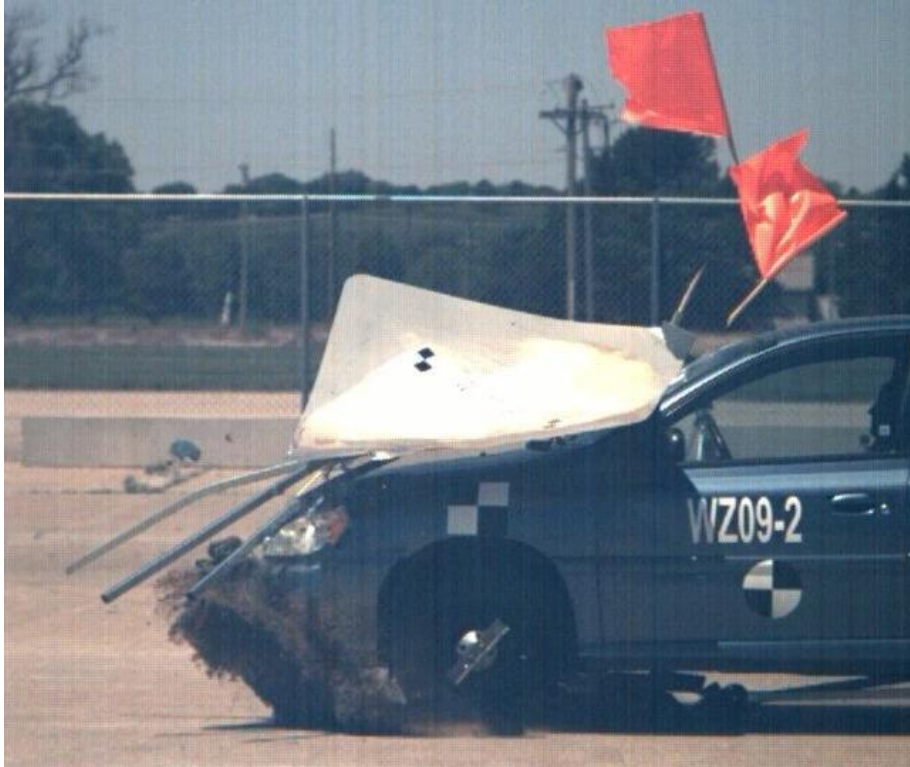
Sign stands that resemble a tripod shape when oriented 90 degrees to the vehicle were found to have a potential to rotate and rise into the air, resulting in the top of the support impacting and penetrating the windshield, as shown in Figure 105 (System No. 2B). Since the legs and mast were not intended to breakaway or yield significantly, the motion and weight of the entire system had the potential for significant windshield damage.

Figure 105. System No. 2B, Tripod Oriented at 90 Degrees
