# FAILURE ANALYSIS OF GREY IRON ENGINE FLYWHEEL

## Abstract:

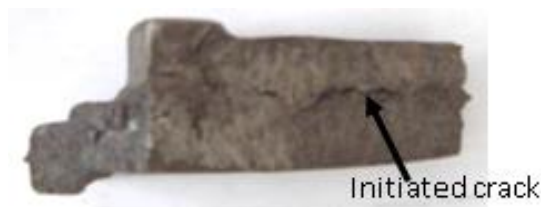
Fig. 1 shows a partial view of the failed flywheel as received from the foundry. The intact flywheel is shown for comparison in Fig. 2. It can be inferred from it that the crack initiated in the centre of the flywheel and propagated toward the fringe surface (Fig. 1). From the colour of the section in Fig. 1, we deduce that this crack should belong to cold crack, rather than hot crack.

Figure 1. The as-received section of failed flywheel.

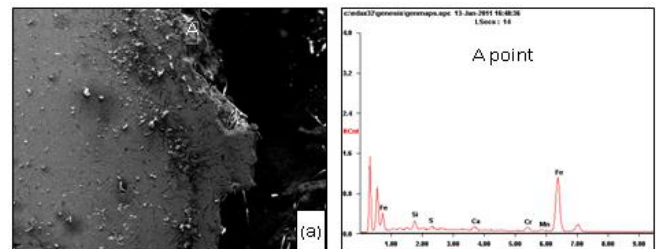
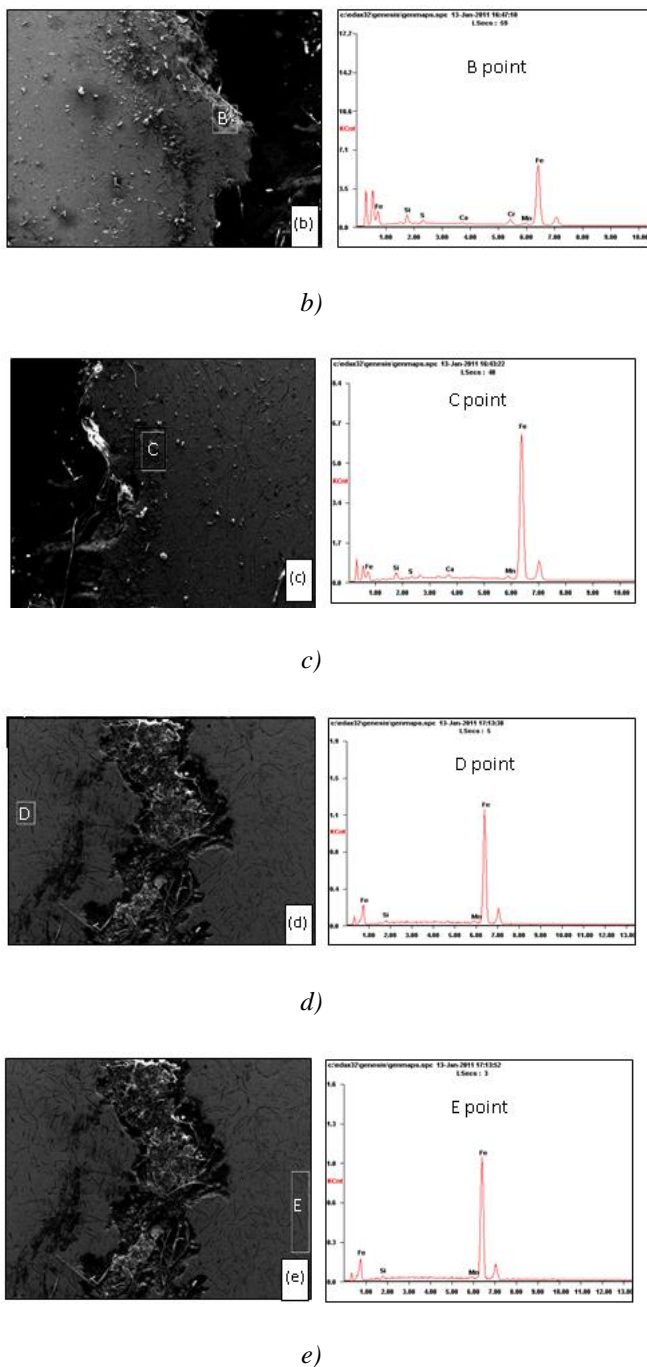
Fig. 3 shows EDS analysis of the fracture surface by SEM: the EDS result shown in Fig. 3 is also given in Table 2. It can be seen that regions A and B near the crack zone contain higher Si, S, and Ca, while the normal regions C and D remote from the crack have less Si, and no S or Ca. This indicates that some inclusions containing Si, S, and Ca may have been responsible for the fracture of the flywheel. During casting, potential origins for such inclusion formation were:

Figure 3. EDS analysis of the fracture surface (a-e).

It can be inferred from the results of Fig. 3 and Table 2 that the aforementioned causes of inclusion formation may be the second, and/or third, and/or fourth, rather than the first (*i.e.* due to the absence of oxygen).

- 1) During inoculation treatment, the tapped temperature of the molten iron controlled was within the specified range of 1450 to 1500°C, thus ensuring the complete melting of the inoculant.
- 2) Before pouring molten iron into the casting mould, the coating agent and inclusions such as slag on its surface should be completely eliminated.
- 3) A ceramic filter was not used in this pouring system to block slag and so on from entering the mould for casting the flywheel while the molten

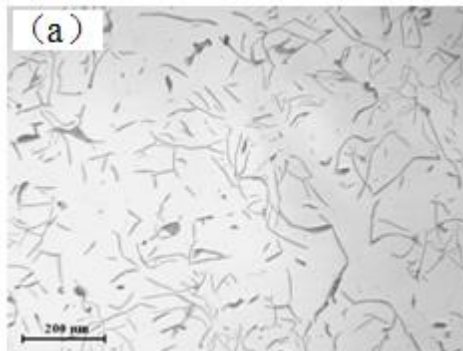
The sample for metallographic investigation was taken from the cracked zone of the fractured flywheel. Microstructural observations and hardness inspection both near-crack and far-field were conducted. The results are shown in Fig. 4 and Table 3, and evaluated according to the properties of this flywheel. The lower hardness correlated well with the presence of higher ferrite content in the near-crack zone.

a) graphite near the crack zone

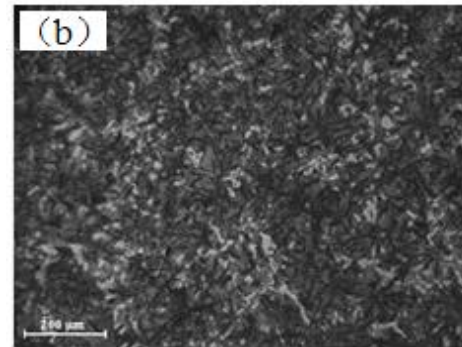
b) matrix near the crack zone

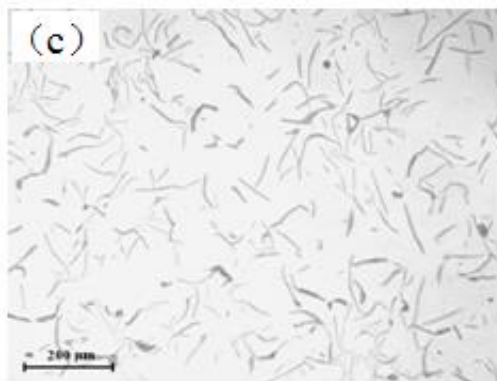
c) graphite of the normal zone

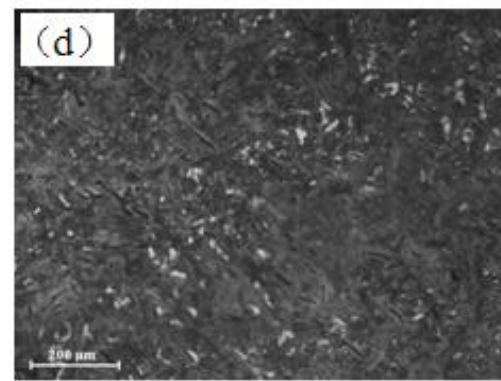
d) matrix of the normal zone

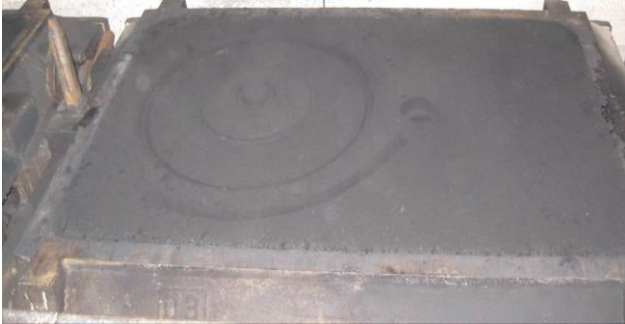
Figure 5. The upper sand mould.

iron was being poured, however, a proposed filter design is shown in Figures 5 and 6.

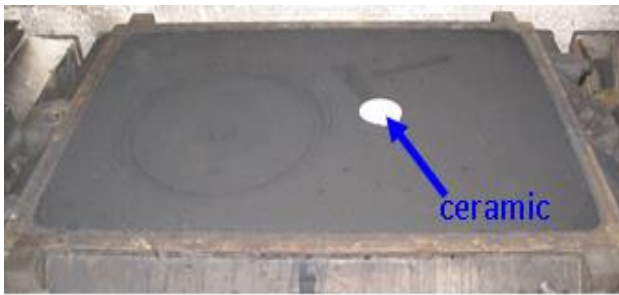
Figure 6. The lower sand mould.
