TECHNICAL REPORT NO. 246

The Installation of a new Transmission Monitor in Izaña in 2004 November

Steven J. Hale and Brek A. Miller

2005 January 26

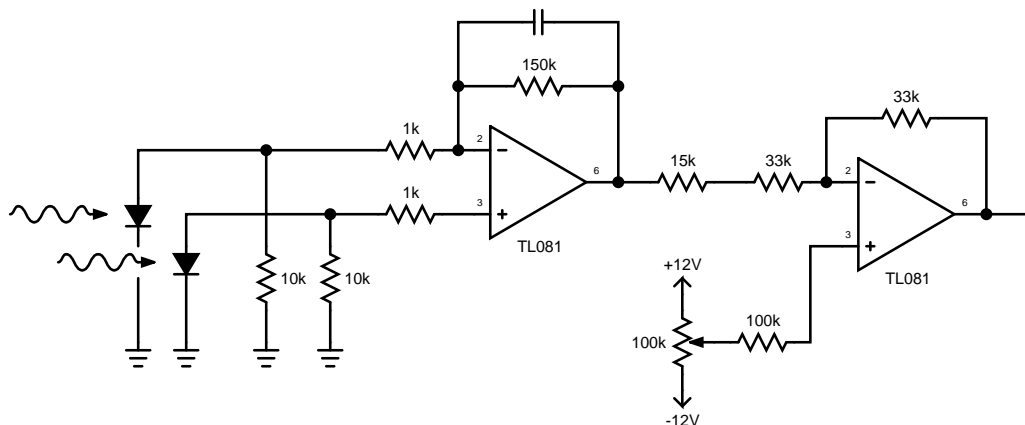
Pere told us that the problem was with the power supply inside the autoguider differencer. The internal 5-V supply was working, but someone had had to connect an external ± 15 -V supply to the differencer.

We guess that perhaps there was previously a problem inside the autoguider differencer (a short somewhere, perhaps) that was causing too much current to be drawn from the regulators making them shut down. This problem was probably cleared when the wires were rearranged to accommodate the external supply.

Figure 1: A partial schematic drawing of the autoguider differencer.

While we were examining the autoguider differencer, we made a note of part of the circuit inside. It is built on a piece of Veroboard. We did not remove the Veroboard so we could not make a complete circuit drawing, but we were able to learn that the photodiodes are being used in voltage mode. The partial circuit is shown in Figure 1.

We decided not to reconnect the external supply. The autoguider differencer worked correctly for the remainder of our visit. We did periodically check the temperatures of the regulators, but nothing seemed amiss.
