TECHNICAL REPORT NO. 261

The Grand Opening of the Las Campanas Zoo

Steven J. Hale and Brek A. Miller

2006 February 1

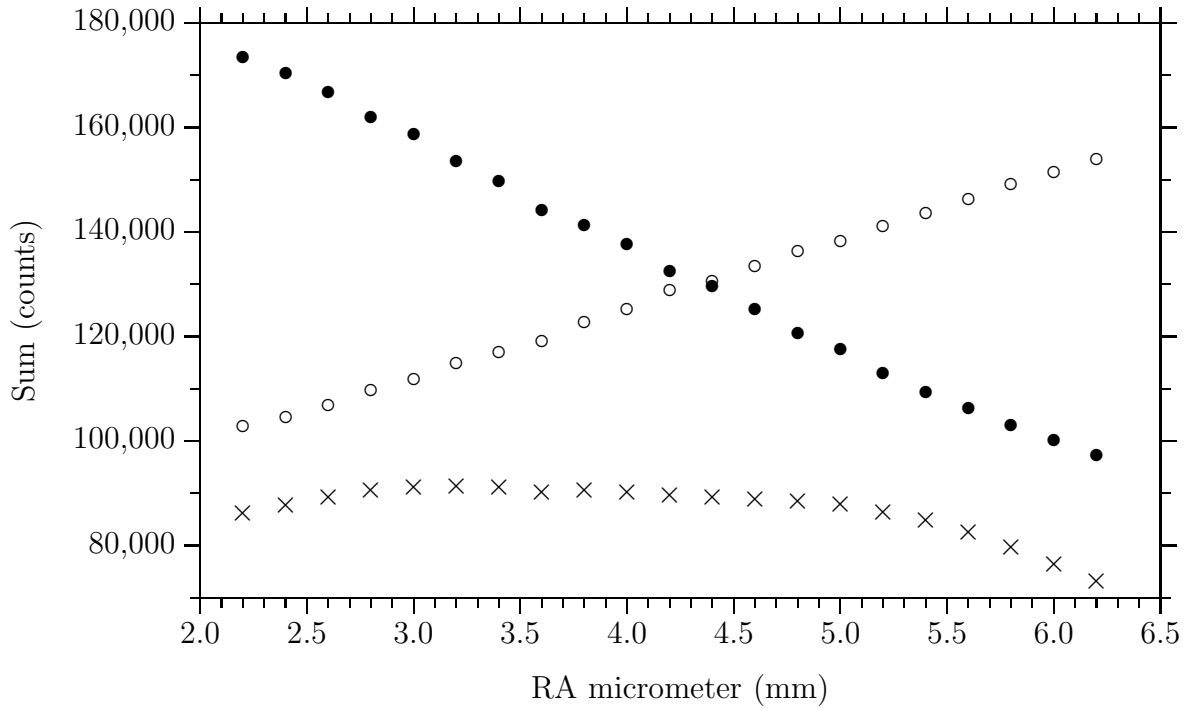
We performed two autoguider scans in order to check the alignment of the mount. The results of the right-ascension scan are shown in Figures 1 and 2. It looks like Hannibal is centered when the right-ascension micrometer is set to 4.3 mm while Ivan is centered at 4.5 mm. The autoguider telescope is 500 mm long, so the angular offset between the two spectrometers is:

$$\theta = \frac{0.2 \text{ mm}}{500 \text{ mm}} = 0.00040 \text{ rad} = 0^{\circ}0229 = 1'374.$$

Figure 1: Hannibal sums from an right-ascension autoguider scan. The plot shows how the starboard sum (●), port sum (○), and transmitted sum (×) varied. The transmission monitor data has been multiplied by two. This scan was done with the declination micrometer set at 1.6 mm.

After that scan, we set the micrometer to 4.4 mm hoping that this would be in the middle. But it looked like this now favored Ivan, so we nudged the micrometer back to 4.3 mm. Incidentally, the micrometer was set at 4.2 mm before we began the scans.

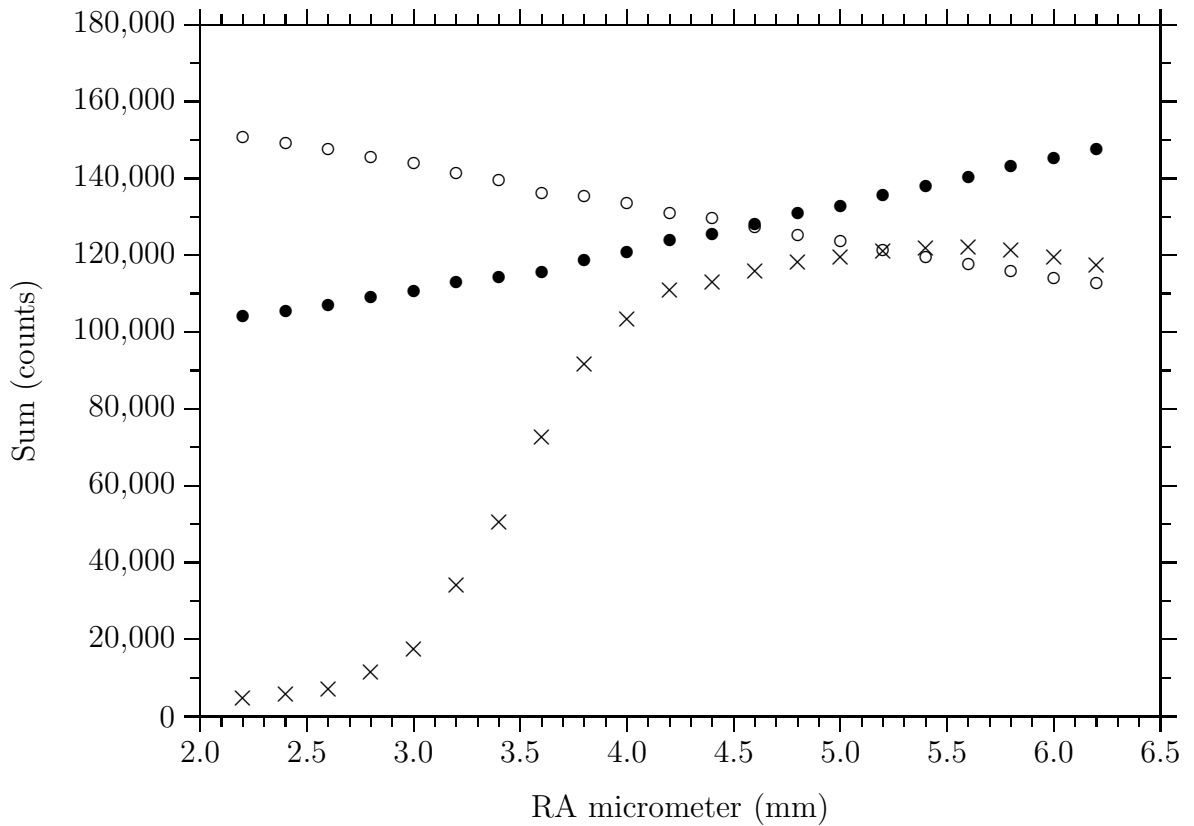
Figure 2: Ivan sums from an right-ascension autoguider scan. The plot shows how the starboard sum (●), port sum (○), and transmitted sum (×) varied. The transmission monitor data has been multiplied by ten. This scan was done with the declination micrometer set at 1.6 mm.

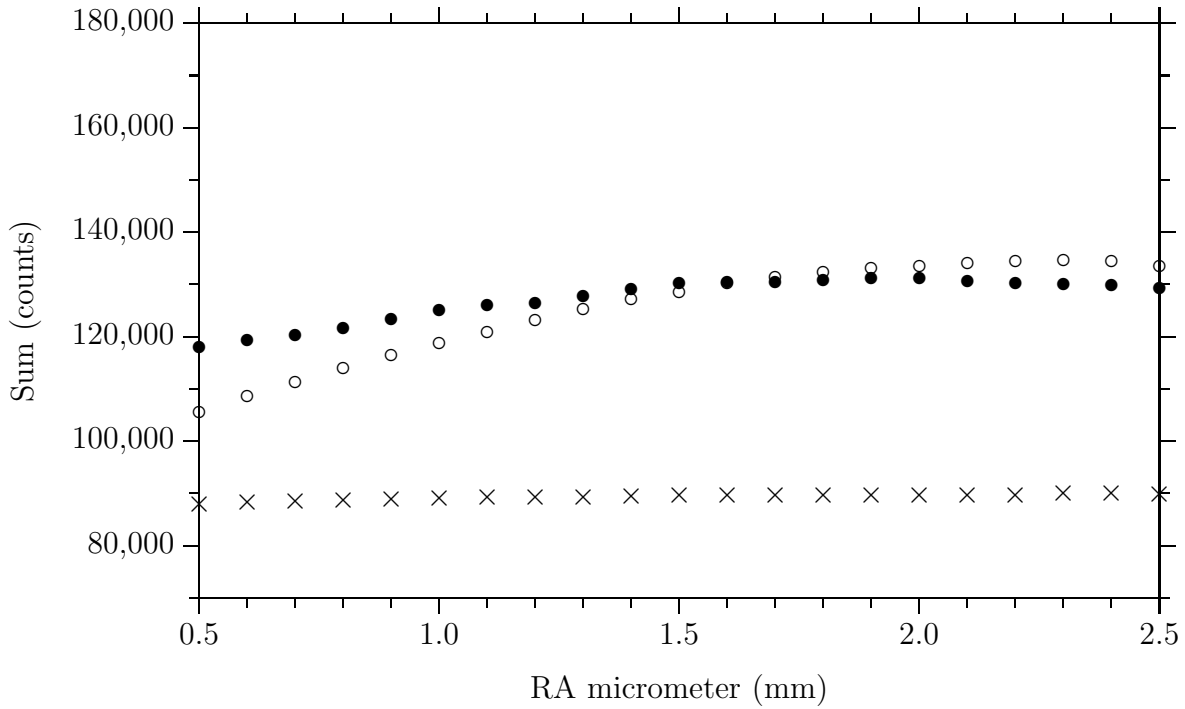
Figure 3: Hannibal sums from a declination autoguider scan. The plot shows how the starboard sum (●), port sum (○), and transmitted sum (×) varied. The transmission monitor data has been multiplied by two. This scan was done with the declination micrometer set at 4.2 mm.

The results of the declination scan are shown in Figures 3 and 4. It looks like Hannibal wants the declination micrometer set to 2.0 mm while Ivan wants 1.25 mm. We compromised and set it at 1.6 mm. Before the scan, the micrometer was set to 1.4 mm.

$$\theta = \frac{0.75 \text{ mm}}{500 \text{ mm}} = 0.00150 \text{ rad} = 0^\circ 08' 59'' = 5'16''.$$

The center box in the mount is 290 mm long. To correct this error, we would need a 0.435-mm-thick shim under the front of Ivan.

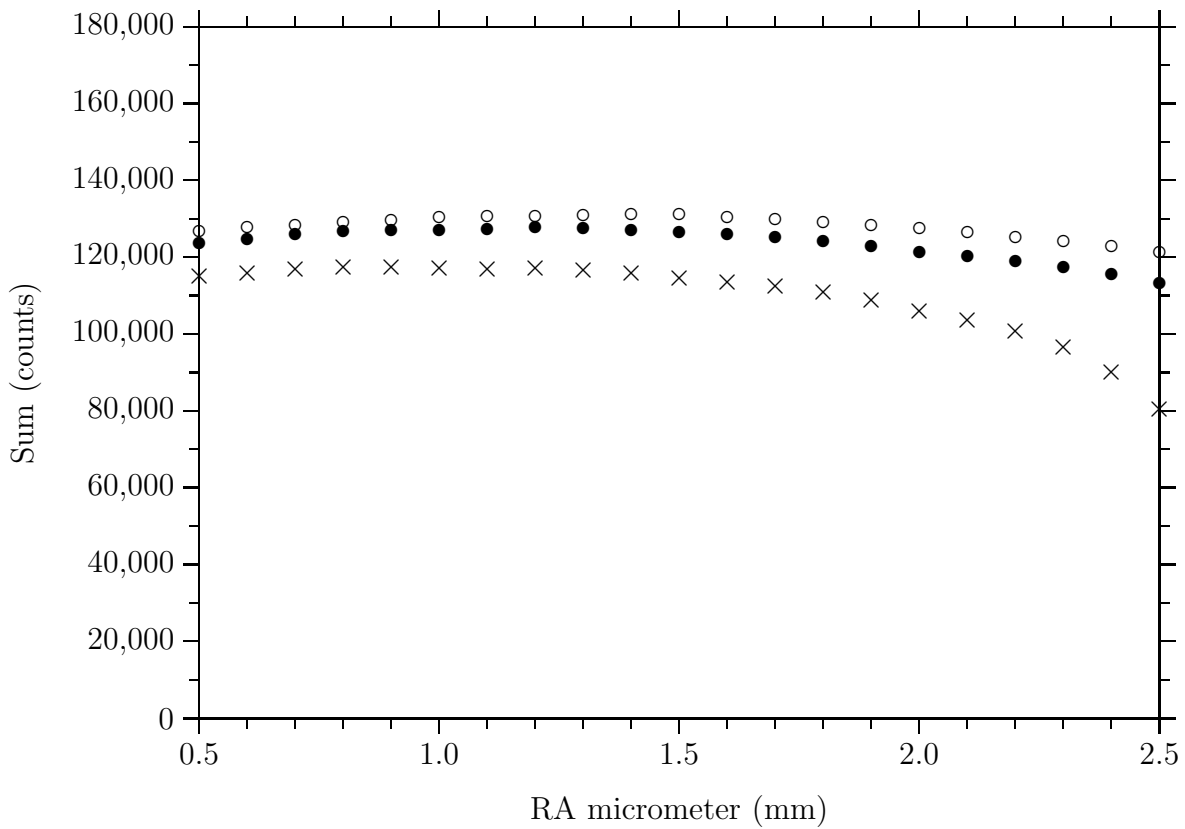
Figure 4: Ivan sums from a declination autoguider scan. The plot shows how the starboard sum (●), port sum (○), and transmitted sum (×) varied. The transmission monitor data has been multiplied by ten. This scan was done with the declination micrometer set at 4.2 mm.
