# BiSON

TECHNICAL REPORT NO. 360

## The Installation of a Digital Autoguider and Tiger Counters in Narrabri in 2013 April

2013 May 20

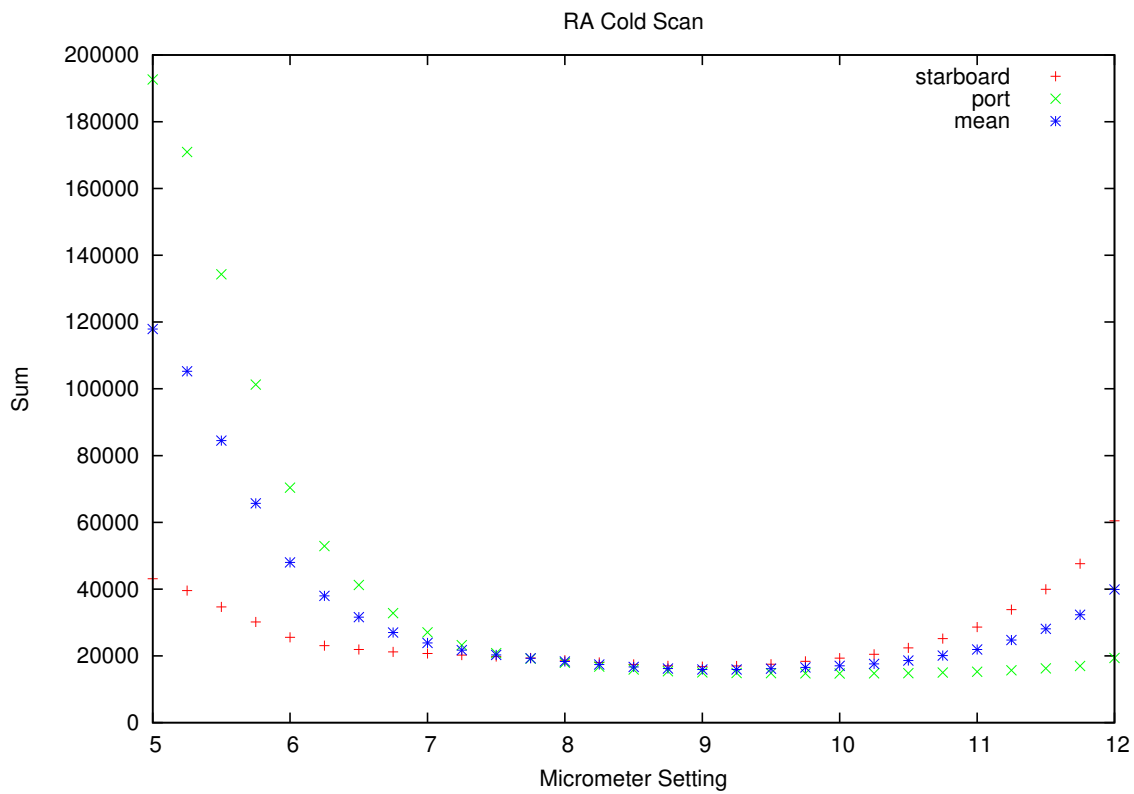
Figure 1: RA Cold.

Four autoguider scans were performed. Both axes were scanned with the potassium cell cold, and then again with the cell hot. The results from the cold scan are shown in figures 1 and 2. The results from the hot scan are shown in figures 3 and 4.

Initially the RA micrometer was set to 9.1 mm and the Dec micrometer set to 8.5 mm. The scans show the ideal alignment to be at RA 9.0 mm and Dec 8.5 mm.

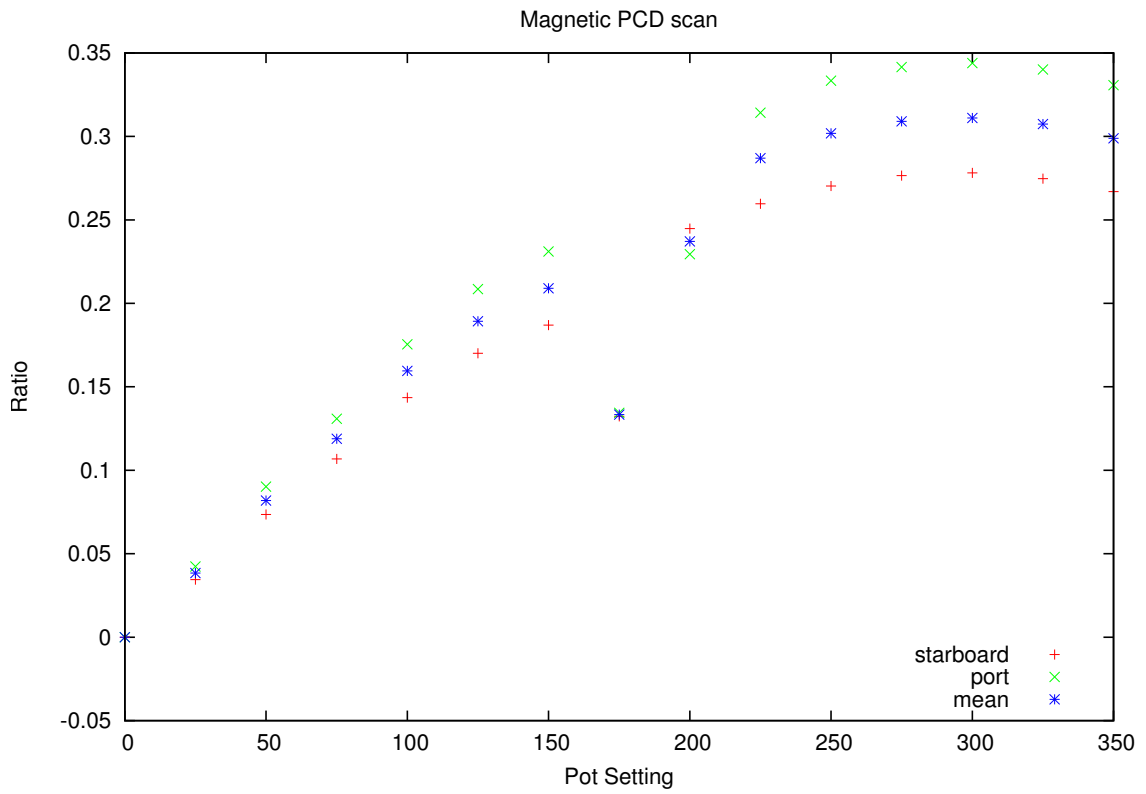
Figure 6: Magnetic PCD scan.

Calibrating the magnetic Pockels cell is slightly more tricky. The magnetic Pockels cell was replaced, and the velocity Pockels cell removed. The magnetic Pockels cell was then moved behind the polariser into the velocity position. The scan was then repeated using the magnetic cell and driver. The results are in figure 6. The initial setting was “250”, the new scan suggests the best setting is “300” and so the magnetic driver was adjusted to the new optimum.

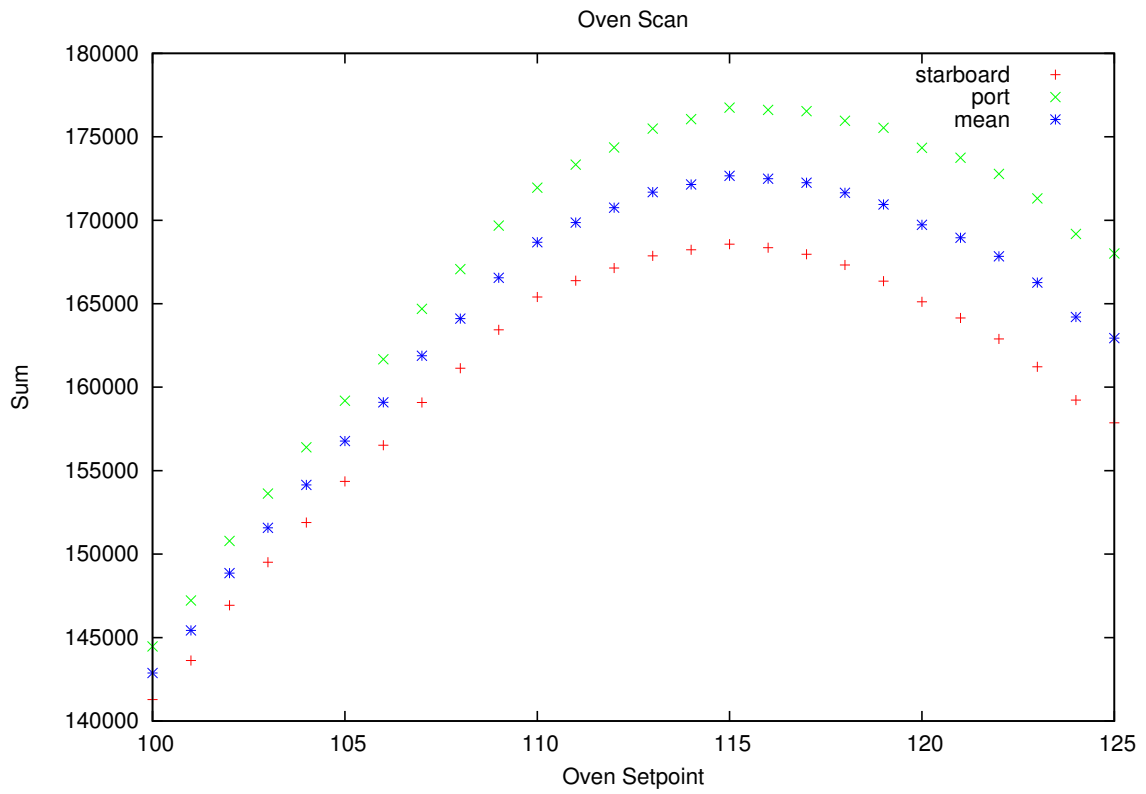
Figure 7: Oven Temperature Scan

The potassium cell was slowly scanned over a range of temperatures. The results are in figure 7. Initially the oven was set to 113 C. The temperature scan shows 115.5 C to be correct, and so the temperature setpoint was updated.
