A RGBD-based system for real-time robotic defects detection on sewer networks

L. Merino, D. Alejo, S. Martinez-Rozas and F. Caballero

Abstract. In this paper we summarize the automatic defect inspection onboard the sewer inspection ground platform SIAR. We include a general overview of the software and hardware characteristics of our platform, making a special emphasis on the sensing devices and software systems that are used for defect inspection. The main detection algorithm makes use of the a priori knowledge of ideal sections of the sewers that can be found in the Geographic Information Systems (GIS), and uses a variant of the Iterative Closest Point (ICP) algorithm for finding structural and serviceability defects. Then, we describe the software modules that are in charge of storing the alerts found by the detection system and of displaying them to the operator. The whole system has been tested in two field scenarios on different locations of the real sewer network of Barcelona, Spain.

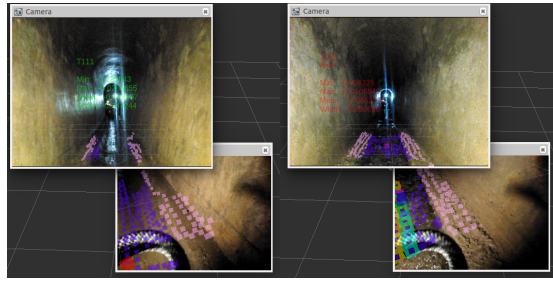
Fig. 6. Left: the serviceability of the gallery is correct. The frontal and down right cameras are shown (there is a down left camera that is not shown for clarity). In green, the absolute values for the height of the gutter are displayed in the frontal image for the operator. In purple and pink, the 3D points corresponding to the gutter and curb respectively. Right: serviceability alarm. The values are displayed in red. Many of the 3D points in the down-right camera (marked as colored points) are detected as departing from the ideal section (the gutter is blocked by debris).

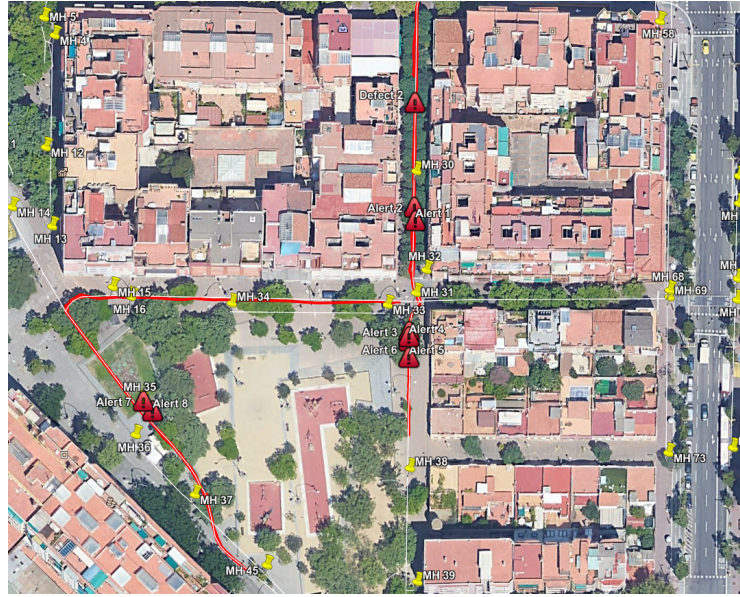
During the inspection, four serviceability defects were automatically detected and localized by the platform. In particular, our algorithm detected two main zones where there are very noticeable defects where human intervention would be needed for cleaning purposes.

Fig. 9. Inspection report of the experiments at Virrei Amat square. The path followed by the SIAR platform is marked in a red line. The generated alerts by the system are shown in red exclamation marks.

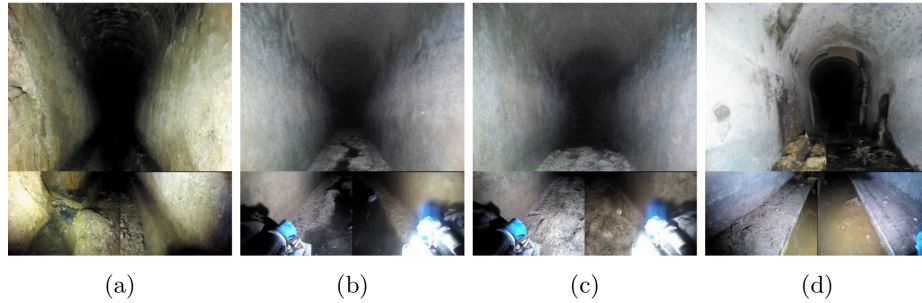
Serviceability defect 1: Alerts 1 and 2. Fig. 10-a shows a composition of the three images from the frontal cameras. In this case, there are noticeable sediments on the gutter and in the leftmost curb.

Serviceability defect 2: Alerts 3 and 4. Fig. 10-b presents a composition of the three images from the frontal cameras. In this case, sediments are accumulated in the gutter and they prevent the water from flowing.

Serviceability defect 3: Alerts 5 and 6. Fig. 10-c presents a composition of the three images from the frontal cameras. Sediments are accumulated in the gutter and prevent the water from flowing. The accumulated water at the end of the serviceability defect can be found in the video ⁴.

Fig. 10. (a-d): Composed snapshot in Alerts 1-4 in Virrei Amat, respectively.

Serviceability defect 4: Alerts 7 and 8. Fig. 10-d presents a composition of the three images from the rear cameras. We found a noticeable sediment over the rightmost curb and some sediments at the gutter.

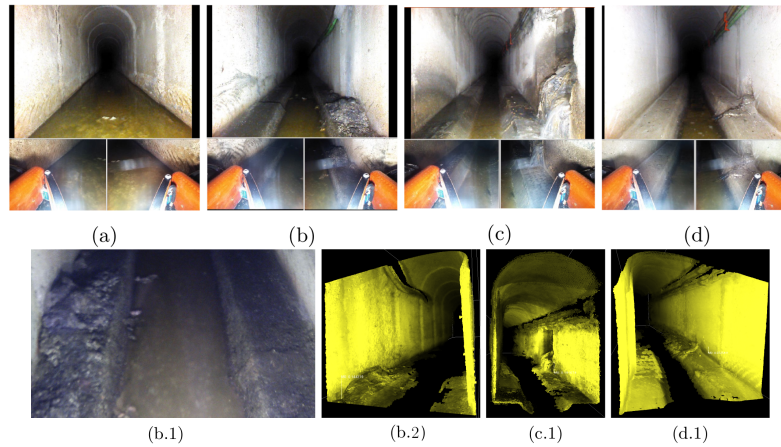
Serviceability defect 1: Alerts 1 and 2. The system detected an anomaly in the serviceability in the first part of the inspected area. In this case, the water covered the complete surface of the floor and thus the anomaly was reported. The obtained data indicates an anomaly in the gutter levels as shown in Fig.12-a.

Structural defect 1: Alert 3. Structural defect 1. Fig. 12-b and 12-b.1 show the visual and 3D representations, respectively. In this case, a noticeable obstacle of 14.4 cm can be found in the rightmost curb.

Structural element 1: Alert 4. The system detected an inlet in one of the sides of the gallery. Fig. 12-c and 12-c.1 show visual and 3D representations of the surroundings of the inlet, respectively. We estimated its height on 19.1 cm, which can be of use for determining if it has been built according to the laws.

Structural defect 2: Alert 5. Fig. 12-d and 12-d.1 show visual and 3D representations, respectively. We observe a 7.2 cm tall inlet with its sediments.

Fig. 12. (a) Composed snapshot in Serviceability Defect 1 of the experiment in Pas-seig Garcia Faria. (b) Composed snapshot in Structural Defect 1, with an obstacle in the rightmost curb. (b.1) Detail of the obstacle obtained with the arm camera (b.2) Obtained 3D mesh in Structural Defect 1 (the obstacle is on the left). (c) Composed snapshot in Structural Element 1. There are some sediments under an inlet on the rightmost curb. (c.1) 3D mesh in Structural Element 1. (d) Composed snapshot in Structural Defect 1. It is on the rightmost curb and is composed by sediments that come from an inlet. (d.1) 3D mesh in Structural Defect 2.
