# Purbeck-Southampton Pipeline: Final Report of Botanical, Morphological and Reinstatement Post-Construction Surveys

Project leader: F.H. Dawson  
Report date: July 1992  
Report to: BP Petroleum Development Ltd  
Contract no.: CC/WYT 0015 2.8.91  
IFE report ref.: RL/T04053d1/5  
TFS project no.: T04053d1

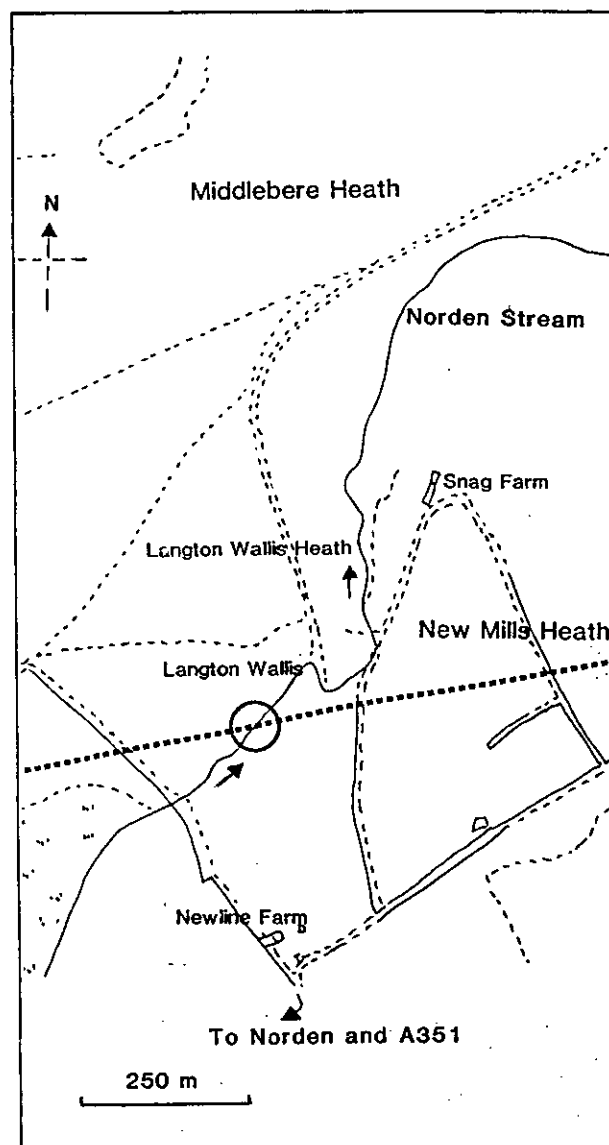
The Norden Stream lies in the ecologically important Middlebere Heath. Both artificial banks have been constructed from concrete bags, and have become well vegetated. The immediate bank flora consists of many ephemeral weedy plants including *Anagallis arvensis* L., *Galium palustre* L., *Hieracium* L. sp., *Lotus corniculatus* L., *Plantago major* L., *Polygonum* L. sp., *Rumex* L. sp., *Stellaria* L. sp., *Taraxacum* Weber sp., *Trifolium* L. sp., *Urtica dioica* L. and several terrestrial grasses. There are also hazel saplings (*Corylus avellana* L.), and the hawthorn (*Crataegus monogyna* Jacq.) hedgerow has been replanted above the left bank; these shrubs will be beneficial in helping to bind the soil and prevent erosion. There does not appear to be any erosion resulting from the artificial banks at this site.

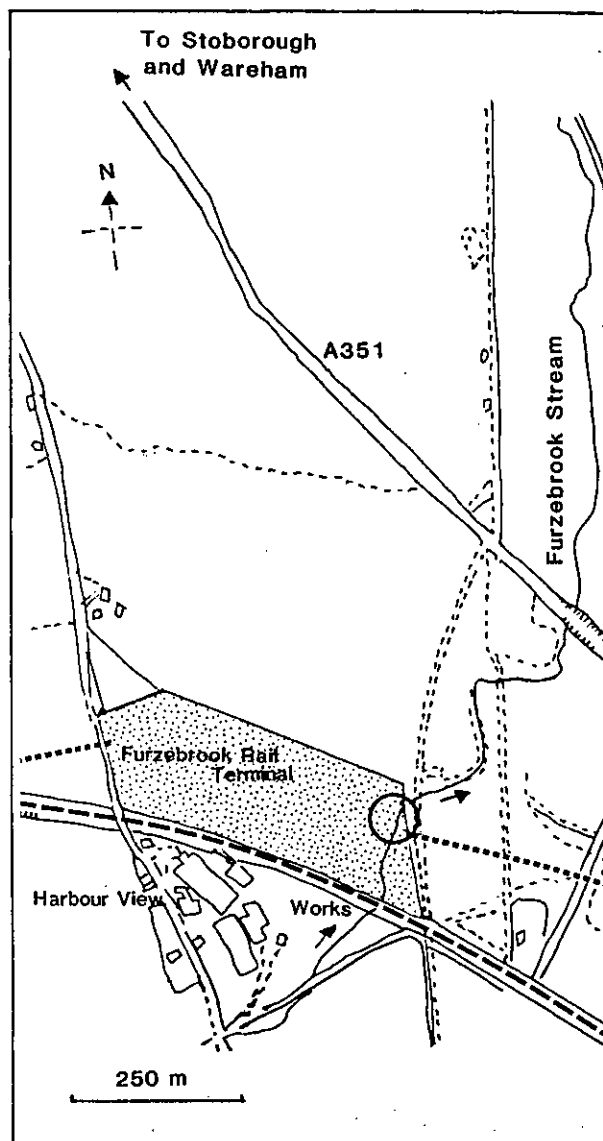
The artificial banks have been constructed using boulders overlaid with two-inch wire mesh and top-soil; this soil layer has largely eroded, and numerous gaps are consequently developing between the boulders. The vegetation which is able to grow over these artificial banks is ephemeral, with weedy species including: *Achillea millefolium* L., *Anagallis arvensis* L., *Cirsium* L. sp., *Epilobium* L. sp., *Geranium robertianum* L., *Hieracium* L. sp., *Plantago major* L., *Polygonum* L. sp., *Potentilla* L. sp., *Prunella vulgaris* L., *Pteridium aquilinum* (L.) Kuhn, *Ranunculus acris* L., *Senecio jacobaea* L., *Trifolium repens* L. and several terrestrial grasses.

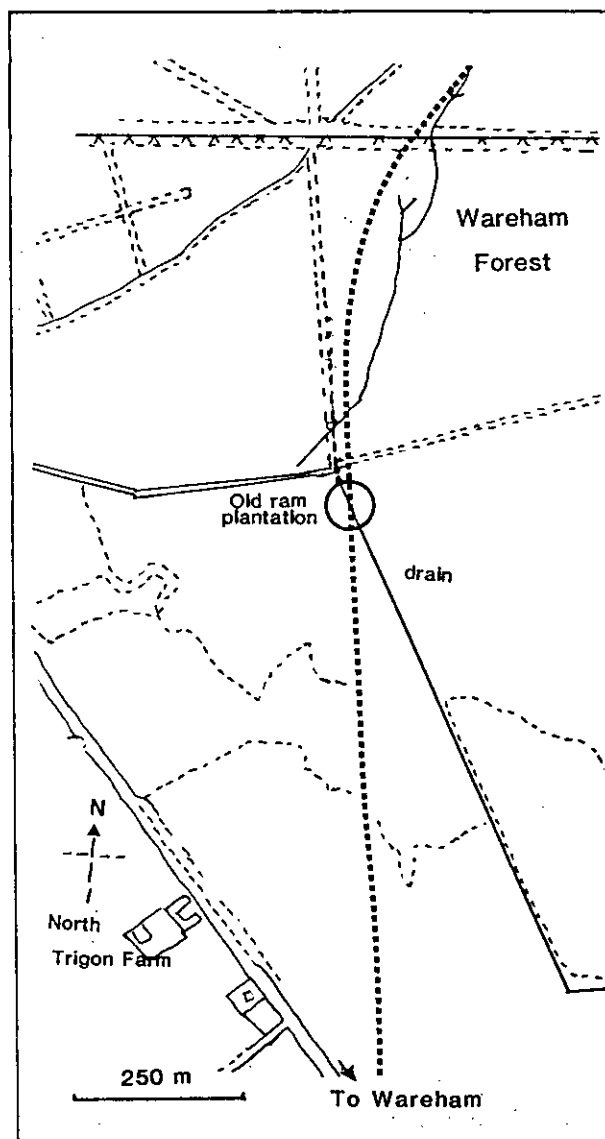
The artificial banks are constructed from concrete filled bags, overlaid with a rope mesh. The vertical faces of the banks are unvegetated, although the top of the banks are covered with terrestrial grasses, and several gorse bushes (*Ulex europaeus* L.).

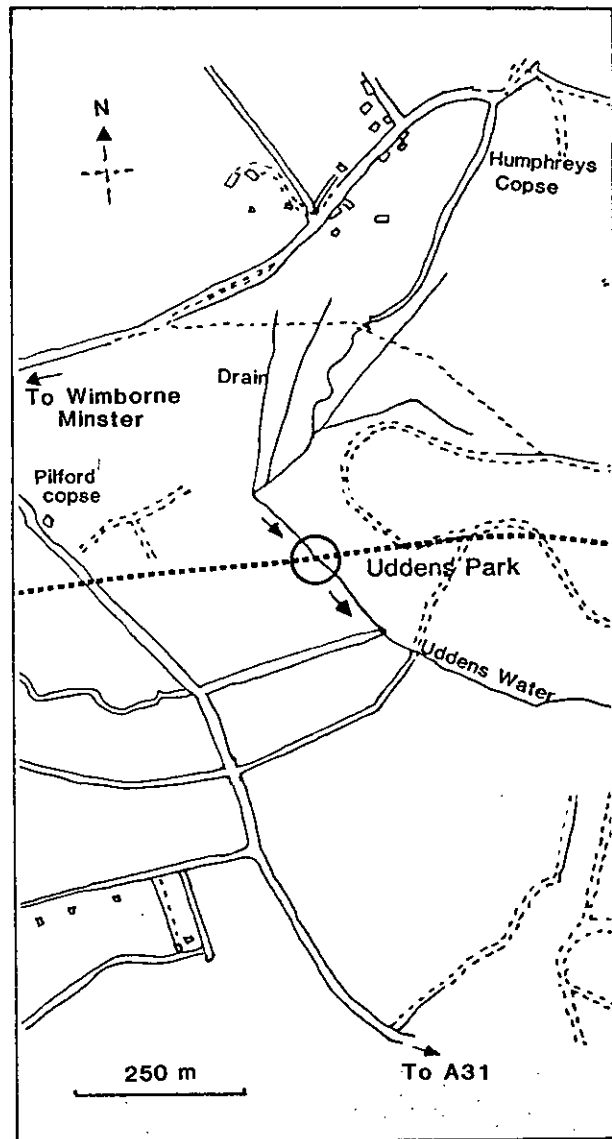
The artificial banks are constructed using concrete filled bags, and consequently there is no vegetation on the right bank which is nearly vertical; the left bank has been built at a markedly more shallow gradient. The vegetation on the bank behind the concrete bags is dense, although not very diverse, consisting of *Cirsium* Miller sp., *Epilobium* L. sp., *Galium* L. sp., *Ranunculus acris* L., *Rumex* L. sp., *Trifolium* L. sp., *Urtica dioica* L. and several terrestrial grass species. No orchids were discovered in the adjacent field, as reported by Dawson *et al.* (1986b).

There does not appear to be an erosion problem, although cattle use the left bank as a watering point and consequently cause some soil poaching. Slight erosion is also occurring downstream of the concrete bags forming the right bank, although this seems to be due to

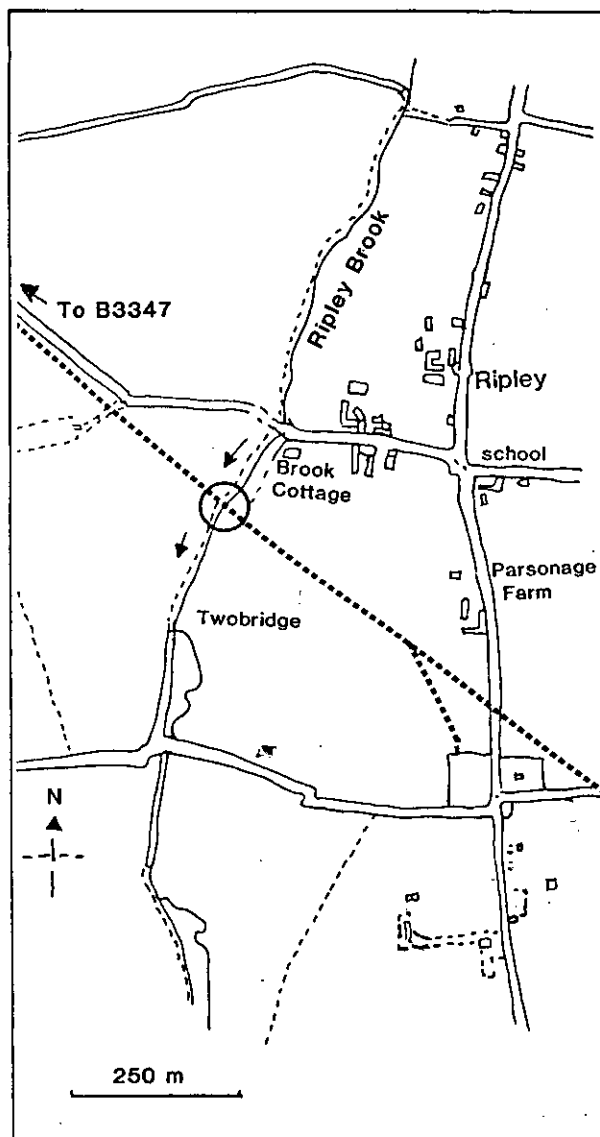
Both banks have been constructed from artificial concrete bags, with negligible re-vegetation occurring due to lack of top-soil; much of the left bank is obscured by overhanging terrestrial vegetation, however. Erosion is occurring along most of the right bank beneath the lowermost concrete bags; this has resulted in the loosening of the lower bags, and might ultimately result in the collapse of the bank.

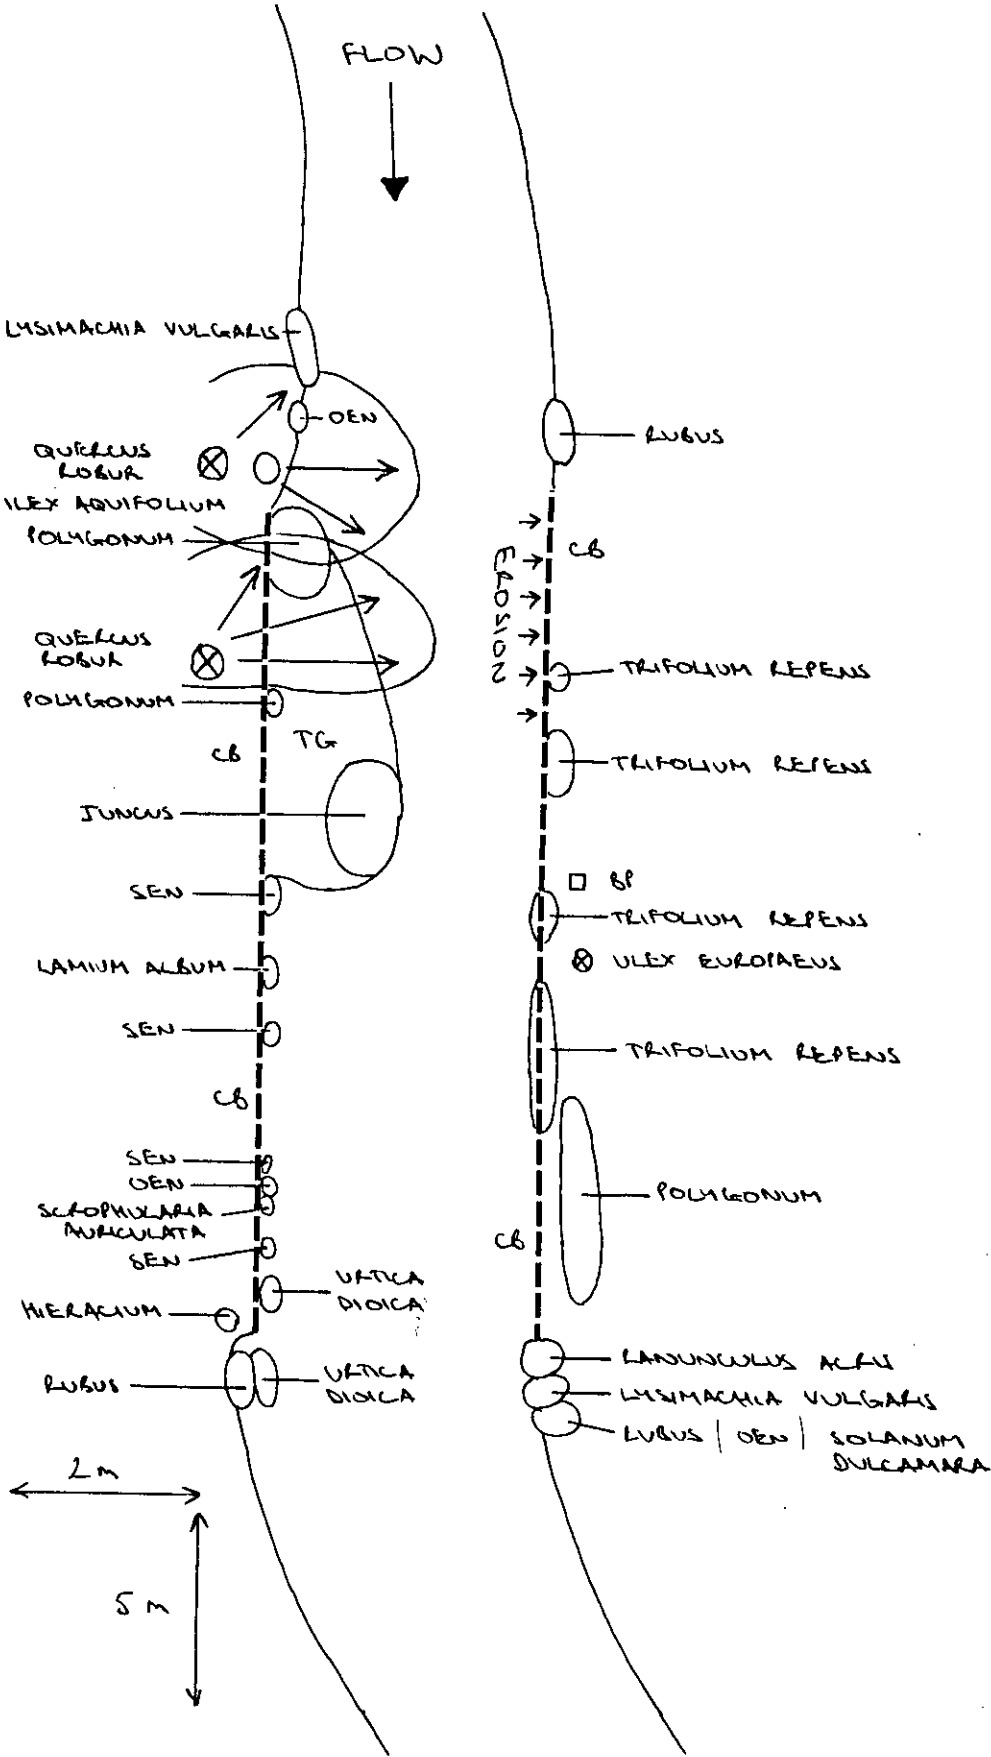
**FIGURE 2.** Map of Ripley Brook at the site of the oil pipeline crossing, showing location of major plant populations etc. BP = position of BP pipeline marker post; CB = artificial bank constructed using concrete bags; Oen = *Oenanthe crocata* L.; Sen = *Senecio jacobaea* L.; TG = terrestrial grasses. Dashed lines indicate position of artificial banks.

The use of concrete filled bags for the construction of artificial river banks is widespread. Its use often causes erosion of the substratum, however, beneath the lowermost layer of bags. Several of the sites studied have been highlighted as exhibiting unacceptable levels of this pattern of erosion, viz. Ripley Brook, Danes Stream and the Avon Water Tributary; it is recommended that these sites be further reinstated.

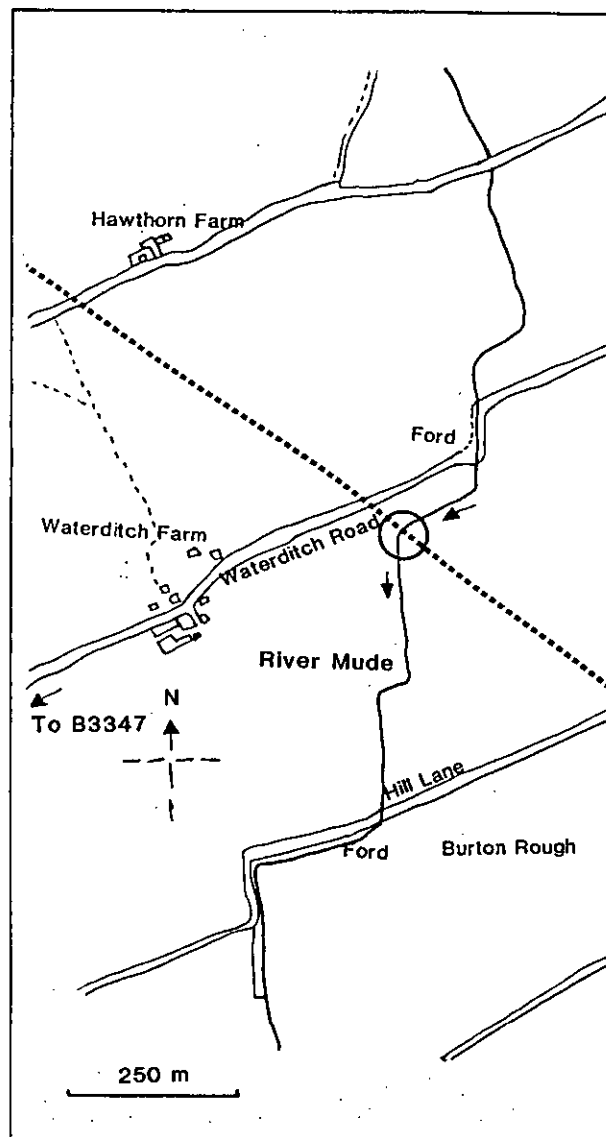
Both artificial banks are apparently constructed from concrete filled bags, although the bags are almost completely obscured from view by a layer of topsoil (mainly clay); this topsoil was probably laid during construction work to aid re-vegetation. The flora of this topsoil is dense, although it is predominantly grasses, which were probably planted (either as seeds or turves) during the construction work. There are, however, large areas of *Epilobium hirsutum* L.

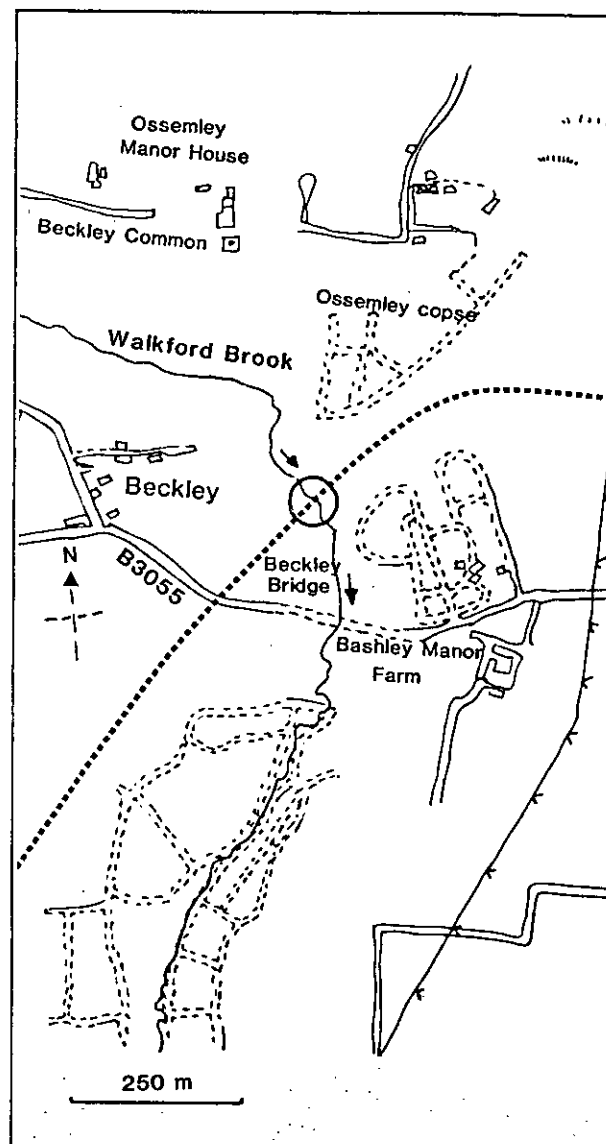
Both artificial banks have been constructed from concrete filled bags. The margins are very steep, and consequently there is no vegetation, although both margins are partially obscured by overhanging terrestrial plants. The terrestrial vegetation is dominated by grasses, although the site is very species rich (Table 4).

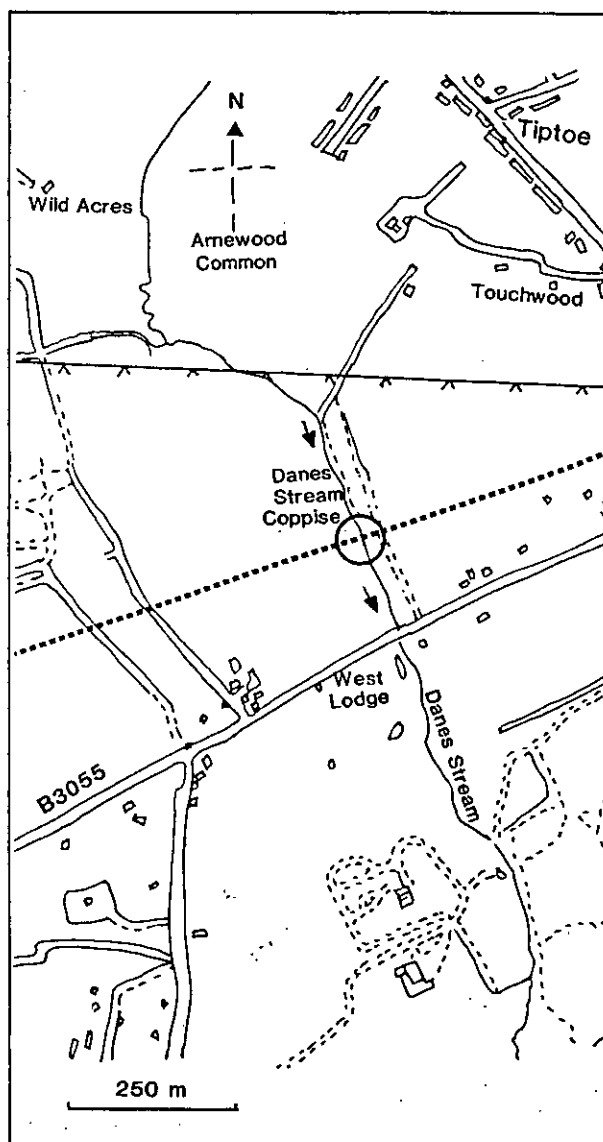
Both artificial banks are very steep, and have been constructed from concrete filled bags without any topsoil. As a consequence of this, there is no vegetation, although both banks are obscured by overhanging terrestrial grasses. The central area of the left bank is showing erosion beneath the lowermost of concrete bags; this is resulting in subsidence, which may possibly cause collapse of the bank.

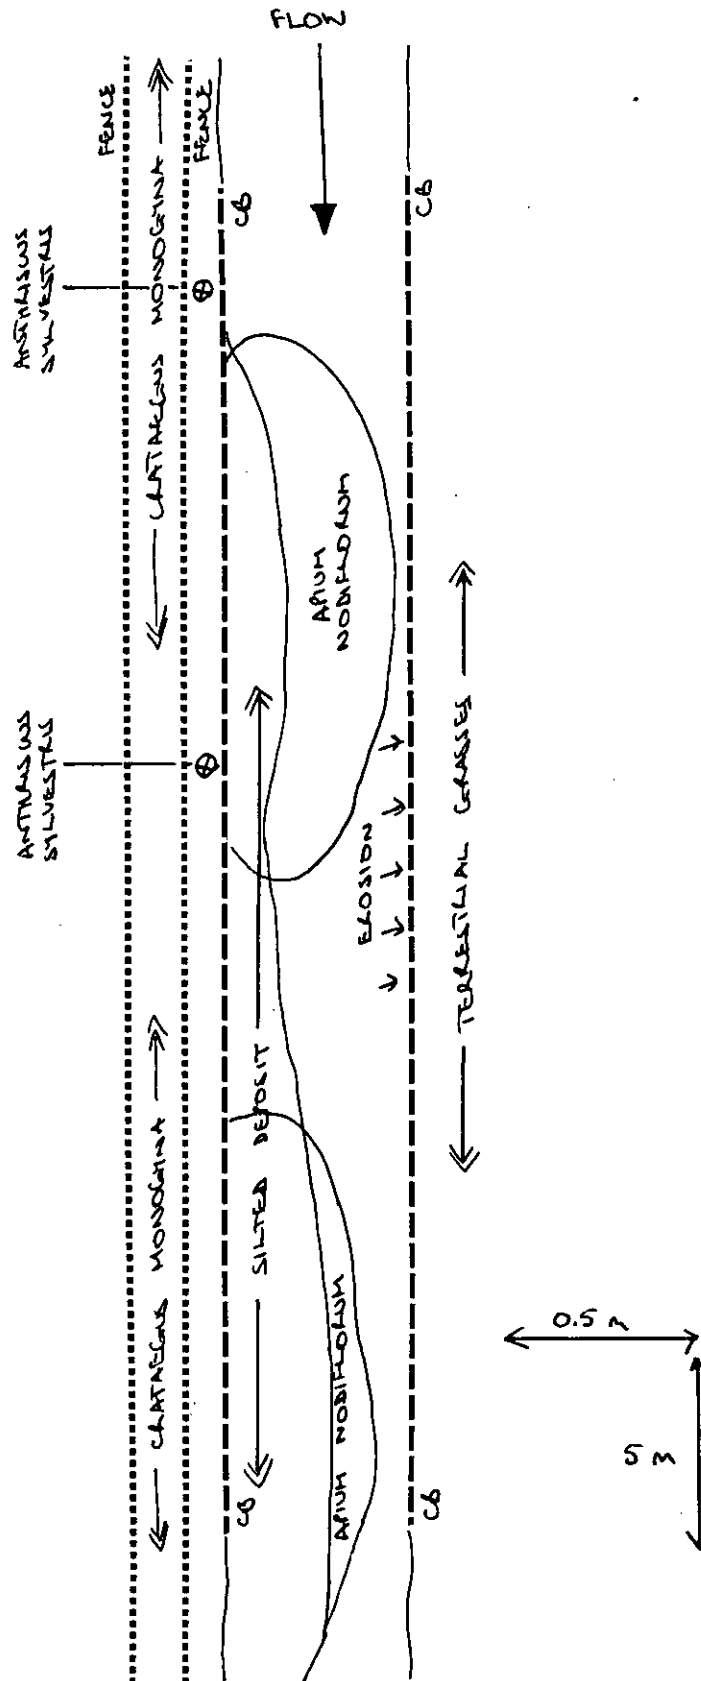
**FIGURE 3.** Map of Danes Stream at the site of the oil pipeline crossing, showing location of major plant populations etc. CB = artificial bank constructed using concrete bags; TG = terrestrial grasses. Dashed lines indicate position of artificial banks.

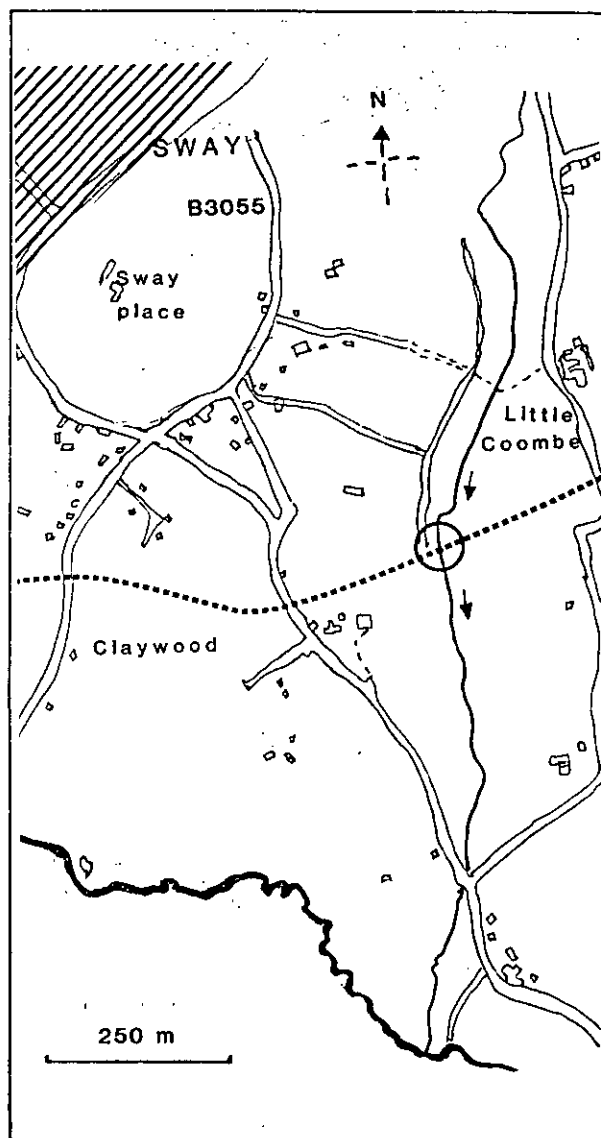
The artificial banks have been constructed using two different methods, viz.: concrete filled bags, and stones cemented together. Both types of banks have been constructed at a very steep angle, which has prevented re-vegetation. Large sections of both banks (but particularly the right bank) have collapsed due to the undermining of the lowermost layer of stones; this was especially noticeable in the stone/cement banks.

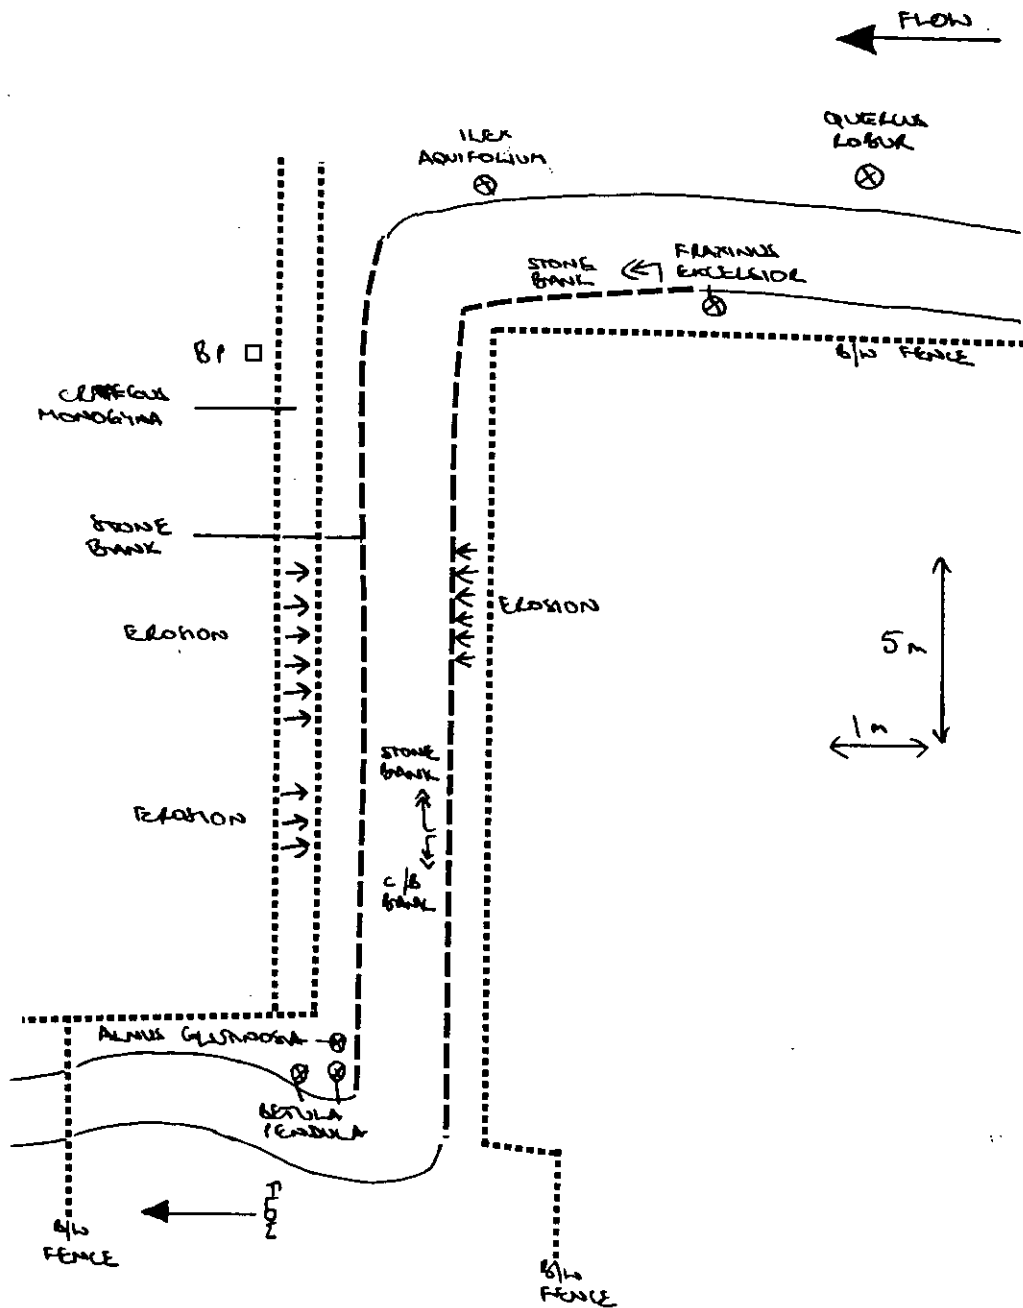
FIGURE 4. Map of Avon Water Tributary at site of oil pipeline crossing, showing location of major plant populations etc. BP = position of BP pipeline marker post; CB = artificial bank constructed using concrete bags; B/W = barbed wire fence.

Although many of the sites on the Purbeck-Southampton pipeline route lack significant bank vegetation as a result of the use of concrete bags, bank reinstatement to alleviate this problem alone is not regarded as necessary. The problem of erosion of the artificial banks is more critical, however: as noted above, the Ripley Brook, Danes Stream and Avon Water Tributary sites are recommended for further bank reinstatement.

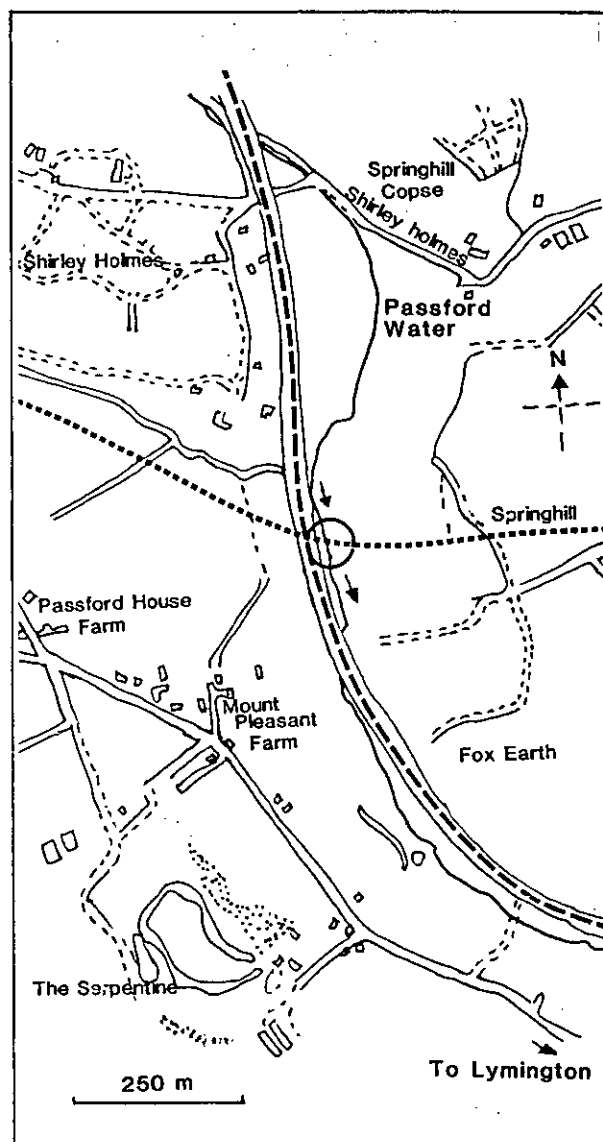
The left artificial bank is constructed from concrete filled bags; the downstream half of this bank is covered with rope mesh, and there is an outflow pipe from the adjacent fishing lake entering through upstream half. The right artificial bank is primarily constructed out of steep stone cladding, but with concrete filled bags on the upstream quarter. Both banks have been constructed to a far greater height than was observed at any of the other pipeline crossing sites; this is apparently so that periodic high flood levels can be accommodated without breaching the banks.

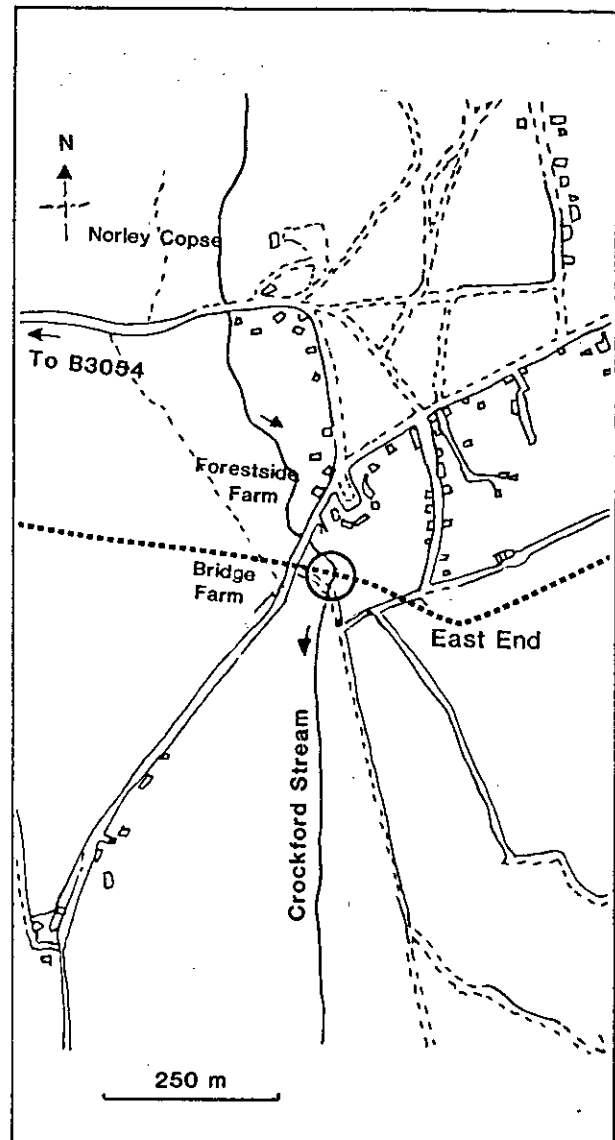
The artificial left bank is shallow, and has been constructed using an earth/gravel mixture; slight erosion has occurred, resulting in a soil area within the channel which has become vegetated with both semi-aquatic and terrestrial plants. The right bank forms a large levee protecting the adjacent field; it is similar to the left bank, although it is steeper and shows a greater degree of erosion. Most of the erosion appears to be occurring on the existing levee, however, whereas the newly constructed levee resulting from the BP pipeline is quite well vegetated and is resisting erosion.

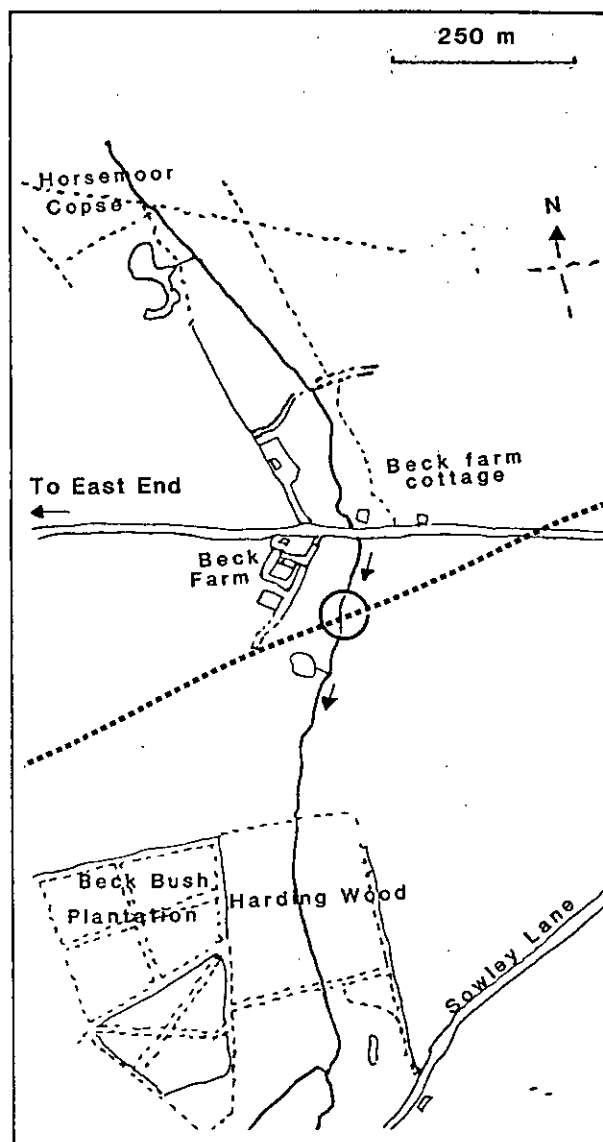
The entire stretch of the stream running alongside Beck Farm has previously been straightened and realigned. The artificial banks at the pipeline construction point appear to be constructed from soil, and not concrete bags; the angle of the right bank is markedly shallower than the left. There is erosion of the soil banks at several positions along the river, although this does not appear to be restricted to the pipeline construction zone.

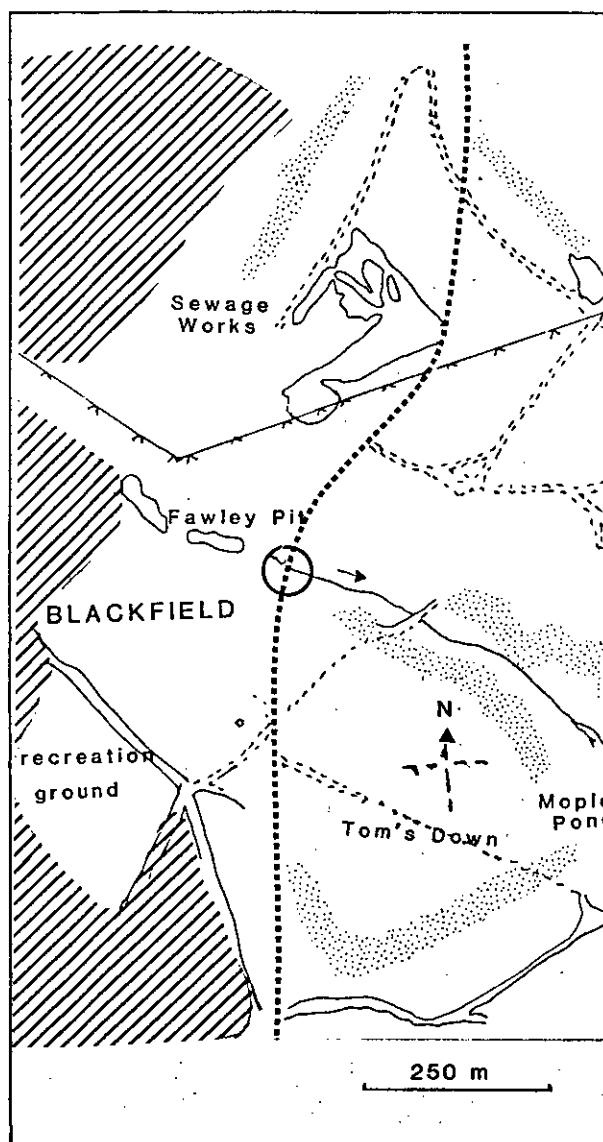
The Mopley Pond Stream is very small, and flows over large boulders and solid bedrock into a large and stagnant pond. Both the stream and the pond are polluted with a surface layer of oil (or possibly bacteria), which has probably originated from the quarry immediately upstream. There is very little aquatic vegetation in the stream due to the nature of the substratum. The artificial banks of the stream at the crossing point are very tall but are earthen and are therefore able to sustain a considerable degree of re-vegetation. The flora of the right bank is largely restricted to weedy species, although a blackthorn (*Prunus spinosa* L.) hedgerow has been planted. The left bank has numerous gorse shrubs (*Ulex europaeus* L.), which are also possibly planted. Some of the stinging nettles (*Urtica dioica* L.) were observed to have the parasitic dodder *Cuscuta europaea* L. growing on them; this is a rare plant which is believed to be decreasing in Britain (Clapham *et al.*, 1987: 365-366).
