THE ROYAL CHAPEL OF NATIONAL PALACE OF SINTRA: A STUDY OF TIMBER ELEMENTS

D. F. Henriques^{1,2} and V. Baptista¹

¹ ISEL – Instituto Superior de Engenharia de Lisboa

*The work consisted in the characterization and structural assessment of tribune's first floor beams. Inspections took place between January and May 2018. The wood present in most of the structural and secondary elements is coniferous, most of which has been identified as *Pinus Sylvestris, L.* The work was carried out in situ by visual inspection and by non-destructive and semi-destructive tests. Water content, drill resistance and penetration resistance were measured. Physical-mechanical properties of the timber members were estimated based on the in-situ measurements and the scientific literature. Visual strength grading was also applied to the floor beams. From the results obtained several important information were taken. Report and recommendations were presented as the conclusion of the study.*

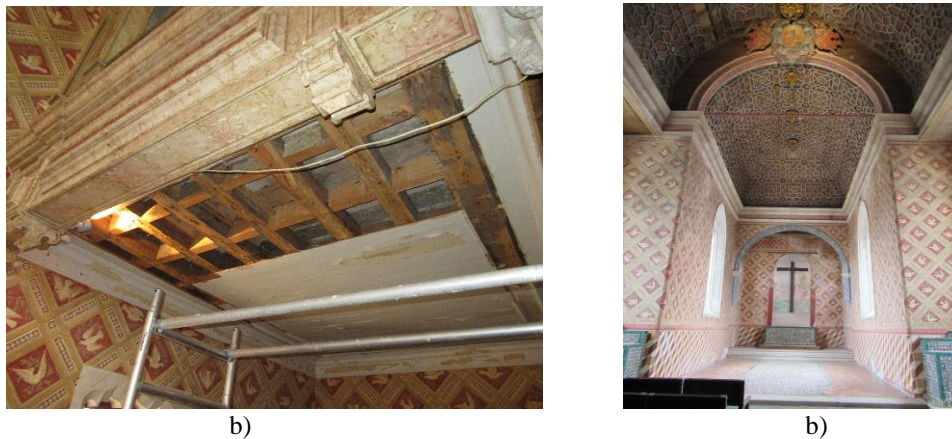
Figure 2: a) Tribune's beams b) Chapel and main altar view

The structure of tribune's floor is formed by wooden beams, simply supported by a metallic beam that is supported on the walls having a stone column in the middle span. It is impossible to check the other side of the beams but is thought that is a fixed support on the wall. The length of the beams is approximately 5,30 meters, and the distance between the axis of the beams is about 45 centimeters. The cross sections of the beams are: height between 13 and 14 centimeters and width between 12 and 19,5 centimeters. Between the beams there are wooden blocks with a regular section (8,5 x 14,4 cm), and in the corners there is a diagonal wooden element which allows better connection between beam-block. The use of blocking has the main purpose of reduce transversal deformation, consequently increasing transversal stiffness. These details reveal a high carefulness in this important construction in that time. The area under study is just a half of the area of the tribune's floor, and it is constituted by 7 beams, which were numbered from B1 to B7 (Figure 2.a)). The beam B1 is the closest to the stone column and B7 one is nearby the wall.

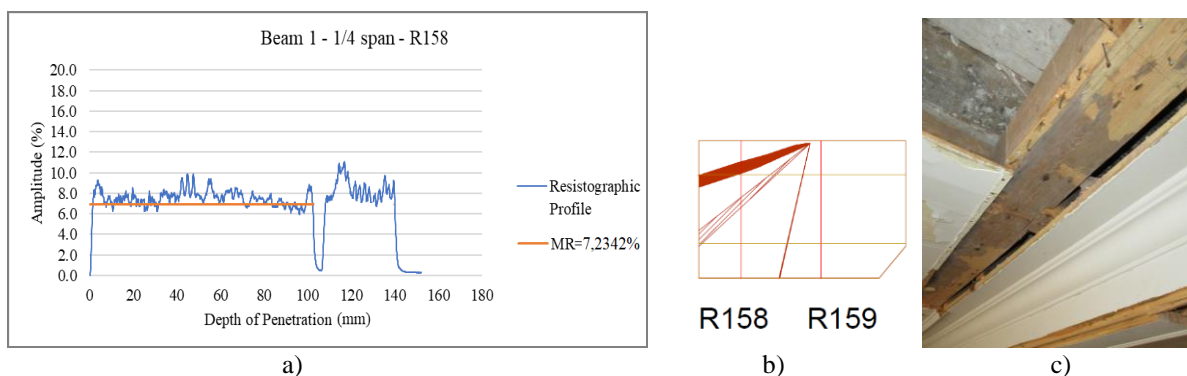
Figure 4: a) Resistographic Profile; b) Section of beam 1; c) View of beam B1

In beam 1 it was taken three measurements, one of them is shown on 4 a), and in the other beams was take two measurements, in vertical sense and horizontal sense. The 4 b) presents a section of the beam B1 near to the support. The vertical lines represent the two drill tests. The two horizontal lines mark the marginal area used to evaluate the element to the existence of knots. There is an area totally full that represent a crack and the other two areas represent the knots.

Regarding damage or degradation, can be referred the big crack in beam B1 in a plane almost horizontal. So, requested to bending, it ends up closing and seems not have significant impact in its loss of resistance to the simple bending. There also seems to be some degradation by beetles spread in the non-visible face of the beams. This situation will have to be checked.
