STUK-B-STO 52 / DECEMBER 2003

THE DOSE AND IMAGE QUALITY IN MAMMOGRAPHY PRACTICE IN FINLAND

Asko Miettinen, Markku Pirinen

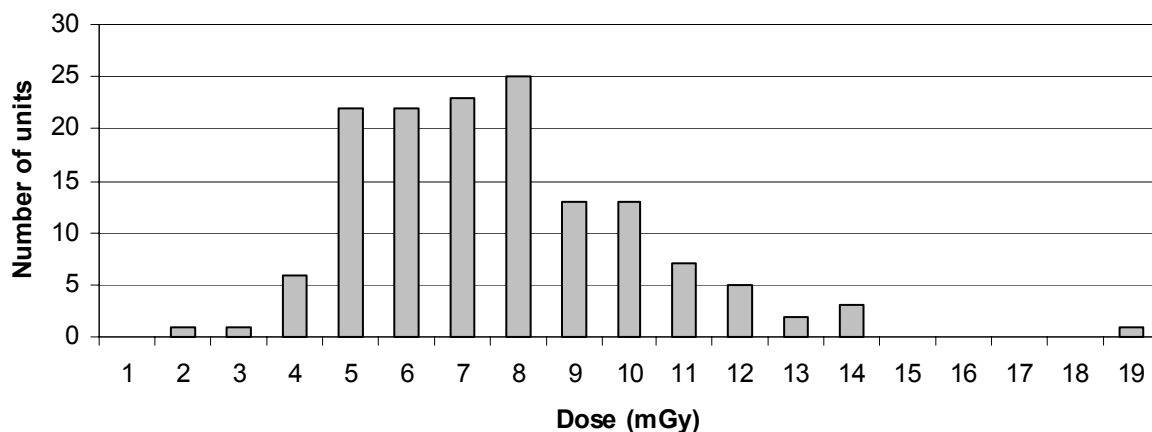
Figure 1. The ESD distribution in imaging the 4.5 cm thick PMMA phantom.

The distribution of the measured ESD values for the 4.5 cm thick PMMA phantom is illustrated in Figure 1. The range of ESD is from 2 to 18.3 mGy with the average of 7.2 mGy. The average dose for screening units was 6.6 mGy, and the average dose

of the units used solely for clinical application was 7.5 mGy. The average ESD for imaging the 2 cm thick PMMA phantom (Figure 2) was 1.1 mGy (range 0.32–2.9 mGy), and the average ESD for imaging the 6 cm thick PMMA phantom (Figure 3) was 18.1 mGy (range 4.4–48.5 mGy).

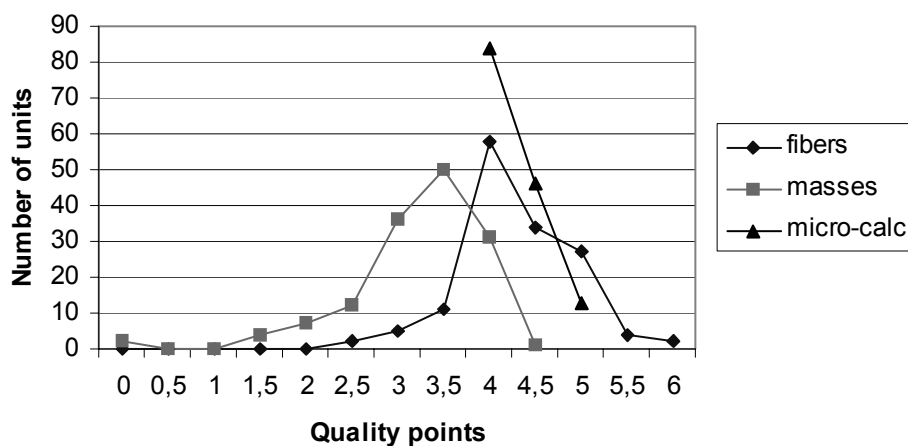
Figure 4. Number of units as a function of quality points, classified in accordance with the visibility of the three test objects.

The distribution of devices with respect to the quality points (number of the visible groups of each of the three different object types in the test phantom) is shown in Figure 4. Twenty-five facilities (17%) did not achieve the minimum of three points for the tumor-like masses. Eighteen facilities (13%) did not achieve the minimum of four points for fiber details. All facilities fulfilled the minimum requirement of three quality points

for micro-calcifications. Altogether there were 28 units (20%) which did not fulfil the minimum requirements for the visibility of either tumor-like masses or fibres of the test phantom. In addition, there were 22 units which had the film density lower than the requirement of 1.2 although they complied with the test object visibility criteria. Altogether there were 50 units (35%) which did not fulfill the criteria of the test phantom.

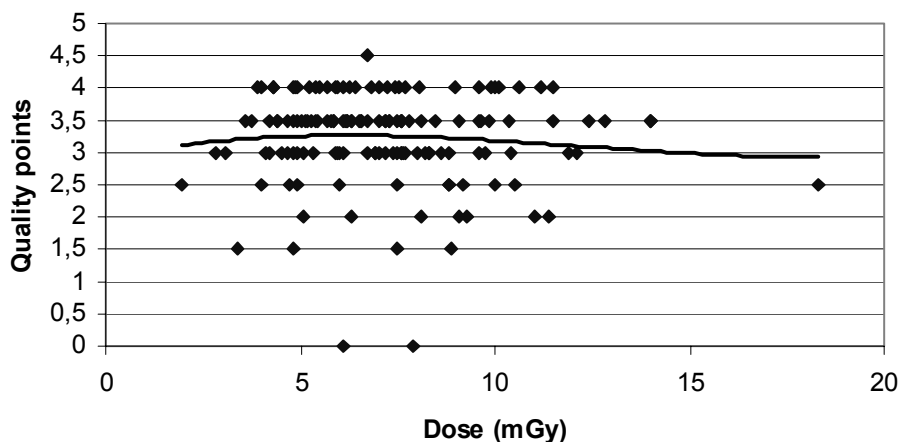
Figure 5. Quality points for the visibility of tumor-like masses in the RMI 156 phantom, plotted against the ESD.

The quality points related to the visibility of the various detail object types have been plotted against the ESD in the 4.5 cm thick PMMA phantom in Figures 5–7. A similar plot for the sum of the quality points is shown in Figure 8. The trend curve shown in these figures is a polynomial of 3rd order fitted to the points (created by Microsoft Excel programme). A histogram of quality point distribution for ESD values is shown in Figure 9. The dependence of quality points between the visibility of tumor-like masses and fibres is shown in Figure 10.

The reason for the two zero values in Figures 5 and 10 was in both cases the notable processing artifacts.

It can be concluded from Figures 5 to 8 that there is not a clear correlation between quality points and ESD, and any threshold for the minimum ESD producing good quality points cannot be set. Good quality points can be obtained within a large range of ESD, and with much lower values than the diagnostic reference level of 10 mGy. Closer examination of the results (Figure 9) would suggest that the best quality points are obtained, on the average, with ESD values from 4 to 8 mGy. However, below 4 mGy there were only seven units, and six of them were very old, low-power devices from one manufacturer; five of them without a grid. This could explain the low quality points for the results with the lowest ESD: the low quality is not necessarily directly due to the low ESD.

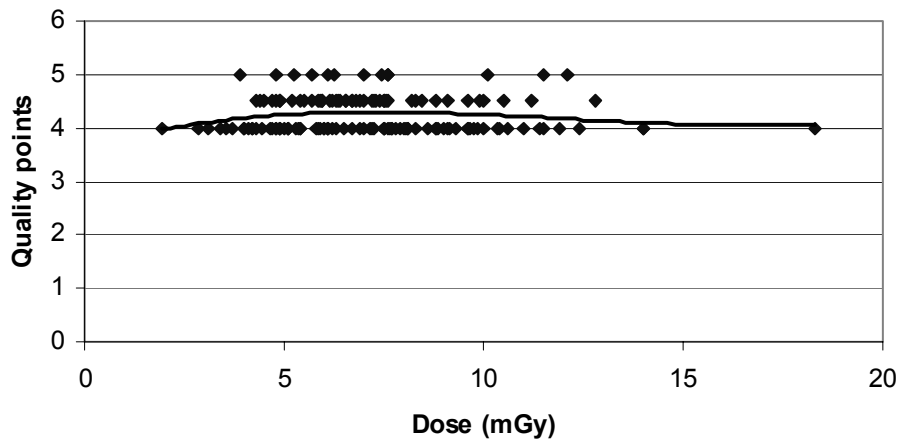
Figure 7. Quality points for the visibility of micro-calcifications in the RMI 156 phantom, plotted against the ESD.

From Figure 10 a trend can be seen, that the visibility of tumor-like masses is related to the visibility of fibres. Therefore, the sum of the quality points for the visibility of these two objects could also be used as an indicator for the possible correlation between quality points and the given characteristics. For convenience of the study, the sum of these two components will be used in the following. The sum of all the three components would be less useful for this purpose, because the quality points for the visibility of microcalcifications are fairly constant and always acceptable (Figure 7).

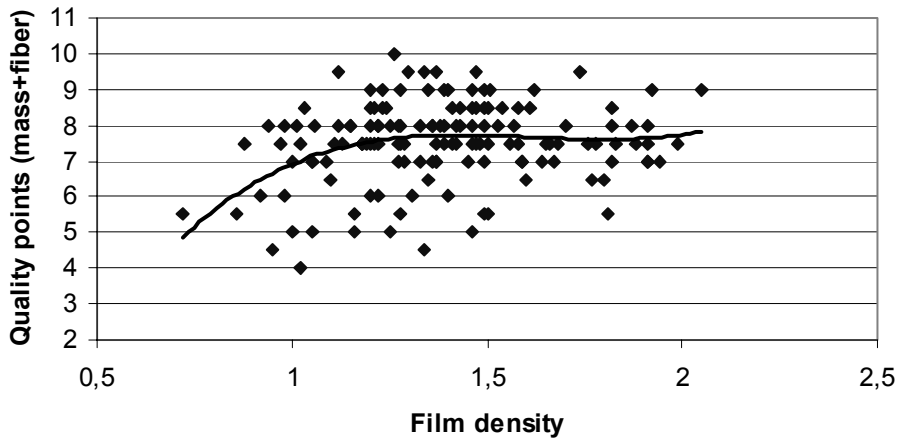
Figure 11. Quality point dependence on film density.

The dependence of the quality points (the sum for masses and fibres) on the film density is shown in Figure 11. It can be seen that below the optical density of 1.2, the relative number of low values of quality points (quality points less than seven) is significantly higher than above this density (33% below 1.2 compared with 14% above it). Below the density of 1.2, the quality points for masses (average 2.9 points) are less than the acceptance limit of 3 points while that for fibres just around the limit of 4.0 points. Above the density of 1.2, the average quality points for masses are 3.3 and for fibres 4.4. However, low quality points also occur in many cases above the density of 1.2; 14%

of this group was below seven points. The under-exposure of the film is obviously one reason for the poor image quality but cannot explain most of the cases.

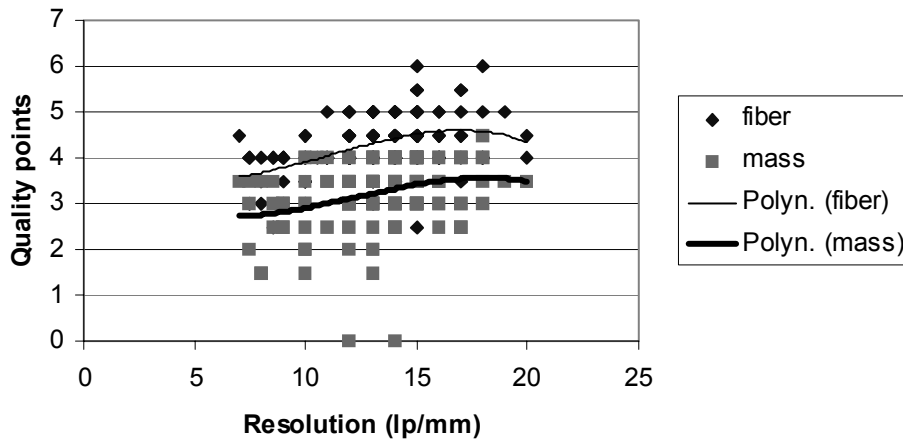
Figure 12. Quality point dependence on spatial resolution.

The dependence of the quality points for tumor-like masses and fibers on spatial resolution is shown in Figure 12. The quality points tend to decrease significantly when the resolution falls below the minimum requirement of 12 lp/mm (mainly old devices). In other words, poor visibility of masses and fibers seems to be connected with poor resolution. As the quality points for the visibility the micro-calcifications were always acceptable (4–5 points), all tested devices produced sufficient resolution to meet the minimum threshold for identifying micro-calcifications.

On the basis of the results, the minimum resolution of 12 lp/mm seems a reasonable requirement as one criterion for acceptable image quality, although this requirement alone will certainly not provide sufficient guarantee for good visibility of all types of interesting objects.

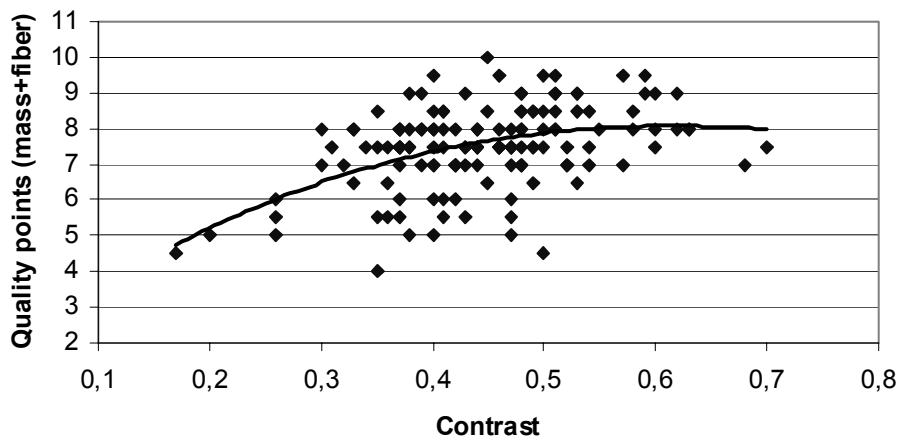
Figure 13. Quality point dependence on contrast.

The dependence of the quality points on contrast is shown in Figure 13. The quality points tend to decrease noticeably below the minimum acceptable contrast of 0.35. The average quality points (the sum for masses and fibers) for the contrast below 0.35 was 6.6 points.

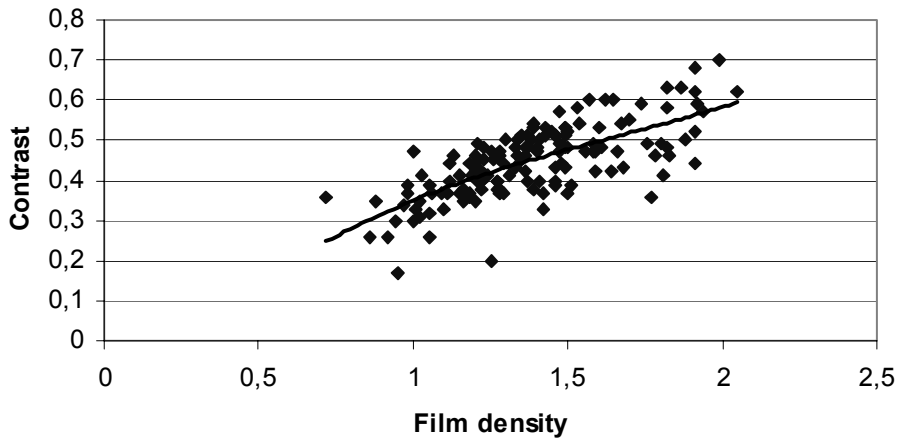
Figure 14. Contrast versus film density.

In Figure 14, contrast is plotted versus film density. There is a clear trend that a low film density, or under-exposure of the film, yields also a low contrast.

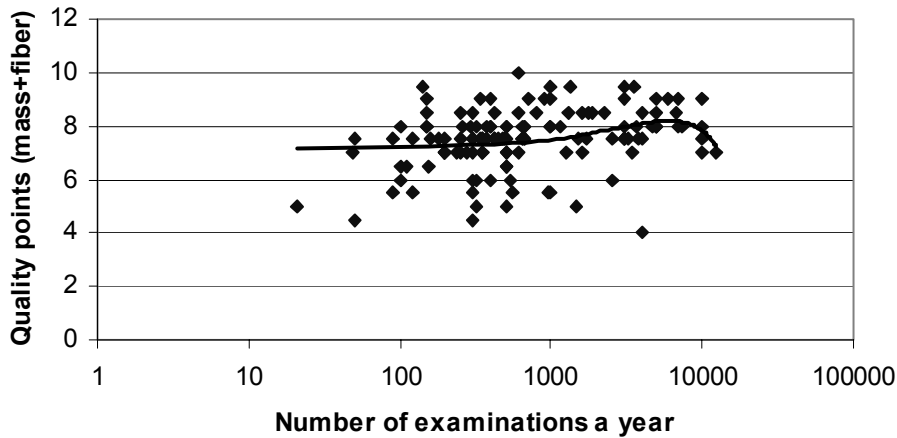
Figure 15. Quality point dependence on the number of examinations per year.

The number of examinations per year is not a good predictor of image quality, as can be seen from Figure 15. Although there is an apparent peak of quality points in the trend curve above about 1000 examinations per year, the scatter of quality points is very high throughout the scale. There are several facilities with a high number of examinations per year that produced sub-optimal quality images and vice versa. For example, the lowest score (4 quality points for the sum for masses and fibres) was attained by a facility that

performed approximately 4000 examinations a year, while one of the highest scores (9.5 quality points) was achieved by a facility that performed only 150 examinations a year. Nevertheless, facilities with the lowest number of examinations seem not to perform too well generally.
