Tornado Damage Assessment in the aftermath of the May 20th 2013 Moore Oklahoma Tornado.

Tornado Damage Assessment in the aftermath of the May 20th 2013 Moore Oklahoma Tornado

March 2014

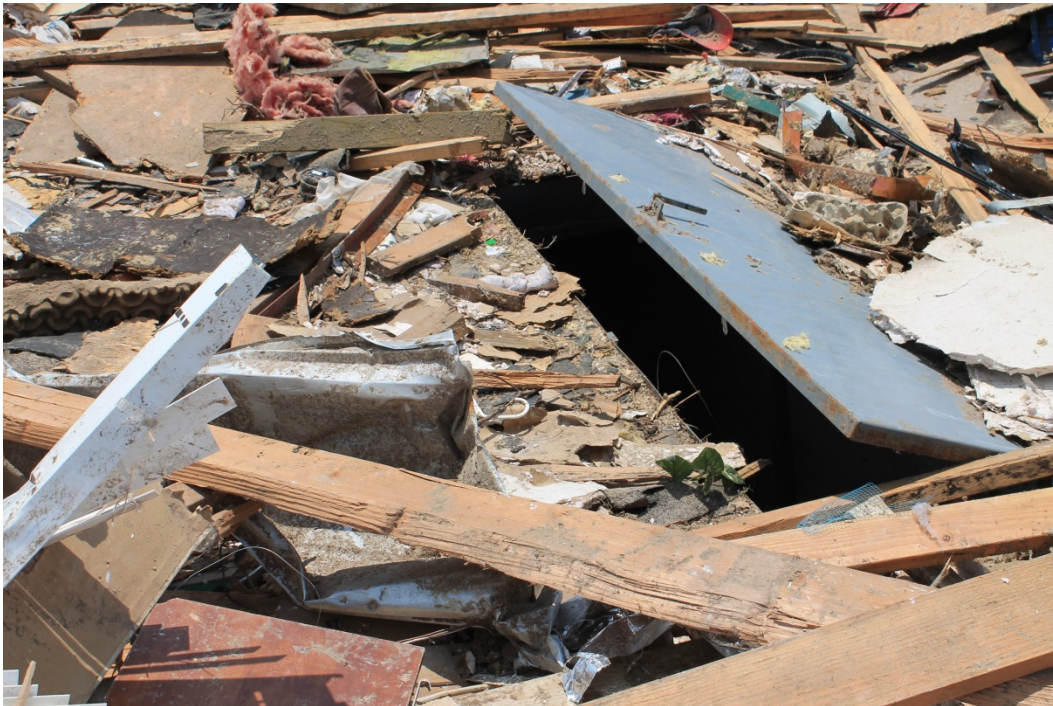
Figure 4.4, Debris blocked storm shelter after an attached garage failed.

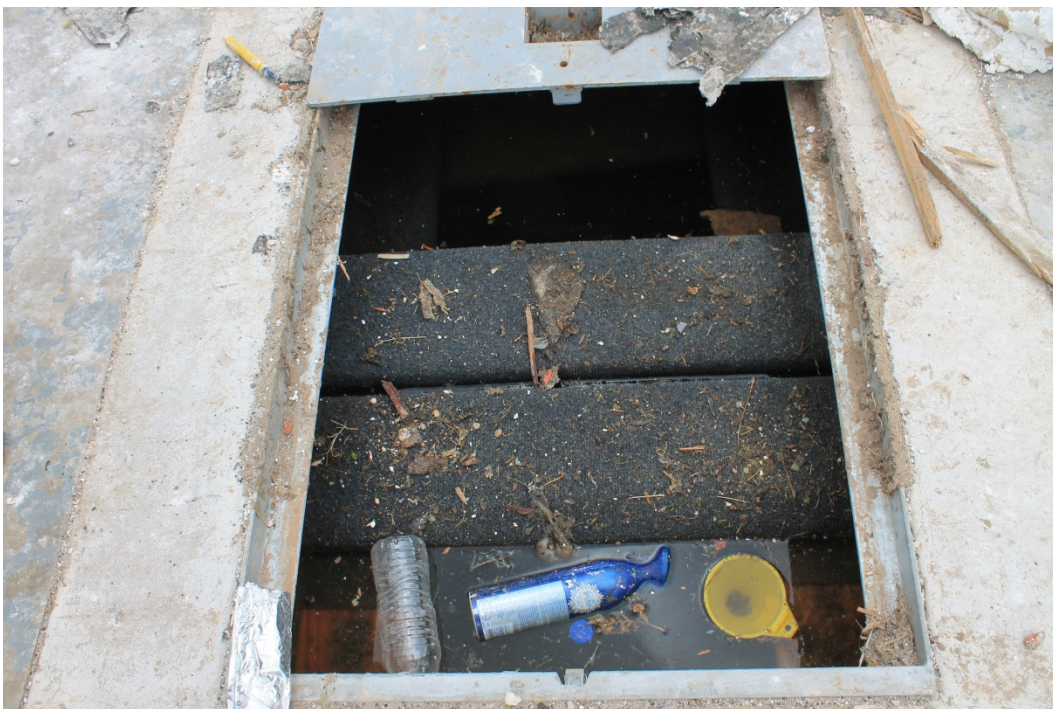
Figure 4.5, Flooded storm shelter from severed water lines and rain. Floating debris indicates that water has reached the top of the storm shelter.

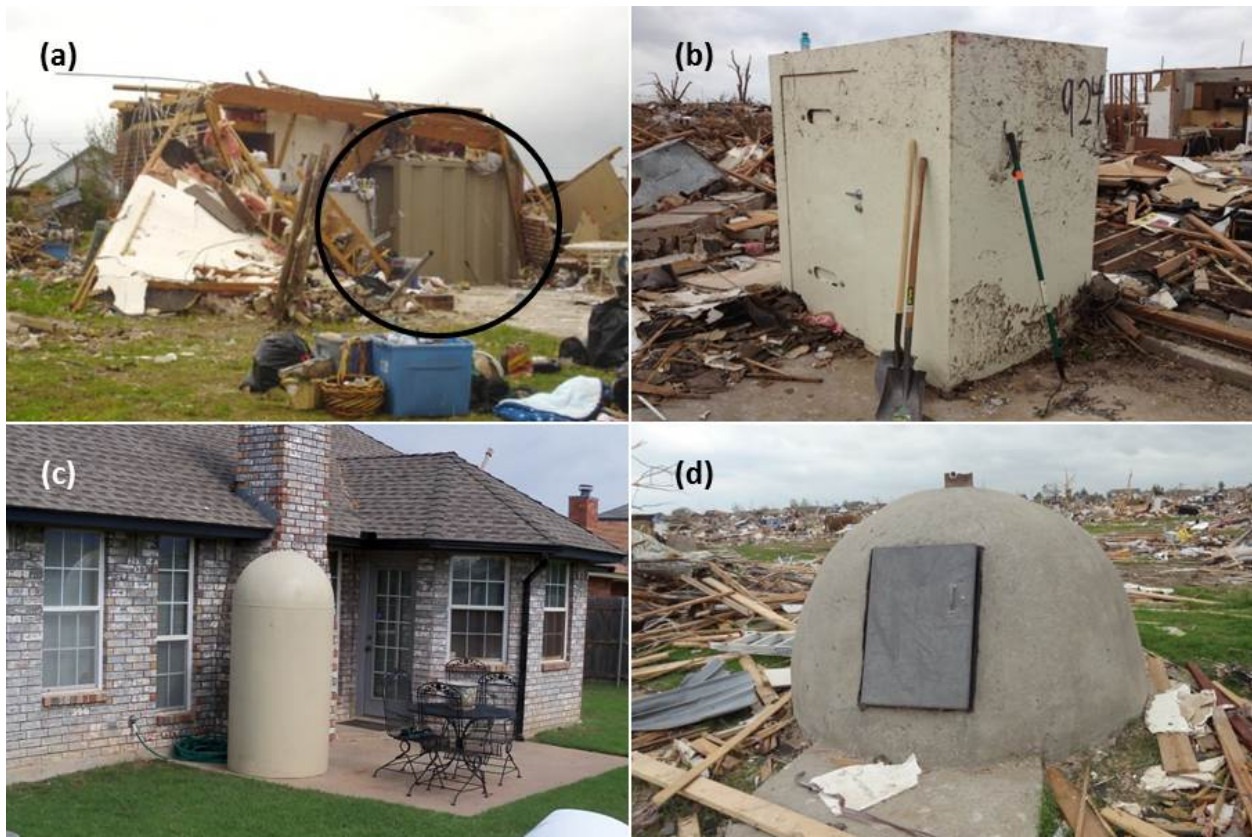
Figure 4.8(a). The shelter exterior was scratched and buffed from debris impact, but no major dent or perforation occurred. In addition, portions of the home's roof system fell on top of the storm shelter but no major damage was observed. The second above ground steel storm shelter was found at the intersection of SW 13th St and Penn Ln. This shelter was in an area of EF4 damage and is shown in Figure 4.8(b). The exterior of the storm shelter showed signs of significant scratching and buffing impact from windborne debris, however, no major damage or perforation was observed. Both of the above ground steel storm shelters successfully met their intended purpose.

Figure 4.8, Residential shelter images; (a) and (b) steel storm shelters bolted to the garage slab; (c) cylindrical steel exterior storm shelter; and; (d) homemade concrete dome refuge.

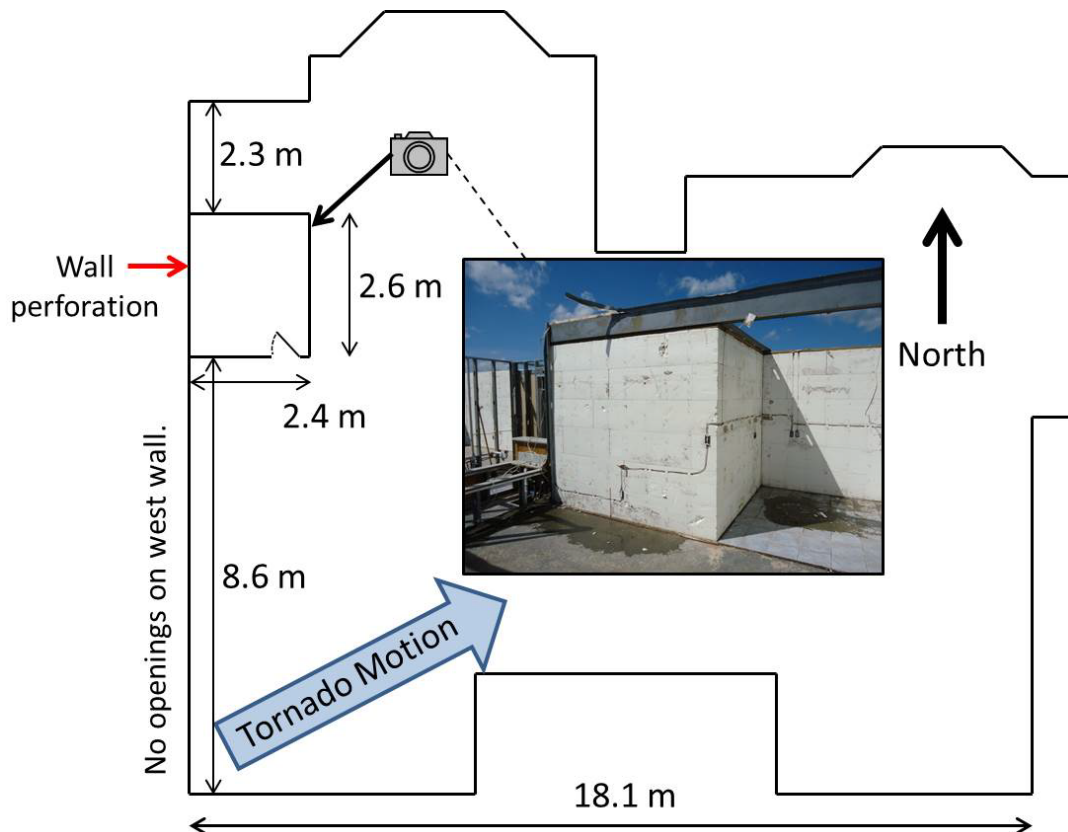
An above ground ICF waffle grid safe room was found at this home. Although waffle grid ICF is no longer an industry standard, ICF waffle grid safe room design is still included in the current FEMA 320 guidelines (FEMA, 2008). This ICF safe room doubled as a storage closet. The safe room measured 2.4 m by 2.6 m (8 feet by 8.67 feet) with walls that were 2.4 m (8 feet) tall. A FEMA recommended door with three dead bolts was used. An exterior schematic of the home showing the location of the safe room and an inset image of the safe room are shown in Figure 4.9. As seen in Figure 4.9, one of the walls of the safe room is also an exterior wall.

Figure 4.9, Floor plan of ICF home where failure of an above ground safe room occurred. An exterior image of the safe room is shown as well as the tornado motion. The red arrow indicates the location of perforation by two metal poles.

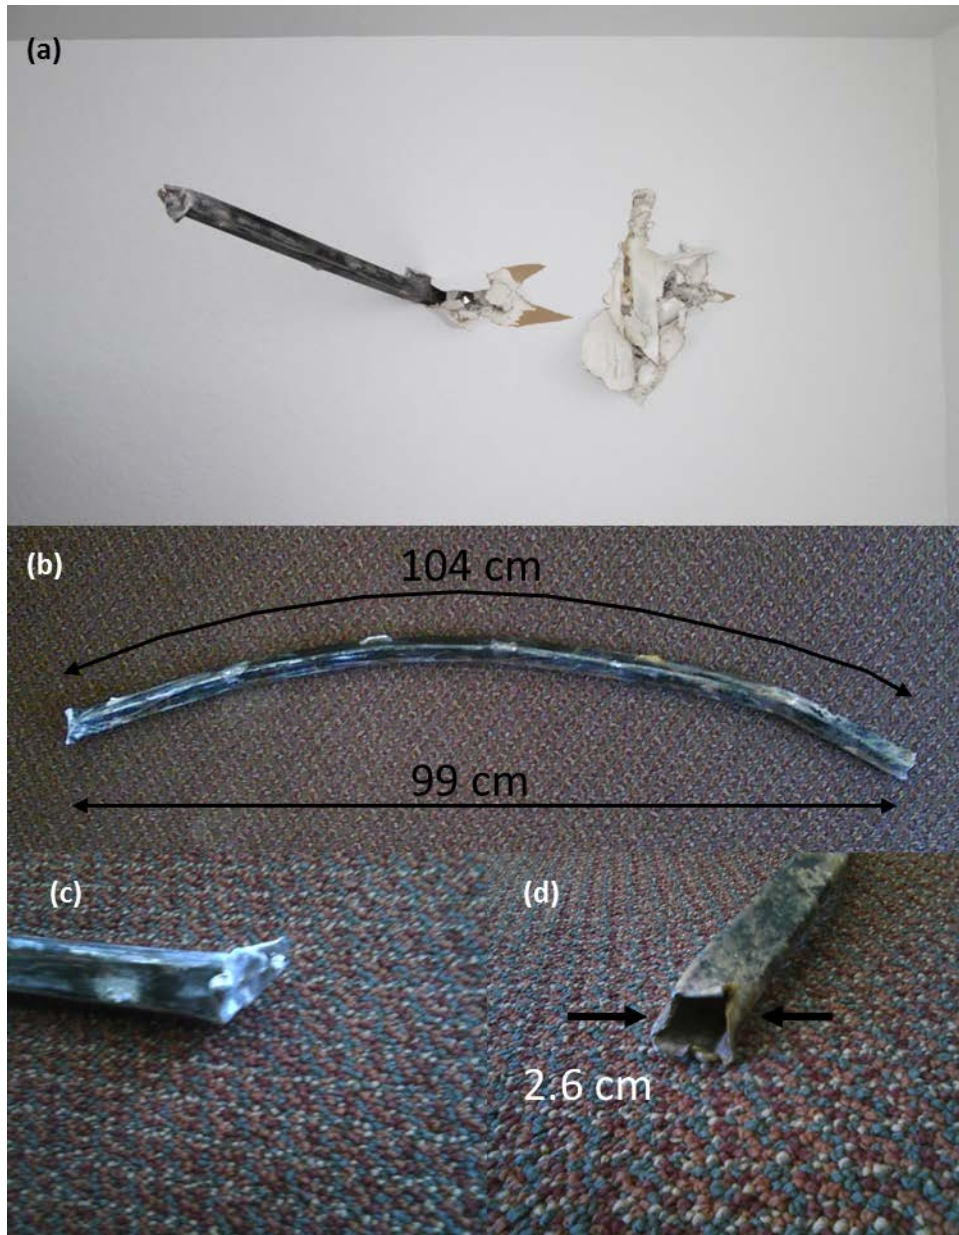
The west exterior wall of the safe room was perforated by two square metal poles shown in Figure 4.10(a). It should be noted that in Figure 4.10(a), only one projectile is shown. The second projectile was removed but evidence of the perforation is indicated by a hole on the right side of the image. The homeowner was seeking shelter in the safe room during the tornado and was nearly injured when the poles came through the wall inches from his head. The poles entered the safe room and extended approximately 0.6 m (2 feet) into the room. Based on inspection of the exterior wall of the safe room, it is likely that the poles struck some part of the thick cell center and, due to the rounded shape, deflected to the thinner portion of concrete where the metal was able to penetrate into the interior of the safe room. A pole taken from the site measured to be approximately 2.5 cm (1 inch) square with a thickness of 0.23 cm (0.09 inches). The pole was bent and had a tip to tip length of 99 cm (39 inches) and an arc length of 104 cm (41 inches) along the curve. Detailed images of one of the projectiles are shown in Figure 4.10(b-d).

Figure 4.10, Illustrated is (a) the wind borne projectiles which punctured the ICF safe room wall nearly striking the home owner (one projectile has been removed); (b) detailed dimensions of one projectile; (c) the end which punctured the wall; and (d) the other end used for thickness measurements.

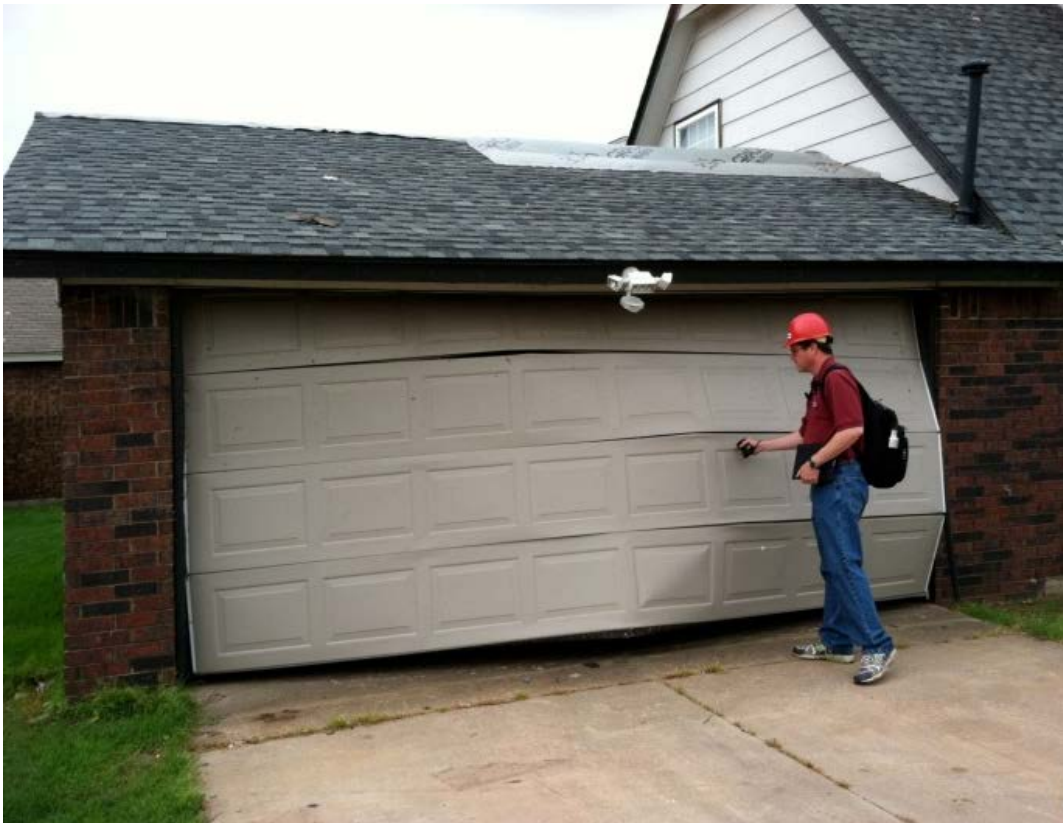
Some houses on the fringe of the 2013 Moore OK tornado path had partially collapsed garage doors as shown in Figure 5.1 below. Though slight in terms of property damage, the consequences of losing the garage door were frequently severe.

Figure 5.1, Partially collapsed light-gage metal garage door of house on tornado damage fringe.

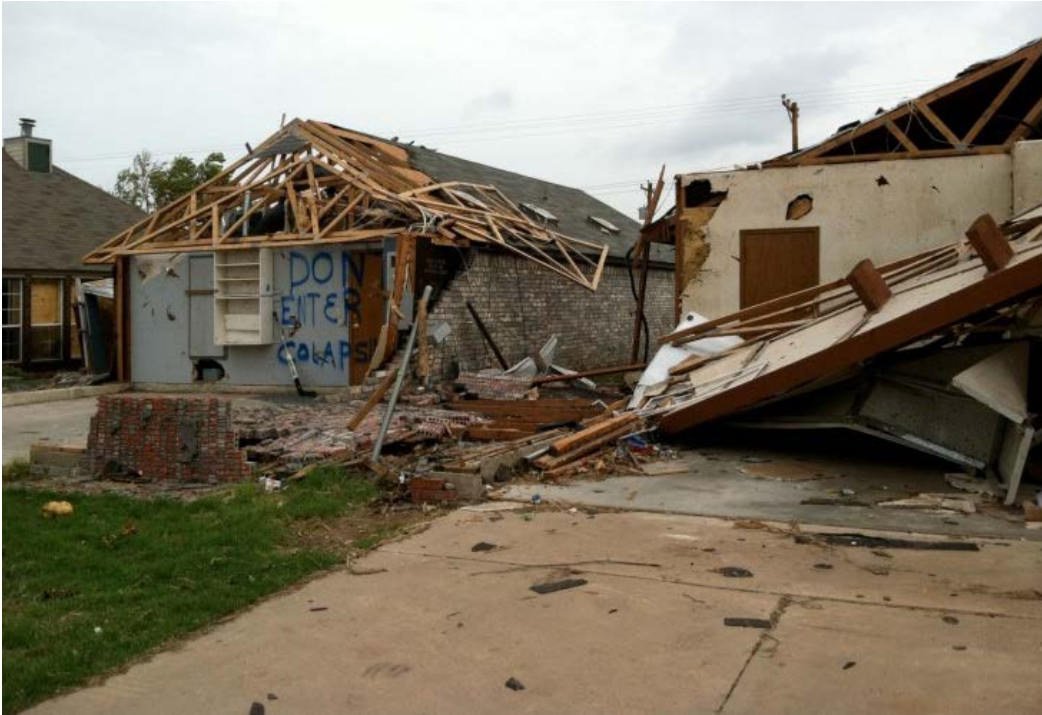
up and off. This resulted in essentially complete loss of lateral support to the tops of the garage walls on either side of the large garage door as shown in Figure 5.2 and Figure 5.3. The short walls adjacent to the garage door opening were typically not sheathed (e.g. with plywood) and therefore had minimal shear stiffness.

Figure 5.2, Garage removed from house on left with protruding garage.

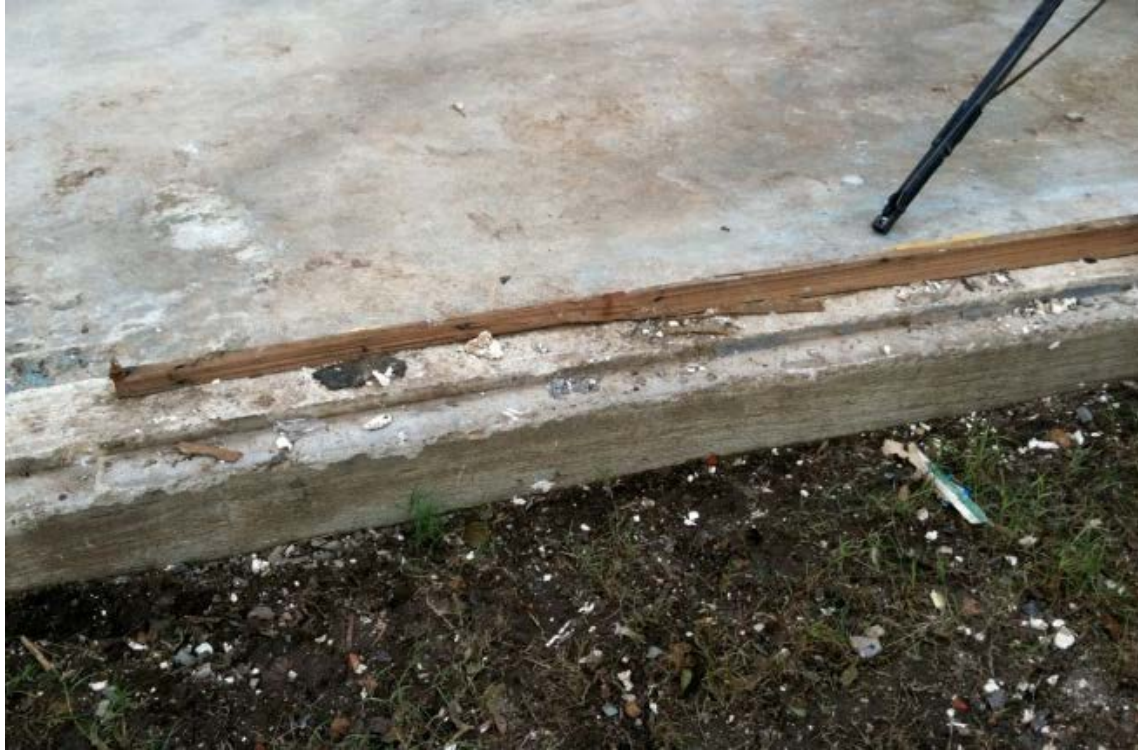
Figure 5.4, Failed sill plate with anchor bolt still attached.

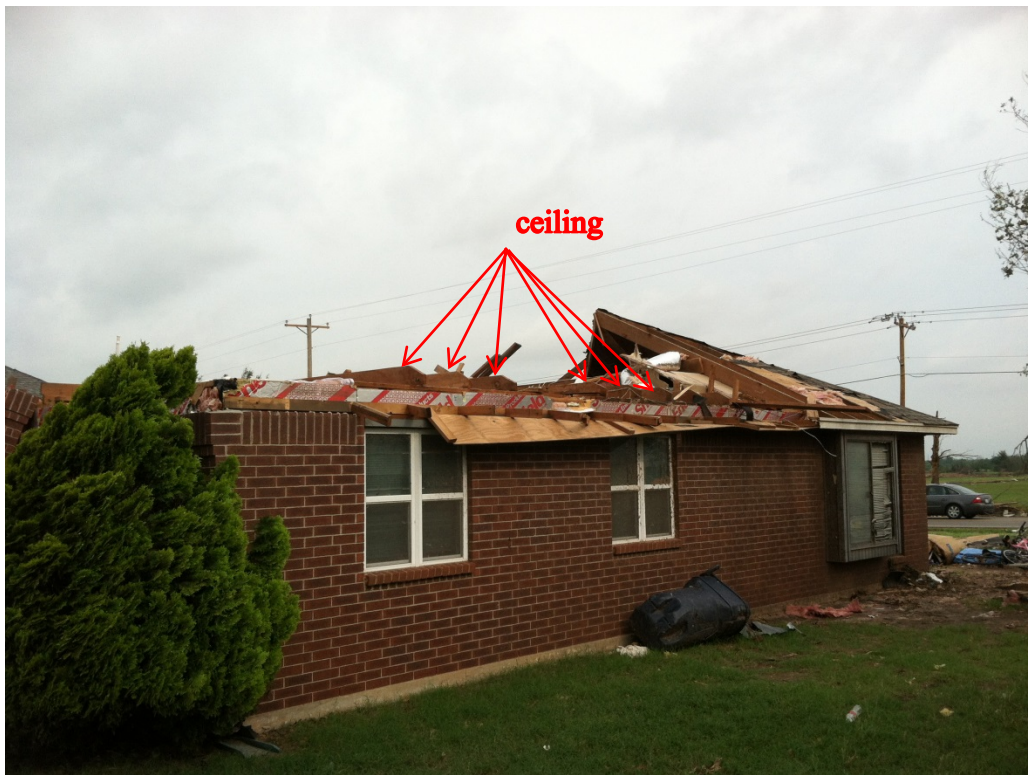
Figure 5.6, Missing roof but intact ceiling joists.

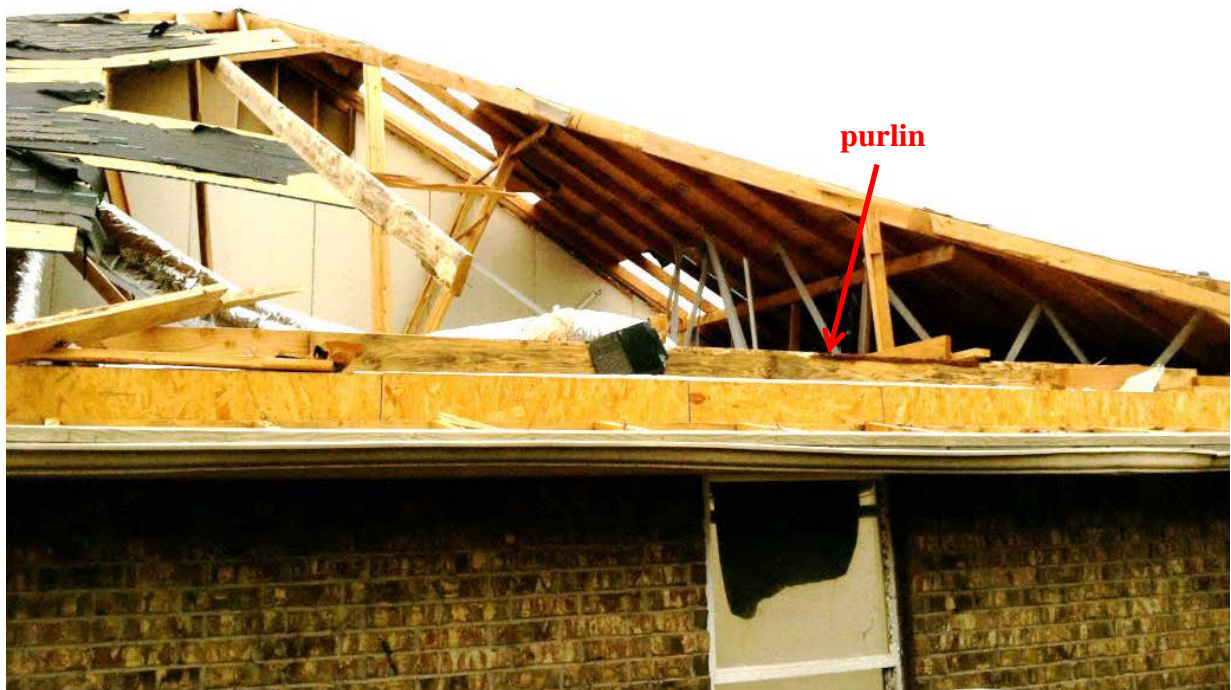
Figure 5.7, Long unsupported spans of rafters on typical “high profile” roof. Lateral support to bottom of rafters indicated by red arrow.

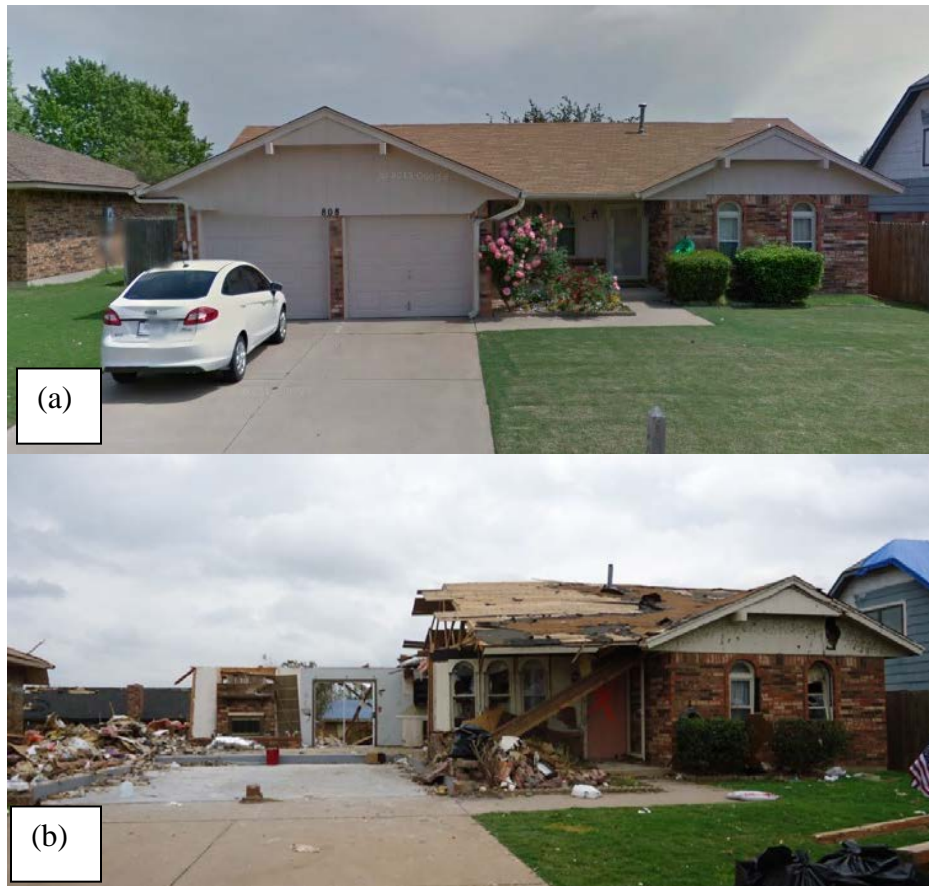
Figure 5.10, 808 S. Silver Leaf Drive (a) before (Google Maps, 2013) and (b) after the tornado. The Degree of Damage (DOD) on the EF scale was 6 based on the removed roof structure and most walls remaining intact, which suggests wind speeds between 104 and 142 mph with an expected speed of 122 mph. The collapsed walls indicated a DOD nearer to 7 and wind speeds toward the high end of this range.

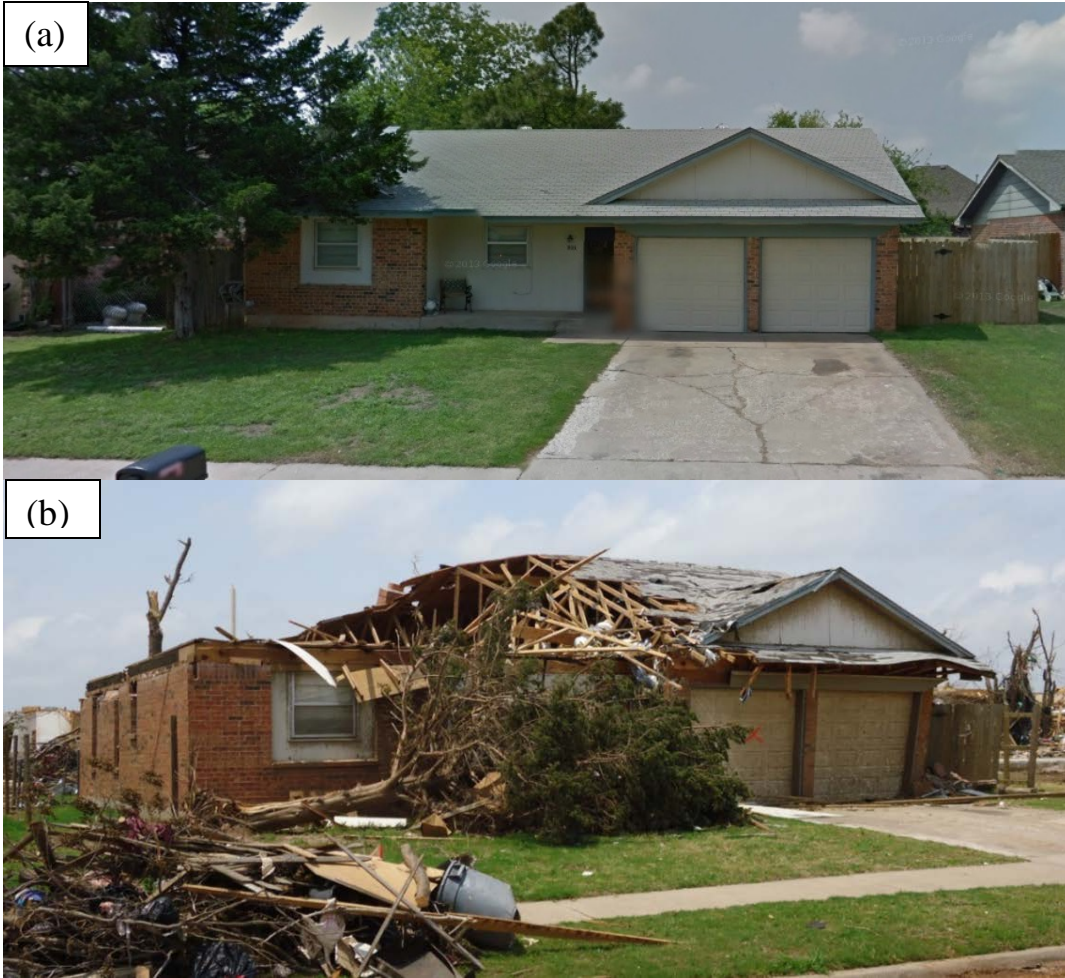
Figure 5.15, 805 S. Silver Leaf Drive (a) before (Google Maps, 2013) and (b) after the tornado. The Degree of Damage (DOD) on the EF scale was 6 based on the removed roof structure and most walls remaining intact, which suggests wind speeds between 104 and 142 mph with an expected speed of 122 mph.

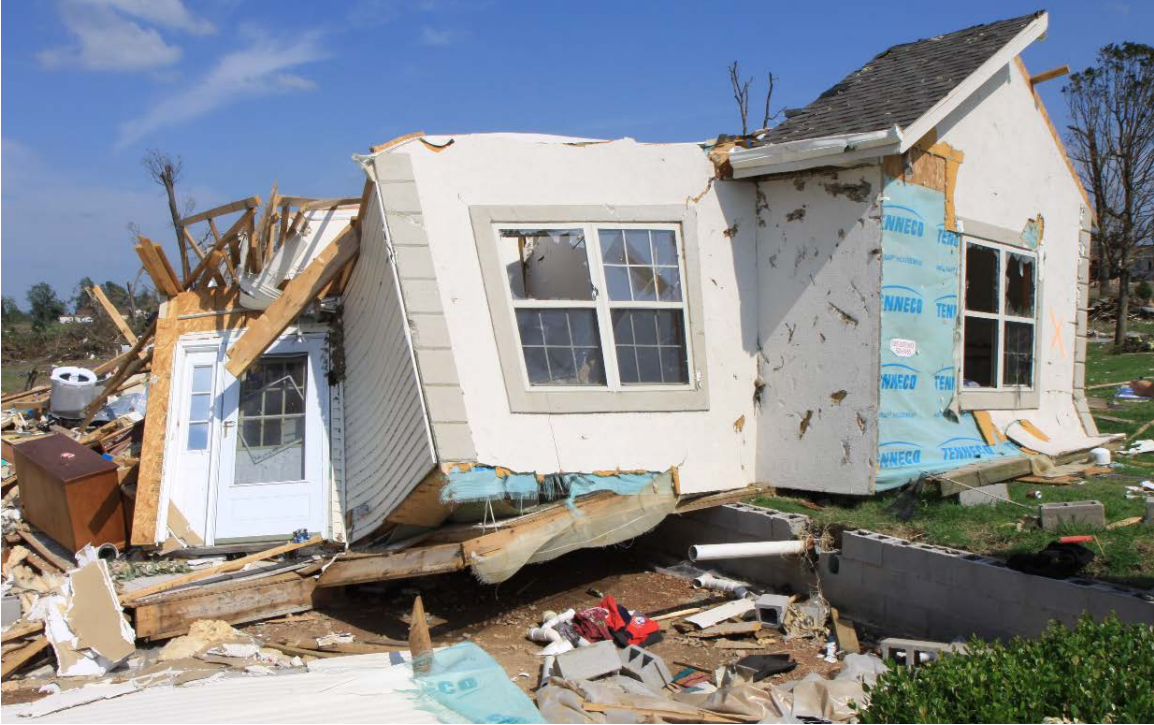
Figure 5.19, House shifted off of foundation in Joplin, MO after 2011 Tornado.

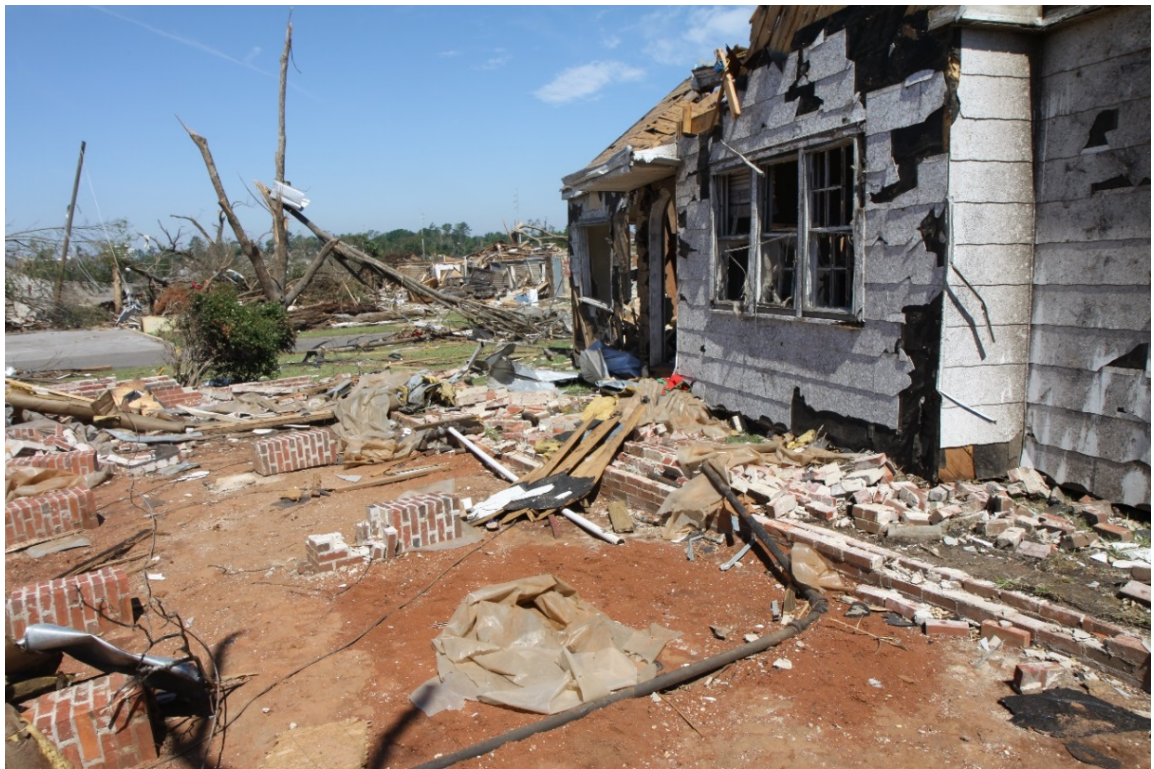
Figure 5.20, House shifted off of crawlspace foundation in Tuscaloosa, AL after 2011 Tornado.

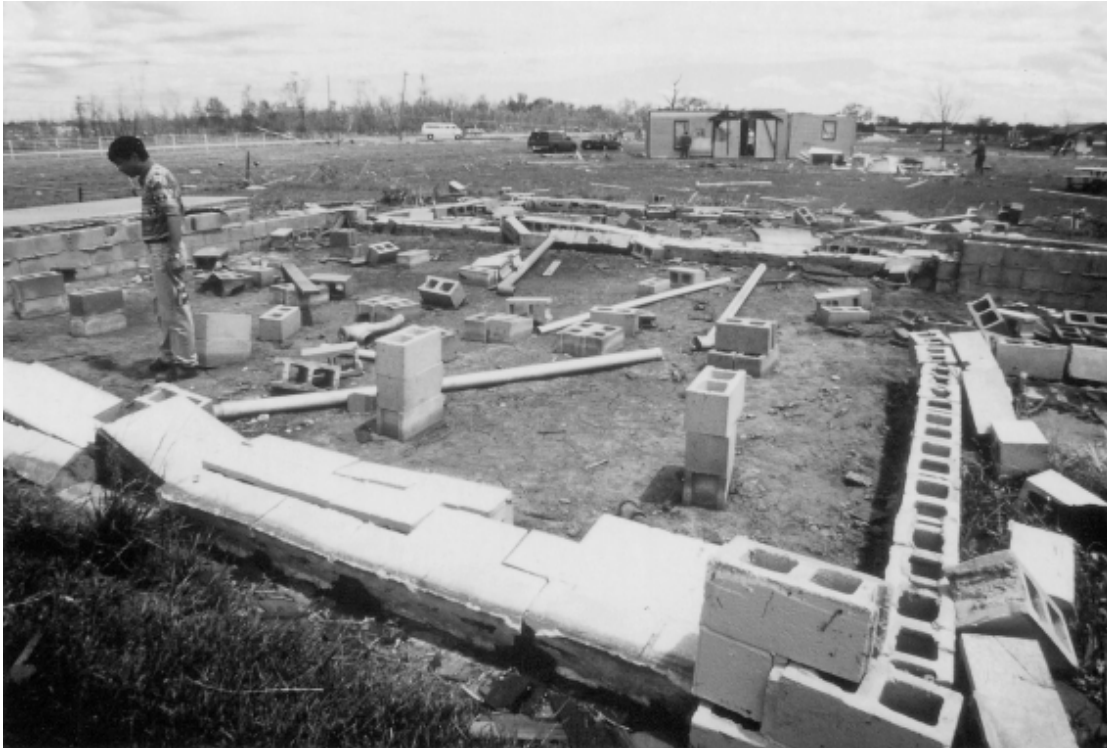
Figure 5.21, House shifted off foundation 90 m in Moore, OK after 1999 tornado (Marshall, 2002).

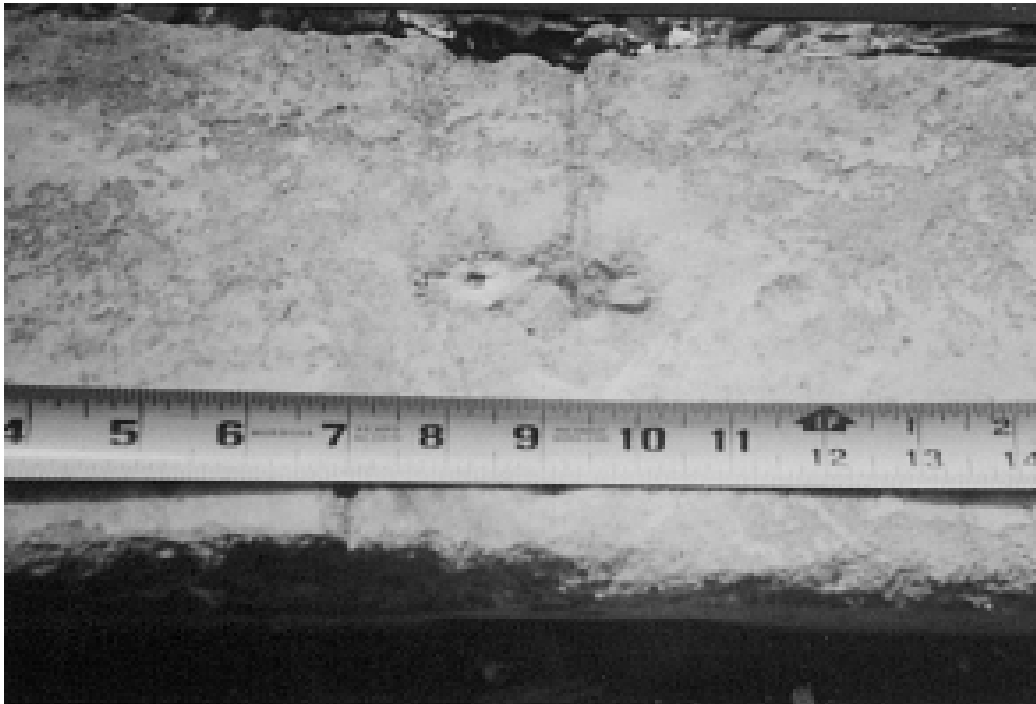
Figure 5.22, Scrape mark in the surface of concrete slab foundation indicating where the wall bottom plate along with the tapered cut nail connection were moved laterally (Marshall, 2002).

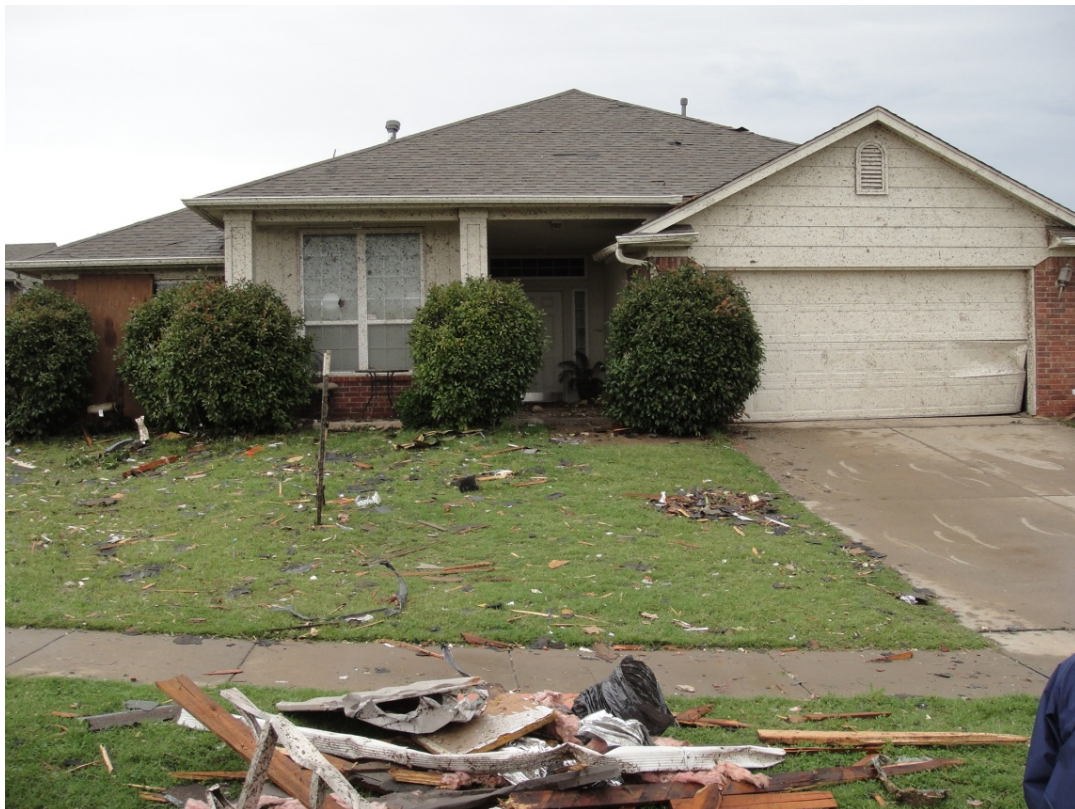
Figure 5.23, Stage 1 -- Wind Pressure Initiates Failure of the Garage Door

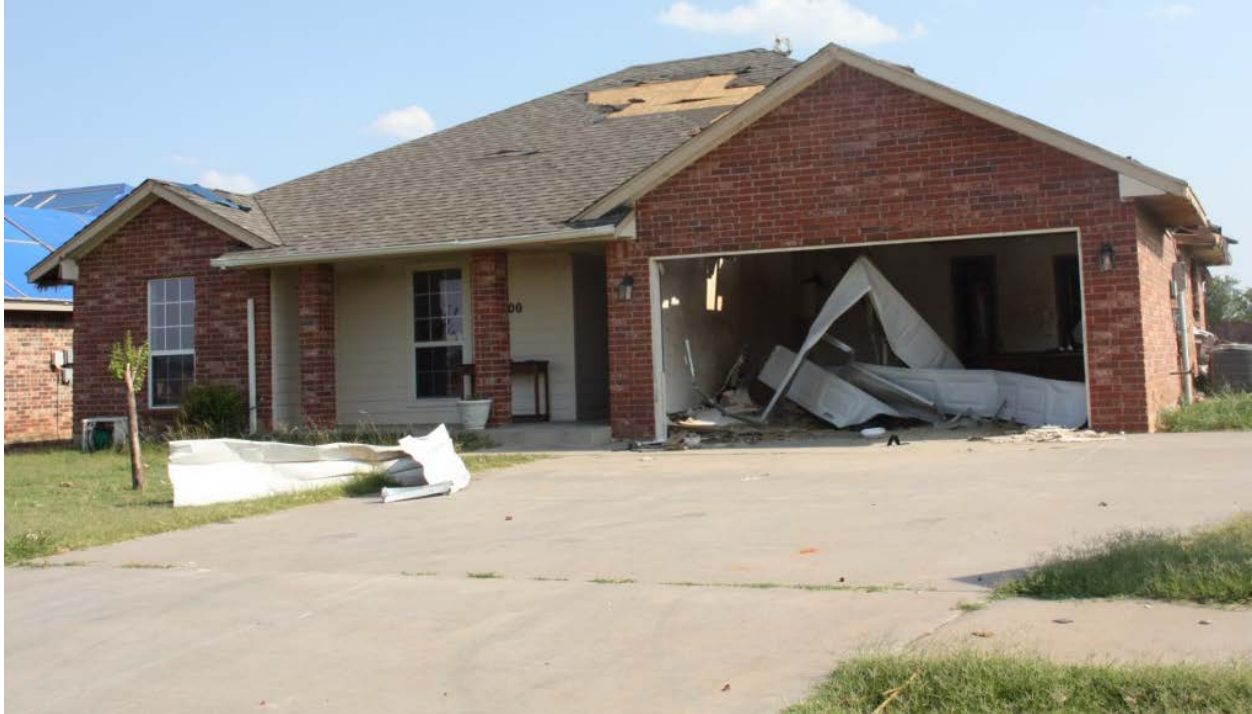
Figure 5.24, Stage 2 -- Garage Door Completely Destroyed

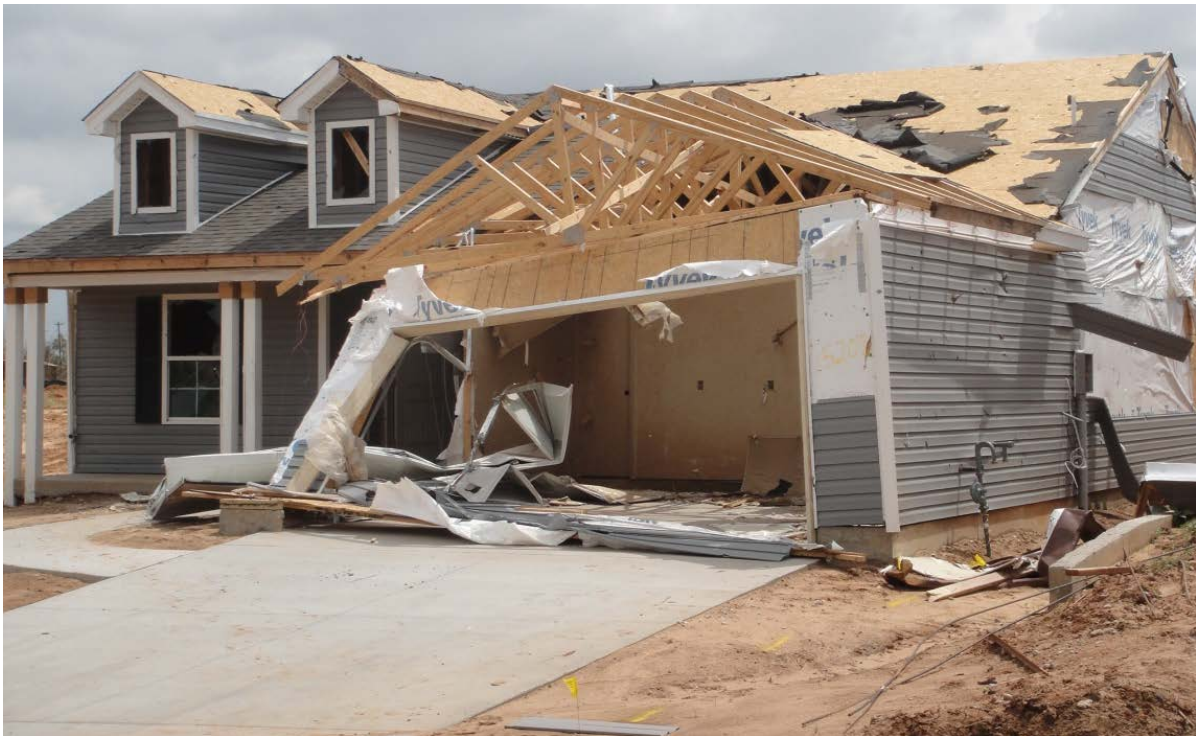
Figure 5.26, Stage 4 -- Garage Wall Framing Starts to Fail

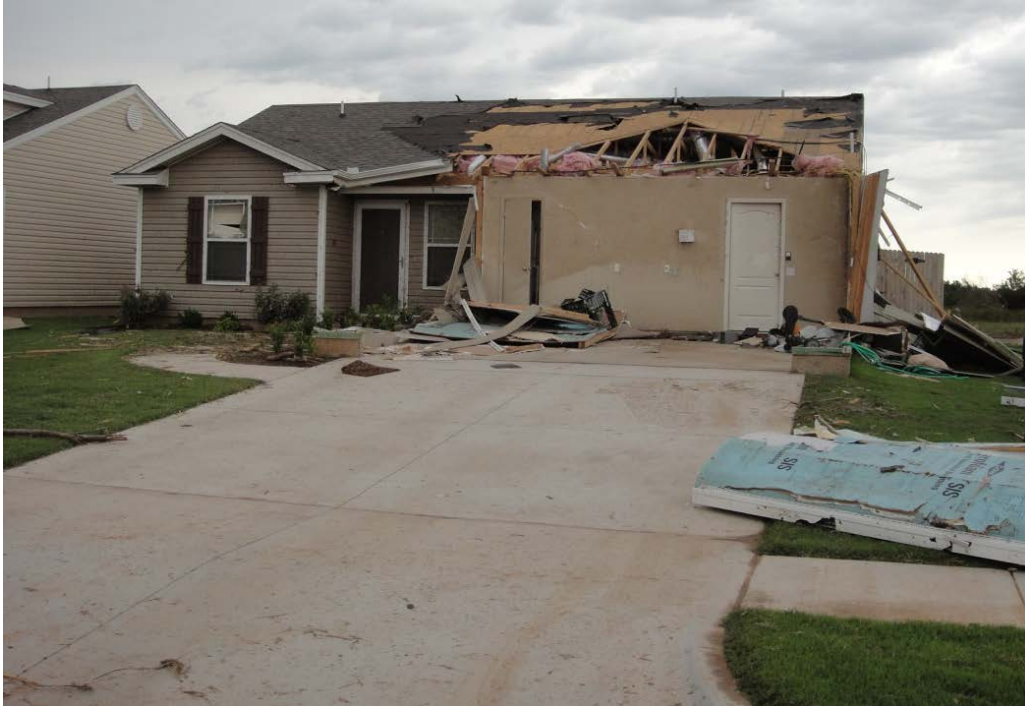
Figure 5.27, Stage 5 -- Garage Completely Destroyed; Main Roof Begins Peeling Off; Attic is now partially Enclosed

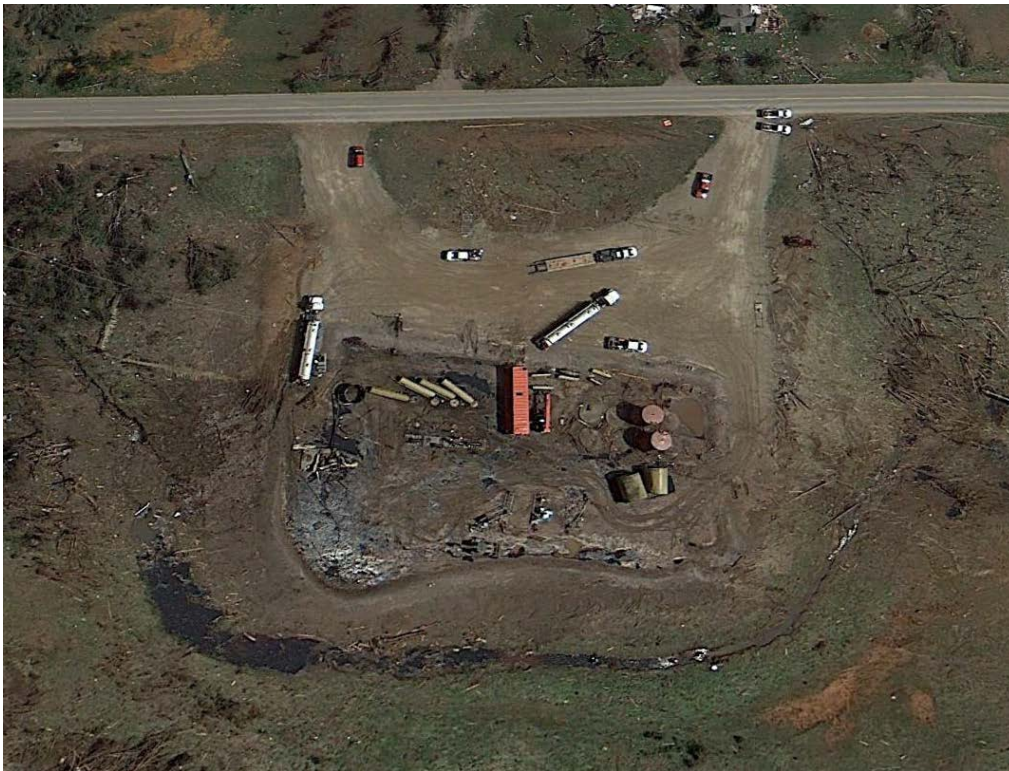
Figure 6.28, Damaged Tank Farm

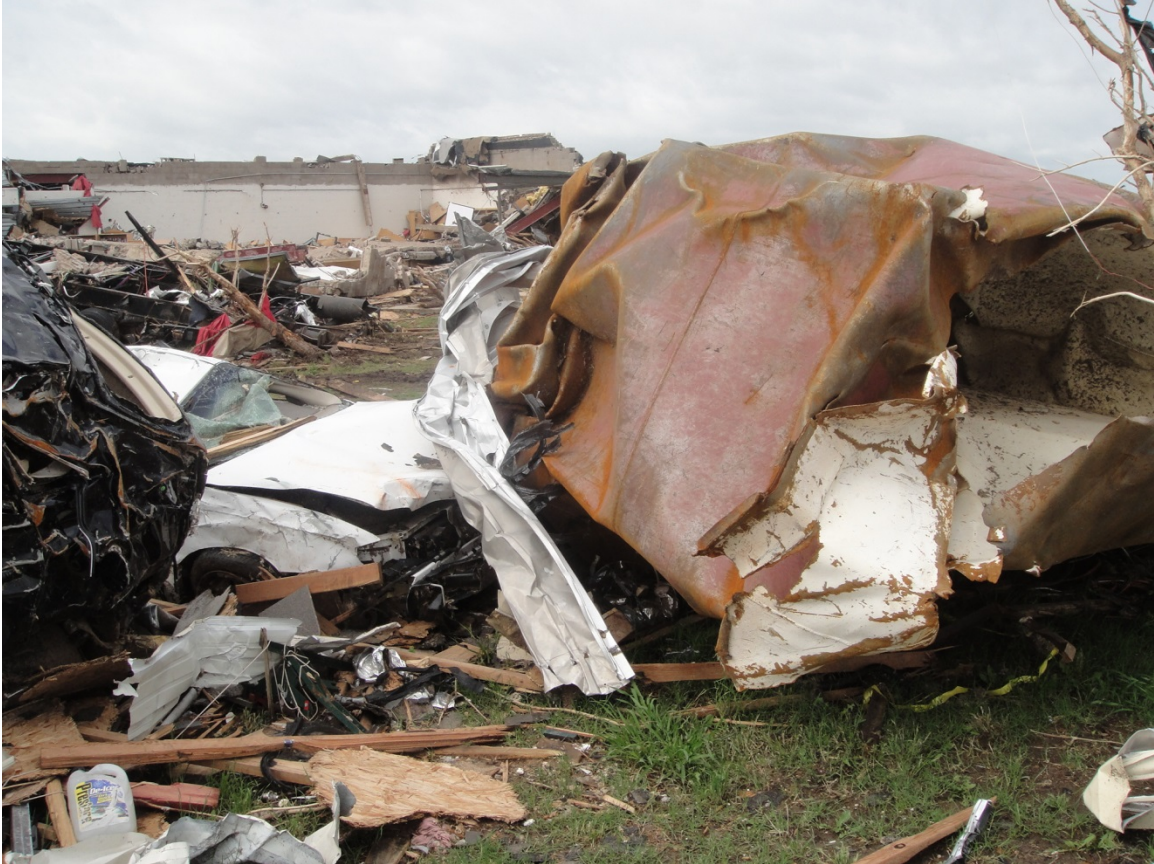
Figure 6.31, Oilfield Tank on Briarwood Lawn

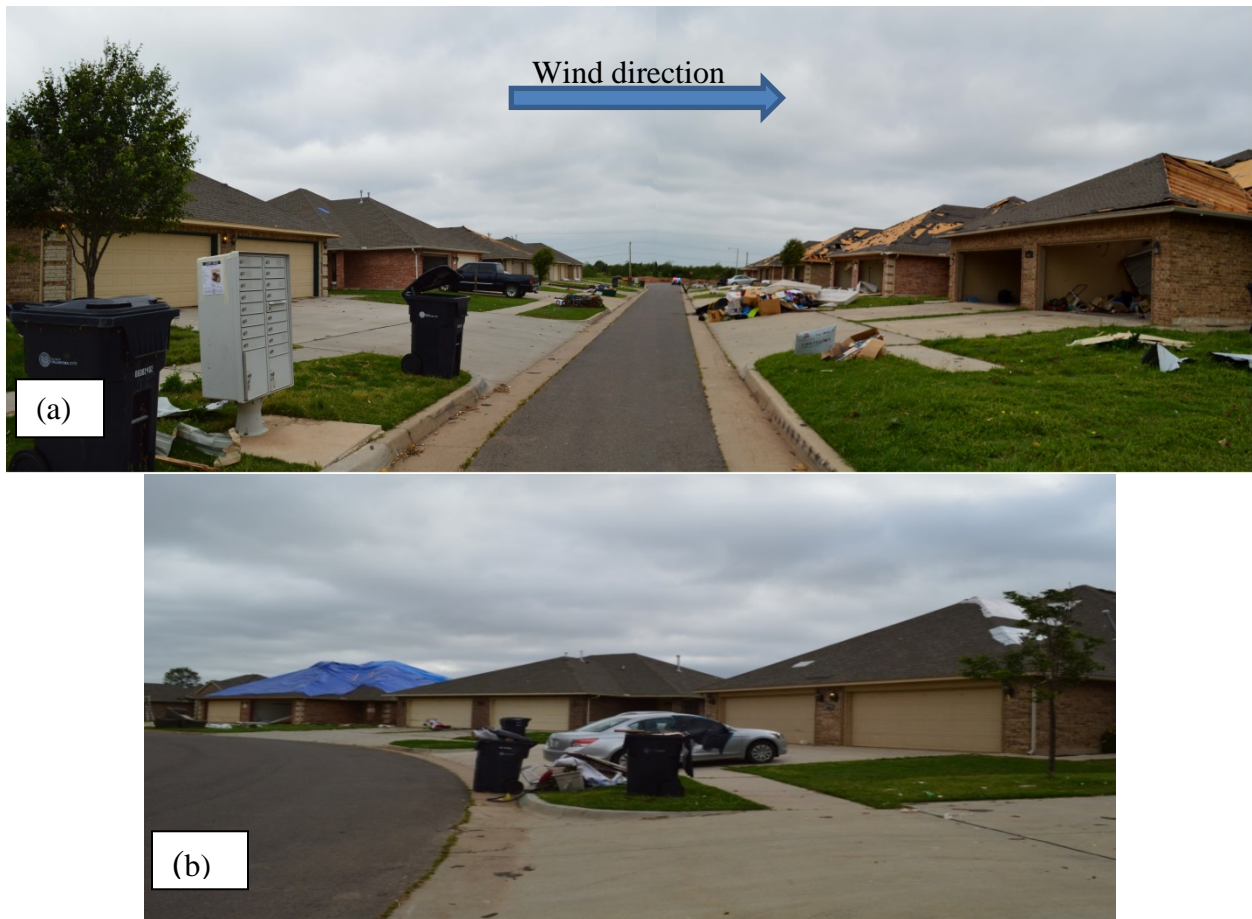
Figure 7.2, Different garage door damage levels (a) on both sides of SW 151st Street and (b) when house directions change.
