A Deeper Look into the Ionospheric Scintillation eXplorer (ISX): A Failure Analysis

John M. Bellardo, Grigory Heaton, Cassandra Kraver, Dave Pignatelli, Ryan Nugent, Alicia Johnstone, Pauline Faure

California Polytechnic State University, San Luis Obispo

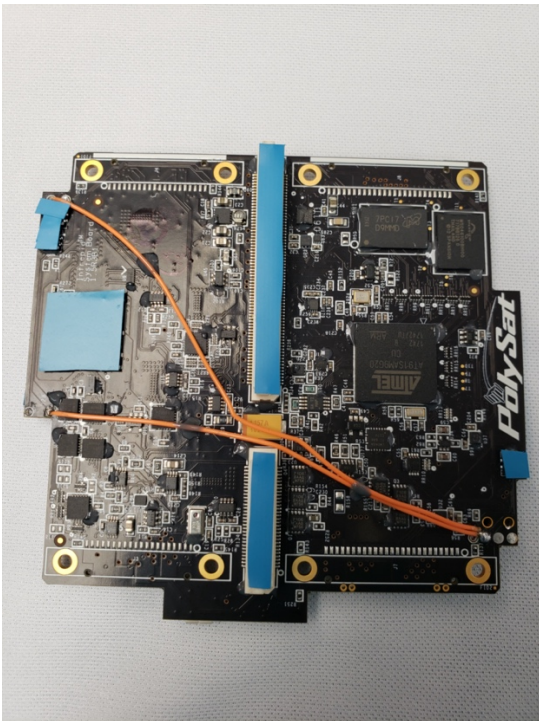
ISX experienced a ground testing anomaly after a thermal backout test involving one of the traces on the PCB that controls the power-on sequence. The trace expanded and cracked in such a way that minor physical pressure was required to the board in order for it to turn on. This issue was resolved pre-flight by adding a wire modification that bypasses the fragile trace. After the modification was added the board returned to its expected behavior. It is possible that

other traces may have experienced a similar failure, however that possibility is reduced both by ground environmental testing that originally identified the broken trace and the small number of times we have successfully flown the same avionics board with the same wire modification. It is also possible that the wire modification itself failed. The light weight of the additional wire, plus installation procedures that include both staking and conformal coating, and vibrations testing of the modification make this particular failure also unlikely. Figure 2 shows the wire modification staked to the system board prior to conformal coating.

Figure 2: Wire mod to bypass fragile trace applied to the system board

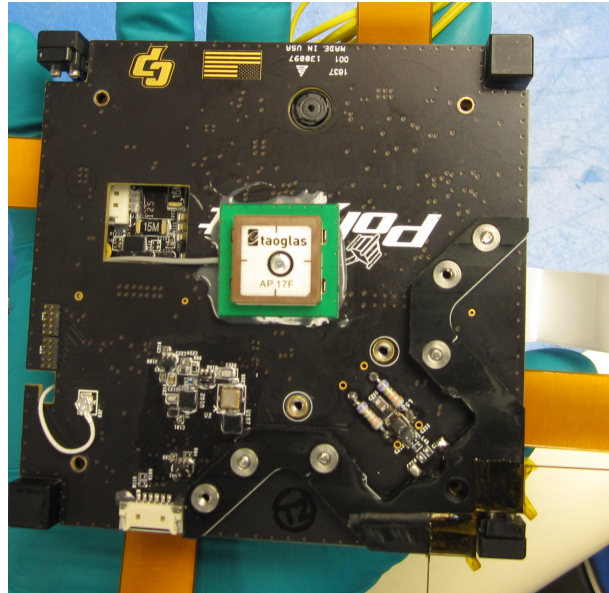
Another possibility considered is that the spacecraft antenna failed to deploy. There are two primary concerns if the antenna doesn't deploy. First, the signal strength of the radio transmissions is noticeably reduced, making it nearly impossible to close the link, however the transmissions are typically still visible using a software defined radio. One of our previous missions, ExoCube, experienced an antenna failure which resulted in this situation. That failure was most likely caused by a bad solder joint. Based on the lessons learned from ExoCube the antenna deployment mechanism was redesigned and all solder connections are now on a PCB. Redundant burn circuits were also added to allow recovery if one of the circuits fails. This new design, as seen in Figure 3, was extensively tested on the ground with different simulated environments. It

has also successfully flown on the DAVE mission prior to ISX. Since no signal was observed from ISX across many months of passes this failure mode is unlikely to have occurred.

Figure 3: The ISX -Z panel, showing the antenna deployment mechanism in the lower-right corner. Note the antenna is deployed in this picture.

The second concerning outcome of a failed antenna deployment is that power reflects off the stowed antenna and causes the power amplifier to blow out. This creates a break in the RF chain preventing all transmissions. This failure has been observed multiple times while ground testing radio hardware when proper handling procedures were not followed. There is no telemetry or other data available to refute this, other than the extensive testing and flight heritage of the deployment mechanism.
