# JOINT TRANSPORTATION RESEARCH PROGRAM

# Concrete Box Beam Risk Assessment and Mitigation:

Volume 1 — Evolution and Performance

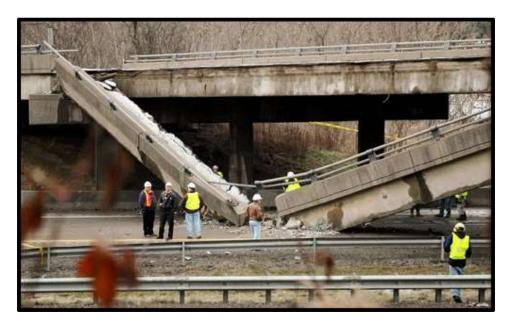
Despite efforts to repair adjacent box beam bridges, there have been a number of documented collapses in the last few decades. In 1998, an exterior beam collapsed in Illinois (Hawkins & Fuentes, 2003). Similarly, on December 27, 2005, an exterior beam of an adjacent box beam bridge (Lake View Drive Bridge in Washington County, Pennsylvania) shown in Figure 1.2 collapsed under dead load (Harries, 2009). A survey conducted by PennDOT determined that these failures are not isolated to the Midwest. States such as Colorado, Florida, Illinois, Indiana, Ohio, Pennsylvania, and Virginia have all reported failures of box beam bridges (Macioce et al., 2007).

Figure 1.2 The Lake View Drive Bridge collapse (McCloskey, 2005).

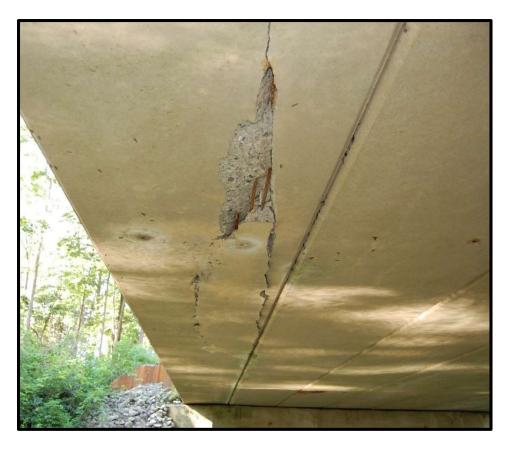
Figure 4.4 Cracking, spalling, and exposed strands in exterior beam on east end.

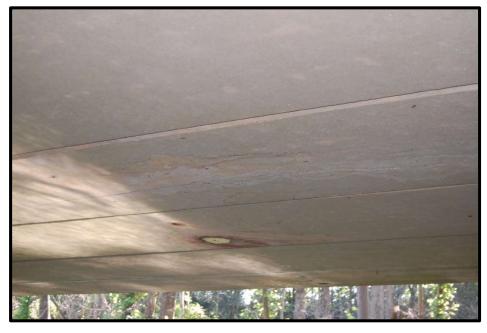
Figure 4.5 Longitudinal crack in middle beam.

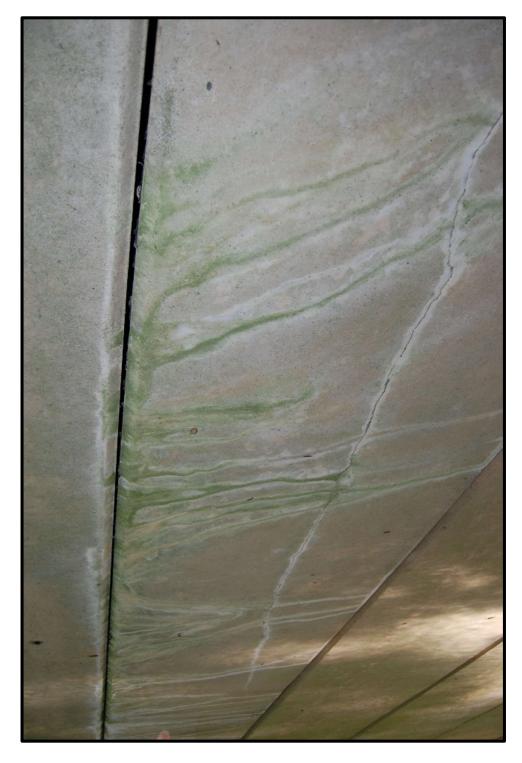
Figure 4.6 Longitudinal crack and staining at first interior beam.

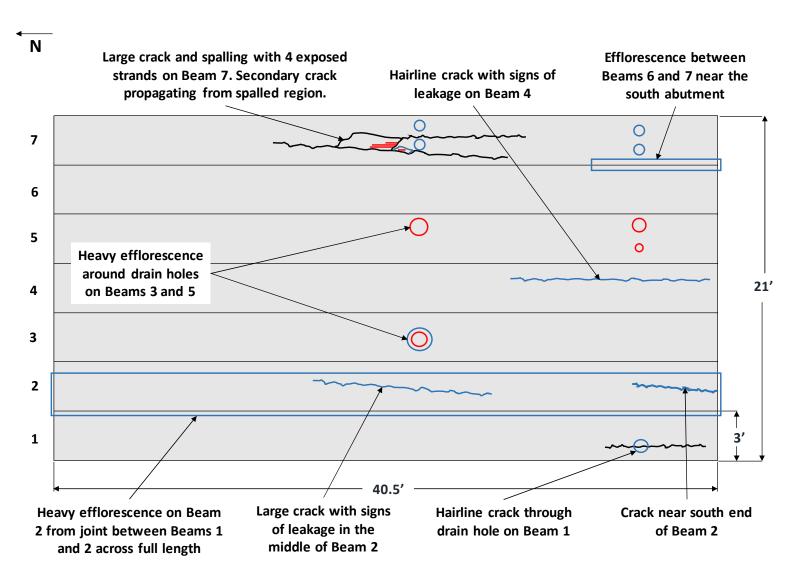
Figure 4.7 Deterioration map of pond creek bridge (35-00013).

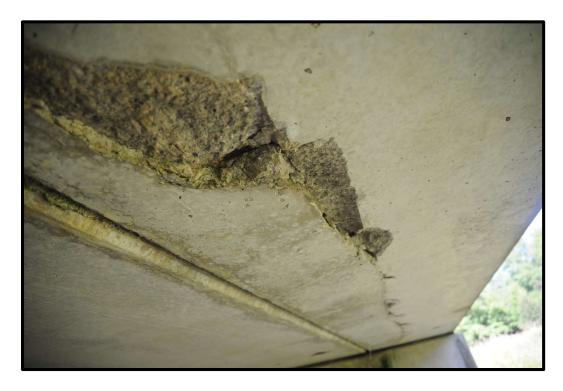
The most deteriorated span was on the east end of the bridge. One of the exterior beams has a large region of spalling with two exposed stirrups and signs of water leakage around the shear key (Figure 4.8). The other exterior beam has a longitudinal crack in the bottom flange and a hole in the top flange (Figure 4.9). The hole revealed standing water in the void of the box beam. The middle span has one beam with a longitudinal crack in the bottom flange and signs of water leakage at the shear key (Figure 4.10). The complete map is provided in Figure 4.11.

Figure 4.9 Exterior beam with spalling and exposed stirrups.

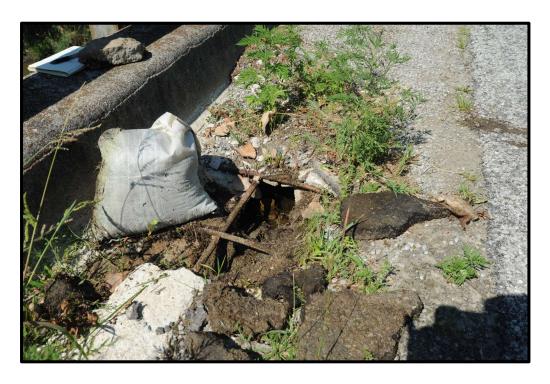
Figure 4.10 Hole in top flange of box beam.

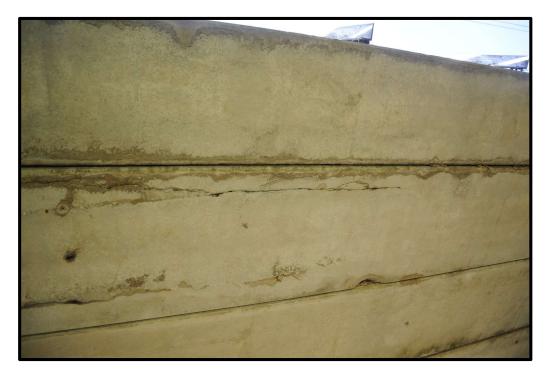
Figure 4.11 Longitudinal crack, spalling, and efflorescence in bottom flange in middle span.

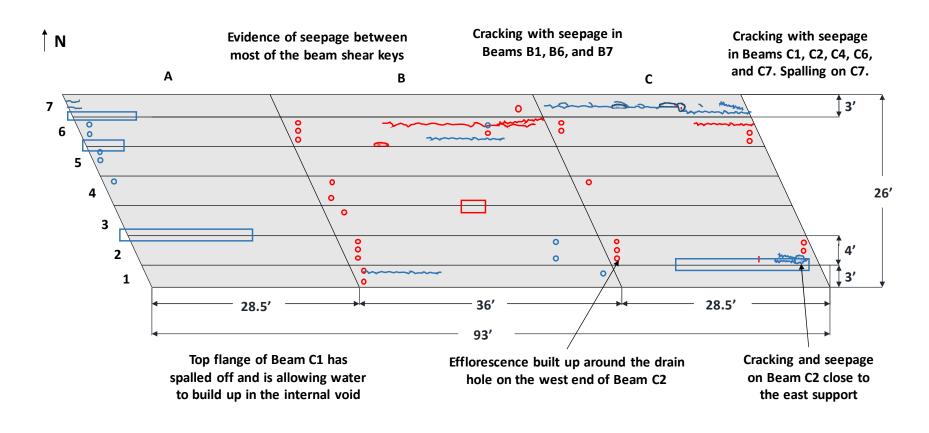
Figure 4.12 Deterioration map of rock creek bridge (90-00079).

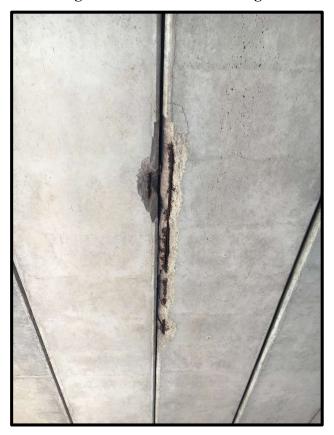
The bottom of the superstructure is in good condition compared to the Pond Creek and Rock Creek bridges. Spalling at the bottom corners of two adjacent beams with two exposed strands in the middle of the span was noted (Figure 4.13). Between Beam 3 and Beam 4, rust staining was observed towards midspan (Figure 4.14). Corrosion and two exposed stirrups were also observed at the southeast corner of the bridge (Figure 4.15). The complete deterioration map is provided in Figure 4.16.

Figure 4.14 Region of spalling with two exposed strands.

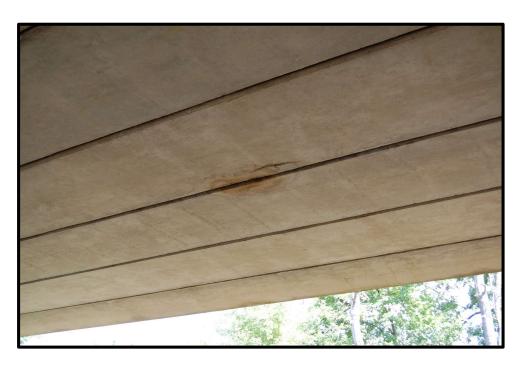
Figure 4.15 Staining near bottom of longitudinal joint.

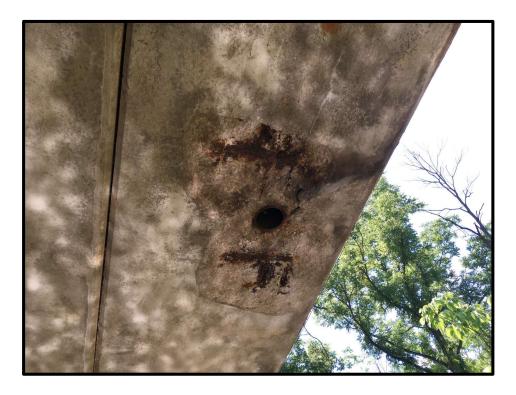
Figure 4.16 Corrosion and exposed stirrups around steel downpipe.

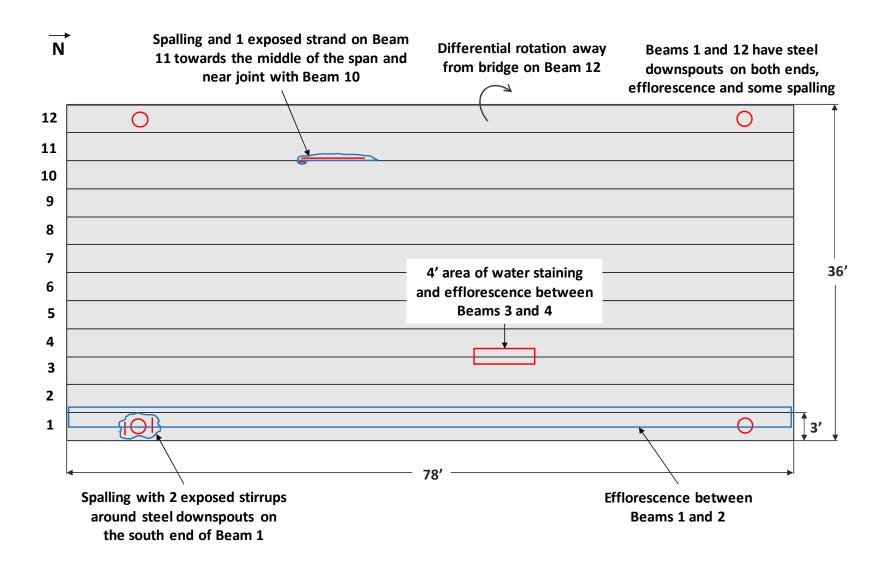
Figure 4.17 Deterioration map of Clear Creek Bridge (005-35-05912 B).

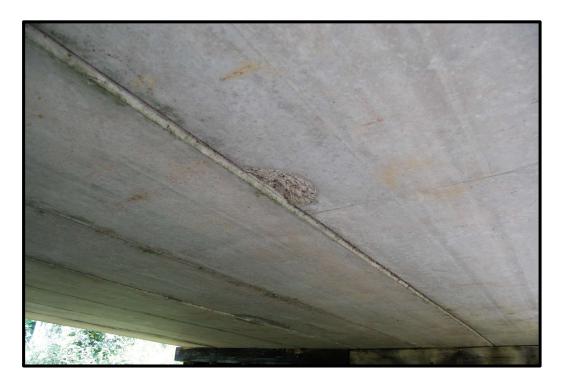
The underside of the Yellow Creek Bridge has small regions of spalling at the edges of the first interior beams along with an exposed strand (Figures 4.18 and 4.19). An exposed stirrup was observed on the exterior face of the exterior beam on the east side (Figure 4.20). Patched potholes were scattered across the concrete wearing surface and were filled with asphalt (Figure 4.21). A correlation was made between the location of the patches and the location of the longitudinal joints of the box beams. A complete map of the deterioration is provided in Figure 4.22.

Figure 4.19 Spalling along bottom of longitudinal joint.

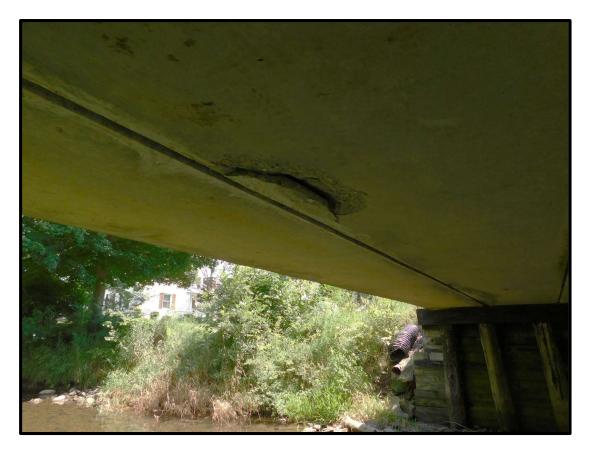
Figure 4.20 Spalling with exposed strand on Beam 7.

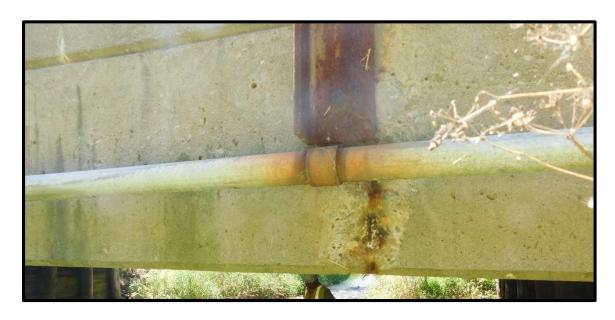
Figure 4.21 Spalling and exposed stirrup on the exterior face of Beam 8.

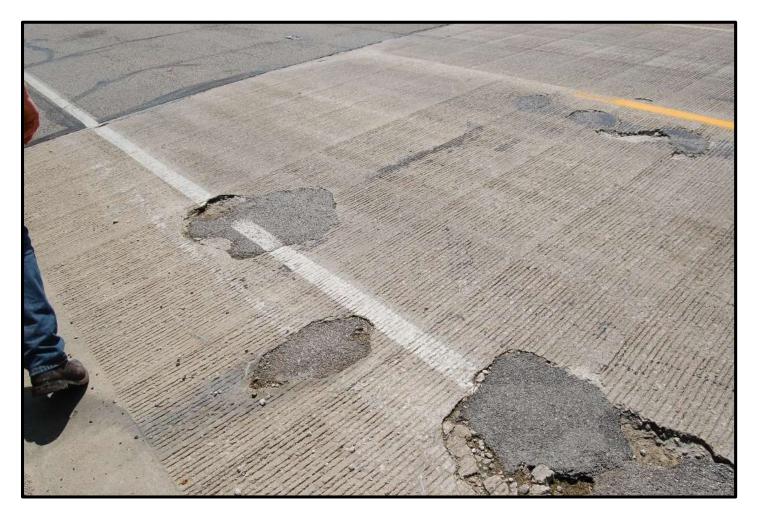
Figure 4.22 Potholes in wearing surface.

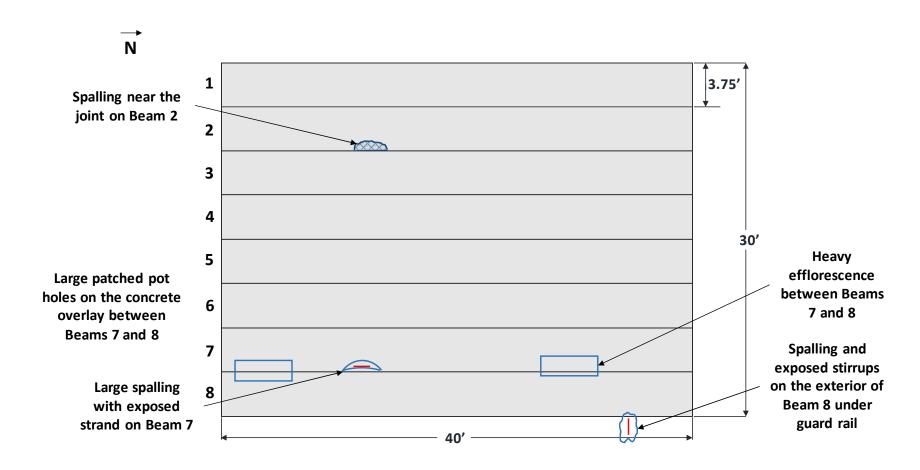
Figure 4.23 Deterioration map of Yellow Creek Bridge (019-43-06147 B).

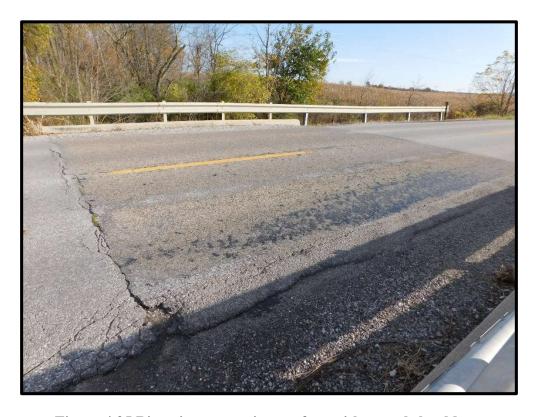
Figure 4.25 Bituminous wearing surface with gravel shoulders.

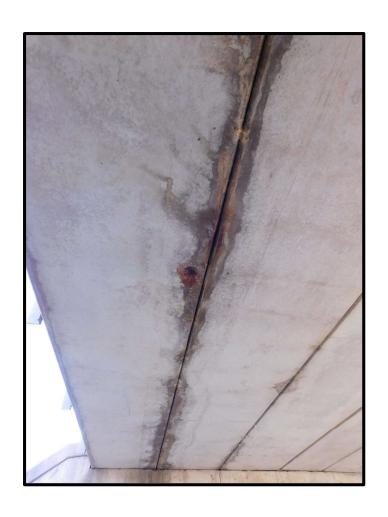
The only problems observed on this bridge were located at the longitudinal joints. On November 3, 2016, which was a relatively dry day, five of the seven longitudinal joints showed leakage. The most moisture along with efflorescence was observed at the exterior joints and extended the full length of the span. In addition, spalling and corrosion were observed at the exterior joint on the east side (Figure 4.25). Moisture was also observed at the interior joints, generally near midspan (Figure 4.26). Leakage was observed near the abutments between Beams 6 and 7. The complete deterioration map is provided in Figure 4.27.

Figure 4.26 Efflorescence, spalling, and corrosion along bottom of exterior joint.

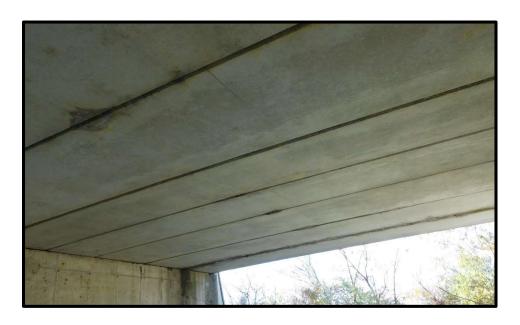
Figure 4.27 Efflorescence along bottom of interior joint.

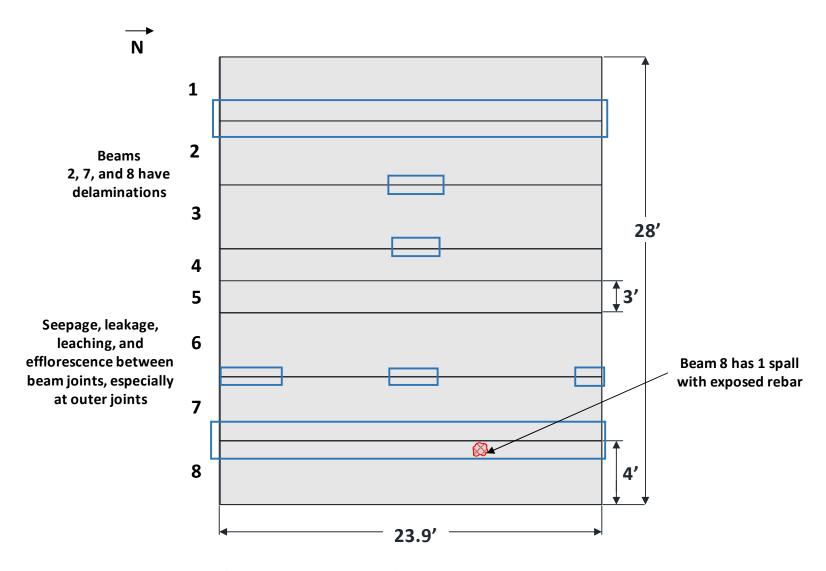
Figure 4.28 Deterioration map of Beal-Taylor Ditch Bridge (02-00221).

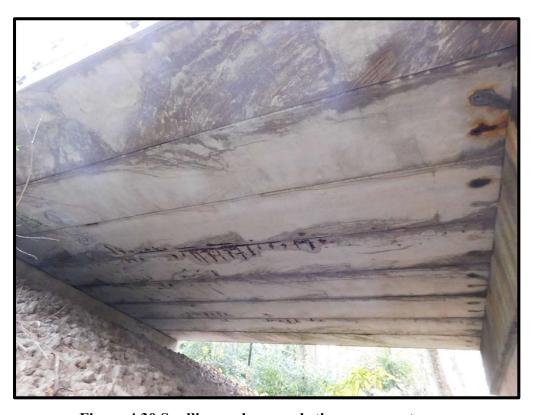
This bridge was noted to be in the worst condition compared to the other five bridges inspected. The end spans have multiple regions of spalling with exposed stirrups and strands (Figure 4.29). Corrosion on the west span was so severe that prestressing strands had fractured and debonded from the concrete (Figure 4.30). Strands were observed hanging from the underside of the superstructure. Spalling initiated near the longitudinal joints and, over time, moved closer to the center of the beams. For one particular beam, 24 exposed stirrups and four exposed prestressing strands were noted. The middle span appeared in better condition with only three locations of spalling, each region having three exposed stirrups (Figure 4.31). A complete deterioration map is provided in Figure 4.32.

Figure 4.30 Spalling and exposed stirrups on east span.

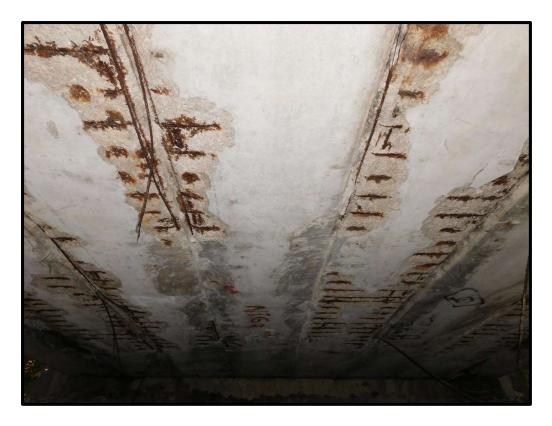
Figure 4.31 Spalling, corrosion, and fractured prestressed strand on west span.

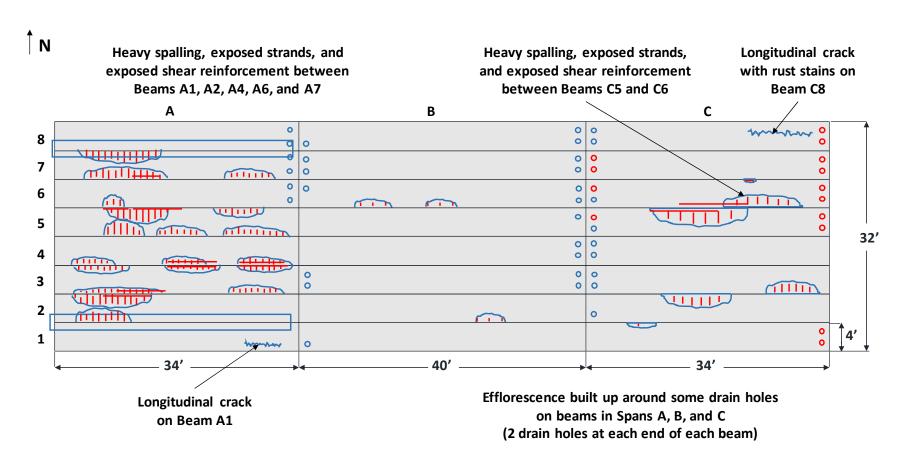
Figure 4.32 Deterioration map of Main Street Bridge (02-00601).

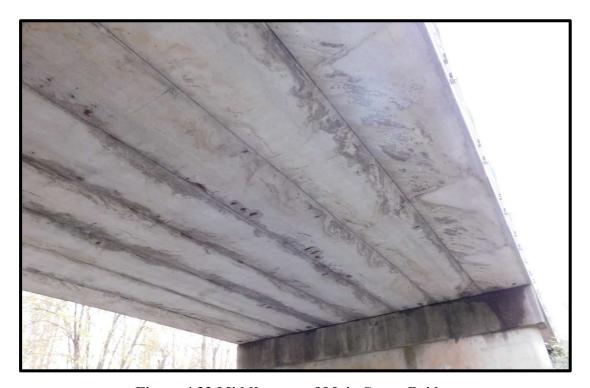
Bridge (Figure 4.33), Beams 2A and 7A are next to exterior joints that showed signs of leakage. Both beams have spalling and exposed stirrups on the side closest to the leaking joint. For this bridge, however, numerous beams have spalling and exposed reinforcement in the bottom edges adjacent to the joint.

Figure 4.33 Middle span of Main Street Bridge

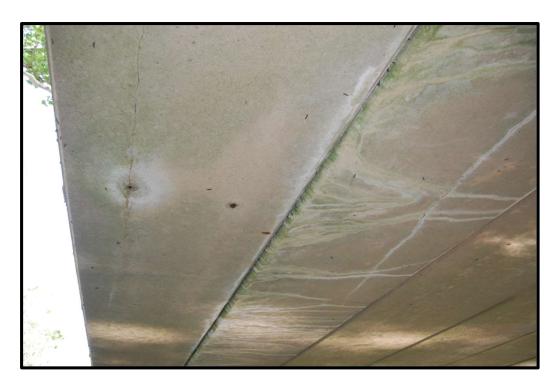
A combination of fractured shear keys and reflective cracking in the wearing surface leads to water seepage through the joints. Water staining on the bottom side of box beams near the longitudinal joint was frequently observed. The Pond Creek (35-00013) Bridge exhibited water staining and efflorescence at the exterior longitudinal joint. The staining revealed that the water was seeping through the joint and curling onto the bottom side of the first interior beam (Figure 4.33). The Main Street (02-00601) Bridge also had efflorescence and rust staining near the longitudinal joint (Figure 4.34). In both cases, staining occurred between the exterior and first interior beams. This leakage may be an indication that the exterior shear keys are not performing as well as the interior shear keys. Torsion of the exterior beam may be a contributing factor.

Figure 4.34 Water staining at the exterior longitudinal joint (Pond Creek).

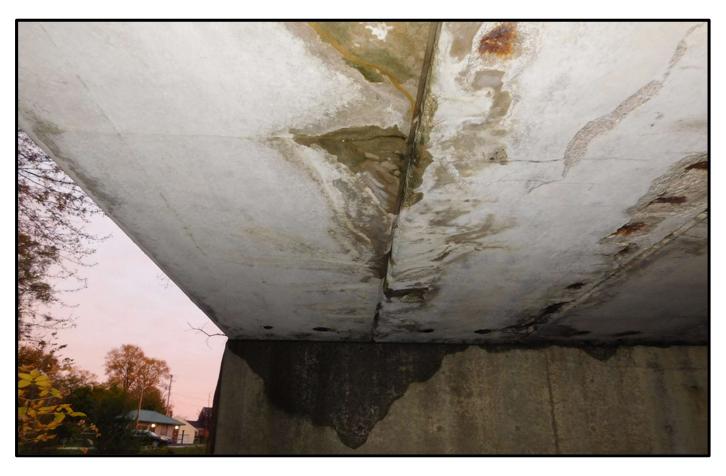
Figure 4.35 Water staining and effloresce at the exterior longitudinal joint (Main Street).

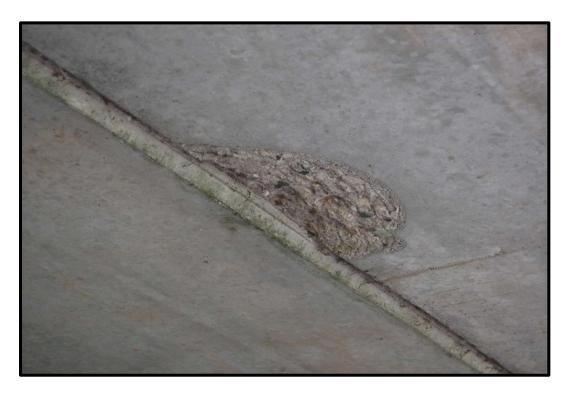
The Clear Creek (005-35-05912 B) Bridge had a larger region of spalled concrete that occurred on both sides of the longitudinal joint. The spalled concrete exposed prestressing strands in the bottom corners of each box beam near the joint (Figure 4.36).

Figure 4.36 Spalling near longitudinal joint (Yellow Creek).

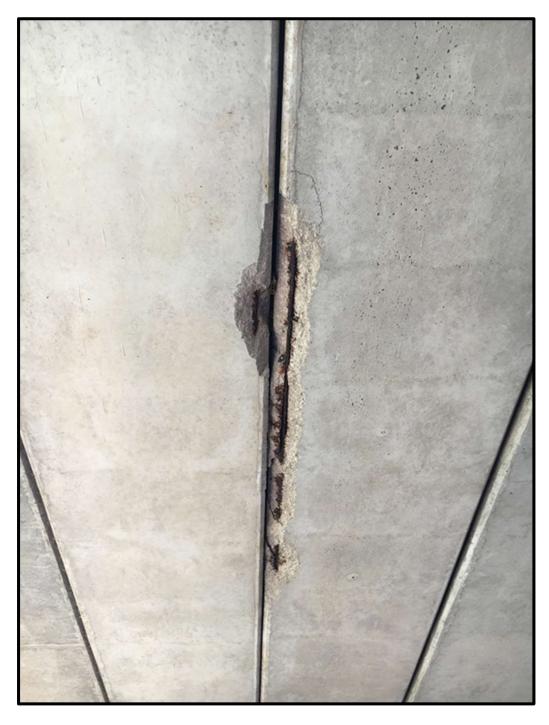
Figure 4.37 Spalling and exposed strand in the bottom corner of box beam (Clear Creek).

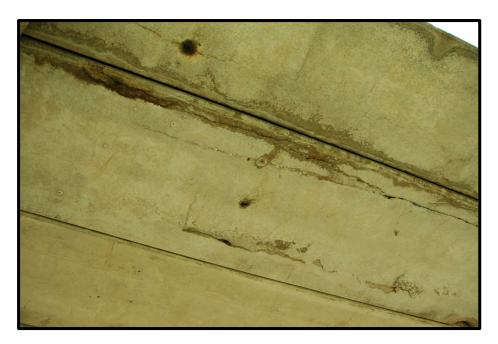
Longitudinal cracking was found on the bottom flanges of the adjacent box beams. Cracking usually occurred near midspan and was generally observed on or near the exterior beams. Rock Creek (90-00079) Bridge had two locations of longitudinal cracking. The first was in the middle span on the first interior box beam. Rather than being in the center for the flange, the longitudinal crack was closer to the joint with the exterior beam (Figure 4.37). This crack may be indicative of corrosion of the prestressing strand in the bottom corner of the beam. Longitudinal cracking was also observed on an exterior beam in the east span of the Rock Creek (90-00079) Bridge. This crack was closer to the center of the flange; however, the crack propagated toward the shear key closer to the abutment (Figure 4.38). A large region of spalling was observed in the center of the crack and exposed three prestressing strands. A group of drain holes was noted near the damaged location. Deterioration may have begun due to standing water in the void, causing corrosion of the prestressing strands, ultimately resulting in cracking and spalling.

Figure 4.38 Longitudinal cracking in bottom flange near shear key (Rock Creek).

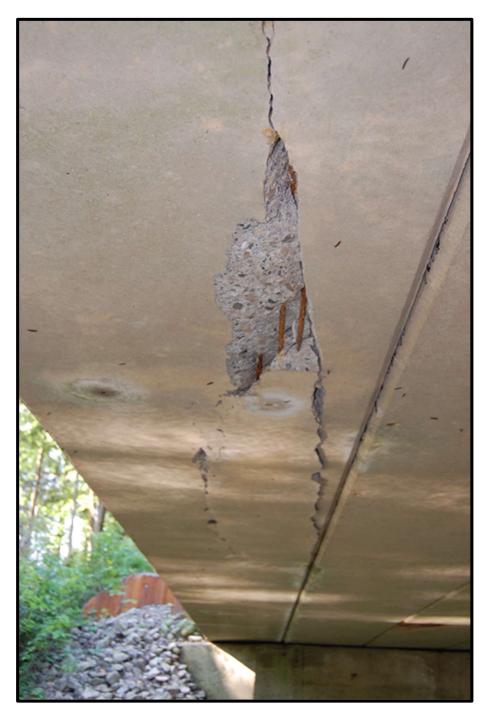
Figure 4.39 Spalling and exposed strands (Yellow Creek).

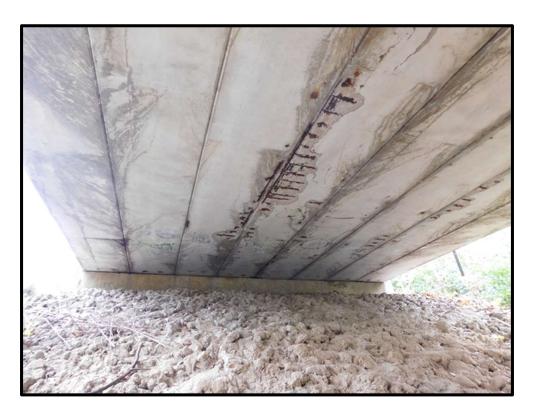
Corrosion of the reinforcement, both prestressing and stirrups, was frequently observed during the inspections. The worst case of corrosion was observed on the Main Street (02-00601) Bridge in Fort Wayne, IN. Spalling of concrete exposed a large number of stirrups and prestressing strands (Figure 4.39). In one span, the prestressing strands had fractured and debonded from the concrete, leaving them hanging from the underside of the beams (Figure 4.40).

Figure 4.40 Corrosion of shear reinforcement (Main Street).

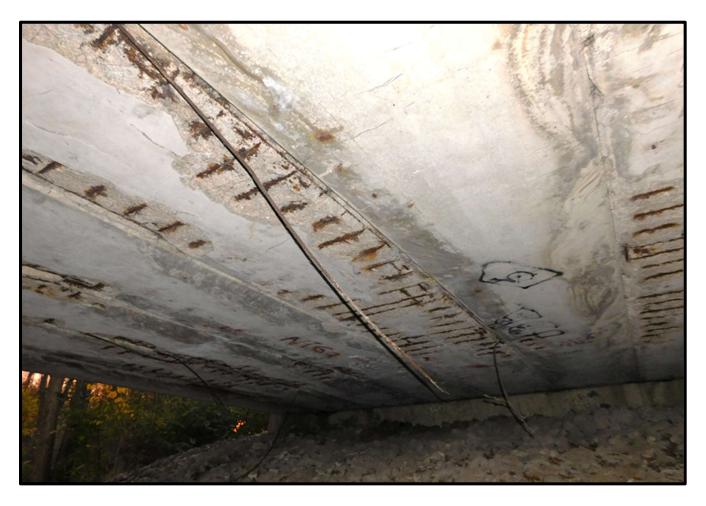
Figure 4.41 Fractured prestressing strands and corroding shear reinforcement (Main Street).

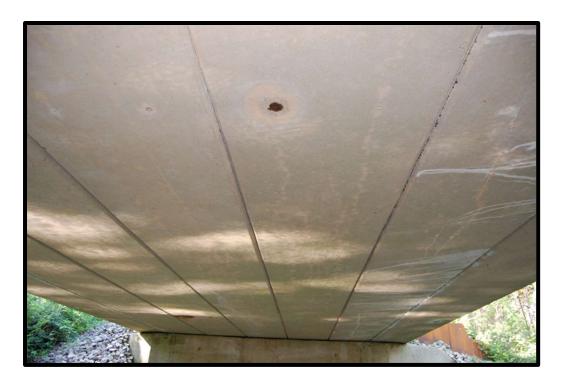
Cardboard that was used in the past to form the voids in prestressed box beams decomposes if exposed to moisture and can clog the drain holes. Therefore, standing water can accumulate in the box beams and accelerate deterioration. Furthermore, this added dead load reduces carrying capacity of the bridge. In many cases, rust staining and efflorescence were observed around the perimeter of drain holes. As an example, rust staining was observed around the drain holes of the Pond Creek (35-00013) Bridge (Figure 4.41). In contrast, the staining around the drain holes on the Main Street (02-00601) Bridge was black in color (Figure 4.42). For a number of the bridges, it was clear that water is being retained in the voids due to the clogged drain holes. In many cases, the clogged drain holes allow slow release of water while the drainage capacity of others is questionable.

Figure 4.42 Rust staining around drain holes (Pond Creek).

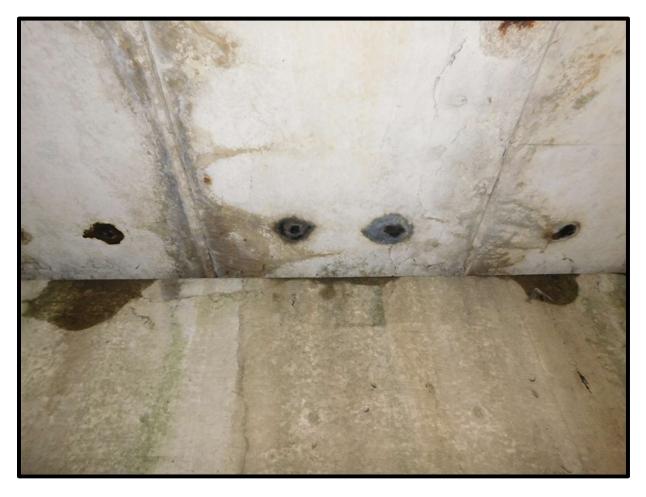
Figure 4.43 Black residue around drain holes (Main Street).

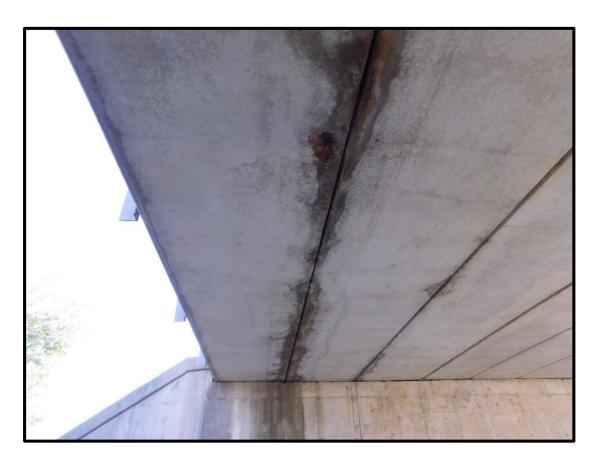
The eccentricity from the curb, railing, and/or barrier produces torsion which may cause rotation of the exterior beam, especially if there is failure of tie rods or no continuity from the wearing surface. This rotation can cause tension in the top region of the shear key, which may explain why the joint between the exterior and first interior beam is frequently observed to be leaking (Figure 4.43). Curb outlets also enable water to leak onto the side of exterior beams, leading to efflorescence, chloride penetration, and corrosion (Figure 4.44). Reduction of these exterior strands could lead to further section eccentricity.

Figure 4.44 Leaking exterior joint (Beal-Taylor Ditch).

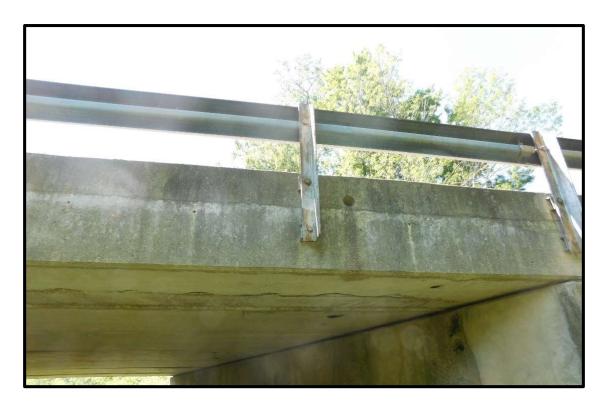
Figure 4.45 Curb cutout and efflorescence on exterior beam (Rock Creek).

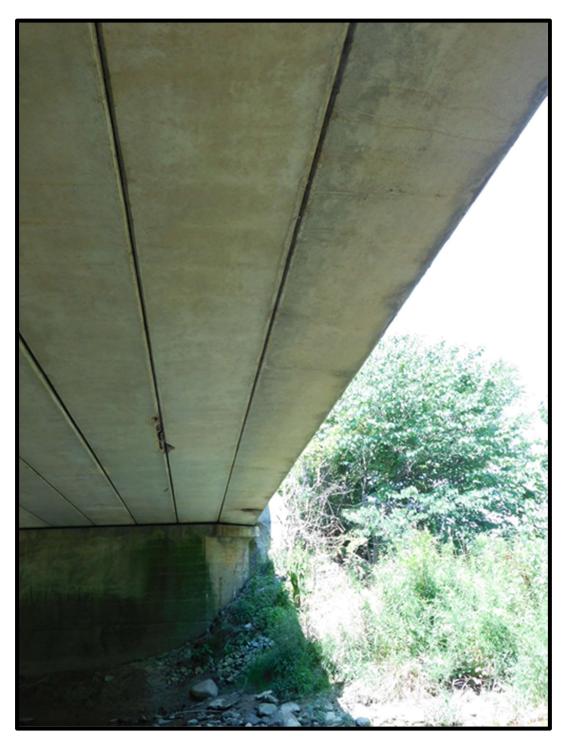
Rotation of the exterior beam was observed at the Clear Creek (005-35-05912 B) Bridge. The exterior beam on the west side appeared to have rotated away from the bridge (Figure 4.45). In this case, there was no staining at the bottom of the joint, and both the exterior beam and the first interior beam seemed to be in good condition. For this bridge, it is believed that the differential rotation may be caused by improper seating on the bearing pads. This rotation appears to have been in place since the reconstruction in 1980.

Figure 4.46 Rotation of exterior beam (Clear Creek).

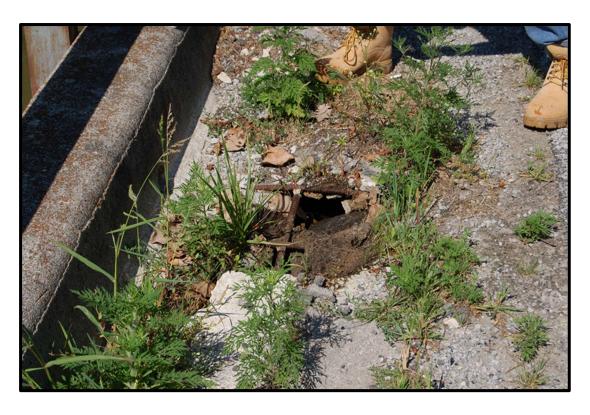
Figure 4.47 Opening in top flange of exterior beam (Rock Creek).

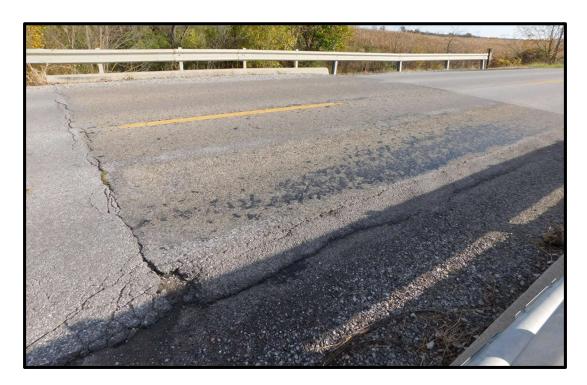
Figure 4.48 Reflective longitudinal cracking in bituminous wearing surface (Beal-Taylor Ditch).
