A Survey of Physical Parameters and Natural Radioactivity in the Wooden Church of “Archangels Mihail and Gavril,” Draghia

Ancuța Țenter, Marin Cotetiu, Alexandra Cucos, Bety Burghеле, Kinga Szacsvai and Verginica Schroder

Abstract

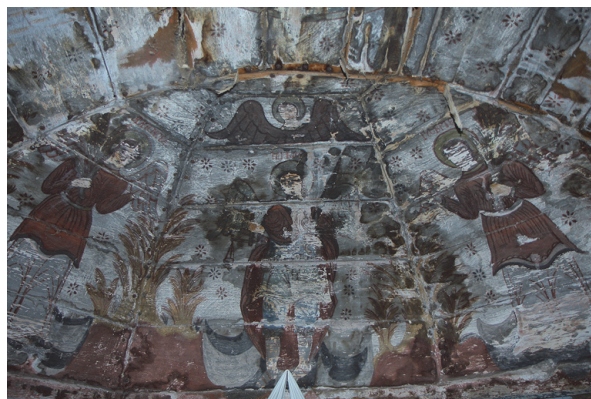
Tannins from the wood support and solubilized organic substances were migrated in the pictorial layer in the infiltration zones (**Figure 5**).

Figure 5.
Semicap altar—degradation caused by humidity infiltration.

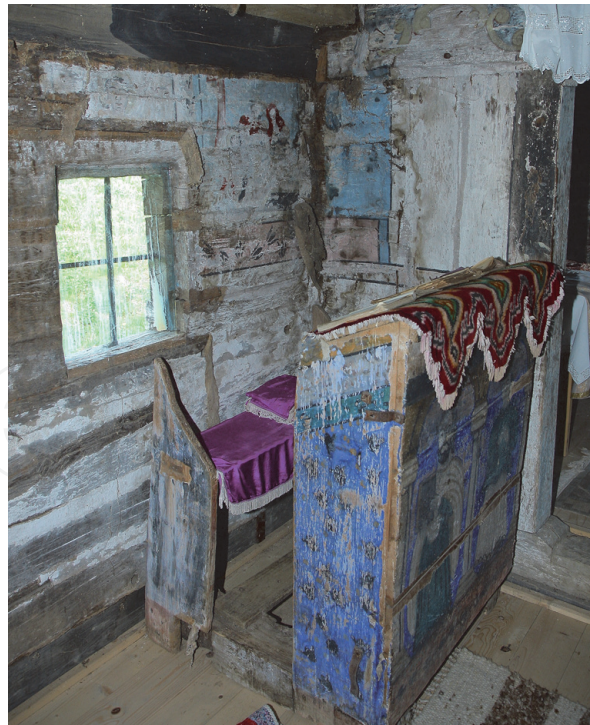
Figure 6.
Section from the north wall.

These degradations were highlighted by direct visual examination and with magnifying glass, in shining light. There are massive losses of pictorial layer, up to the support, due to the wear caused by deletion and involuntary hit of the surface (**Figure 6**).

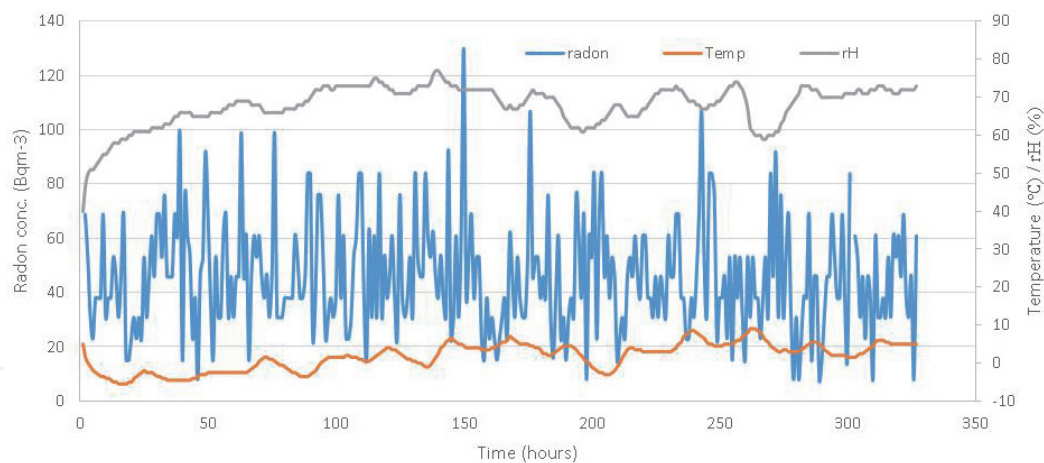
The first monitoring stage was chosen during winter (February 2019). A Radon Scout (SARAD GmbH, Germany) was placed inside the church and set to record data every 60 minutes. During this period, a minimum value of -5.5°C and a maximum of 8.5°C were recorded, with an average value of 1.73°C (**Figure 7**). The

Figure 7. Time series distribution of radon and physical parameters in the wooden church of “Archangels Mihail and Gavril,” February 2019.

average relative humidity of the recorded air was 67.95%, which was well above the recommended of 50–60% [25].

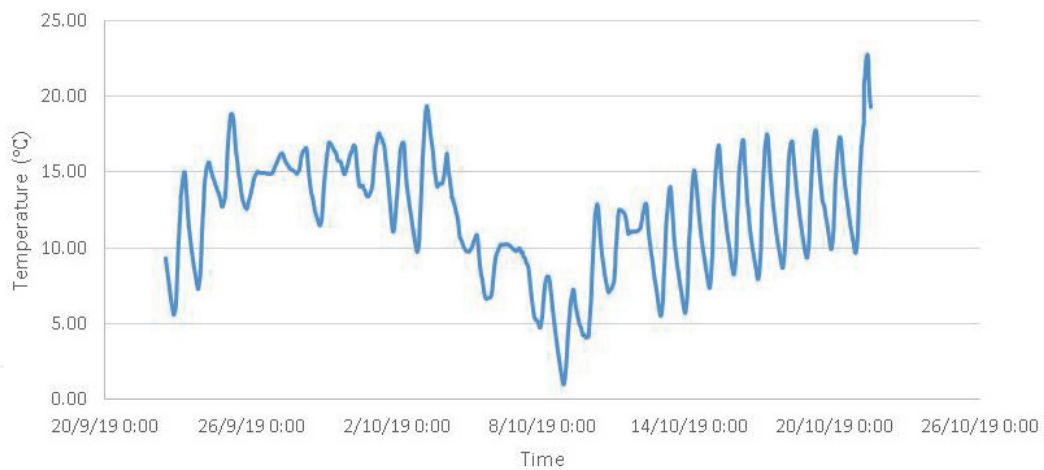
Overall, an inside average temperature of 13°C was recorded during the monitoring period. However, the temperature inside the wooden church ranged between 1°C and a maximum of 33.44°C . A 36 h window (23.09.–24.09) showed a

Figure 9.
Time series of indoor temperature during the second measuring campaign (September–October 2019).

temperature difference of 11°C indoors. These increases and decreases in temperature at such short intervals, which occur quite frequently during the monitored period, are not the most suitable conditions for the state of conservation of the painting. They produce expansions and contractions of the material, causing ruptures and cracks in the oil on the canvas. These frequent repetitions cause the material to become excessively friable [26].

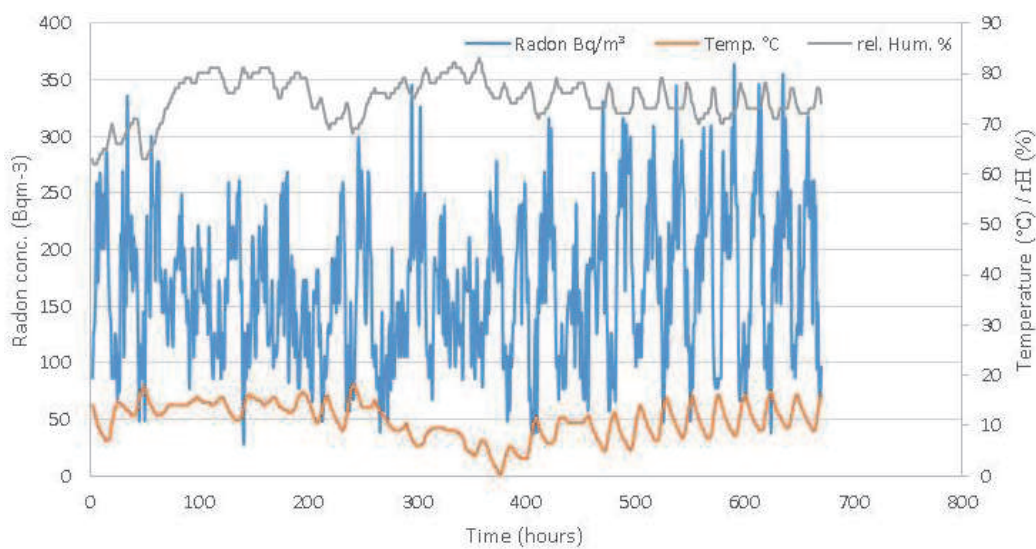
Figure 10.
Time series distribution of radon and physical parameters in the wooden church of “Archangels Mihail and Gavril,” September–October 2019.

Alongside temperature data loggers, a Radon Scout was installed to record hour-by-hour data of radon, temperature and rH indoors. During this period, a minimum value of 0.5°C and a maximum value of 18°C were recorded, leading to an average value of 12°C (**Figure 10**).

Active radon measurements carried out during the two separates campaigns yielded indoor radon activity concentrations ranging from 29 to 364 Bq m⁻³. During the first campaign, one of the windows could not be closed properly; this allowed a high air exchange rate that led to the dilution of indoor radon to an average value of 46 Bq m⁻³. By the time the second campaign took place, the faulty window was restored. The average value of 166 Bq m⁻³ was recorded during the second monitoring campaign. The indoor radon time series for the two seasons [35] monitored were represented in **Figures 7 and 10**.

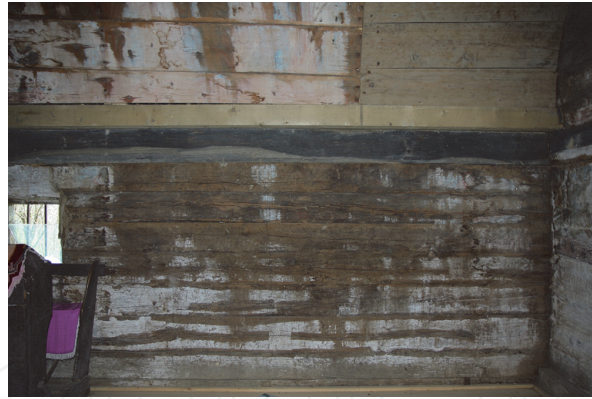
The highest average values (80.30, 80.90, and 80.30%) were recorded in sampling points 10, 11, and 12, behind the door of the church. This may explain the state of advanced degradation, the painting being almost completely obliterated, more so than in other areas inside the church (Figures 13 and 14).

Figure 13.
Degradation state of paintings near sampling point 10, 11, and 12.

The outdoor climatic changes increase the preservation issues inside the wooden church, causing a constant indoor microclimate fluctuation, making the task of keeping the mural painting in optimal conditions in the long term a very difficult one. Under these conditions, a recommendation would be to install a portable air

dehumidifier with a setting function allowing the relative humidity of the indoor air to be decreased between 50 and 60%.

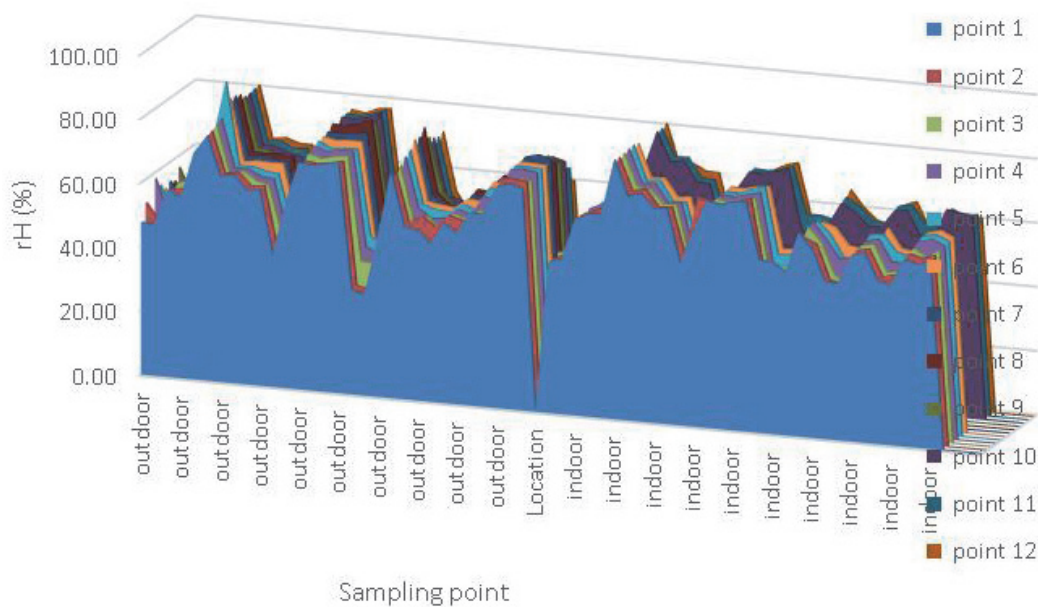
Figure 14.
Indoor/outdoor variations of relative humidity.
