Polish Experiences in Handling Water Hazards during Mine Shaft Sinking

Piotr Czaja, Paweł Kamiński and Artur Dyczko

Abstract

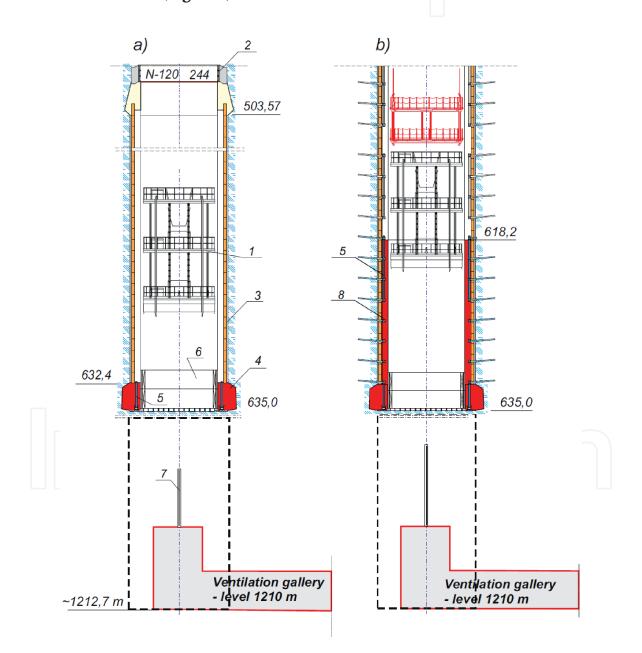
Figure 1.

The last phases of shaft sinking in the frozen rock area. (a) Installation of foundation for the final shaft concrete lining. (b) Section of final shaft concrete lining with drainage. Explanations: 1, three-deck shaft working platform; 2, cast-iron shaft lining; 3, preliminary pre-cast segmental shaft lining; 4, shaft lining foundation; 5, boreholes in the drainage system; 6, sliding formwork H = 3.75 m; 7, dewatering borehole TS-1 (d = 3.5," L = 576 m); 8, final concrete lining.

After the two last reinforced concrete panel rings had been completed, with excess material excavated to make a curb gap 4 (**Figure 1**) at a depth of 632 m, a small water leak, estimated at about 3-5 L/min, was noticed at the shaft bottom at the thill sidewall interface. The water was clean, very cold, and slightly salty. For a shaft sunk using the freezing method, in which the freezing core usually has a temperature below -15° C, this was unusual and perplexing. Since the freezing pipes had reached a depth of 635 m, no liquid water should have occurred at a depth of 632 m. However, this phenomenon could be partly explained by the water's salinity. Unfortunately, the electrical conductivity of this water has not been documented. In these circumstances, the TS-1 dewatering borehole work was intensified. Also, work commenced on the final concrete lining 8 (**Figure 1**)—constructed from the bottom up—equipped with a drainage system [7].

It was found that even though all the freezing safety requirements had been observed, the ice mantle along this section was not completely watertight and did not fully prevent water inflow into the shaft face. The movement of slightly saline water at a temperature above zero (tw > 0°C) caused the frozen mantle to be soaked from below and consistently thawed, with water inflows effectively increasing day by day. The situation was becoming dangerous, as no shaft pipe drainage had been planned down to this depth. This meant that the shaft had no pipelines through which the water could be pumped up to the surface. The further section of the shaft was designed to allow drainage via the TS-1 dewatering borehole drilled from a level of 1212.7 m (**Figure 2**).

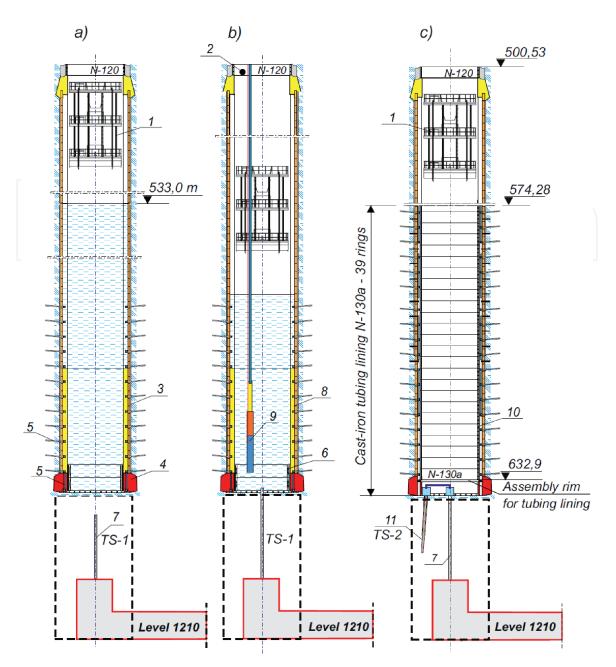
Figure 2.

The increasing inflow of water was diverted to the surface using only buckets. After about 2 weeks of shaft work involving the construction of a concrete curb at a depth of 635 m and the construction of an 18 m final concrete lining, water inflow into the shaft had increased to about 700 L/min. In this situation, it was impossible to continue any work in the shaft other than intensive dewatering using of buckets. Ultimately, this measure did not save the shaft from partial flooding. The water table in the shaft stabilized at a depth of 533.0 m, which means that the water column was 102 m (see **Figure 2**).

Due to the prolonged length of the 564 m TS-1 dewatering borehole and the water level reaching 533 m (Figure 2a), the decision was made to use a highperformance RITZ submersible pump (HDM 6723/11DPF). Installed 4 weeks later, with a capacity of 15 m³/min, the submersible pump succeeded in quickly dewatering the flooded shaft section (Figure 2b). Also, after 2 months of further work, the water inflow into the shaft was found to have reached 2.5 m³/min. The dewatering borehole TS-1 (Figure 2) was successfully completed almost at the same time the shaft was dewatered using the submersible pump. After 6 weeks of intensive and highly precise drilling work, the borehole reached the shaft bottom, located only 0.5 m from the shaft axis. By this point, the water inflow had increased to 3.0 m^3 / min. Since the water inflow was expected to increase further, the decision was made to drill a second dewatering borehole—TS-2 (Figure 2c). Due to the considerable water hazard associated with a water inflow of 3.0 m³/min, it was also decided that the section with a waterproof tubing lining be extended to the 650 m level. In addition, the decision was made to comprehensively grout the entire area affected by the substantial water inflow.

The phases of dewatering the sunken shaft section. (a) Shaft flooding. (b) Dewatering of the shaft using a "RITZ" submersible pump, (c) replacing the concrete lining along the 574.3–632.9 m section with a cast-iron tubing lining. Explanations: 1–8, see **Figure 1**; 9, RITZ submersible pump; 10, cast-iron tubing lining; 11, TS-2 dewatering borehole.

The substantial water inflow forced the shaft construction company to both further redesign the shaft lining and adjust the sinking technology along the 635–650-m-deep section. Apart from the costly dewatering, one of the direct effects of the partial shaft flooding was the need to redesign the lining in the flooding area (**Figure 2**). The concrete panel lining was replaced by a tubing panel lining, with a concrete tube set between them (**Figure 2c**) [7]. Due to this replacement, it was additionally necessary to:

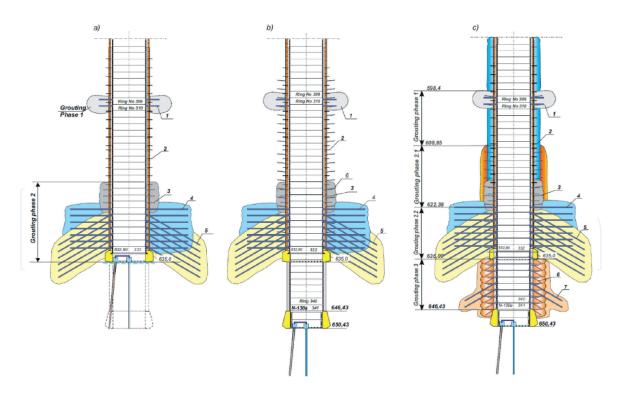
Figure 3.

Grouting process and shaft sinking along the 635–650 m section. (a) Grouting along the 598.4–635.0 m section, phase 1 and 2; (b) shaft sinking along the 635–650 m section, (c) grouting along the 635–650 m section, phase 3. Explanations: 1, cementation of the rock behind the lining (insulating layer) in N-130a tubing rings 309 and 310; 2, grouting of the rock behind the tubing lining through concrete plug holes in the tubing; 3, grouting of the rock and tubing lining through "cementation" holes in tubings (2-m-long horizontal holes); 4, grouting of the rock and tubing lining through "cementation" holes in tubings (10-m-long horizontal holes); 5, grouting of the rock and tubing lining through concrete plug holes (15-m-long inclined holes); 6, grouting of the rock and tubing lining through in tubings (2.0-m-long inclined holes), 7, grouting of the rock and tubing lining through "cementation" holes in tubings (10.0-m-long inclined holes).

polyurethane adhesive was used in addition to the cement grout. The grouting work is illustrated in **Figure 3** [7]. Once the 635–650 m section of the shaft had been sunk, a curb was made in the tubing lining, comprising 130a tubings (9 rings) installed from the top down at a depth of 650 m, and a shaft face dewatering system was installed using boreholes TS-1 and TS-2 (**Figure 2**).

In the third phase, cement grout was injected behind the lining along the 635–635.0 m section (**Table 2**). Then, as part of the fourth grouting phase, the entire 574–500 m section of the tubing lining was sealed. It took a total of more than 500 t of materials (**Table 2**) to complete the grouting process.

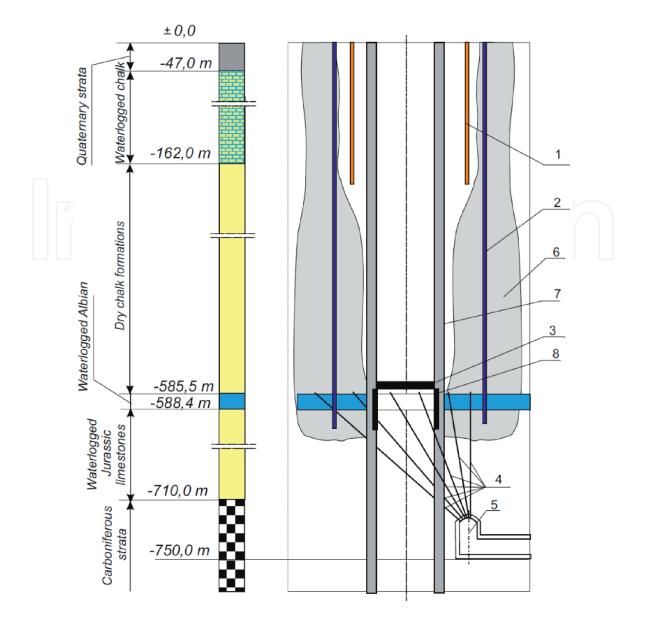
Figure 4.

Diagram of the S-1.3 shaft sinking using both rock freezing and rock heating. 1, boreholes for rock heating along the 0–180 m section; 2, boreholes for deep freezing along the 0–570 m section; 3, concrete plug above the Albian layer; 4, drainage boreholes in the Albian layer; 5, working with a drilling chamber at a depth of 754 m; 6, frozen rock mantle; 7, final concrete panel lining; 8, cast-iron tubing lining along the Albian formation section.

depth of 162 m (see **Figure 4**). Below the 180 m level, the plan was to sink the shaft to a depth of 570 m using conventional method, i.e., without rock freezing. This would substantially reduce costs. The biggest puzzle, and, as the construction company would see, the greatest challenge involved in this shaft sinking project was the thin (\approx 2.9 m) Albian layer (**Figure 4**), which was composed of sandy-lime quicksand with a water pressure of about 5.5 MPa. An assumption was made that a shaft working could pass through such a thin layer of waterlogged formation once the layer had been provided with borehole drainage system (**Figure 4**) drilled in the working at a depth of 754 m. With the drainage system in place, the pressure could be reduced, making it possible to petrify both the Albian formations and the Jurassic formations deposited underneath, all the way to the Carboniferous roof. This way, the shaft could be sunk conventionally down to the target depth of 1035.45 m.

Regrettably, this plan failed, too. The shrinkage stress in the steel due to the low temperature of the brine caused the outer column to leak, allowing water to enter the borehole. This complicated the whole process of section freezing, making it necessary to reconsider freezing along the entire depth of the shaft. As feared, the freezing caused damage to the lining along the 0–570 m section soon after commenced. At this point, the decision was made to apply a globally unprecedented solution, in which the lower section of the shaft was frozen, while the upper part of the shaft, along the 0–180 m section, was heated with warm water. To provide the inflow of warm water, the engineers used the boreholes drilled to freeze the first section of the shaft along a circle with a diameter of 14 m. The work diagram is presented in **Figure 4**.

The engineers considered it necessary to drill 43 additional boreholes at a depth of 610 m. These had an unusual diameter of 308 mm and were drilled in an 18 m diameter circle [3, 8]. Also, an unprecedented decision was made to use sectional freezing—an approach which, although theoretically known and viable, had not been applied in shaft construction before. Thus, the boreholes were fitted with two freezing pipe columns and a column of downcomer tubes inside a 139.7 mm diameter column. They were properly sealed so that the brine could circulate only in the lower parts of the boreholes, below 570 m.
