STRAY CURRENT CORROSION OF COPPER SHEATHING AND KEEL COOLING PIPE OF A 36' TRAWLER

K. RAVINDRAN

Central Institute of Fisheries Technology, Cochin-5

The results of investigations into the cause of an accelerated corrosion of copper sheathing and keel cooling pipe of a 36' wooden trawler are reported. The corrosion is attributed to the stray electric currents originating from the electrical wiring system. The sources of stray currents and the remedial measures have been suggested.

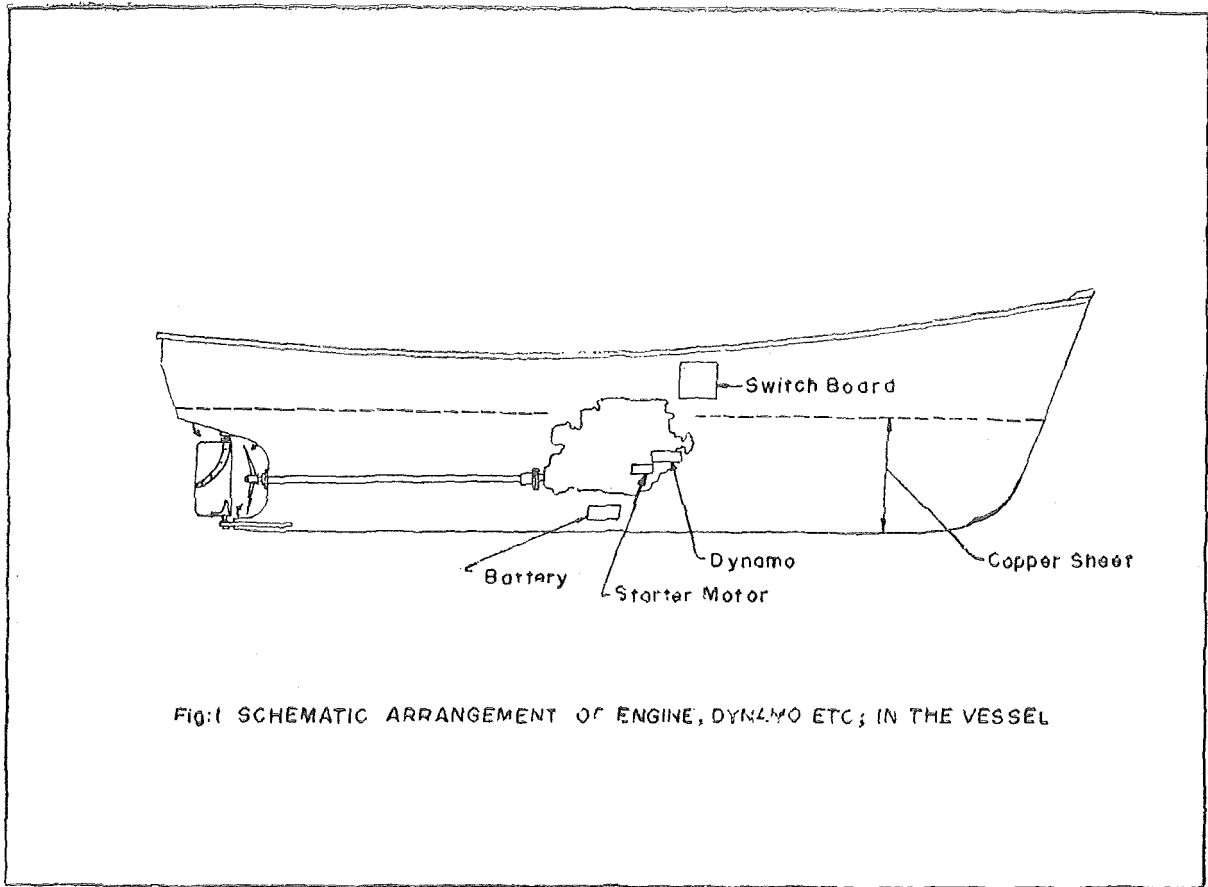
FIG.1 SCHEMATIC ARRANGEMENT OF ENGINE, DYNAMO ETC; IN THE VESSEL

engine and the generator were working for some hours daily and repair works were going on. When the vessel was hauled up it was observed that some of the copper sheets and cooling pipe were severely corroded. Corrosion was noticed at the bilge and stern area. The keel cooling pipe had undergone severe corrosion from outside. The hull repairs were completed by replacing the corroded copper sheets and keel cooling pipe and the trawler was operated for about seven months. At the end of this period the vessel was examined and was found to have suffered similar type of corrosion observed earlier. An investigation was undertaken to find out the cause of observed rapid corrosion.

The arrangement of starter motor, engine, dynamo and battery in the vessel is schematically shown in Fig. 1 and the electrical wiring circuit in Fig. 2.

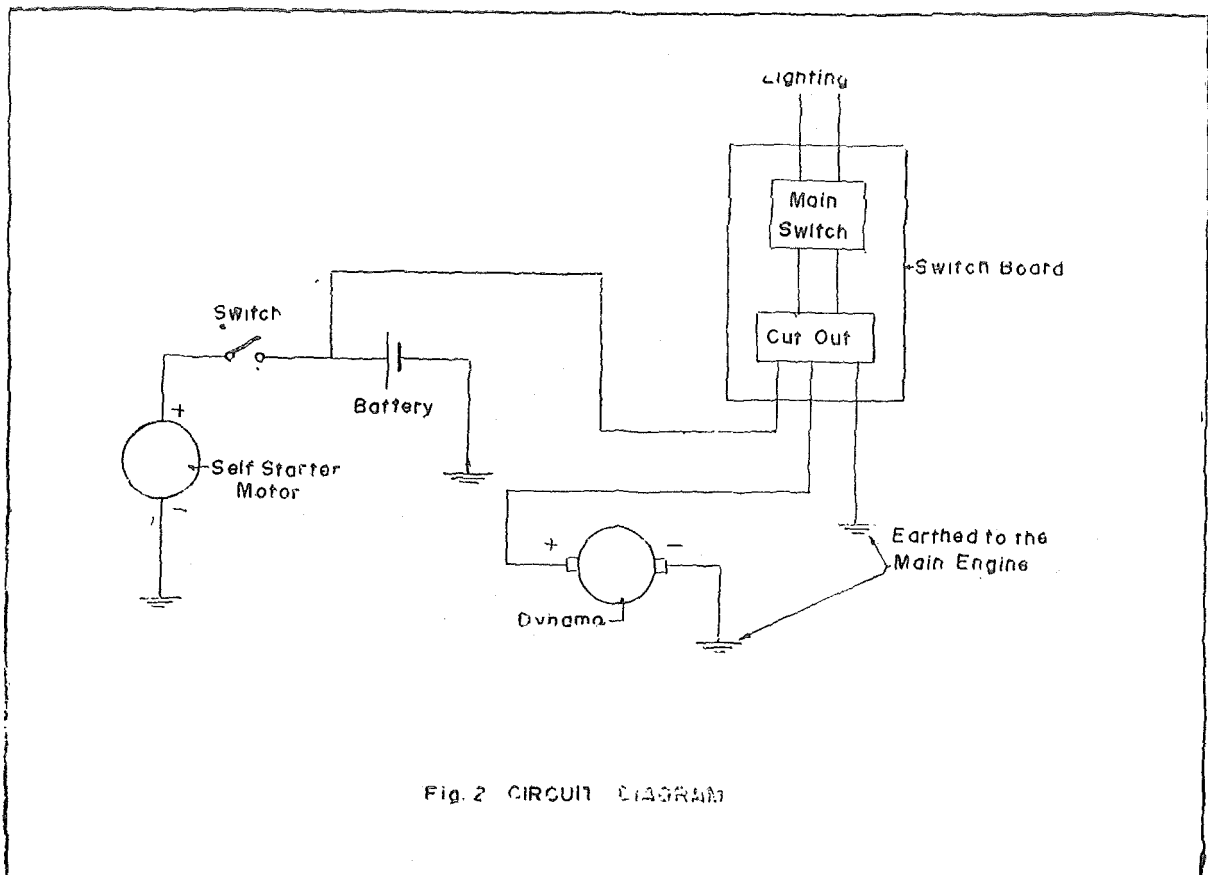
Fig. 2 CIRCUIT DIAGRAM

Some of the metallic components present on the wooden hull of the vessel are not in direct electrical contact. The propeller shaft, for example, is separated from the hull metallic components by wooden stern bearing offering high electrical resistance. A wooden structure damp with sea water (which is having a low electrical resistance of about one ohm per

foot cubed) conducts electricity. When a bare wire or a cable with broken insulation is in contact with a damp wood, electricity flows through the wood to the metallic skin fittings. In such cases metals which form anode will be seriously attacked. The presence of stray electric current is indicated by the results in Table III and the path of current leakage is shown by arrows in Fig. 1. An increase in corrosion rate by about 15 times when the metal coupons were in electrical contact with the hull establishes this fact. Serious localized pitting results especially at discontinuities. For each ampere of current leaving from the hull about 10 kg. of copper will be wasted in a year. The electrical systems in the trawler were checked, repaired and the vessel despatched to Veraval. No such complaints were noticed after that.

Insulation faults particularly in the earth return, cause stray currents, which flow through sea water between isolated metal structures. Intense leakages usually occur when junction boxes are placed in a damp place. Faulty electrical earthing of echosounders and other equipments also causes serious troubles.

A two wire system of electric wiring is to be adopted. The cables should be able to withstand salt spray. Especially at bends, insulation breaks and the bare wire comes in contact with moist wood.
