MODIFICATION TO THE BILGE AND SEA WATER PUMPS FITTED IN 17.5 METRE JINGHA TYPE TRAWLERS

A. RANJAN

Deep Sea Fishing Station, Bombay.

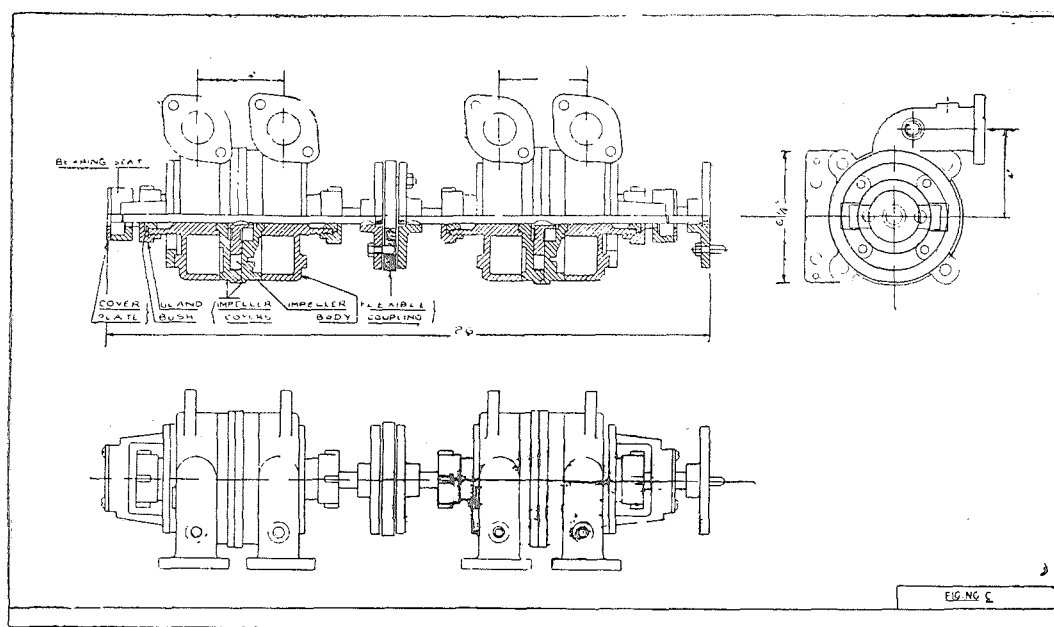
Fig. 'C' shows modified centrifugal pump fitted on to the main engine. The main modification is the replacement of water seals with $\frac{1}{4}$ " gland packing which can quite easily be tightened without dis-

tapping new holes in the cylinder block. The original tap holes were plugged and revetted over. The sea water lines as well as the bilge lines both inlet and discharge require modification due to the fact that there has been longitudinal displacement of the pumps to the extent of approximately 50 mm. There was no need to replace the pipes but some were heated and bent to suit the new position of the pump flanges. As the bilge pumps run dry when the bilges are not connected, it was necessary to have the pipe connection between the delivery of the sea circulating pump and suction side of the bilge so as to prevent the bilge running dry thereby burning packing and overheating the shaft. The discharge of both the pumps are more than the original as the clearance between the impeller and pump body has been maintained to the minimum.
