Fire Risk Assessment of Low Cost High Rise Residential Buildings in Kuala Lumpur: A Case Study

Farid Wajdi Akashah*, Timothy Kurannen Baaki, and Shing Peng Lee

Centre for Building, Construction and Tropical Architecture (BuCTA), Faculty of Built Environment, University of Malaya (UM), 50603 Kuala Lumpur, Malaysia.

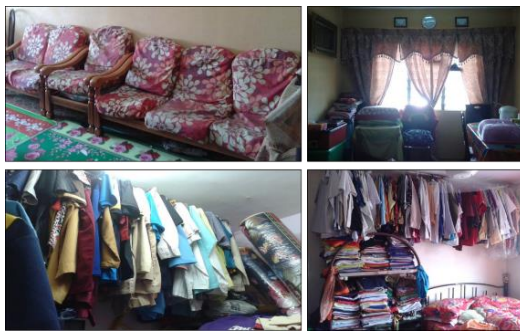
The list of potential ignition sources and potential fuel sources are shown in Table 10. The results show that majority of the ignition sources are electrical installations while the potential fuel sources are almost entirely household items (see Figures 7 and 8). As

Figure 7: Potential fuel sources in the living room and bedroom

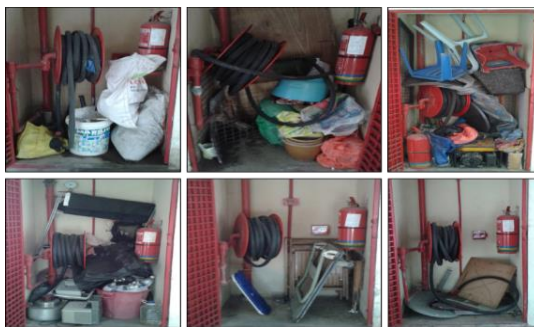
shown in Figures 8 and 9, it can be seen that the potential of, especially fuel sources, is

enhanced by poor housekeeping as items are cluttered and stuffed haphazardly.

Figure 8: Potential fuel sources in the fire-fighting equipment room

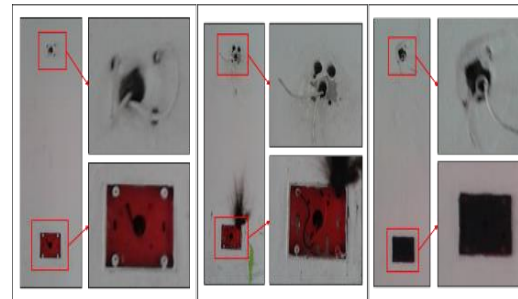
A smoke detector is provided only in the centre lift lobby of PHP P and Q while three (3) sets of manual call point and fire alarm can be found only on the 5th 10th and 15th floors of each block of PHP P and Q. At PHP R, there is no smoke detector or a complete set of manual call points and fire alarms. Figure 9 show the

vandalized smoke detectors and manual call points.

Figure 9: Vandalized manual call points and fire alarm

To add, the building management should design and implement a preventive maintenance regime in order to make sure that existing fire safety equipment are in optimal working condition. There is also need for designing and implementation of an emergency evacuation and action plan that will clearly instruct building occupants and users on evacuation operations and routes and provision of an emergency assembly point.

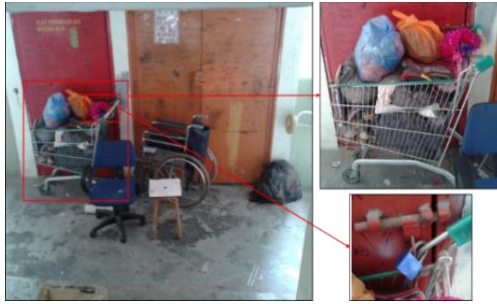
Approximately 80% of the fire-equipment rooms in all the case study PHP buildings were locked and inaccessible during inspection. In addition, clutter blocked the access to fire-fighting equipment room (see Figure 10). There also were vandalized hose reels with missing or broken valves and nozzles as well as missing portable fire extinguishers as shown in Figure 11.

Figure 10: Trolley, chair and wheelchair blocking access to fire-fighting equipment

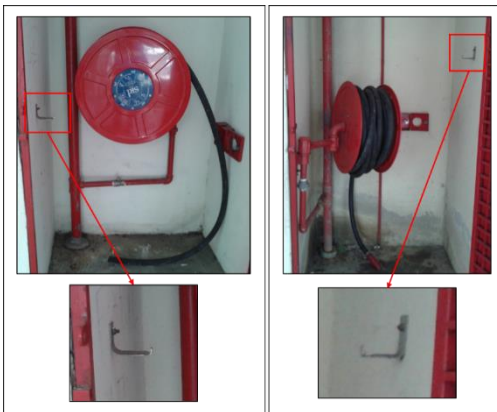
Figure 11: Missing portable fire extinguishers

Secondly, the fire safety systems in all of the dwelling units of the observed PHP buildings require immediate upgrade, taking into consideration also the needs of physically challenged persons. The kitchen areas for instance need to be installed with fire blankets hence it was the location within the unit more prone to a fire occurrence. There is however, no legislation mandating the installation of fire blankets, but fire blankets are useful active fire safety equipment effective in putting out as well as containing small fires (Fire Industry Association, 2011). On the other hand, the Tenth Schedule of the UBBL 1984 requires that a minimum of one portable fire

extinguisher be installed in each dwelling unit. Strict enforcement of this By-Law would ensure that minimum fire safety requirements are achieved in this regard. Also, it is suggested that some form of automatic early fire detection and warning system e.g. self-contained devices like smoke and heat alarm be installed in areas such as the bedrooms, living rooms, dining rooms, etc. Zhang & Wong (2009) note that this system has been well implemented in residential buildings and has proven effective in reducing loss of life and property in the event of fires. And although the Fire Services Act 1988 (Act 341) exempt isolated private dwellings from having

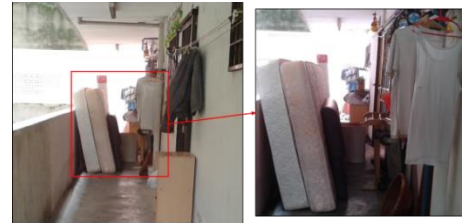
Findings show that all the case study buildings had the recommended minimum corridor width of 1,542mm, however, as shown in Figure 12 the corridors were cluttered with household items. This narrowed the width of the travel pathway and will be an obstruction in the event of emergency and mass egress.

Figure 12: Escape route blocked by mattresses and other items

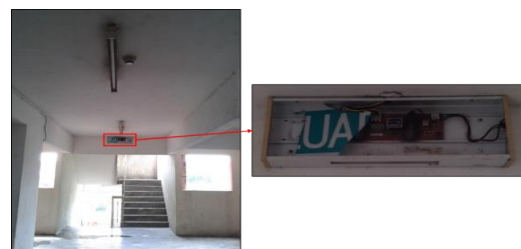
There were inadequate emergency exit signs in all the case study buildings because most of the signs were vandalized (see Figure 13). Also, none of the emergency exit signs in the case study buildings were illuminated, a non-compliance with By-Law 172(4). Also, some of the indication signs were stripped off and covered with graffiti, making them illegible as shown in Figure 14. Installed fire-fighting equipment also had no designated signage. In Figure 15, there is no signage designating fire-fighting equipment thus not complying with By-Law 248 (2) of the Uniform Building By-Law 1984 and MS 1539.

Figure 13: Vandalized emergency exit sign

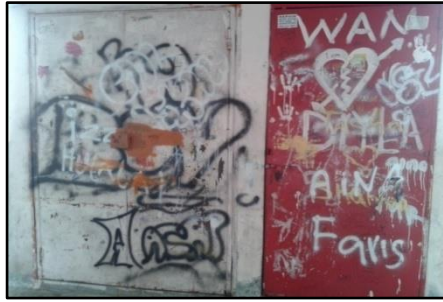
Figure 14: Fire indication sign covered by graffiti

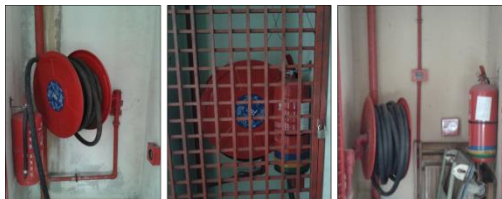
Figure 15: No provision of fire safety sign for each fire extinguisher

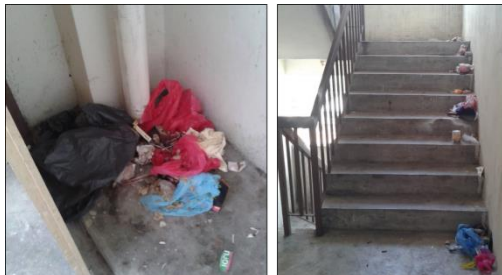
Although it was found that cleaning was performed every day, there was still garbage in common areas such as stairwells and lift lobbies at all the case study buildings (see Figure 16).

Figure 16: Garbage scattered around lift lobby and staircase

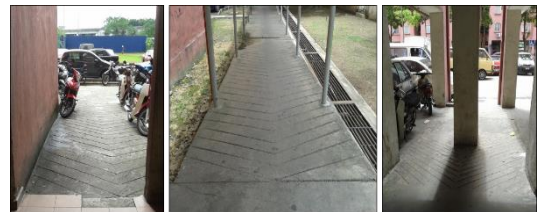
While ramps for disabled persons were provided in two of the case study buildings, none of the ramps were provided with handrails (see Figure 17).

Figure 17: Ramps without handrails

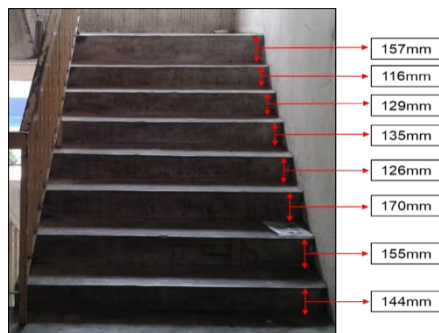
Also, neither guiding block nor embossed marks were found on any of the staircases and handrails of all the case study buildings. Measurements performed indicated that the staircase risers were not uniform in height with

differences in the tallest and shortest riser up to 54mm (see Figure 18). There were also no guiding blocks on any of the staircases at the case study buildings. Braille or embossed lettering was also not provided on any of the lift car buttons in any of the case study buildings (see Figure 19).

Figure 18: Inconsistent riser heights and no guiding block

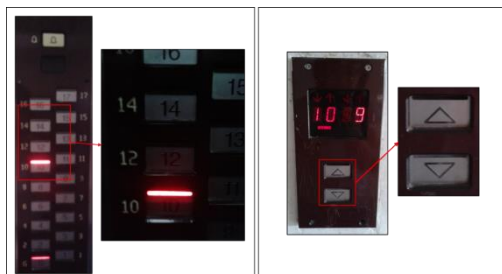
Figure 19: No Braille on any of the lift car buttons
