Full Length Article

Experimental investigations on the chlorine-induced corrosion of HVOF thermal sprayed Stellite-6 and NiAl coatings with fluidised bed biomass/anthracite combustion systems

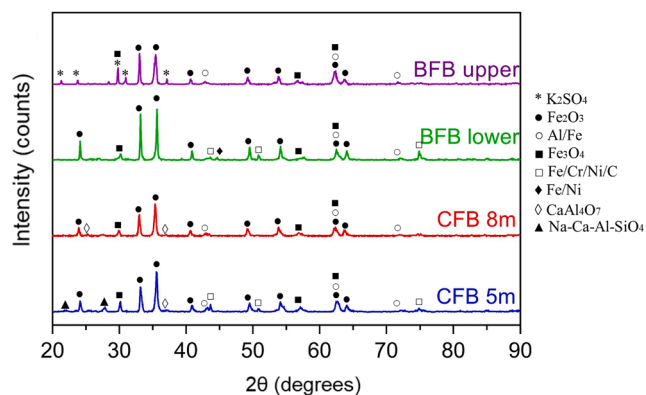
Fig. 4. XRD patterns of the plain 304 stainless steel sample surfaces after the test.

Fig. 4 shows the phase analysis of both the remaining scales and the exposing areas of the 304 stainless steel specimens after the tests. As seen, the corrosion of the 304 SS was mainly attributed to the substrate oxidation forming Fe_2O_3 and Fe_3O_4 on the surface. Regarding the two samples installed in the BFB rig, a minor fraction (based on the semi-quantification by the software MAUD using ICSD library) of K_2SO_4 and Al/Fe could be identified on the upper sample surface while Fe/Cr/Ni/C (304 SS) and Fe/Ni could only be detected on the lower one. The

difference between the XRD results indicates that: (1) at the upper position, the K-bearing fly ash interacted with the 304 SS and the Al/Fe alloy [30] was present due to the Al attack from the fuel as well as the sand particles; (2) at the lower position with the higher local temperature, Fe/Ni was detected due to the oxides spallation. Moreover, the bed particles collision onto the substrate could brush off the ash deposits and the iron oxides, exposing the 304 SS substrate (Fe/Cr/Ni/C). When it comes to the CFB-tested 304 SS samples, major corrosion products (Fe_2O_3 and Fe_3O_4) similar to those formed on the BFB samples were identified. Besides, the calcium aluminium oxide was found on the CFB

samples due to the Al-rich fly ash (Table 1) attack during the corrosion development. Sodium calcium aluminosilicates were detected on the 5 m platform sample. This was attributed to the anthracite inherent Na, Ca contents forming high melting point eutectics with the presence of SiO₂ under the local fuel combustion temperature after a long period of operation.

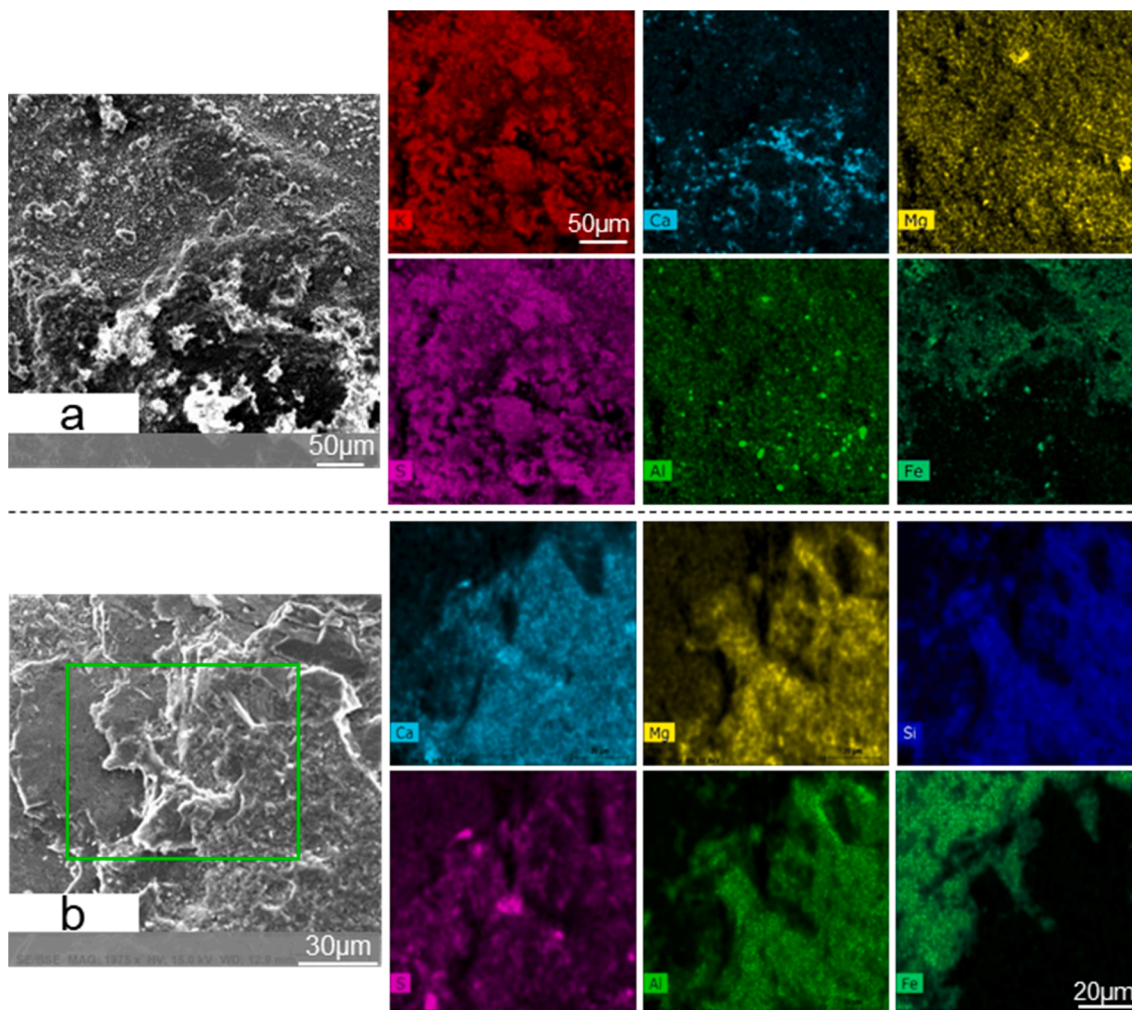
Fig. 5. SEM/EDX elemental mapping on the coating surface after 10 nm carbon coating: a) BFB upper 304 SS; b) CFB 8 m 304 SS.

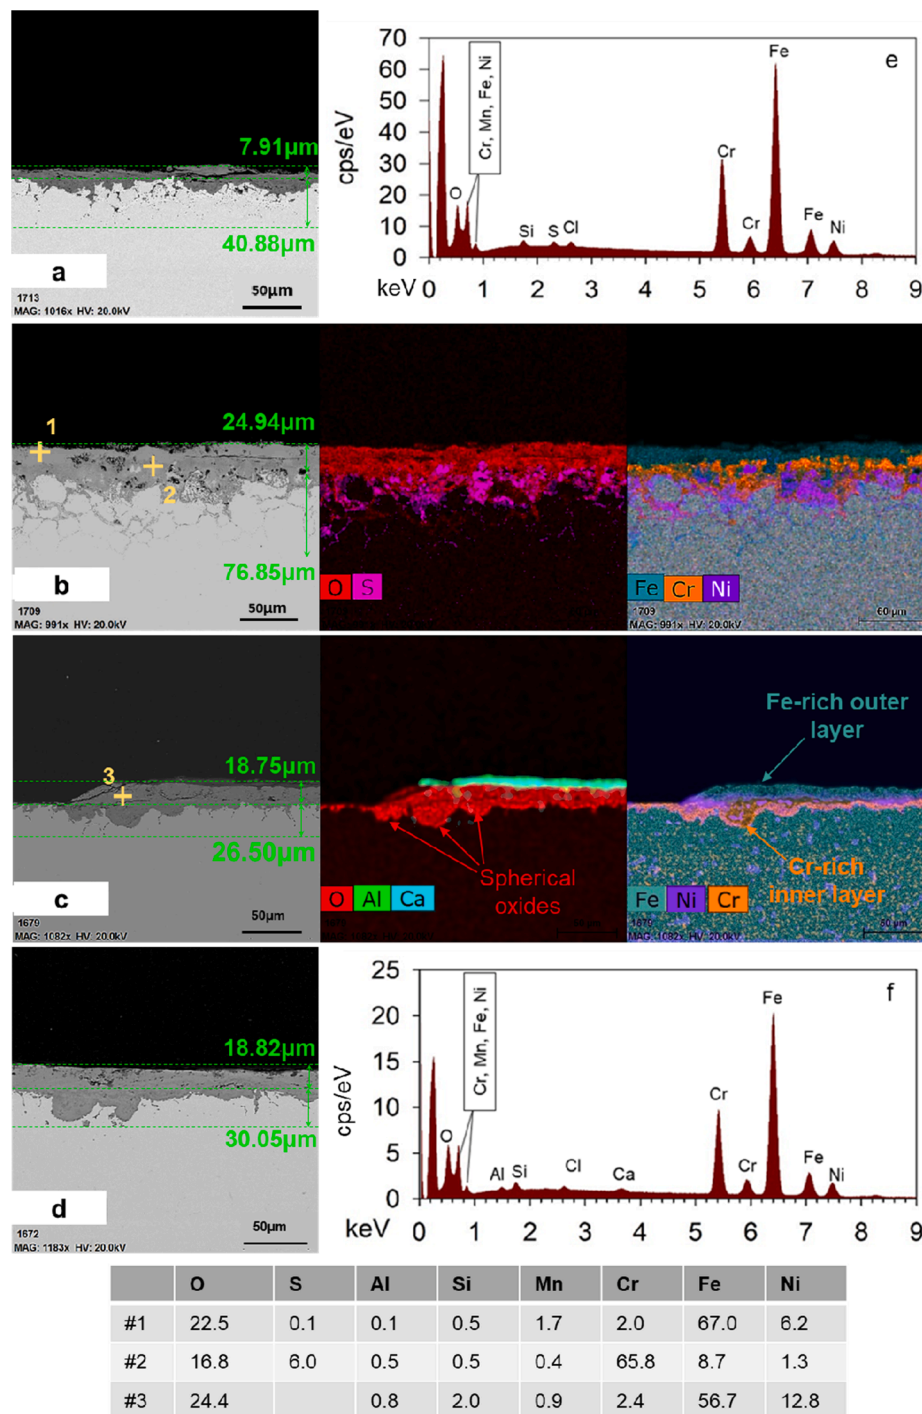
Fig. 6. SEM/EDX on the cross-section of the 304 SS substrates: (a) BFB lower position; (b) BFB upper position; (c) CFB 8 m platform; (d) CFB 5 m platform; (e) EDX map spectrum across the corrossions on the BFB upper sample; (f) EDX map spectrum across the corrossions on the CFB 8 m sample; Spot analysis on the corrossion products were conducted [wt%].

The corrosion products could further diffuse into the substrate and therefore the cross-section scanning under SEM is of great importance to verify the corrosion rate. A thin layer of corrosion products of ca. 8 μm could be observed above the BFB lower substrate (Fig. 6a) with an oxidation intrusion of ca. 41 μm, while thick multi-layered oxides (ca. 25 μm) was observed on the BFB upper substrate (Fig. 6b). The EDX mapping and spot analysis revealed that the outer layer was rich in Fe (spot #1), and the inner layer was mainly Cr-rich oxides (spot #2). Furthermore, the thicker oxides layer led to a deeper diffusion up to ca. 77 μm into the substrate with a dichotomous structure dominating by S and Ni. With regards to the CFB samples, the corrosion products were similar to each other; multi-layered porous oxides with a thickness of ca. 19 μm could be observed above the substrates and spherical oxides were formed as the frontier against the substrate (Fig. 6c, d). The EDX mapping illustrates that the spherical oxides comprised of an outer layer of Fe-rich oxide (spot #3) and an inner layer of Cr-rich oxide.

Given that the CFB tests experienced a much longer exposure time than BFB tests, the 304 SS samples' corrosion rate was substantially slower in the CFB tests. The main reasons can be obtained by comparing the EDX spectrums across the corrosion products on the samples installed at BFB upper position (Fig. 6e) and CFB 8 m position (Fig. 6f): (1) as seen, sulphur content was detected only on the BFB sample and dissolved by the substrate forming nickel sulphides [34], thus accelerating the corrosion rate; (2) Ca and Al were found on the CFB sample, covering the corrosion products in the form of calcium aluminosilicates. These ash-derived high melting point eutectics effectively hindered the diffusion of sulphur which slowed down the corrosion development; (3) the Cl content from the fuels could act as a catalyst during the metal oxidation (R6–R8) [35]. This process could be further accelerated by the ash-derived alkali chlorides (R9–R10) [23,36] and their sulphation (R11) [37]. Therefore, with a higher alkali (mainly potassium) content

in the biomass than anthracite (Table 1) as well as the diffusion of sulphur into the BFB 304 SS, the corrosion rate of the BFB installed samples was much faster than that of the CFB samples.

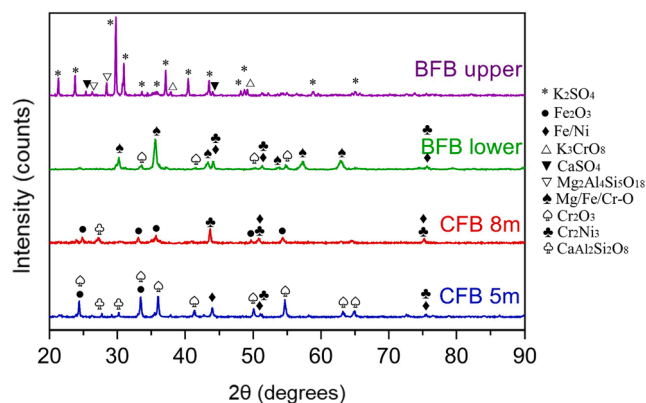
Fig. 7. XRD patterns of the Stellite-6 coating sample surfaces after the test.

According to the XRD results (Fig. 7) of the Stellite-6 coating surfaces, K₂SO₄ deposited on the surface of the BFB upper Stellite-6 sample alongside with magnesium aluminosilicates. The Stellite-6 coating was oxidised, forming K₂CrO₄. With the presence of H₂O₂ and OH⁻ radicals, K₂CrO₄ can be further oxidised into K₃CrO₈ [38]. At the lower position in the BFB, the corrosion of the coating was mainly done by the alloy oxidation forming Cr₂O₃. Magnesium also participated in the surface oxidation process resulting in Mg/Fe/Cr oxides. On the surfaces of the CFB Stellite-6 specimens, the 8 m platform sample was covered by Cr₂Ni₃ and Fe₂O₃, while Cr₂O₃ appeared to be the main corrosion product of the Stellite-6 located at the 5 m platform with the sintered eutectics of calcium aluminosilicates.

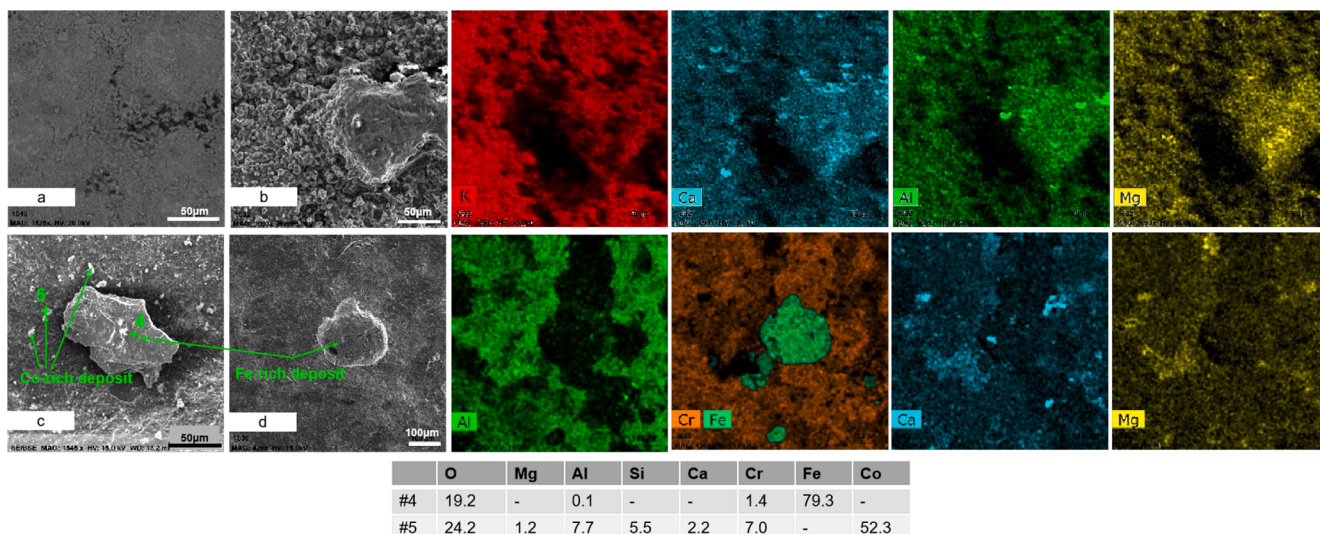
Fig. 8 shows the surface morphology of the Stellite-6 samples under SEM/EDX. A big difference can be observed between the two samples' surfaces located in the BFB combustor. The BFB lower Stellite-6 sample (Fig. 8a) showed a relatively condensed surface with a limited area of sintered fly ash attachment. However, on the BFB upper Stellite-6 sample surface (Fig. 8b), fly ash fusion took place and covered the coating by the molten phase K, Ca, Al, Mg compounds. As explained in the previous section, the widely accumulated fly ash sintering on the upper sample was due to the densified fly ash formation in the freeboard

Fig. 8. SEM images of the Stellite-6 coating surfaces with elemental mapping of selective areas: (a) BFB lower position; (b) BFB upper position; (c) CFB 8 m platform; (d) CFB 5 m platform. Spot analyses on the attached particles were detected [wt%].

zone, and the lower coating sample was vulnerable to self-oxidation because of the bed material collision. In addition, the molten fly ash accumulation on the BFB upper Stellite-6 sample indicates the coating was effectively interdicting the corrosion process comparing to the 304 SS covered by K_2SO_4 deposits with exposed iron oxides (Fig. 5a). However, the molten phase ash can further capture the fine bed particles to form a slagging layer, which may significantly affect the thermal conduction efficiency in practical application of the Stellite-6.

Regarding the two CFB Stellite-6 coating samples (Fig. 8c, d), the surface morphology is similar to each other as the corrosion was mainly formed by coating oxidation (Fe_2O_3 , Cr_2O_3 , etc.). The ash derived Al and Fe could be detected on the coating surface but there were barely any alkali and alkaline earth metals. This was resulted from the much lower content of K in the anthracite ash, which is the main source of the low

melting point eutectics. Moreover, instead of molten ash observed on the BFB Stellite-6 surfaces, ash deposits were found on the CFB samples. The deposits can be generally classified as the attachment of large ($>100 \mu m$) Fe-rich particles (Fig. 8 #4) and fine ($<10 \mu m$) Co-rich particles (Fig. 8 #5). Considering the relatively long exposure time (ca.1630 h), the presence of some ash deposits was expected but no sign of melting indicates the Stellite-6 coating offered excellent slagging and corrosion protection to the substrates in the CFB set-up.

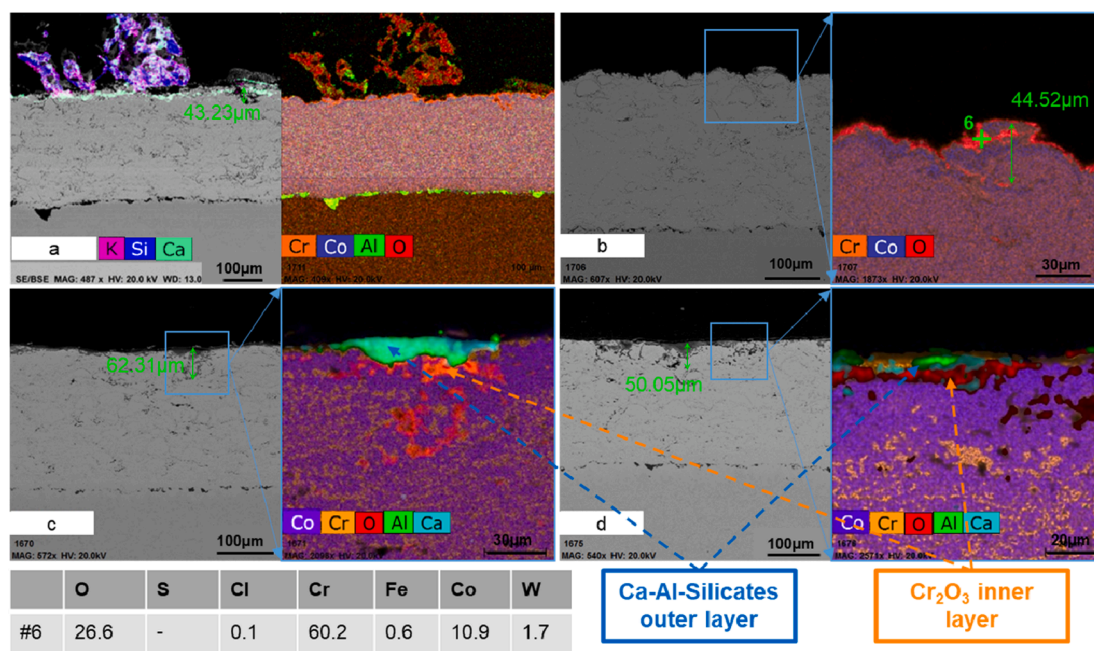
Fig. 9. SEM/EDX on the cross-section of the Stellite-6 coatings: (a) BFB lower position; (b) BFB upper position; (c) CFB 8 m platform; (d) CFB 5 m platform. Spot elemental quantification on the corrosion products was detected [wt%].

Fig. 9 shows the SEM/EDX scanning on the cross-sections of the post-test Stellite-6 coatings. They all have dark areas on the interface between the substrate and the coating, which were the artefacts from grit-blasting by alumina. On the outermost surface of the two BFB installed Stellite-6 coatings (Fig. 9a, b), a much thinner layer of metal oxidation (mainly Cr_2O_3 , spot #6) can be observed comparing to those of the 304 SS

specimens. Moreover, for the four specimens, the penetration of the oxides into the coating (marked with green arrows) was only found at certain spots alongside the outer surface due to the chlorine attack through the coating defects or grain boundaries. This can be attributed to the Co-rich layer beneath the very outer Cr-rich layer. As reported by Luthra [39], the formation of the spinel CoCr_2O_4 can suppress the chlorine diffusion by introducing cobalt oxide (CoO).

An interesting spot was found on the BFB lower Stellite-6 surface (Fig. 9a), where a bed agglomerate was attached. The agglomeration mechanisms were reported in our previous study [28], and the main compositions of the agglomerates are K, Ca and Si. More importantly, the interface between the attached agglomerate and the coating surface was dominated by Ca.

As it has been discussed, potassium can participate in the corrosion process via R9 and R10. However, it was not detected at the outer layer of the coating indicating the priority of Ca over K during the interaction with the Cr_2O_3 via R12 [40]. Moreover, the resultant CaCr_2O_4 can further react with the fly ash derived alumina via R13 [40], and forming stable calcium aluminosilicates as the very outer layer (Fig. 9c, d). This outer layer can cover the corroded Cr hence increase the corrosion resistance of the Stellite-6 coating. As a result, none of the substrates suffered from corrosion because of the protection of Stellite-6.

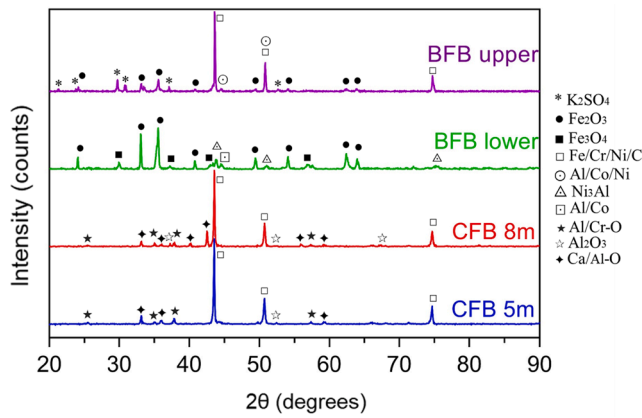
Fig. 10. XRD patterns of the NiAl coating sample surfaces after the test.

The surface XRD identification (Fig. 10) of the NiAl samples revealed the iron oxidation as the main corrosion product of the BFB lower sample. Clear peaks of the 304 SS substrate (Fe/Cr/Ni/C) were found on the BFB upper sample but not on the lower sample. It is reasonable to infer that the NiAl coating spallation could firstly take place on the BFB lower sample leading to a longer exposure time for the oxidation process of the substrate comparing to that of the BFB upper sample. Furthermore, on the upper BFB specimen, K_2SO_4 was detected as the main scale with the formation of Fe/Ni. Nevertheless, at the lower installation point, Fe_3O_4 was detected as the corrosion product after a longer exposure time due to the earlier coating spallation.

The CFB derived samples showed a similar major phase of Fe/Cr/Ni/C due to the NiAl coating spallation. However, it is not consistent with the observations in Fig. 4, as the exposed 304 SS substrate should be further oxidised and forming Fe_2O_3 and Fe_3O_4 considering the extensively long testing time in the CFB system. According to Fig. 10, the reason could be the formation of the Al_2O_3 , Al/Cr-O and Al/Ca-O on the surface. The good thermal stability of these deposits can further protect the substrate from attacking by hot corrosion [41,42].

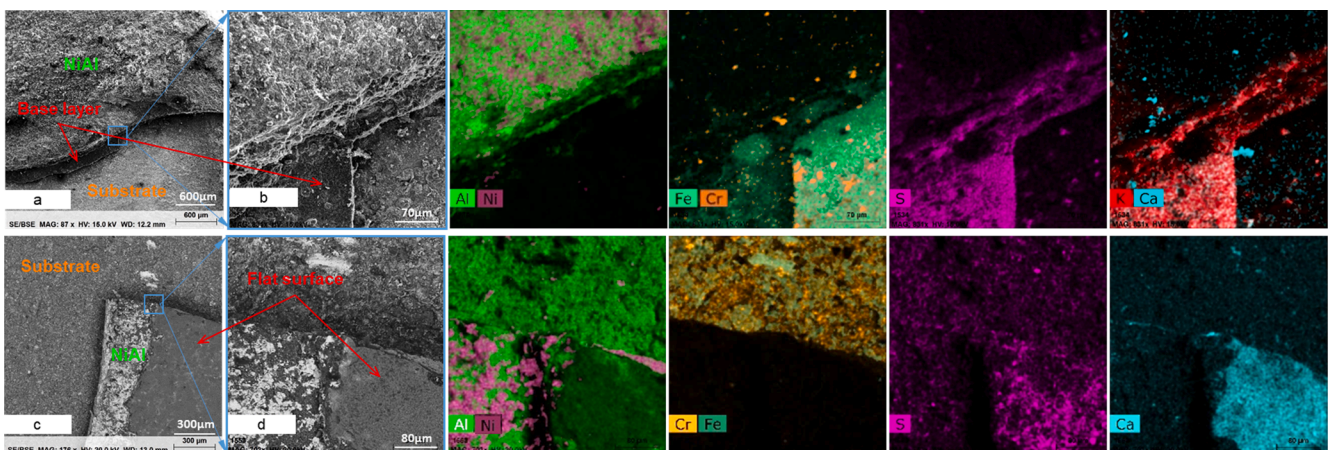
The edges between the remaining NiAl coating and the substrate were observed under SEM/EDX, and selective areas were shown in Fig. 11. In general, the NiAl coating tested at the BFB upper position (Fig. 11a) had an amorphous surface, and a base could be observed at the edge of the original NiAl coating. However, the CFB 8 m NiAl coating (Fig. 11c) showed a flat surface with the exposure of inner NiAl coating material close to the spallation edge. Meanwhile, no base layer was observed between the coating's edges. The elemental mapping of the spallation edge was performed on larger magnification level to highlight the changes of the NiAl coating and substrate. As shown in Fig. 11b, the original NiAl coating successfully hindered the biomass ash-derived K_2SO_4 attachment which was found on the surface of the 304 SS (Fig. 5a) and Stellite-6 (Fig. 8b) samples. Such observation demonstrates the anti-slugging ability of the NiAl coating. Regarding the exposed substrates after coating spallation, there was very little K, Ca scales on the substrate surfaces. However, the edge between the remaining NiAl coating and the substrate provided a reservoir for the K_2SO_4 accumulation, thereby forming of a base layer (Fig. 11). Arguments might be raised as the accumulated K_2SO_4 can react with the 304 SS substrate. In fact, it can be seen in Fig. 12a that the corrosion was developed in the

Fig. 11. SEM images of the NiAl coating spallation areas with elemental mapping of selective specimens: (a) General BFB upper NiAl; (b) Magnified BFB upper NiAl with elemental mapping; (c) General CFB 8 m NiAl; (d) Magnified CFB 8 m NiAl with elemental mapping.

substrate at the spalled coating edge and a crack was developed in the NiAl coating starting at the bottom of the coating edge. But under the operation conditions, the attachment of fly ash is a continuous process. Even after shutting down the combustion, the remaining fly ash in the combustor and freeboard can be captured by this edge. Thus, K_2SO_4 could be observed at the surface of the base layer. It would be a very interesting perspective to further investigate the corrosion development at the coating spallation edge. It is also worth noting that the substrate surfaces of the CFB specimens were covered by Al (Fig. 11d) which was identified as Al_2O_3 in Fig. 10. As discussed previously, the formation of the outer Al_2O_3 layer can prevent the Cl penetration. Therefore, the formation of iron oxides (Fe_2O_3 and Fe_3O_4) was restricted. When it comes to the surfaces of the remaining NiAl coatings, flatter surfaces can be observed on the CFB samples (Fig. 11c, d) in comparison to those installed in the BFB (Fig. 11a, b). This was mainly caused by the Ca-rich deposits according to the elemental mapping results.

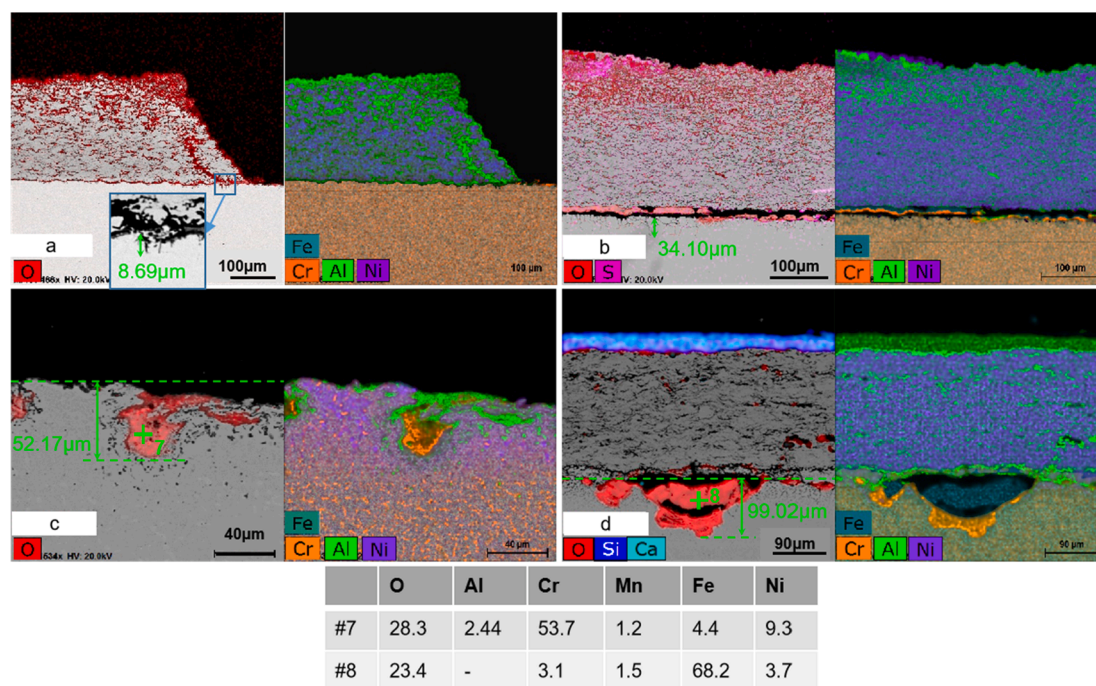
Fig. 12. SEM/EDX on the cross-section of the NiAl coatings: (a) BFB lower position; (b) BFB upper position; (c) CFB 5 m platform; (d) CFB 8 m platform. Spot elemental quantification on the corrosion area was conducted [wt%].

The cross-section SEM/EDX analysis was conducted on the remaining NiAl coatings, and on account of the full spallation of the NiAl on the CFB 5 m sample, the scanning was focused on its substrate (Fig. 12). On the BFB samples, the growth of alumina started at the coating surface, forming an Al-rich layer and developed across the whole NiAl coating, resulting in the thin Al_2O_3 layer at the bottom of the coating under the chlorine attack. Once a thin and coherent layer of Al_2O_3 forms on the alloy surface with a thickness of only a few hundred nanometers can provide certain oxidation protection. However, for HVOF coatings which have rough surface and porosity, this would induce internal oxidation [43]. As a result, the coherent layer of Al_2O_3 can be damaged. As shown in Fig. 12 a, b, d, a thin layer of Al_2O_3 has been formed at the coating surface but internal oxidation could still take place. The specimen in Fig. 12c lost the cover of NiAl coating and under the collision of bed materials the surface was damaged leaving no continuous Al_2O_3 . Consequently, the substrate of the BFB lower sample was corroded with a depth of ca. 9 μm (Fig. 12a) and a 34 μm corrosion depth was developed in the BFB upper substrate (Fig. 12b). These proved the protectiveness of NiAl coating against corrosion comparing to the corrosion of the plain substrate (Fig. 6a, b). Surprisingly, the oxidation of the CFB

installed samples reached a depth up to ca. 52 μm (Fig. 12c, no NiAl left on the substrate) and 99 μm (Fig. 12d) in their substrates. In addition, the spherical oxidations were very similar to those observed on the plain 304 SS specimens (Fig. 6c, d) with Cr-rich (spot #7) and Fe-rich (spot #8) layers. However, the oxidation depths of the NiAl coated substrates in CFB should be less than those of the plain 304 SS specimens. The reasons could be: (1) the damage of the substrate during the spray of the coating as NiAl was much more difficult to be coated than Stellite-6. Impurities (pores, foreign bodies such as grits) at the interface can be introduced during coating process or even the grit blasting process prior to the coatings process to roughen the surface so that residual grits might be retained causing the formation of large impurity or even promote the internal oxidation. (2) The severe spherical oxidations were only observed at the two certain spots (Fig. 12c, d) in the NiAl coated substrates unlike those developed across the 304 SS surface. The deeper oxidation spots could be the largest deformation spots during the NiAl coating spallation, which enhanced the development of the corrosion in the substrate. However, further investigations are needed to clarify this observation.
