# Observations about the seismic response of RC buildings in Mexico City

Over 2000 buildings were surveyed by members of the Colegio de Ingenieros (CICM) and Sociedad Mexicana de Ingenieria Estructural (SMIE) in Mexico City following the Puebla-Morelos Earthquake of 2017. This inventory of surveyed buildings included nearly 40 collapses and over 600 buildings deemed to have structural damage. Correlation of damage with peak ground acceleration (PGA), peak ground velocity (PGV), predominant spectral period, building location, and building properties including height, estimated stiffness, and presence of walls or retrofits was investigated for the surveyed buildings. The evidence available suggests that (1) ground motion intensity (PGV) drove the occurrence of damage and (2) buildings with more infill and stiff retrofit systems did better than other buildings.

Reinforced concrete, earthquake damage, 2017 Puebla-Morelos Earthquake, structural damage, seismic response

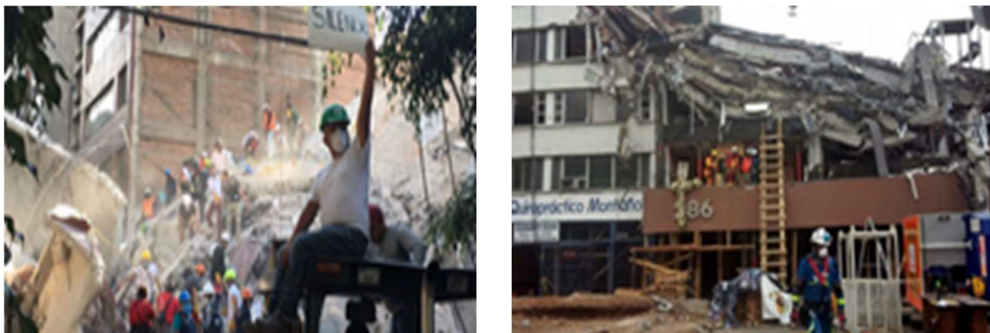
**Figure 2.** Examples of collapses in buildings surveyed by CICM and SMIE (2017). Other examples are available here: <https://notas.tuhogarmexico.com/2017/09/28/asi-lucian-asi-lucen-ahora-los-edificios-se-derrumbaron-en-la-cdmx/>

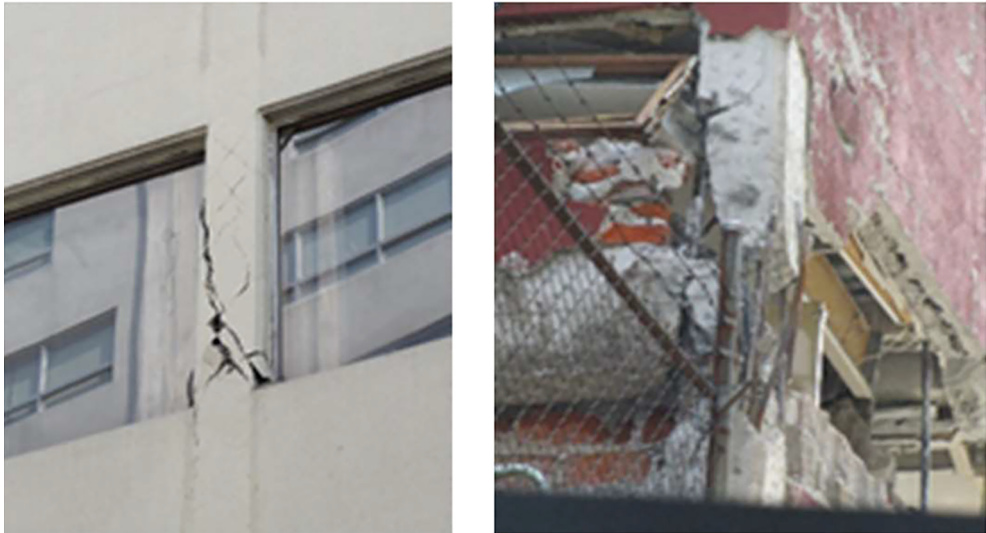
**Figure 3.** Examples of structural damage in buildings surveyed by CICM and SMIE (2017).
