Learning from failure: Damage and Failure of Masonry Structures, after the 2017 Lesvos Earthquake (Greece)

Abstract - On the 12th of June 2017 an earthquake of Mw=6.3 struck SSE of Lesvos Island, causing one human fatality and severe damage to the built environment. The traditional settlement of Vrissa was the most affected area, having masonry structures as the majority of its building stock. The objective of the present study is two-fold: to present the structural damage and failure patterns induced by the Lesvos earthquake to masonry structures; to highlight the causes and weaknesses that led to damage, or the factors that prevented it. Particular attention is paid to traditional construction techniques and architectural features that contributed to the seismic response of the structures, either having beneficial or detrimental effect. To this end, a field reconnaissance has been conducted and meaningful technical conclusions are drawn by the observations. Structural systems of both unreinforced and timber-reinforced masonry are inspected. Besides the identification of frequent cases of local, out-of-plane and in-plane mechanisms, combined global mechanisms are also pointed out

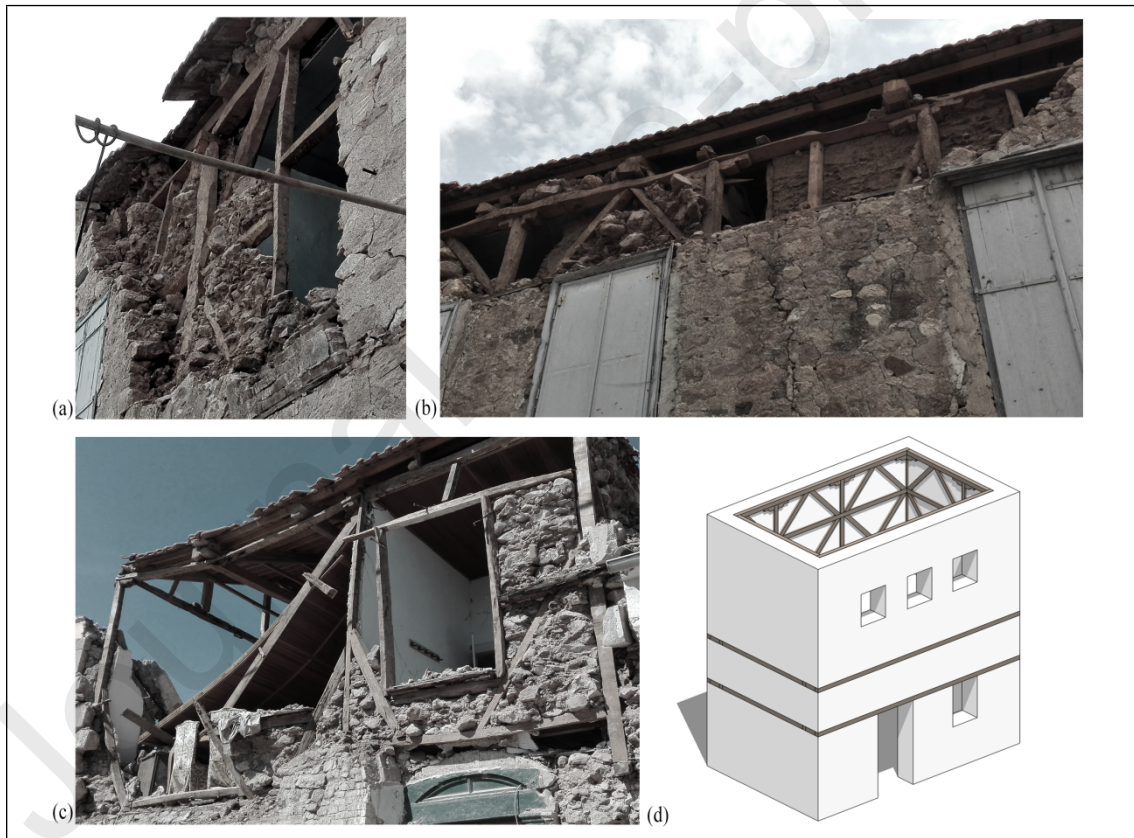
231 collapse of the roof system, thus protecting the buildings' inhabitants. Yet, one could argue
 232 that such OOP failures could have been prevented if the timber-frame was also confining the
 233 outer leaf with timber-laces at regular distances. Furthermore, it should be noted that the
 234 damage was much more extensive in cases with deficiencies, such as the irregular
 235 configuration of the braces, the lack of continuity of the timber-frame at the ground floor,
 236 the presence of poor connections or the level of degradation of the timber (Figure 7 (c)).

Figure 7. (a)-(b) Localized out-of-plane collapse of external unreinforced leaf. Notice the L-shaped corner elements in (b). (c) Extensive damage due to timber deterioration and poor connections. Notice the lack of the timber-frame system at the ground floor. (d) Schematic sketch of timber-frame masonry.

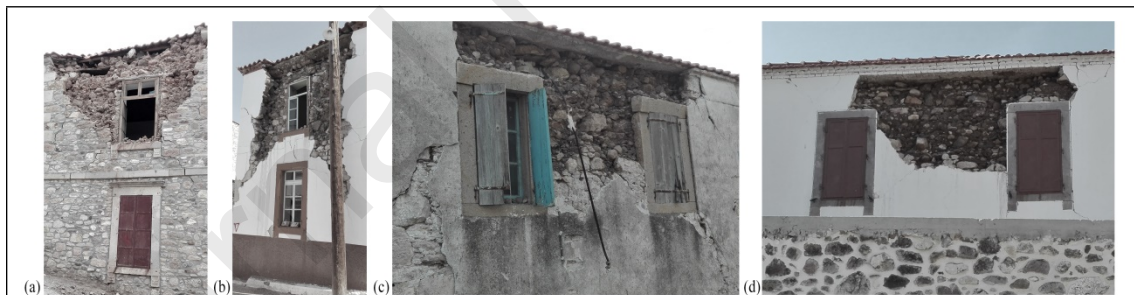
252 Disintegration of masonry can be considered a local mechanism in essence. In literature, it is
 253 also referred to as the “zero” mechanism [26], appearing when a masonry portion is unable
 254 to counteract almost any horizontal action and crumbles into pieces. Many cases of
 255 disintegration were identified during the reconnaissance, mainly as delamination of the
 256 external leaf (Figure 3, Figure 4 and Figure 8). The main factors that triggered such
 257 mechanisms are related to the low quality of the materials, the lack of interlocking stones of
 258 the different leaves or the lack of connection of the leaves with timber-laces.

Figure 8. (a)-(d) Local failures of the external leaf due to wall disintegration.

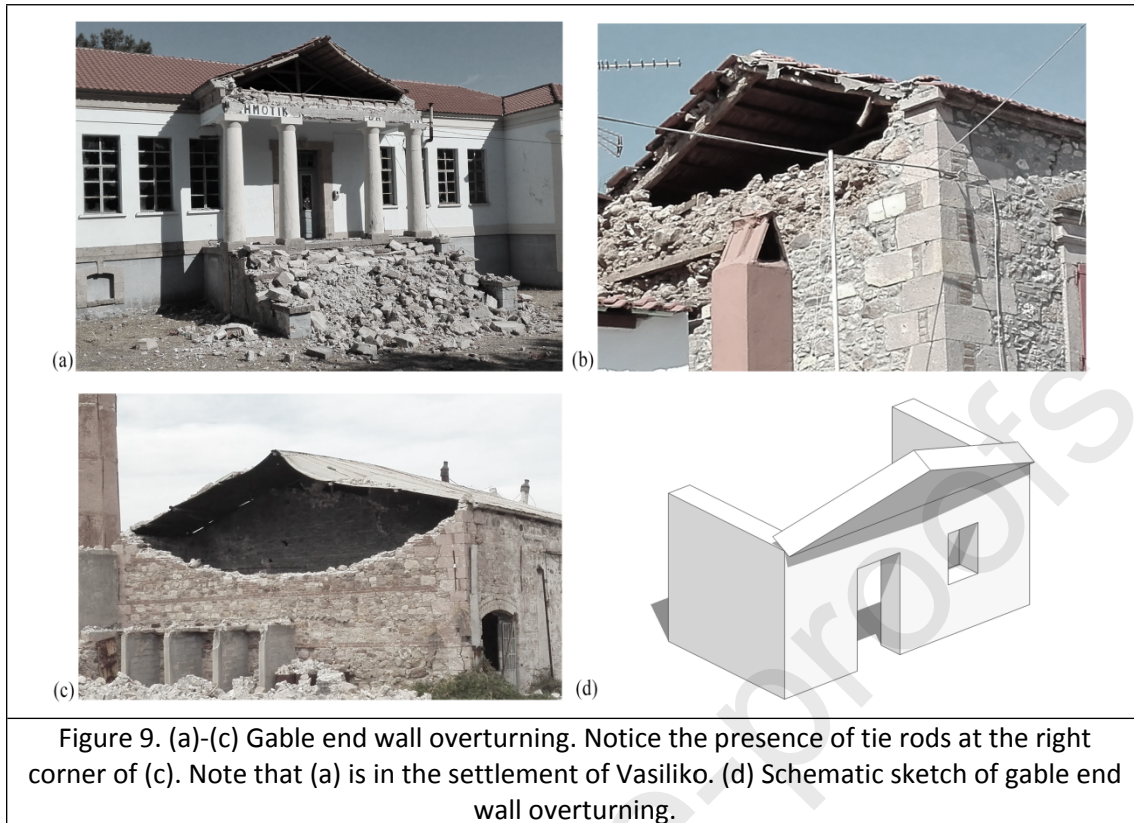
260 Overturning of gable end walls is a frequently occurring local mechanism. The notable
 261 vulnerability of this part of the constructions is attributed mainly to the inadequate
 262 connection with the roofing system and the lack of overburden weight (as the roof rafters
 263 are usually laid on the transversal walls), together with the amplified accelerations at the
 264 gable's height. Several collapses of gable walls were observed during the reconnaissance
 265 (Figure 9). Among them, it is worth to mention the gable wall collapse of the elementary
 266 school of Vasiliko, a settlement of around 7km further inland from Vrissa which suffered
 267 almost no damage. This further highlights the vulnerability of the mechanism (Figure 9 (a)).

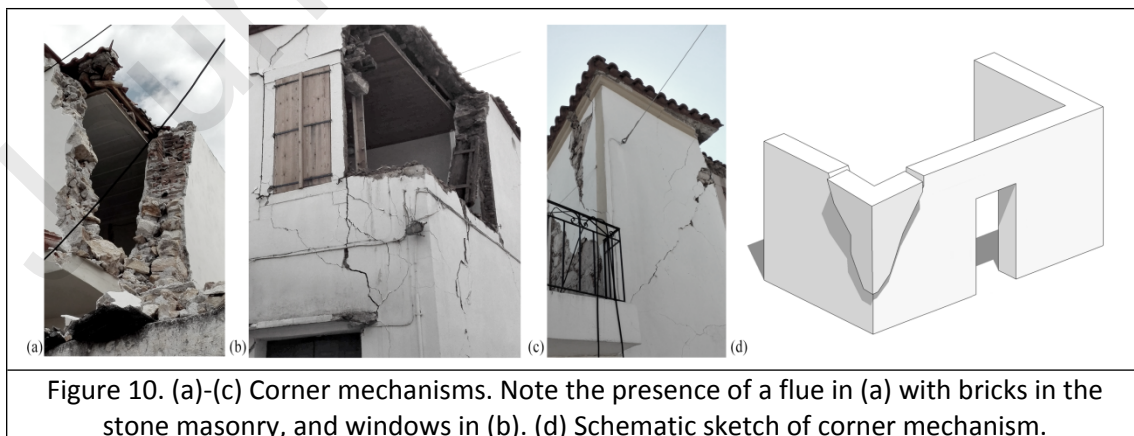
269 Another common local mechanism concerns the top part corners of buildings (Figure 10).
 270 This mechanism originates from the lack of a diaphragm; often in presence of adequate
 271 connections by the quoin-stones, preventing façade detachment and overturning [48,49]. As
 272 a result, a combination of IP rocking-sliding and OOP flexural failure occur, forming wedge
 273 type diagonal cracks. Furthermore, the vulnerability of this mechanism is increased by the
 274 presence of a thrusting roof, and neighboring openings or flues at the transversal walls.
 275 Finally, it should be noted that the occurrence of such mechanism reduces significantly the
 276 capacity of the connecting transversal façades, as they lose a vital transversal support.

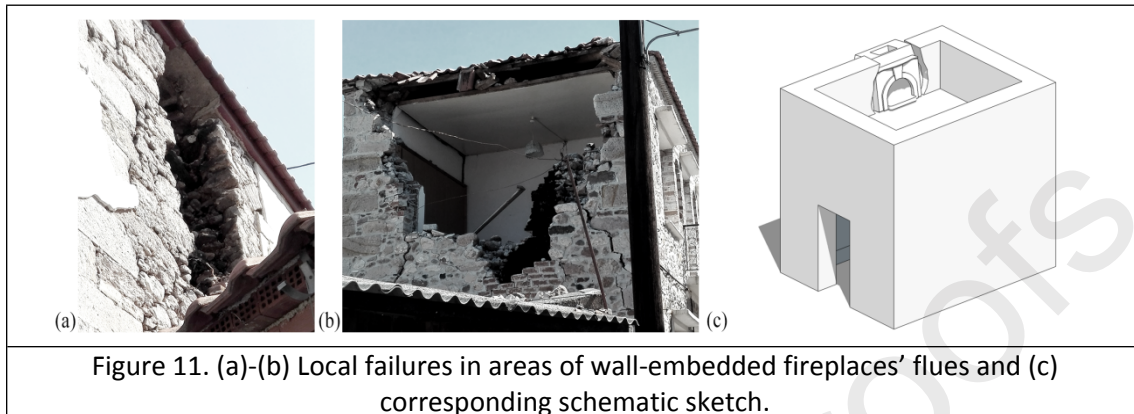
278 Local failures were also observed in areas of fireplaces' flues (Figure 11). The usual
 279 configuration of embedding the fireplace's flue within masonry induces a local section

280 reduction at the wall that makes it much more vulnerable. It is noted that the material
281 degradation caused by the fire and cycles of thermal expansion / contraction further reduces
282 the capacity. Moreover, the vertical discontinuity introduced by the section reduction, could
283 trigger other mechanisms as well.

Figure 11. (a)-(b) Local failures in areas of wall-embedded fireplaces' flues and (c) corresponding schematic sketch.

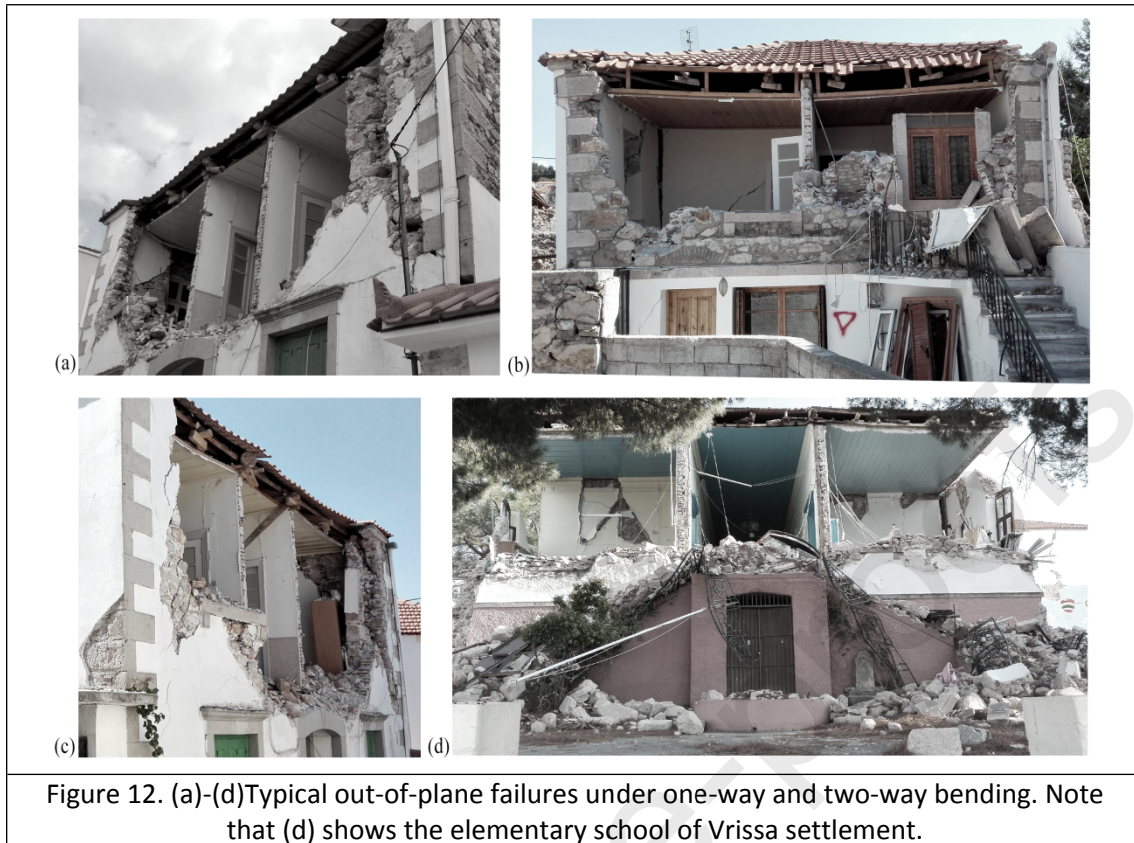
290 Long walls or walls with insufficient transversal support suffer vertical, one-way bending. In
291 particular, the top part of the façades, usually inadequately connected with the roof,
292 behaves as a cantilever about their base or the underneath floor level (rocking type of
293 failure). Similarly, walls with adequately connected transversal walls experience two-way
294 bending, characterized by larger capacity in comparison with the former. Figure 12 depicts
295 typical OOP collapses.

Figure 12. (a)-(d) Typical out-of-plane failures under one-way and two-way bending. Note that (d) shows the elementary school of Vrissa settlement.

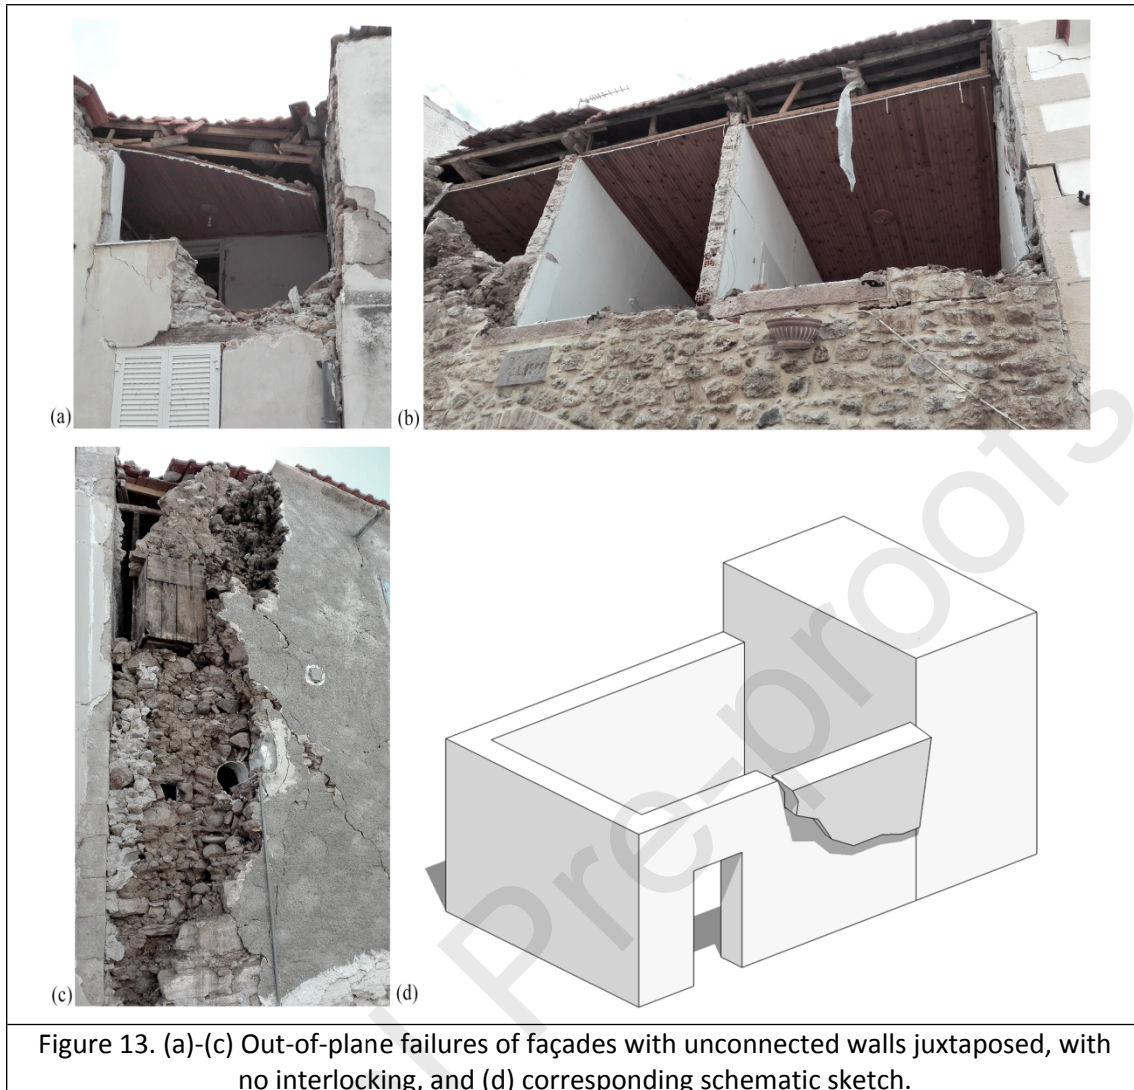
297 The typical plan layout of the constructions in the area contributed to the development of
 298 one-way OOP bending. Since the internal walls were not connected with the masonry walls,
 299 the resulting unconstrained length of the façades (around 10 m) was too large. Several cases
 300 were observed in which one intermediate wall was shared between two structural units; yet
 301 one of them was just resting on the common wall, lacking connection. Such configuration
 302 usually appears when the two units were built at different periods, and the latter unit
 303 increased the internal space by utilizing the existing wall. The seismic vulnerability of such
 304 configuration is clear from a structural point of view, as the transversal façade of the latter
 305 unit lacks a lateral support (Figure 13). A traditional solution in such cases is the insertion of
 306 protruding (or “toothing”) stones to ensure interlocking, although this was not observed in

Figure 13. (a)-(c) Out-of-plane failures of façades with unconnected walls juxtaposed, with no interlocking, and (d) corresponding schematic sketch.

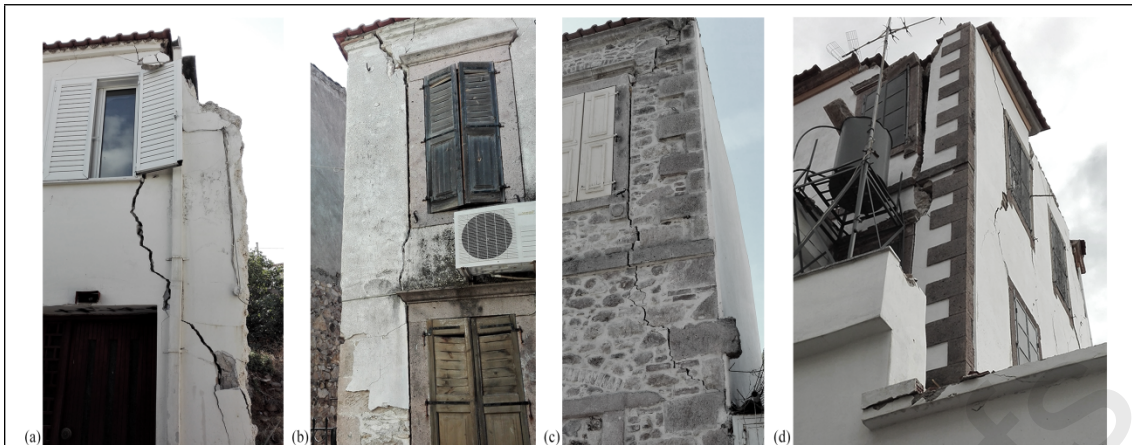
Figure 14. (a)-(d) Weak connection of transversal walls, due to the presence of openings at the corner proximity.

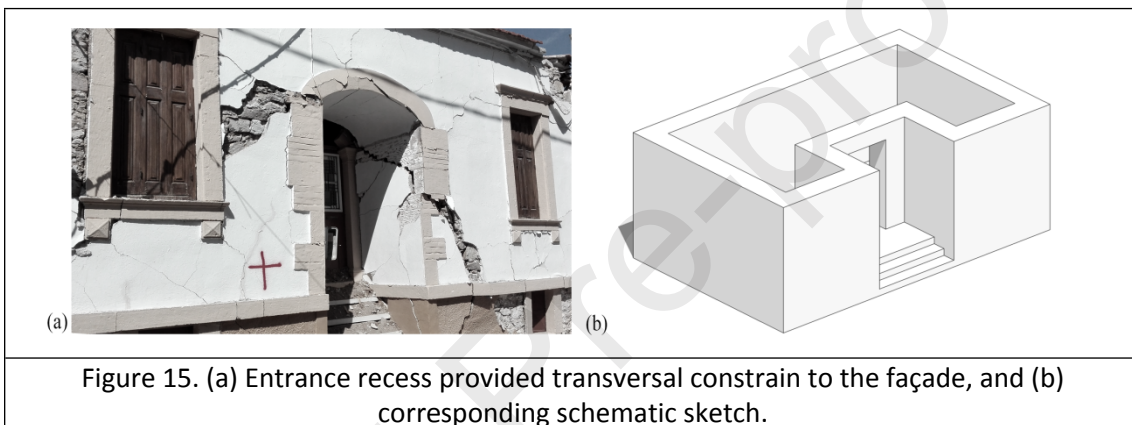
319 for the façades, introducing flanges (Figure 15). A representative example is shown in (Figure
 320 15 (a)), where the transversal walls of the entrance recess suffered IP damage, indicating
 321 their role of supporting the main façade. Nevertheless, this attribute was only effective for
 322 the ground floor.

Figure 15. (a) Entrance recess provided transversal constrain to the façade, and (b) corresponding schematic sketch.

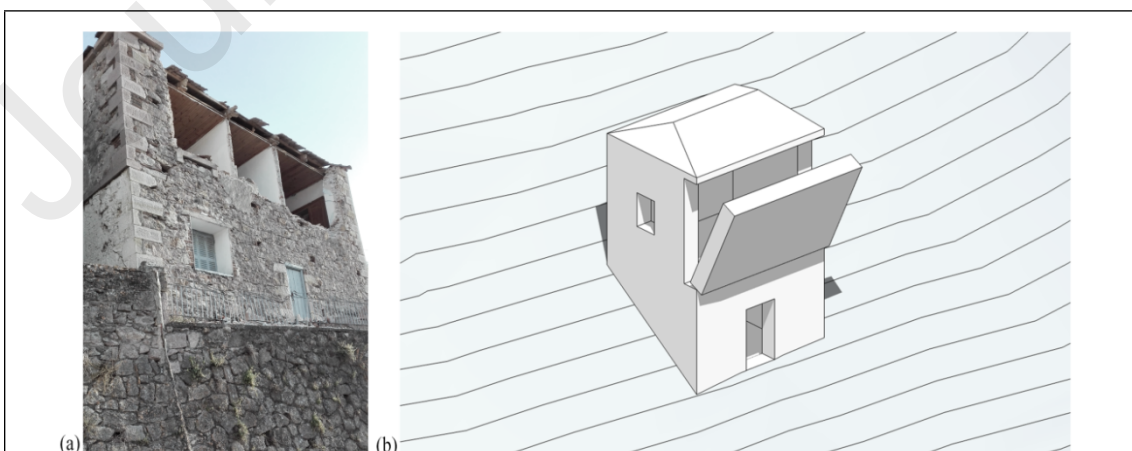
325 The vulnerability of the masonry walls is also governed by the slenderness, with more
 326 damage for walls with higher interstory height. Due to the acceleration amplification across
 327 the height and the lower overburden weight, many OOP collapses of top parts of slender
 328 walls were observed (Figure 12). A representative example of the aforementioned
 329 characteristics can be recognized in slender downhill side façades (Figure 16).

Figure 16. (a) Out-of-plane collapse of downhill side façade, and (b) corresponding schematic sketch.

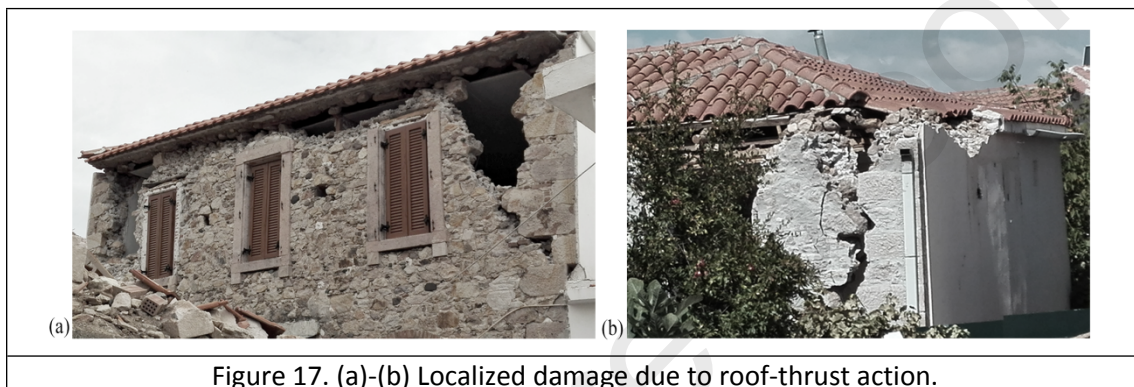
Figure 17. (a)-(b) Localized damage due to roof-thrust action.

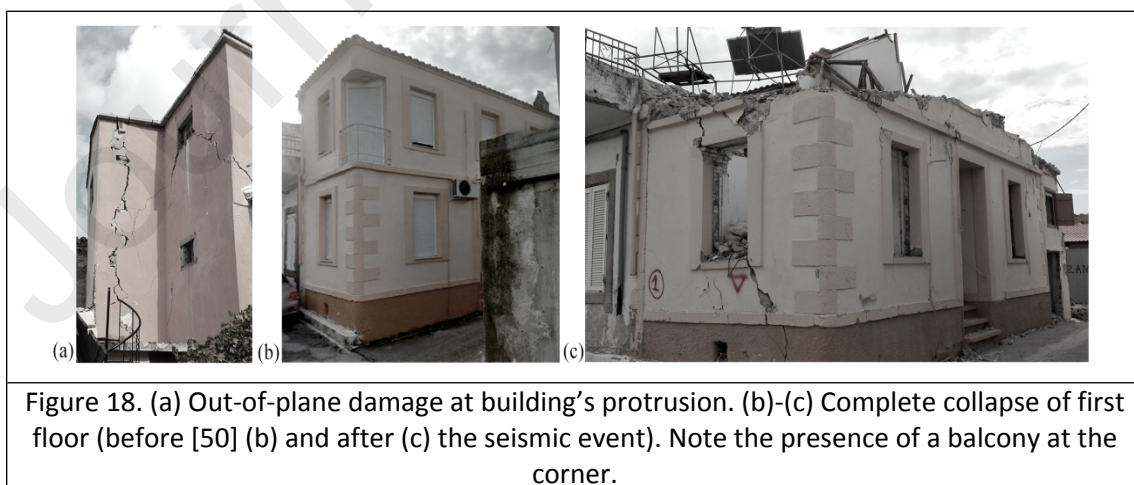
342 Plan irregularities led also to OOP mechanisms. Figure 18 (a) shows a protrusion of a building
 343 that concentrated severe damage due to torsional phenomena taking place. Figure 18 (b)-(c)
 344 displays a case of complete collapse of the first floor. By looking to its condition before the
 345 seismic event, it appears that the owners demolished the corner of the building at the first
 346 floor in order to create a balcony. This eliminated any connection of the transversal walls
 347 and introduced a plan irregularity, certainly contributing to collapse.

Figure 18. (a) Out-of-plane damage at building's protrusion. (b)-(c) Complete collapse of first floor (before [50] (b) and after (c) the seismic event). Note the presence of a balcony at the corner.

524 Interventions that induce irregularities might end up being also decisive for the global
 525 structural integrity. The building shown in Figure 18 (b)-(c) and described in Section 3.2, is a
 526 representative case of this category of interventions with a disastrous outcome.

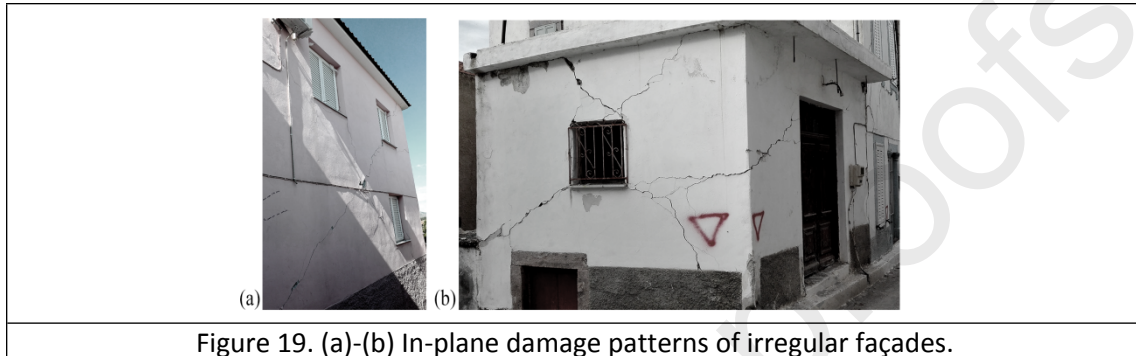
356 In most buildings where the plan and elevation regularity is respected, damage is distributed
357 in the so-called masonry members, i.e. the piers and spandrels. On the other hand, buildings
358 with irregular configuration exhibit damage concentration at the weakest areas (Figure 19).

Figure 19. (a)-(b) In-plane damage patterns of irregular façades.

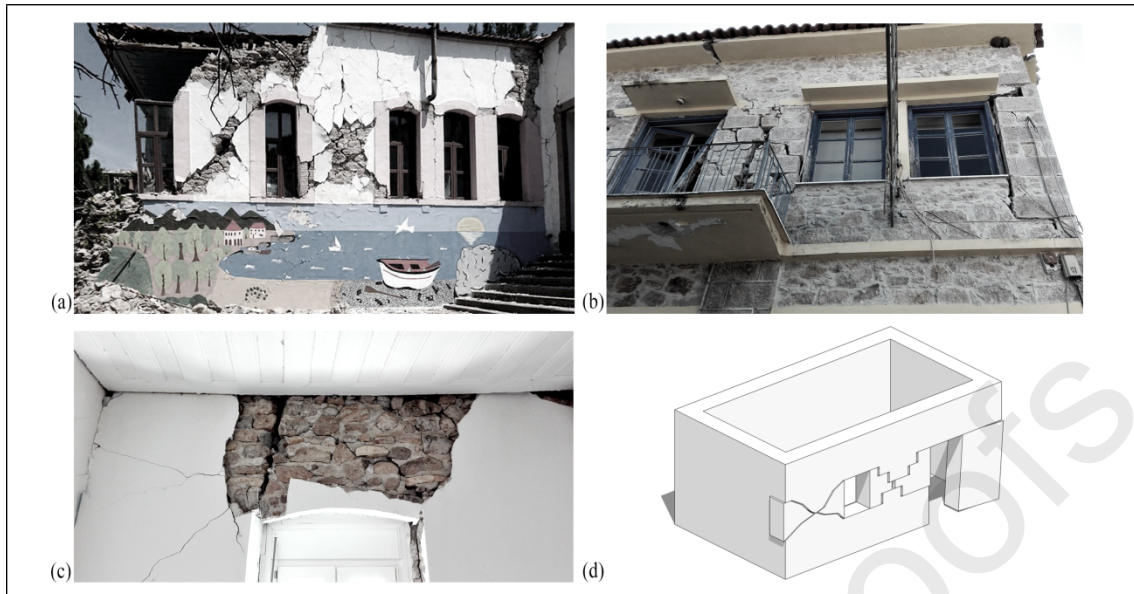
370 until toe crushing occurs. Finally, any combination of the aforementioned modes is
371 commonly observed, especially after cyclic loading reversals. Figure 20 illustrates
372 representative cases of the aforementioned IP damage patterns.

Figure 20. Typical in-plane damage pattern of: diagonal tension (two piers at the left of (a)), joint sliding (left pier of (b) and spandrel of (c)), flexural (right piers of (a), right pier of (b) and spandrel of (c)). Note that (a) shows the side façade of the elementary school of Vrissa settlement. (d) Schematic sketch of in-plane damage patterns.

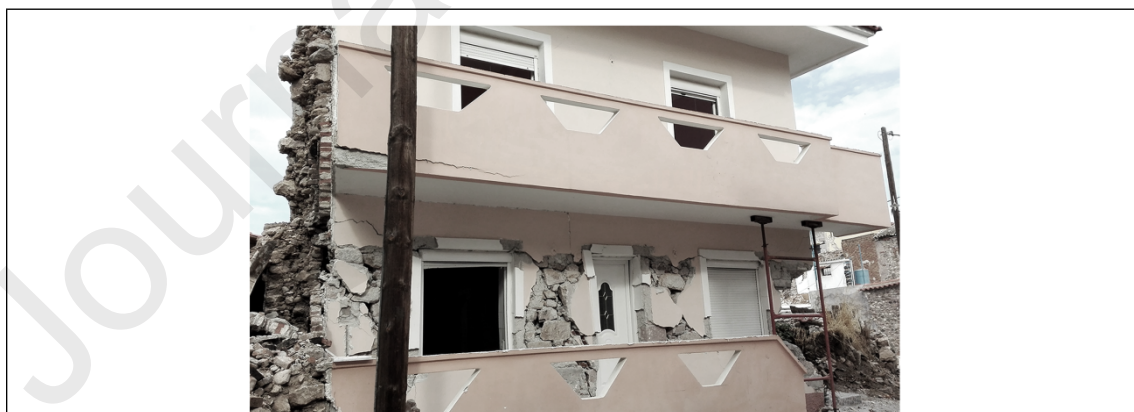
374 As expected, URM structures that experienced IP damage were mostly cases with a
 375 Reinforced Concrete (RC) slab (Figure 19 (a)-(b), Figure 20 (b), Figure 21). By its inherent
 376 stiffness, the slab acts as a diaphragm and thus prevents OOP mechanisms. Nevertheless, it
 377 should not be disregarded that RC slabs possess significant weight and therefore increases
 378 also, moderately, the seismic demand (in masonry buildings most of the weight remains in
 379 the walls). Figure 21 illustrates a building with particularly large mass due to the RC slabs
 380 that even extend to balconies, with severe IP damage in the ground floor.

Figure 21. Severe in-plane shear damage at the ground floor of a building with large mass in the reinforced concrete floor slabs.

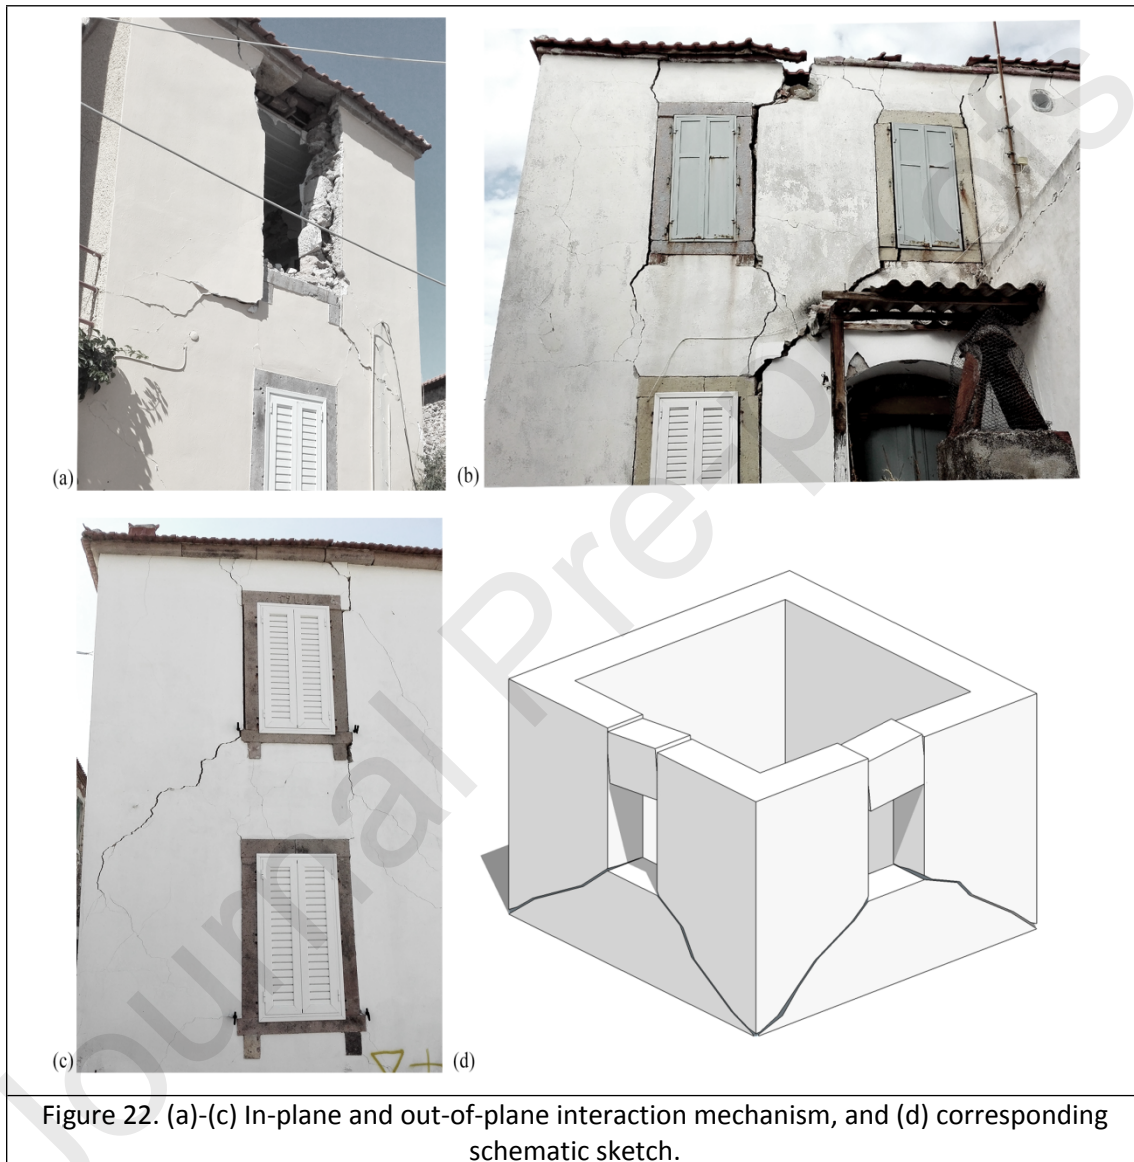
386 The most frequent combined mechanism was the interaction, leading to both: 1) vertical
 387 cracks at the end sections of the spandrels that derive from the IP flexure of the spandrel
 388 and the OOP response of the façade; 2) diagonal cracks at the lower corners of the openings
 389 propagating towards the corners of the structure, that arise by the IP shear damage and the
 390 OOP behavior of the façade (Figure 22). An additional characteristic of this mechanism is
 391 that in most cases it appears mirrored in the transversal façades. The corner mechanism,
 392 mentioned in Section 3.1, is a local manifestation of this mechanism.

Figure 22. (a)-(c) In-plane and out-of-plane interaction mechanism, and (d) corresponding schematic sketch.

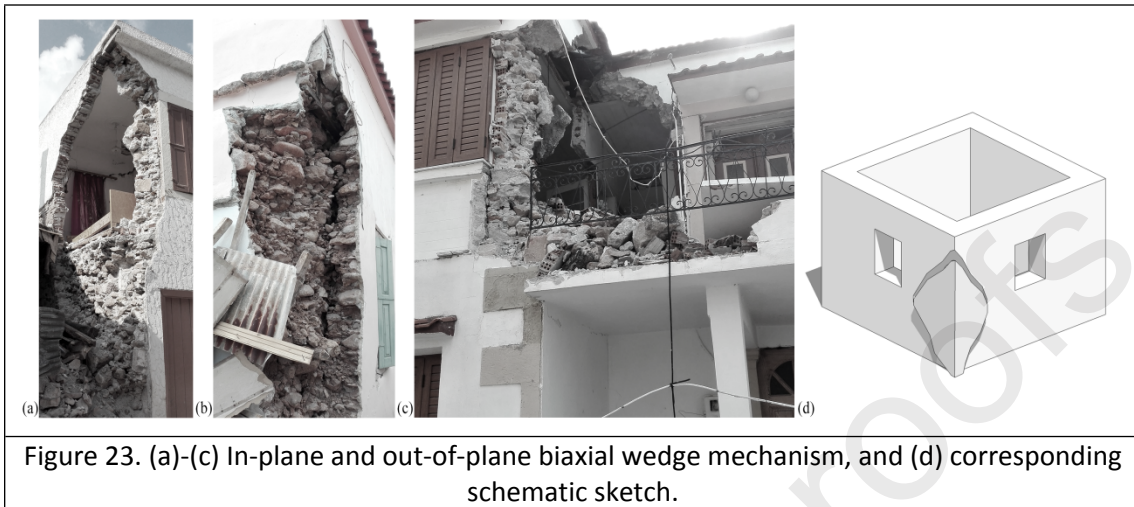
394 Observed only in a few cases, another identified combined mechanism was the wedge
 395 biaxial failure. This appears as a second order mechanism of the previous combined, when
 396 the top part of the construction is restrained. Under this condition, a wedge (usually the
 397 corner of the building) is highly stressed by the biaxial actions up to its capacity, resulting in
 398 a bursting collapse (Figure 23). In case of corners, the failure surface forms a rhombus that
 399 expands over the two transversal walls. In addition, this mechanism was also observed at
 400 the recess corner of a plan-irregular structure, where high biaxial stresses concentrated

401 (Figure 23 (c)). It may be worth mentioning that cut corners, a commonly observed
402 functional detail for street widening (e.g. see the bottom part of the corner at Figure 5 (a)),
403 significantly reduce the capacity of this mechanism.

Figure 23. (a)-(c) In-plane and out-of-plane biaxial wedge mechanism, and (d) corresponding schematic sketch.

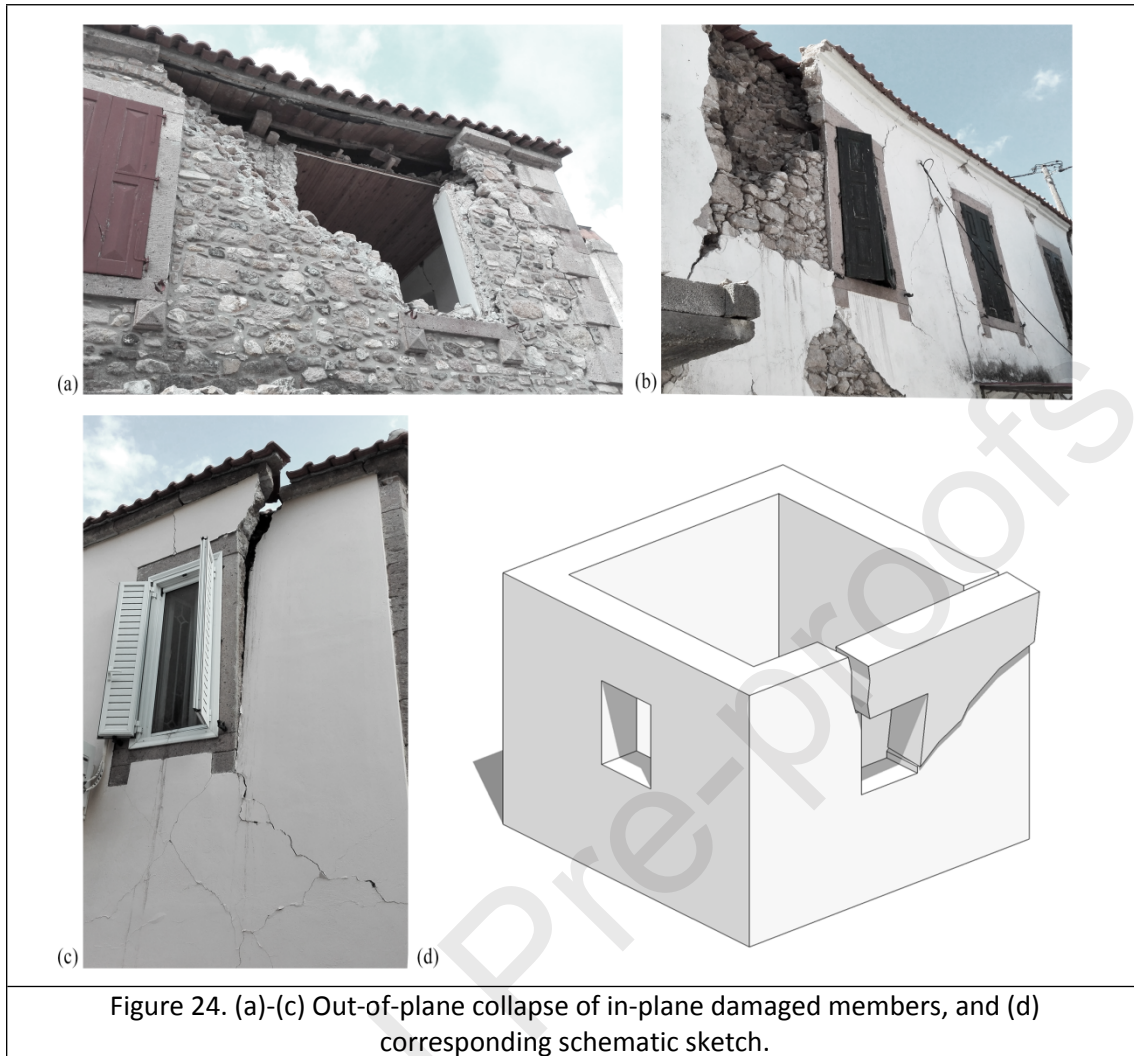
405 Another combined mechanism observed was the OOP collapse of a previously IP damaged
406 wall. This mechanism refers to the strength degradation induced by IP damage to a portion
407 of the masonry wall, which may then be isolated and overturned by OOP actions (Figure 24).
408 The reverse situation was not observed in the field reconnaissance, but it should not be
409 excluded.

Figure 24. (a)-(c) Out-of-plane collapse of in-plane damaged members, and (d) corresponding schematic sketch.

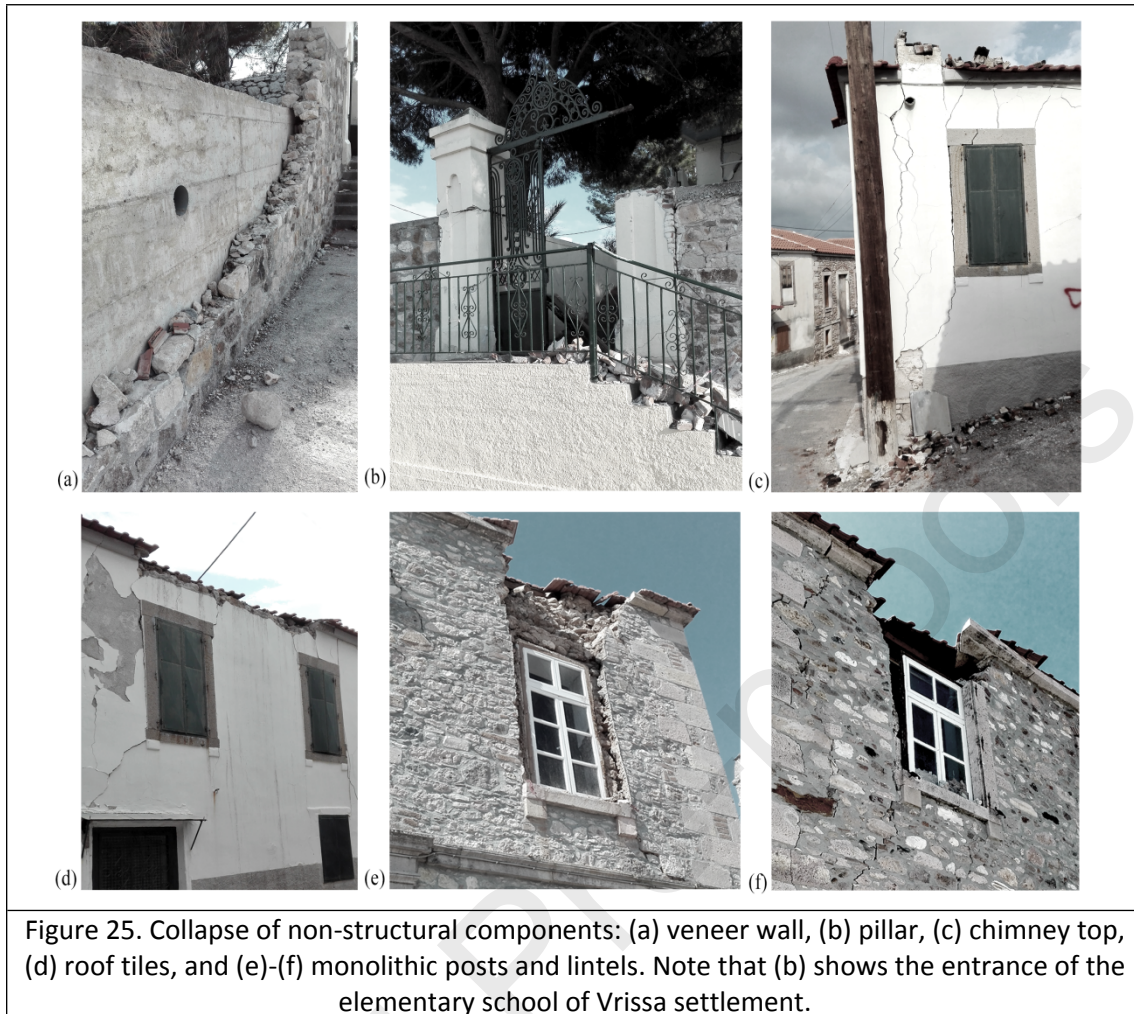
414 Similarly with previous earthquake reconnaissance, collapses were observed in retaining and
 415 veneer walls (Figure 25 (a)), pillars (Figure 25 (b)), chimney tops (Figure 25 (c)), roof tiles
 416 (Figure 25 (d)) and infilled window openings. Yet the most crucial and widespread of non-
 417 structural failures appeared to be the monolithic stones used for posts and lintels of the
 418 openings (Figure 25 (e), (f)). As discussed in Section 2.2.1, this local architectural feature of
 419 the settlement did not possess any connection or interlocking with the rest of masonry and
 420 thus detached easily. More importantly, collapse could undoubtedly lead to fatalities, as
 421 massive stones collapsed at the entrance of the buildings and in the streets during the
 422 seismic event.

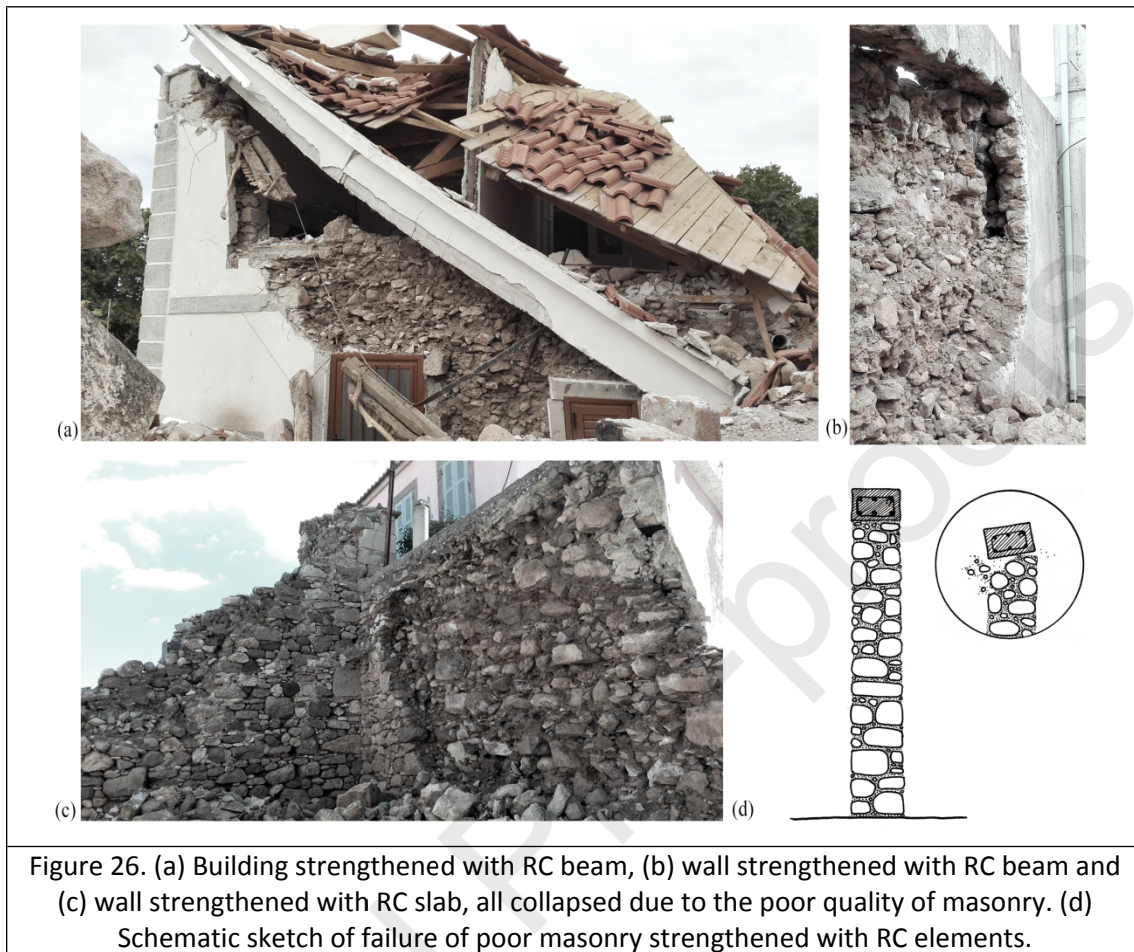
468 Several cases were identified in which a RC beam was introduced at the top of masonry
469 walls (Figure 26 (a), (b)). This strengthening technique falls in the second category and could
470 be beneficial, as it connects and ties the transversal walls (and may add overburden weight),
471 thus reducing the OOP vulnerability of the façades. Nevertheless, local or even global
472 collapses were observed in such cases, with the masonry walls disintegrating (“zero”
473 mechanism). Given the extremely poor quality of masonry, the integrity of the underlying
474 walls was not ensured in order for the enhanced connections to be beneficial. In addition,
475 one could argue about the damage introduced by adding the beam or the subsequent
476 incompatibility of deformation, and about an increase in the demand of the poor masonry
477 walls, due to the added mass of the RC elements, or the destabilizing OOP moments that

481 response of the underlying poor masonry. Had the masonry's integrity been ensured, the
 482 diaphragm could be beneficial.

Figure 26. (a) Building strengthened with RC beam, (b) wall strengthened with RC beam and (c) wall strengthened with RC slab, all collapsed due to the poor quality of masonry. (d) Schematic sketch of failure of poor masonry strengthened with RC elements.

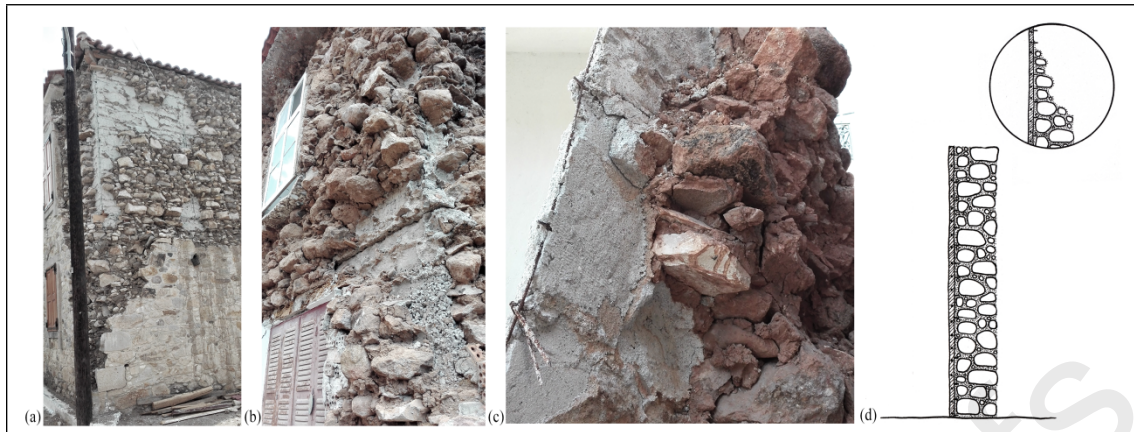
484 Finally, a few cases of RC jacketing were observed. This strengthening technique falls in the
 485 third category, as it intends to increase the capacity and stiffness of the masonry walls, both
 486 for IP and OOP actions. However, as the application was once more over a poor masonry
 487 substrate, failure and collapse were found (Figure 27). At this point it is interesting to note
 488 that if a proper detailing is performed, with applications on both sides of the walls and well-
 489 designed anchors, RC jacketing could act beneficially also for the integrity of the masonry,
 490 i.e. the first category. Nevertheless, very deficient applications of this strengthening
 491 technique were found (Figure 27 (c)), as application was only on the internal surface and
 492 using sparse anchors. The images illustrate clearly that it was masonry that failed rather than
 493 the reinforcement, corroborating the need of prioritization of strengthening interventions.

Figure 27. (a)-(b) Buildings strengthened with RC jacketing, which failed due to the poor quality of masonry. (c) Detail of a collapsed masonry portion strengthened with RC jacketing. (d) Schematic sketch of failure of poor masonry strengthened with RC jacketing on one side.

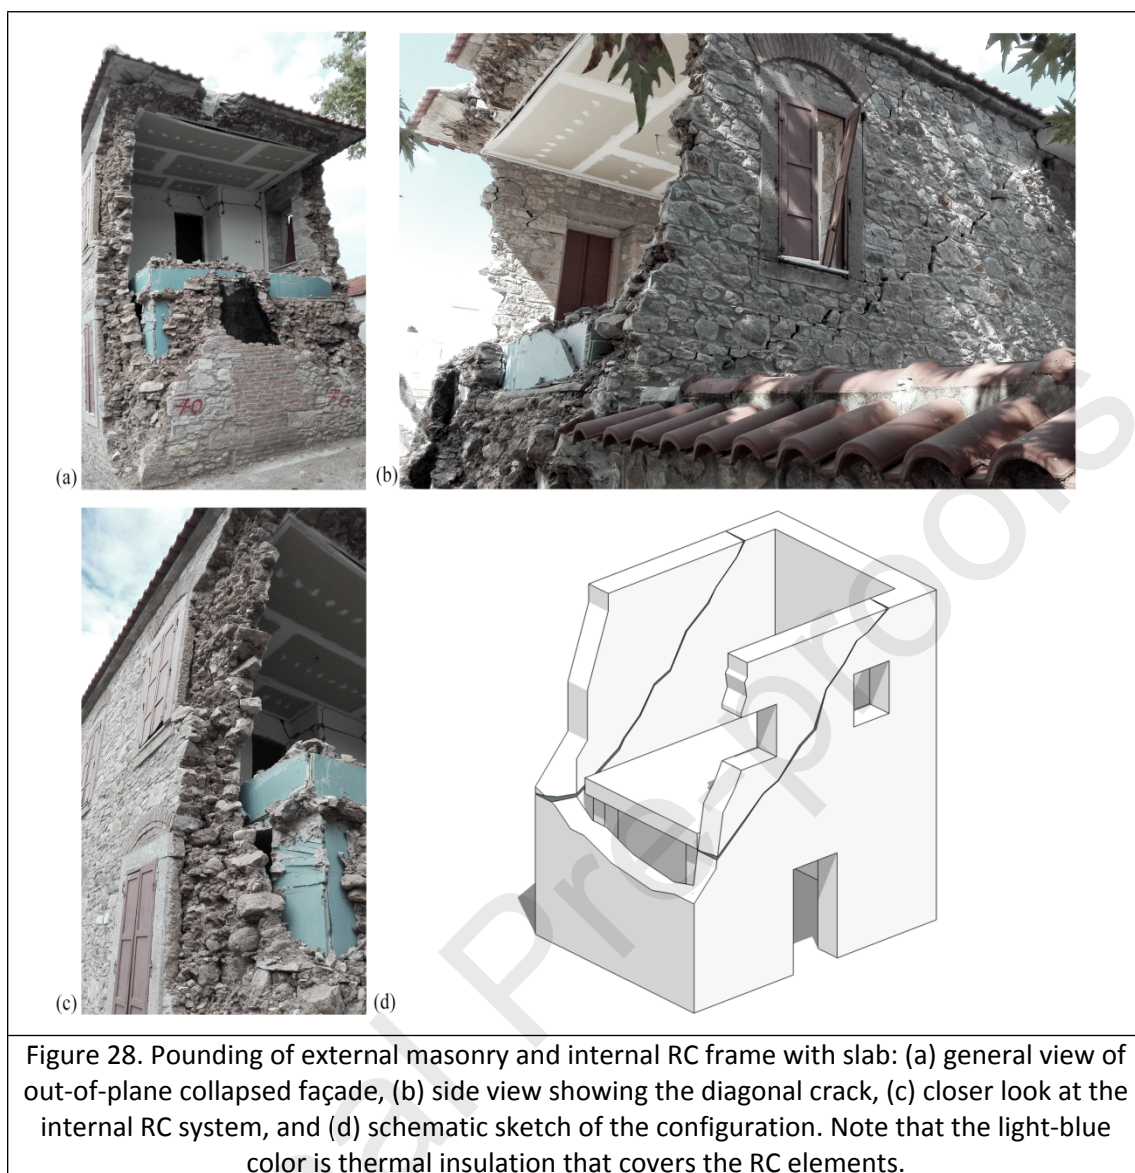
511 walls, inducing severe damage instead of providing strengthening to the existing structure.
 512 In fact, the failure mechanism of the masonry structure observed highlights the behavior, as
 513 the collapsed façade failed under OOP actions exactly at the height of the slab, while the two
 514 transversal walls suffered IP damage that initiated at the aforementioned height and
 515 propagated diagonally, ignoring the openings' layout.

811 Finally, the second case concerns the building presented in Section 4.2 and Figure 28. The
812 observations made there indicate that pounding occurred between the internal RC frame
813 and slab with the external masonry façade. By looking at the damage pattern it is clear that
814 the collision happened at the interface between the slab and the façade that collapsed OOP,
815 while the transversal façades showed only IP damage induced by the previous collision. The
816 façade that collapsed faces SE, while the two transversal façades face SW and NE. Since
817 pounding occurs at large displacements, the aforementioned damage pattern points out
818 that the main seismic component was in the NW-SE direction.

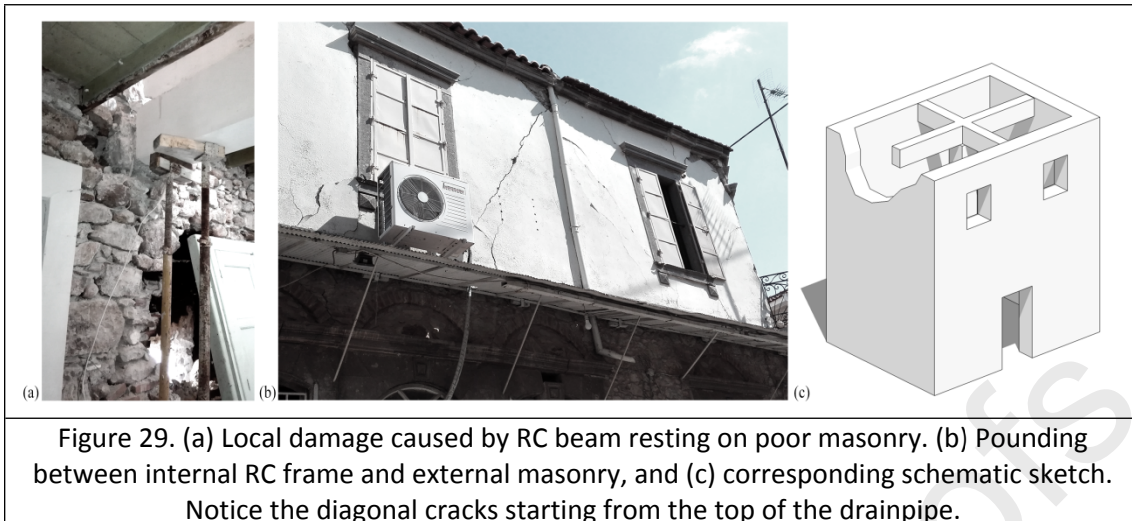
517 A similar intervention scheme inspected included RC columns and beams, the latter resting
 518 on the peripheral masonry façades. In this case, a proper connection among the new RC
 519 beams and the masonry walls was not ensured, resulting into two main damage patterns: 1)
 520 in cases of poor quality of masonry, the concentrated loads caused local disintegration of
 521 masonry (Figure 29 (a)); 2) pounding between masonry and the concrete beams caused
 522 damage to the façades (Figure 29 (b), (c)).

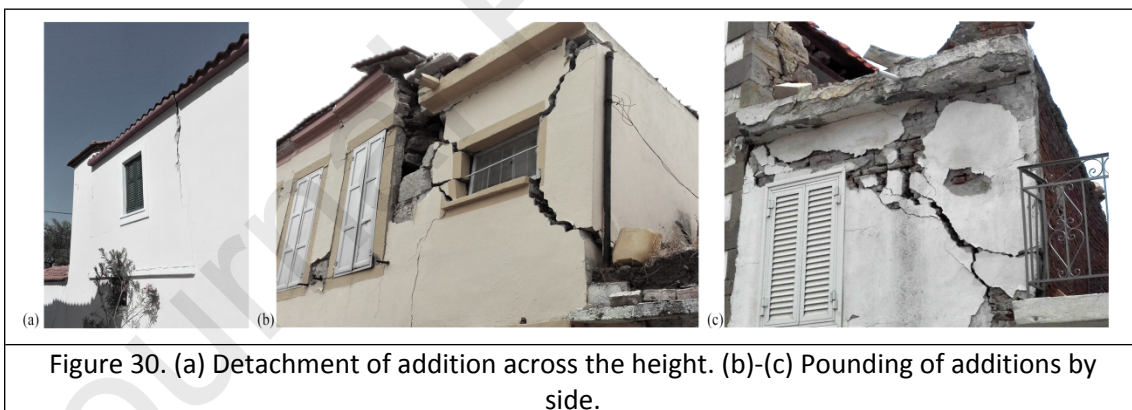
527 Finally, small additions are also a common intervention practice to increase the housing
 528 space. Additions across the height (in elevation) were observed in some cases to suffer
 529 detachment and potential overturning (Figure 30 (a)). Additions by side (in plan) often acted
 530 beneficially as a buttressing element, constraining the OOP failure. Nevertheless, pounding
 531 between the old masonry and the side addition was also identified (Figure 30 (b), (c)).
