Learning from failure: Damage and Failure of Masonry Structures, after the 2017 Lesvos Earthquake (Greece)

Abstract - On the 12th of June 2017 an earthquake of Mw=6.3 struck SSE of Lesvos Island, causing one human fatality and severe damage to the built environment. The traditional settlement of Vrissa was the most affected area, having masonry structures as the majority of its building stock. The objective of the present study is two-fold: to present the structural damage and failure patterns induced by the Lesvos earthquake to masonry structures; to highlight the causes and weaknesses that led to damage, or the factors that prevented it. Particular attention is paid to traditional construction techniques and architectural features that contributed to the seismic response of the structures, either having beneficial or detrimental effect. To this end, a field reconnaissance has been conducted and meaningful technical conclusions are drawn by the observations. Structural systems of both unreinforced and timber-reinforced masonry are inspected. Besides the identification of frequent cases of local, out-of-plane and in-plane mechanisms, combined global mechanisms are also pointed out

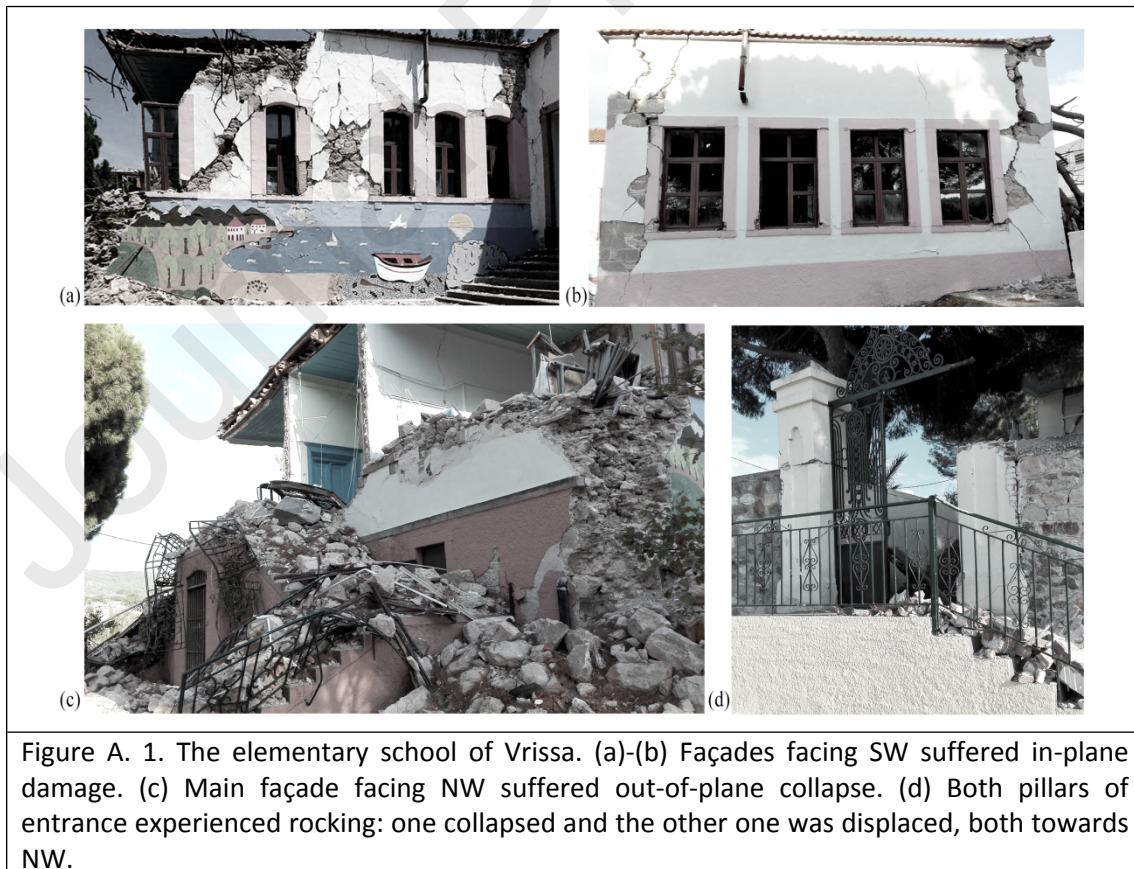
807 direction. In fact, a local landslide occurred at the NE side and the corresponding façade (not
808 showed herein) collapsed OOP. Nevertheless, all the rest façades and the pillars of the
809 entrance point out the same seismic motion directivity towards NW.
