# Geological challenges and geohazard monitoring of a mega engineering hydropower project in Iceland

Fjola G. Sigtryggisdóttir<sup>a,\*</sup>, Jónas Thór Snæbjörnsson<sup>b,c</sup>

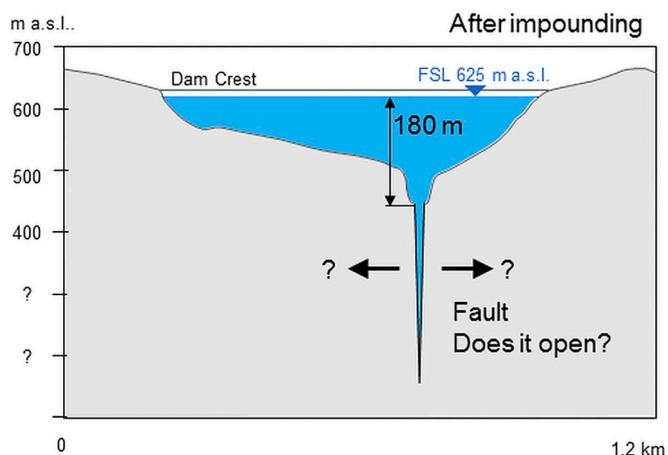
**Fig. 7.** Question on the behaviour of the Toe-wall Fault (DF-1) (see Figs. 5 and 6) in the foundation of the K Dam during impoundment.

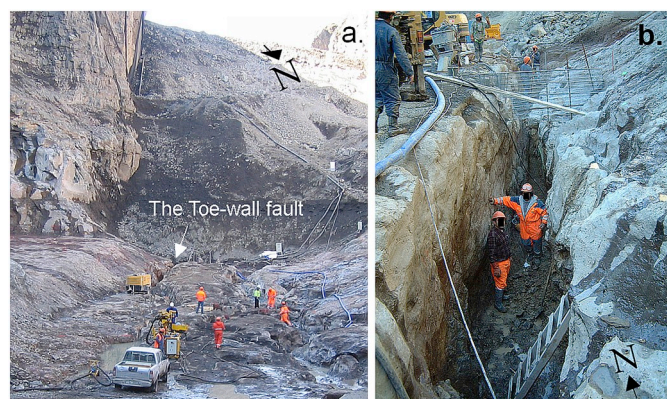
**Fig. 6.** The canyon to be crossed by the K Dam. Excavation of the foundation revealed the Toe-wall Fault (DF-1), later defined as Holocene strike slip fault (see also Figs. 5 and 8a). (a) View towards upstream (south), the arrow points to location of Fig. 6b. (b) View towards downstream (north), the fault is trending 20–25° NNE and considered to be a right-lateral strike slip fault.

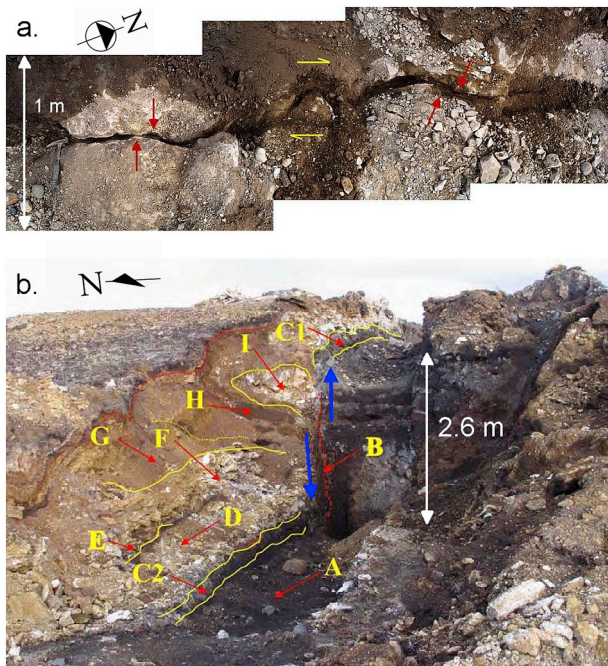
**Fig. 8.** Inspection sites in Fig. 5 (arrow and label SS): (a) Holocene strike slip fault (DF-1, the Toe-wall Fault) on a ledge west of the Jökulsá River, south of the K Dam. (See arrow to inspection site in Fig. 5). The fault trends N20–22°E. (Figure courtesy of Kristján Sæmundsson). (b) Holocene fault. Cross section striking approximately N120°E. Fault displacement relative to tephra marker C is 2.6 m. (For location see inspection site SS on Fig. 5) (A: Tillite or moraine, presumably some 10,000 yr. age; B: Fault escarpment, striking N29°E, showing a downthrow direction; C1, C2. E: Black tephra; D, F, G and I: Different silica deposits; H: Hard soil with prehistoric tephra layers). (Figure courtesy of Ágúst Guðmundsson).

canyon, south of the K Dam (for location see the arrow pointing to the ledge on Fig. 5). Sæmundsson and Jóhannesson (2005) inspected the fault and concluded that a right lateral slip of about 10 cm could possibly be observed on the fault. Furthermore, that uncemented fill of 3 cm could be taken as representing the amount of possible Holocene movement.

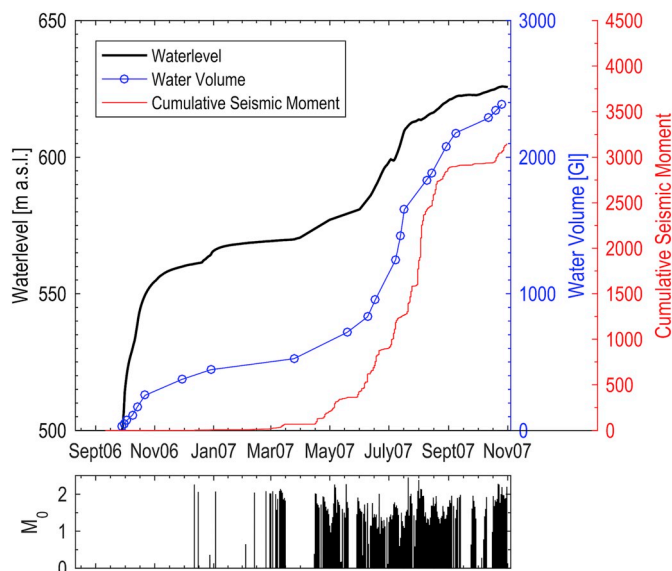
**Fig. 16.** Cumulative seismic moment at Upptyppingar, water level and volume of the Háslón Reservoir between Sep 2006 & Nov 2007. (Adapted from a figure by the Icelandic Meteorological Office, which also provided the earthquake data).

The activity continued in 2007 and when the increase in seismicity was represented by a cumulative curve of seismic moment, it seemingly coincided with the water level increase during the then ongoing filling of Háslón as shown in Fig. 16 (Roberts et al., 2007; Jonsdottir et al., 2007). Accordingly, it was stated by some geophysicists that a relationship to the reservoir impounding should not be ruled out without

The earthquake activity continued into 2008 while the reservoir elevation decreased, and thus the similarity between the curves in Fig. 16 was lost, and the discussion expired. Furthermore, in early 2008 after processing data from a surveying campaign to monitor crustal displacements of benchmark points, the activity (within the marked boundary in Fig. 10) was explained as a geophysical process unrelated to the reservoir filling. The micro seismicity recorded had to be interpreted in connection with the monitoring of crustal movements to fully understand the ongoing processes.

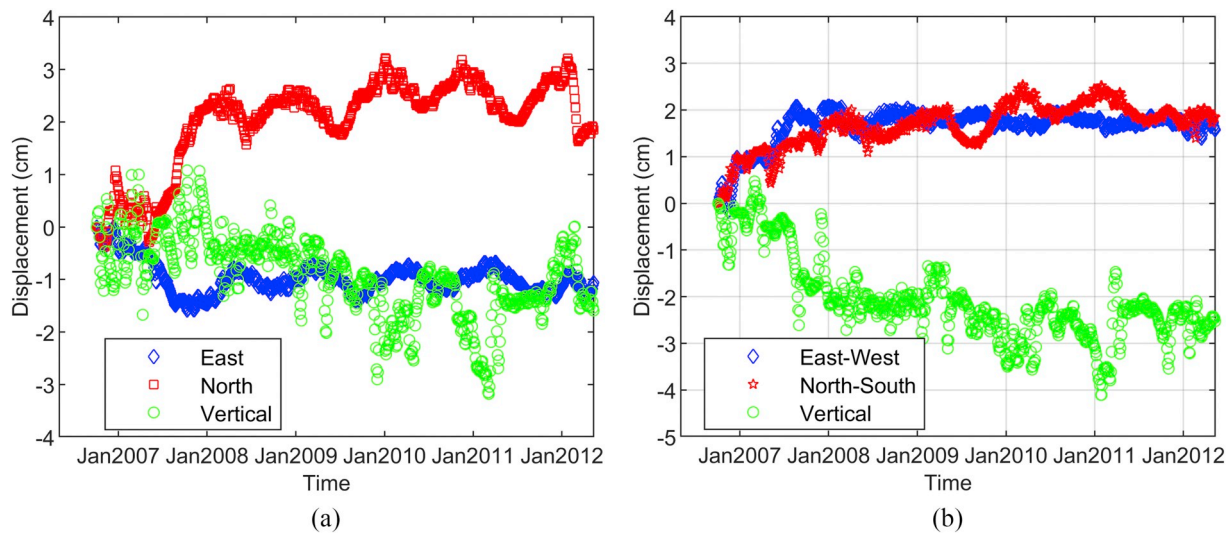
Fig. 18. Results from selected CGPS stations in the Near Dam Network. (a) Displacement in east, north and vertical direction at CGPS station HAHV west of the K Dam, sampled at 2 values per week from the start of reservoir impounding. (b) Differential horizontal and vertical displacement between the CGPS stations HAHV on the west bank and KARA/INTA on the east bank of the K Dam, sampled at 2 values per week.

The reservoir induced horizontal deformation across the Hálslón Reservoir upstream of the Kárahnjúkar dam (K-dam) was observed by GPS campaigns on the Near Dam Network and CGPS observations at stations KARV, HAHV, KARA/INTA and DIST (Fig. 12b). The measured deformations suggest widening of the Hálslón canyon with increased water level during the first reservoir impounding, a trend which may be intensified by the faults underlying the Hálslón Reservoir and the foundations of the dams. This effect was for instance noticed at CGPS Station HAHV, as shown in Fig. 18a, where the benchmark had moved up to 3 cm towards north and 1.5 cm towards west at the end of the first impoundment in October 2007. During the impoundment of the reservoir, the main orientation of crustal movement was between southwest and northwest at HAHV and from southeast to northeast at INTA and DIST, i.e. in all cases more or less across the canyon. Since the first impoundment the location has been more or less stable except for the effects of the annual reservoir filling cycle (see Fig. 2b), which is reflected in the data, especially through the north component. The peak to peak annual variation is in the order of 1 cm (see Fig. 18a).

The development of differential displacement across the K Dam canyon in the period September 2006 to January 2012 is shown in Fig. 18b. The canyon gradually widens during the impounding and moves towards north under the pressure from the water in the reservoir, resulting in a roughly 3 cm total differential displacement between stations HAHV and KARA/INTA, combining the north and east components. After the first impounding, no further permanent movement is observed, only seasonal variations. As the longitudinal axis of the K Dam lies more or less in east-west direction, the east component gives the best estimate of the actual widening of the canyon and thereby possible opening of faults. It is observed in Fig. 18b, that the east-west

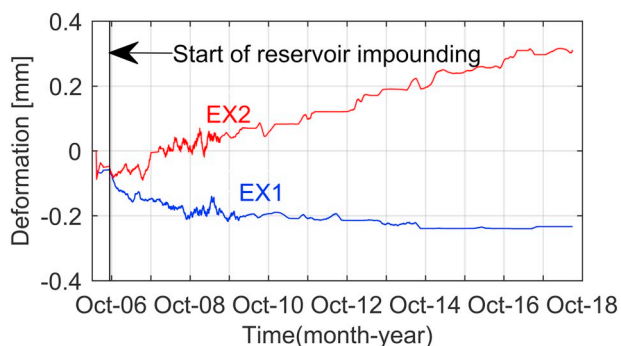
Fig. 19. Monitoring of fault DF-1 (the Toe-wall Fault), with extensometers (see Fig. 13) EX1 and EX2 (original data filtered with a moving average filter with a span of 5%). Negative and positive values respectively indicate tension and contraction.

During and after the impounding, insignificant or minor movement has been detected on instruments monitoring fault movement. The deformation recorded since start of impounding in 2006 to 2009, along the two extensometers crossing the Toe-wall Fault, DF-1 (Fig. 13), is insignificant or < 0.3 mm on each (see Fig. 19). The extensometer EX2 measures subtraction while the EX1 measures extension, considering the alignment of the extensometers this indicates either vertical differential displacement and/or horizontal sliding. However, the movement is insignificant, and the measurements may be influenced by movement of the Toe-wall itself. The insignificant movement is confirmed by other deformation measurements in the Toe-wall. However, there have been movements detected near faults labelled DF-2 and DF-3 in the K Dam foundation. The movement observed near fault DF-2 occurred in 2016 and was an opening in the order of 1 mm which coincided with a sudden increase in water pore pressure. The water pressure was relieved after the measured fault opening and dropped considerably or to a level monitored in 2008. No external trigger could be identified. Some temporary minor increase in leakage was noted following this movement of fault DF-2. The largest persistent movement is detected near fault DF-3, or an expansion in the order of 10 mm. The expansion is measured manually on a simple standard concrete crack monitor installed on a movement joint in the grouting gallery near the fault. The movement follows, with a slight delay, the measured groundwater level at the fault location, which in turn follows the reservoir level as can be seen on Fig. 20. A slight decrease in the response with time can be noted for both the groundwater pressure downstream (GW-D) as well as the measured expansion. The groundwater pressure measured at the fault location (see Fig. 20) is further discussed below. The measured movement is within design limits, but the dam design allows for up to 100 mm expansion on individual faults and movement joints within the structure.

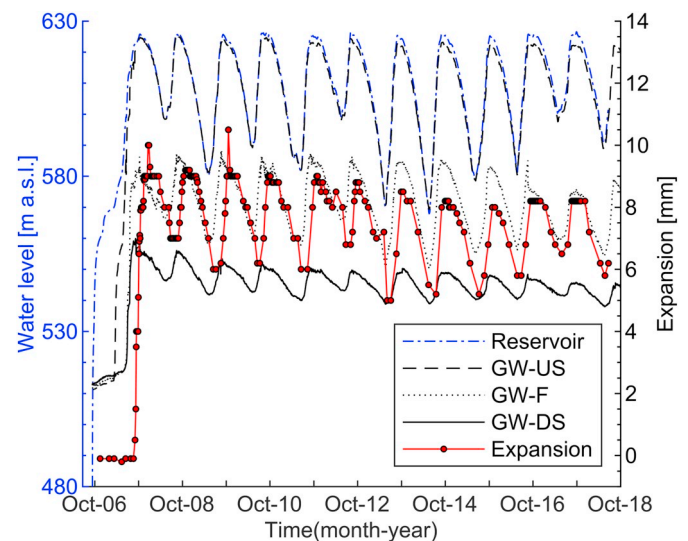
Fig. 20. Measured expansion of movement joint in the grouting gallery of the K Dam near fault DF-3 (see Fig. 4) plotted with groundwater level measured at the fault location, as well as the reservoir water level.

The groundwater pressure is measured at the Fault DF-3 (GW-F), as well as upstream (GW-US) and downstream (GW-DS) the grout curtain at the DF-3 location (see Fig. 4).

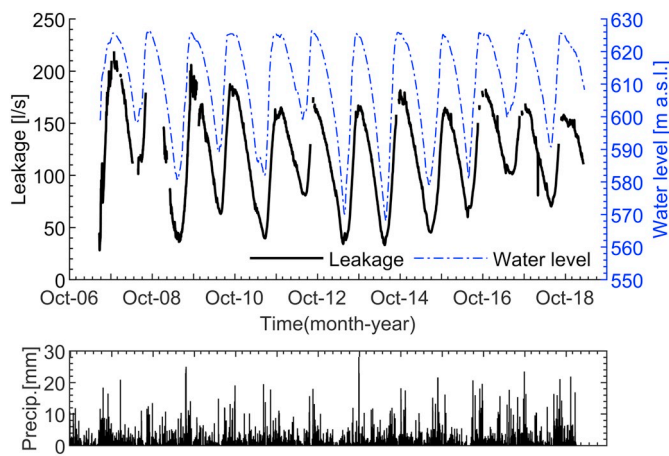
Fig. 21. Leakage measured at the downstream toe of the K dam plotted as a function of time along with the seasonal variations in the reservoir water level and daily precipitation (precip.) (Precipitation data is from a weather station in the area operated by the Icelandic Meteorological Office).

Measured leakage has been in the order of about 200 l/s at the
