Liquefaction and related ground failures from July 2019 Ridgecrest Earthquake Sequence

Paolo Zimmaro, Chukwuebuka C. Nweke, Janis L. Hernandez, Kenneth S. Hudson, Martin B. Hudson, Sean K. Ahdi, Matthew L. Boggs, Craig A. Davis, Christine A. Goulet, Scott J. Brandenburg, Kenneth W. Hudnut, and Jonathan P. Stewart

Description of the Supplemental Material:

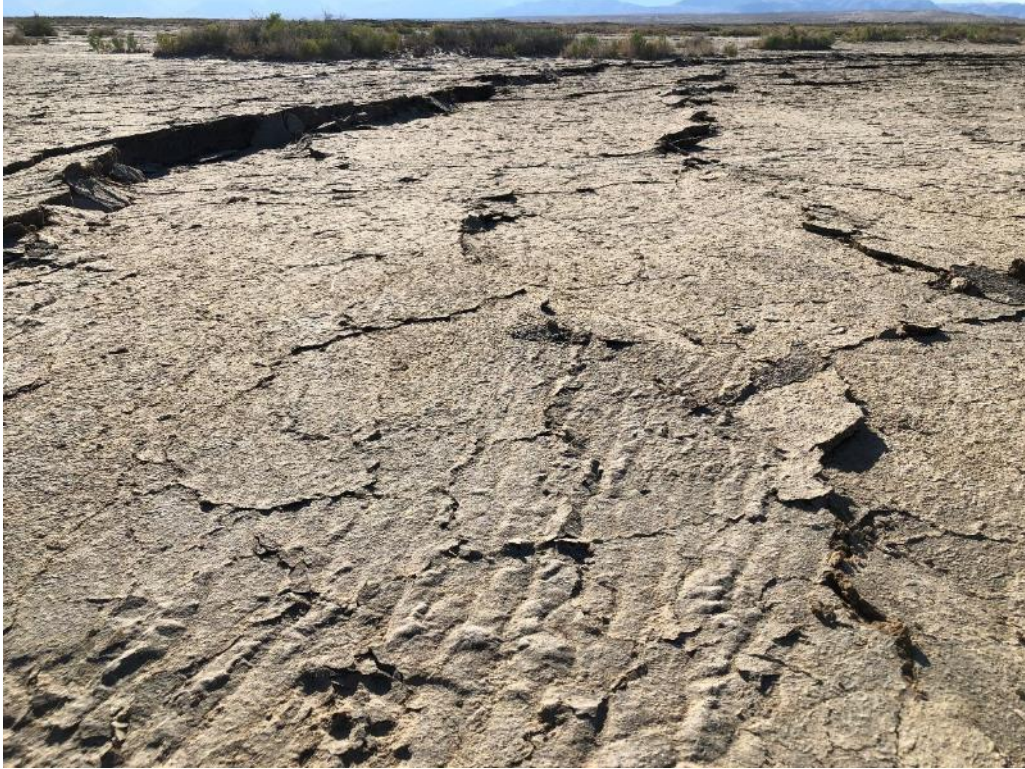
North Dry Lakebed Area – Paxton Ranch – AREA A				
Figure	Latitude (degrees)	Longitude (degrees)	Observation description	Observation type
S1	35.809808°	-117.634767°	Lateral spread meandering cracks, post M 7.1, Photo 8331	Lateral spread
S2	35.807216°	-117.642838°	Sand boils - N15W fissure trend, with second fissure about 25 m to SW, post M 7.1, Photo 8320	Sand boil
S3	35.807064°	-117.635664°	Lateral spread features – helicopter reconnaissance, post M 7.1, Photo 1241	Lateral spread
S4	35.806699°	-117.636770°	Lateral spread features – helicopter reconnaissance, post M 7.1, Photo 1268	Lateral spread
NA	35.807125°	-117.638558°	Sand boil in area of lateral spread, post M 7.1, no photo	Lateral spread and sand boil
NA	35.799415°	-117.645474°	Spring-expulsion of water - lacking blow sediments, post M 7.1, no photo	Spring
NA	35.802661°	-117.630001°	Discontinuous zones of Lateral spread in Dry Lake, post M 7.1, no photo	Lateral spread

Figure S1. Lateral spread features in the Paxton Ranch area on 7/10/2019. Curved, discontinuous zone of disturbed lateral spread cracks with vertical displacement, and some compressional cracks. Lat. 35.809808°, Lon. -117.634767°. Photo 8331 credit B. Olson, CGS.

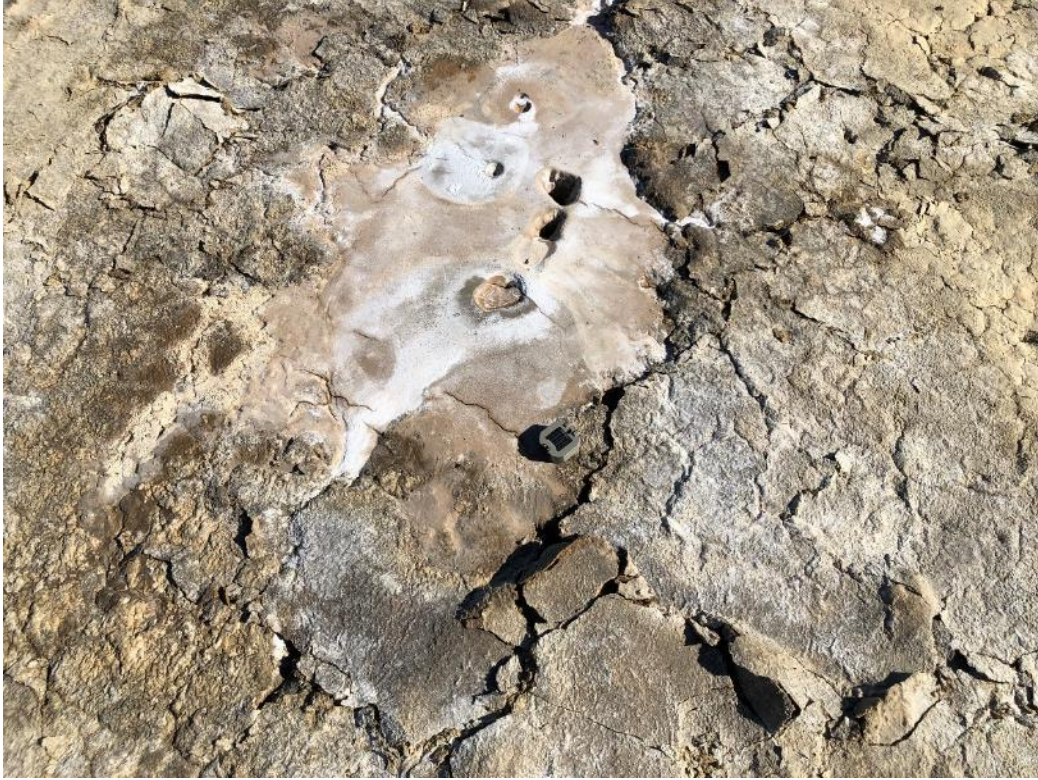
Figure S2. Sand boil in the Paxton Ranch area on 7/10/2019.
Lat. 35.807216°, Lon. -117.642838°. Photo 8320 credit B. Olson, CGS.

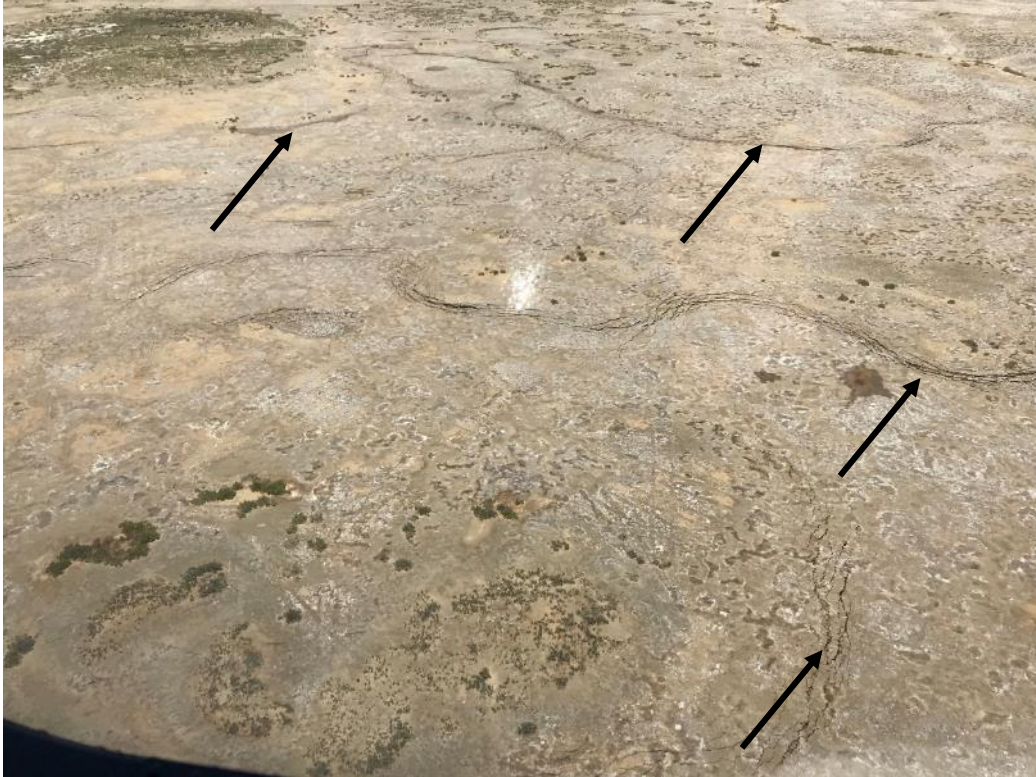
Figure S3. Lateral spread features in the Paxton Ranch area on 7/6/2019. Curved, discontinuous zone of disturbed lateral spread cracks with vertical displacement. Observations made from about 150m above the ground surface during helicopter overflight. Lat. 35.807064°, Lon. -117.635664°. Photo 1241 credit M. DeFrisco, CGS.

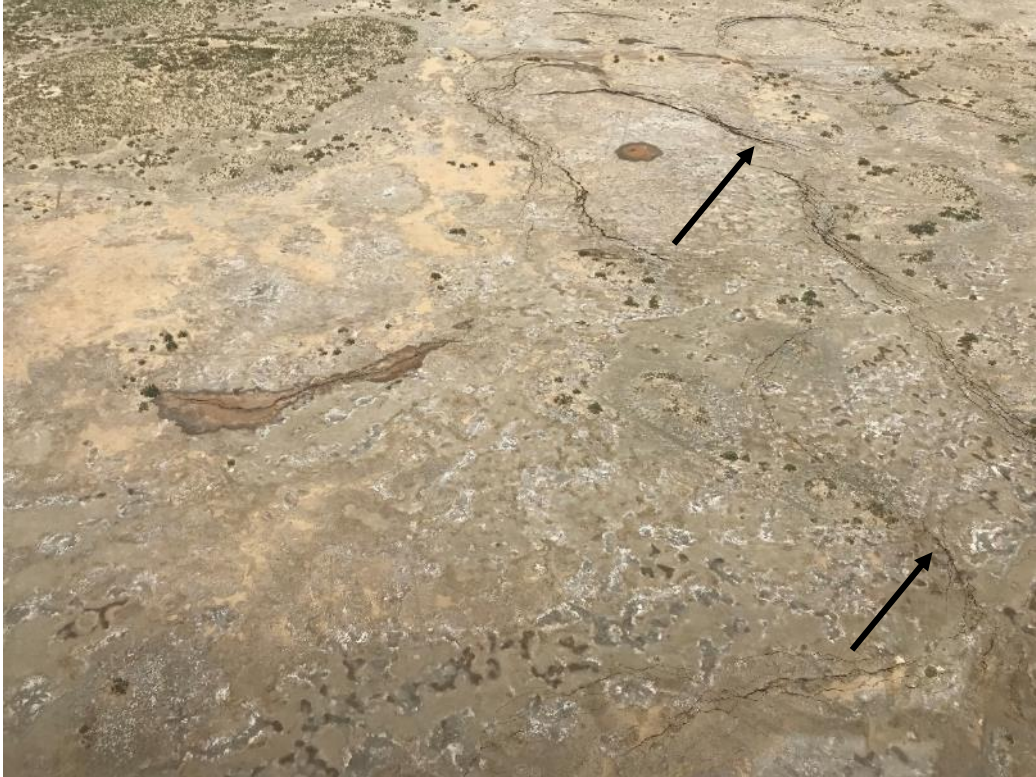
Figure S4. Lateral spread features in the Paxton Ranch area on 7/6/2019. Curved, discontinuous zone of disturbed lateral spread cracks with vertical displacement. Some cracks highlighted by seepage. Observations made from about 150 m above the ground surface during helicopter overflight. Lat. 35.806699°, Lon. -117.636770°. Photo 1268 credit M. DeFrisco, CGS.

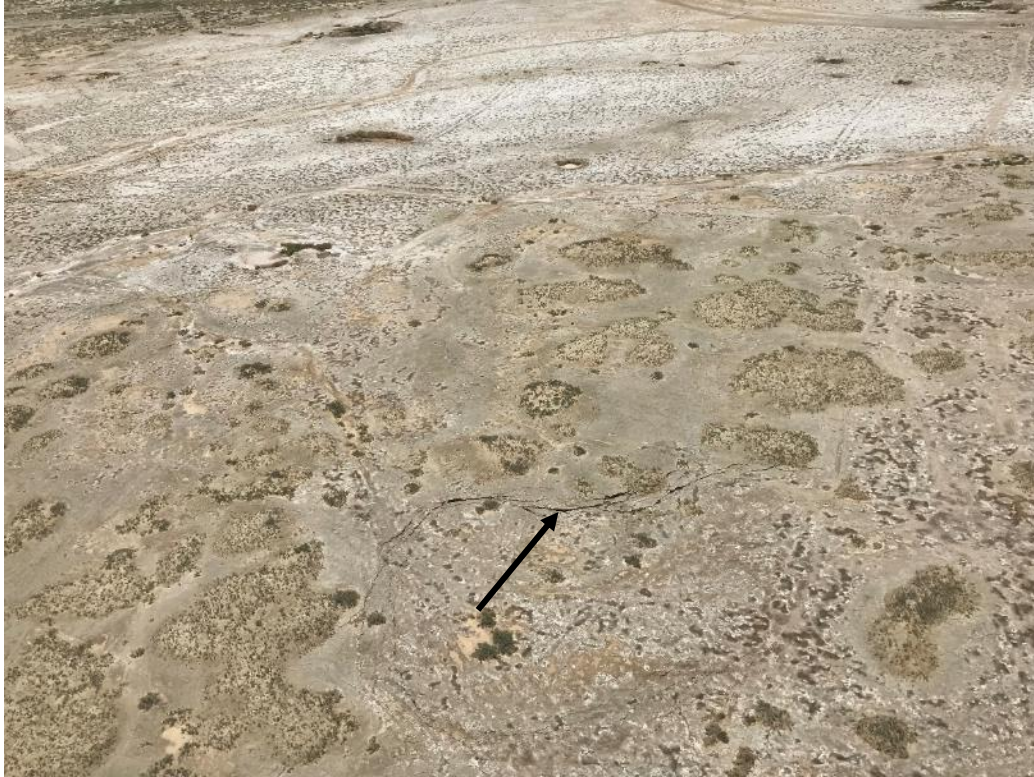
S5	35.810333°	-117.638333°	Lateral spread features – helicopter reconnaissance, post M 7.1, Photo 1294	Lateral spread
NA	35.794489°	-117.615534°	Lateral spread zone, post M 7.1, no photo	Lateral spread
S6	35.801238°	-117.617693°	Large spring along edge of playa, post M 7.1, Photo 2029	Spring
NA	35.77653°	-117.6276°	Pre-existing ephemeral feature that experienced renewed activity from M 7.1 based on review of Google Earth series of historical imagery	Spring

Figure S5. Lateral spread features in the Paxton Ranch area on 7/6/2019. Curved, discontinuous zone of disturbed lateral spread cracks in foreground. Observations made from helicopter overflight. Lat. 35.810333°, Lon. -117.638333°. Photo 1294 credit M. DeFrisco, CGS.

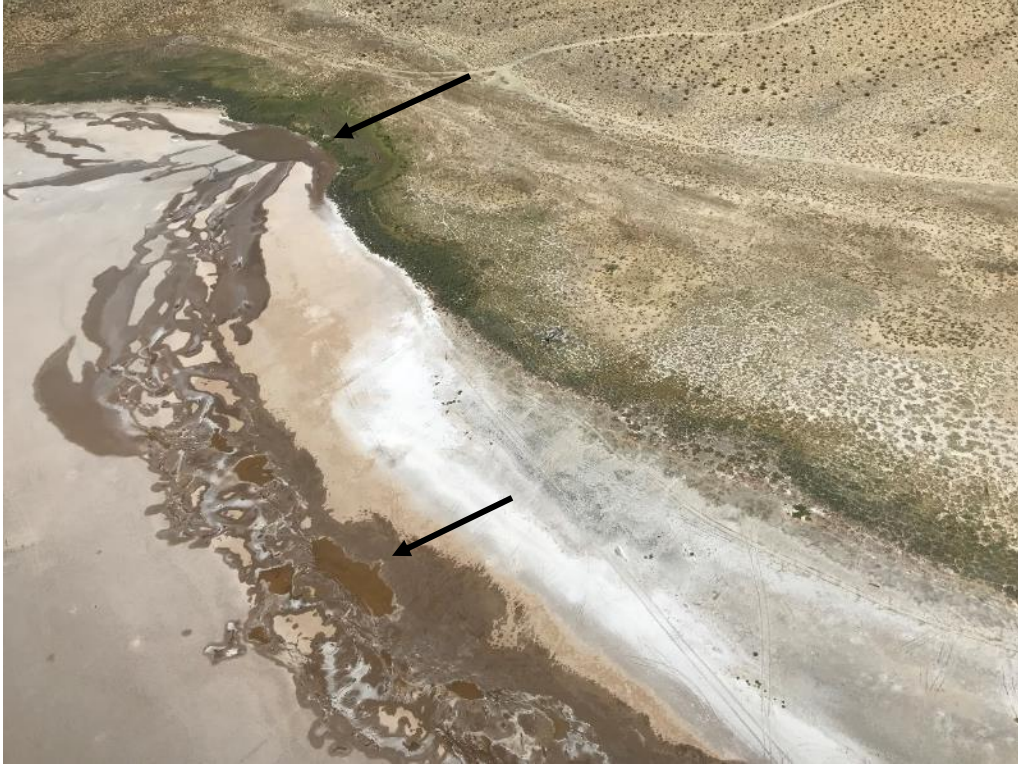
Figure S6. Large spring adjacent to edge of playa. Seepage generated from strong shaking in the Paxton Ranch area on 7/6/2019. Observations made from helicopter overflight. Lat. 35.801238°, Lon. -117.617693°. Photo 2029 credit M. DeFrisco, CGS.

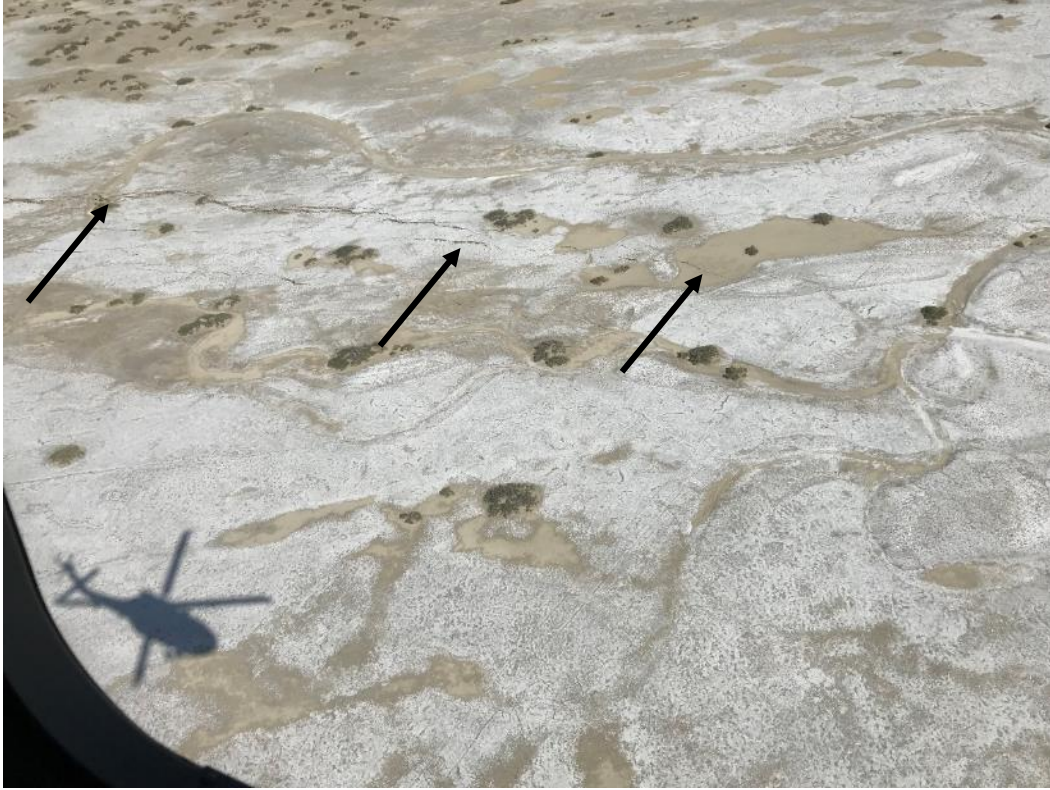
Figure S7. Lateral spread in the Central area - Southeast end of China Lake on 7/6/2019. Discontinuous distributed lateral spread cracks. Ponded water collected in ephemeral drainages across playa. Observations made from helicopter overflight. Lat. 35.730889°, Lon. -117.581806°. Photo 2228 credit M. DeFrisco, CGS.

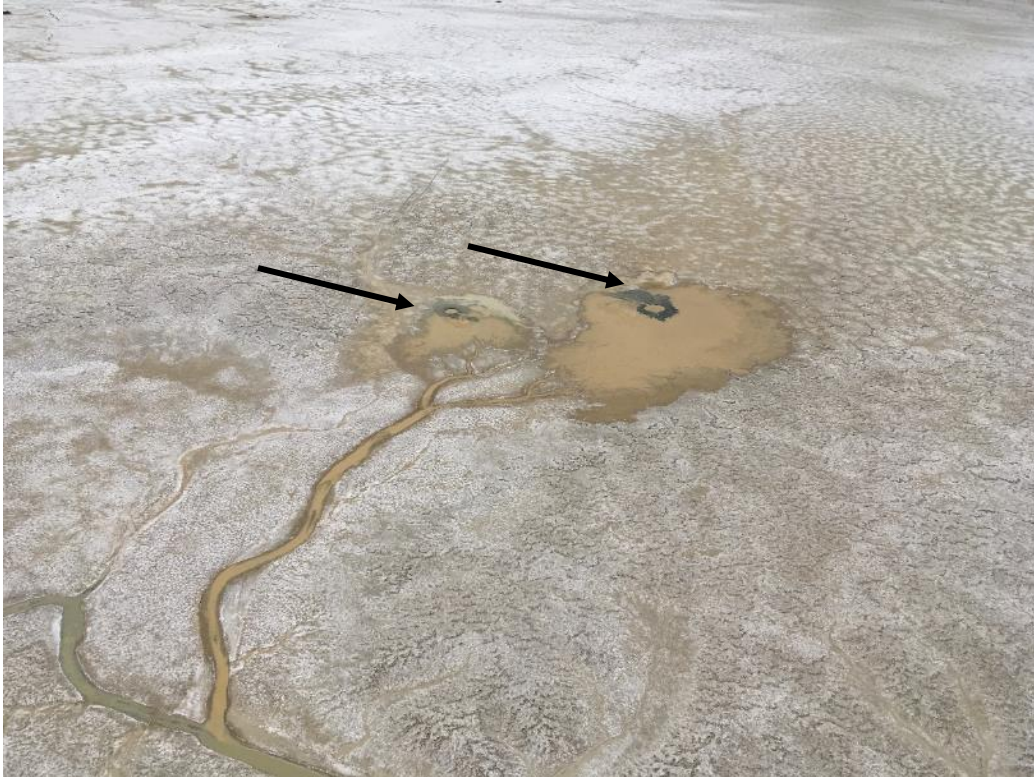
Figure S8. Liquefaction sand boils within Central area - Southeast end of China Lake on 7/6/2019. Smaller sand boil to the left approximately 2 m diameter opening, larger on the right approximately 4 m opening. Lat. 35.733005°, Lon. -117.581745°. Photo 2266 credit J. Hernandez, CGS.

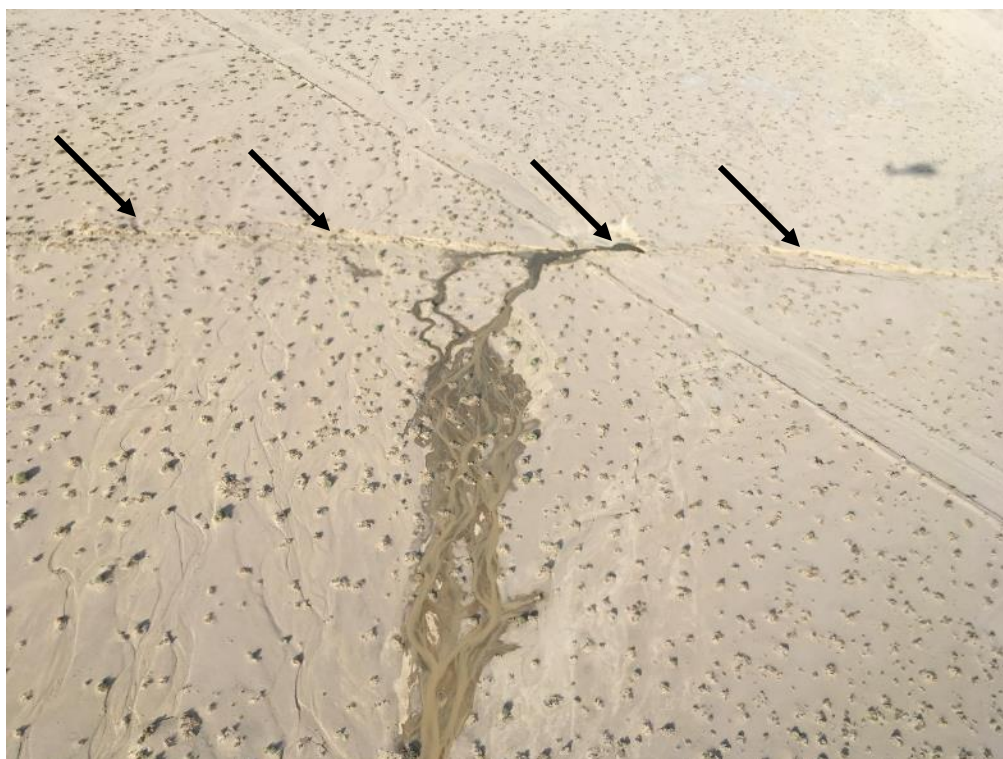
S9	35.725442°	-117.574290°	Ruptured water pipeline, post M 7.1, Photo 1539	Damaged pipeline
NA	35.80666°	-117.6356°	Lateral spread – helicopter reconnaissance, post M 7.1, no photo	Lateral spread
NA	35.80785°	-117.6353°	Lateral spread – helicopter reconnaissance, post M 7.1, no photo	Lateral spread

Figure S9. Ruptured water line Central area - Southeast end of China Lake on 7/6/2019. Rupture generated from surface rupture across pipeline. Lat. 35.725442°, Lon. - 117.574290°. Photo 1539 credit J. Hernandez, CGS.

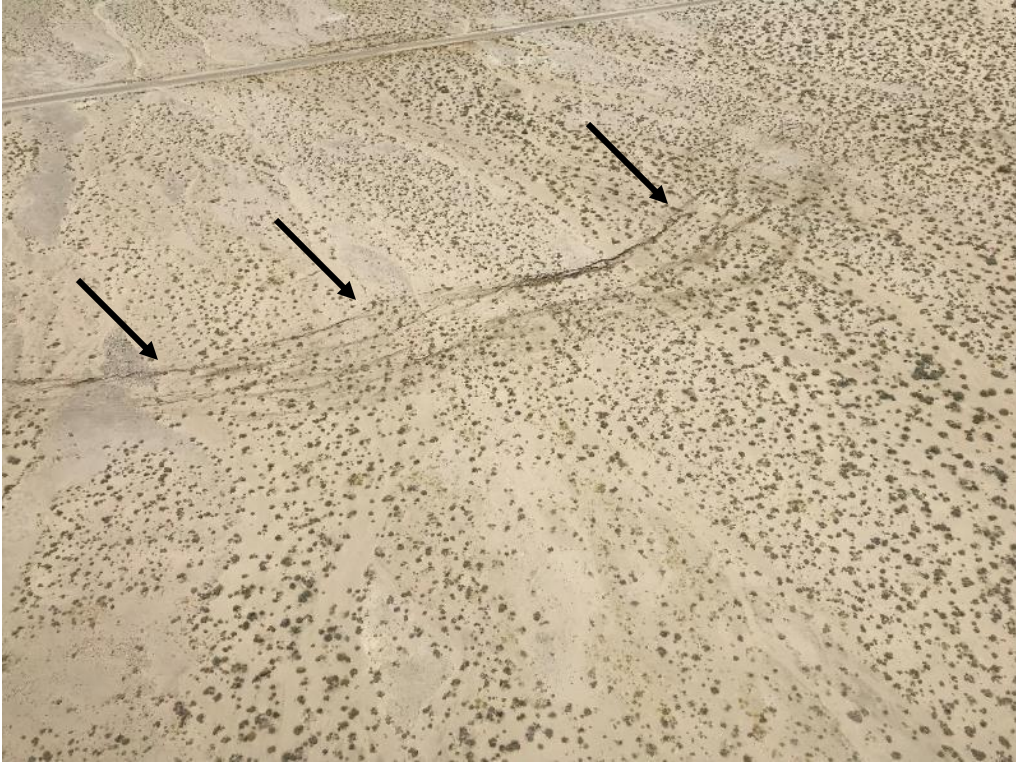
Figure S10. Lateral spread cracks in the Central area - Southeast end of China Lake on 7/6/2019. Cracks near area of detention basin near distal edge of alluvial fan. Lat. 35.724154°, Lon. -117.567795°. Photo 1910 credit M. DeFrisco, CGS.

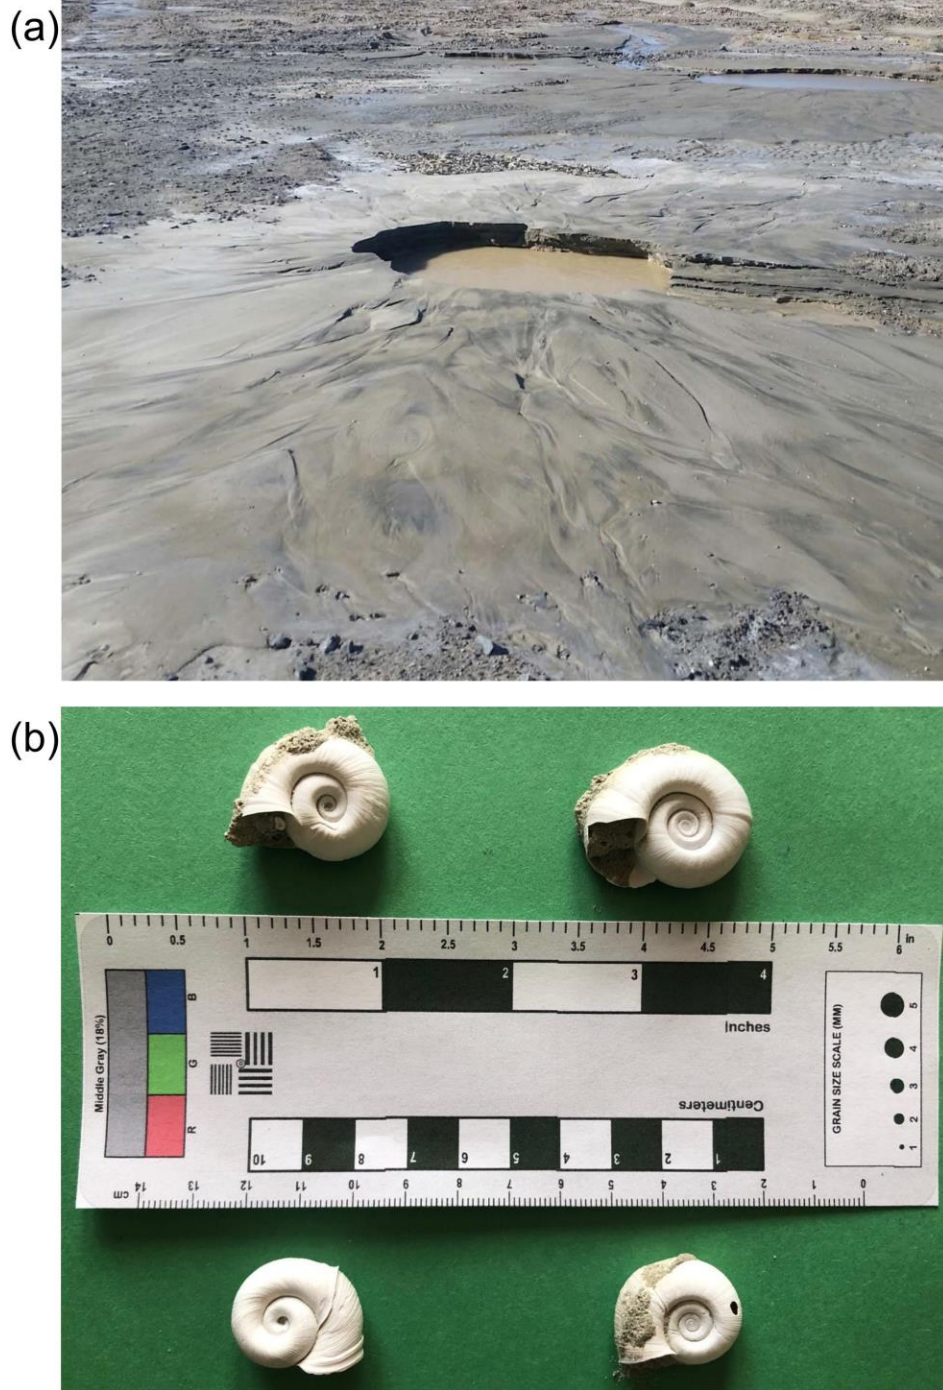
Figure S11. (a) Sand boils on the South-Eastern edge of the China Lake playa, observed after the **M** 7.1 event; (b) fossilized gastropod shells found in the ejecta (bottom portion of Figure S11a, towards the edges of the ejecta). Lat. 35.71504167°, Lon. -117.595000°. Photo 0139 credit US Navy.

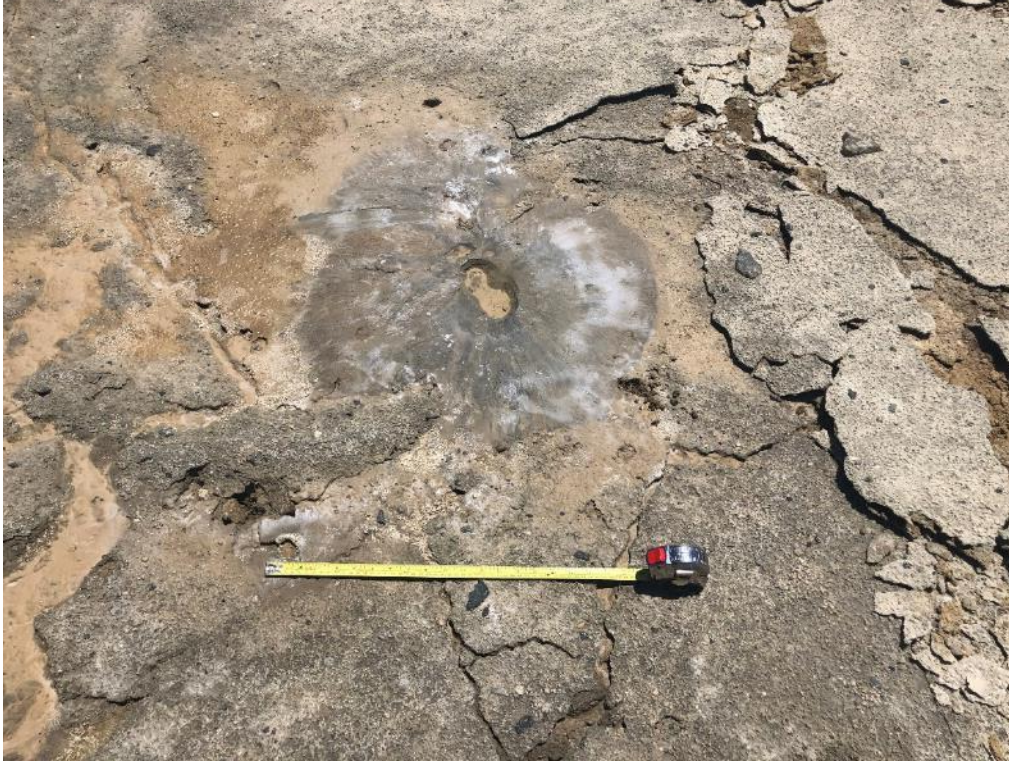
Figure S12. Sand boils within the Salt Wells Valley on 7/12/2019. Area has small sand boils and lateral spread features, located along the **M** 6.5 surface rupture. Extent of sand ejecta approximately 50 cm diameter. Lat. 35.661949°, Lon. -117.520229°. Photo 6795 credit T. Dawson, CGS.

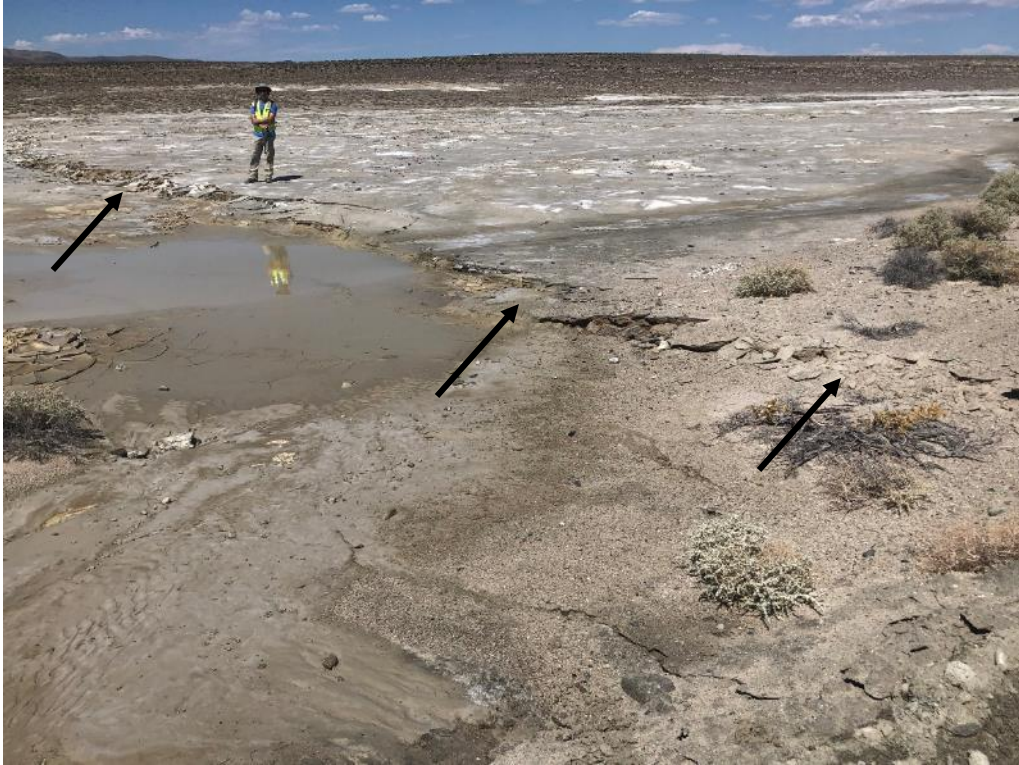
Figure S13. Liquefaction springs along **M** 6.5 surface rupture within Salt Wells Valley on 7/12/2019. Lat. 35.666544°, Lon. -117.515341°. Photo 6801 credit T. Dawson, CGS.

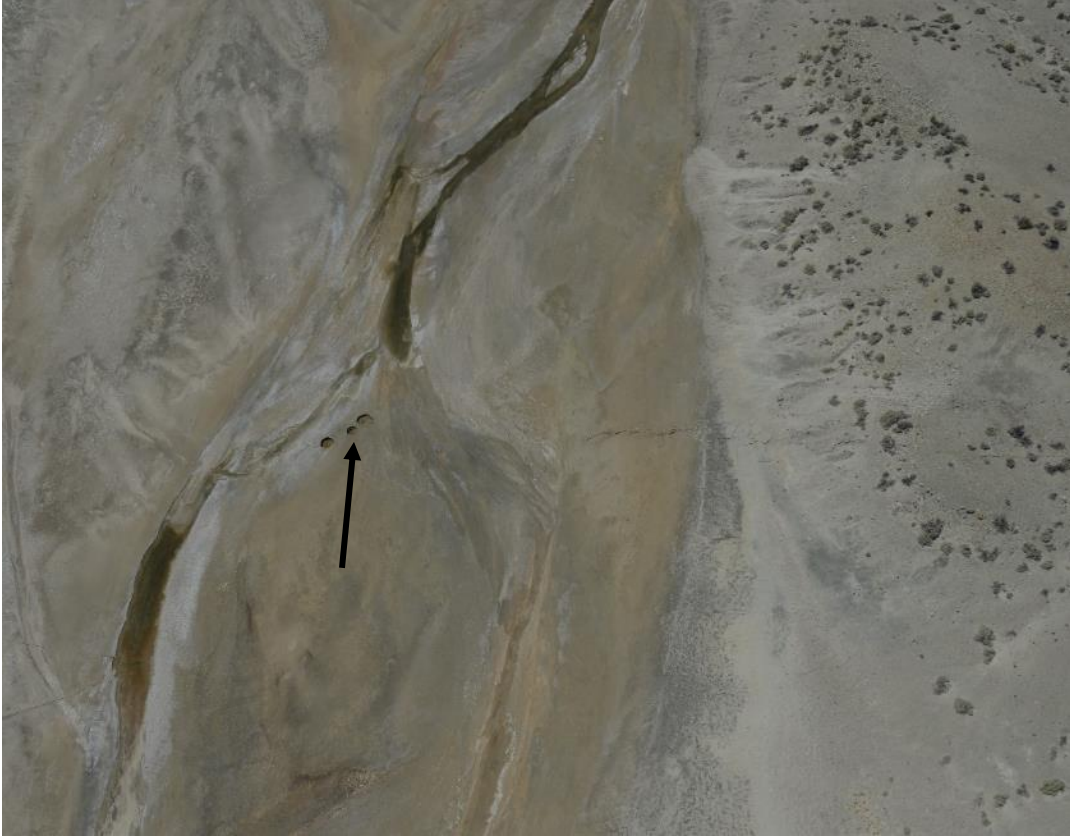
Figure S14. Lateral spread extending into Salt Wells creek, with three circular pits near the center of the frame, generated from **M** 6.5 event. Photo taken 7/5/2019 during overflight observations after **M** 6.5 event. Lat. 35.661797°, Lon. -117.519150°. Photo 0156 credit K. Hudnut, USGS.

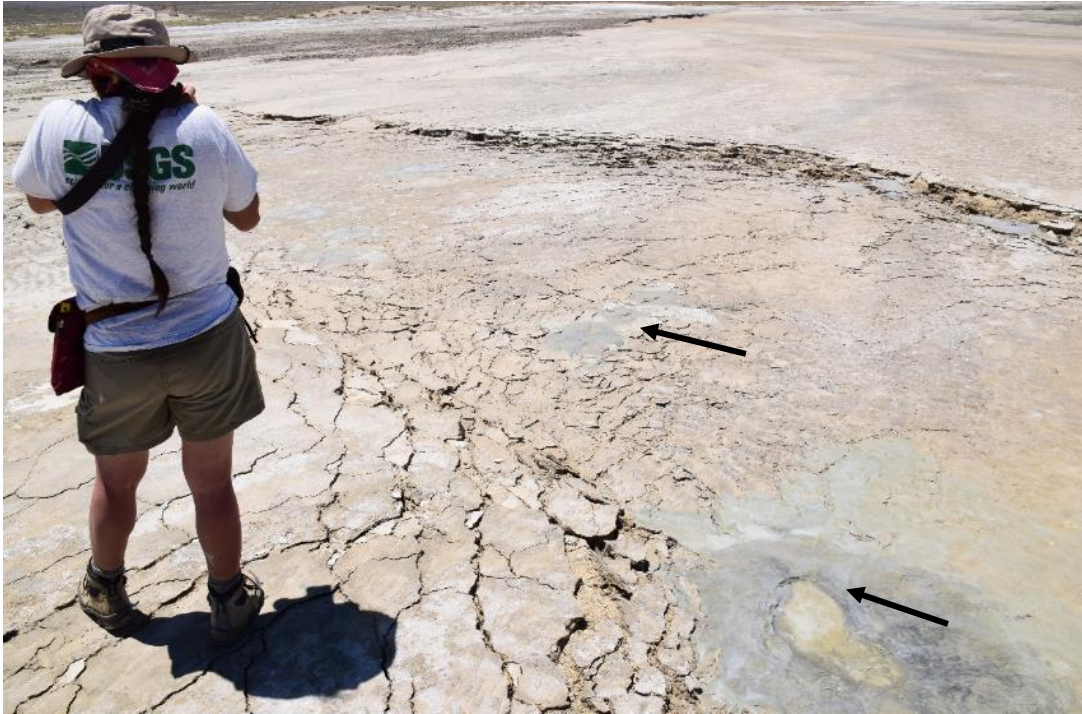
Figure S15. Parallel set of lateral spread cracks and small sand boils within the Salt Wells Valley. Features generated from the **M** 7.1 event. Lat. 35.656551°, Lon. -117.491037°. Photo 0448 credit J. Patton, CGS.

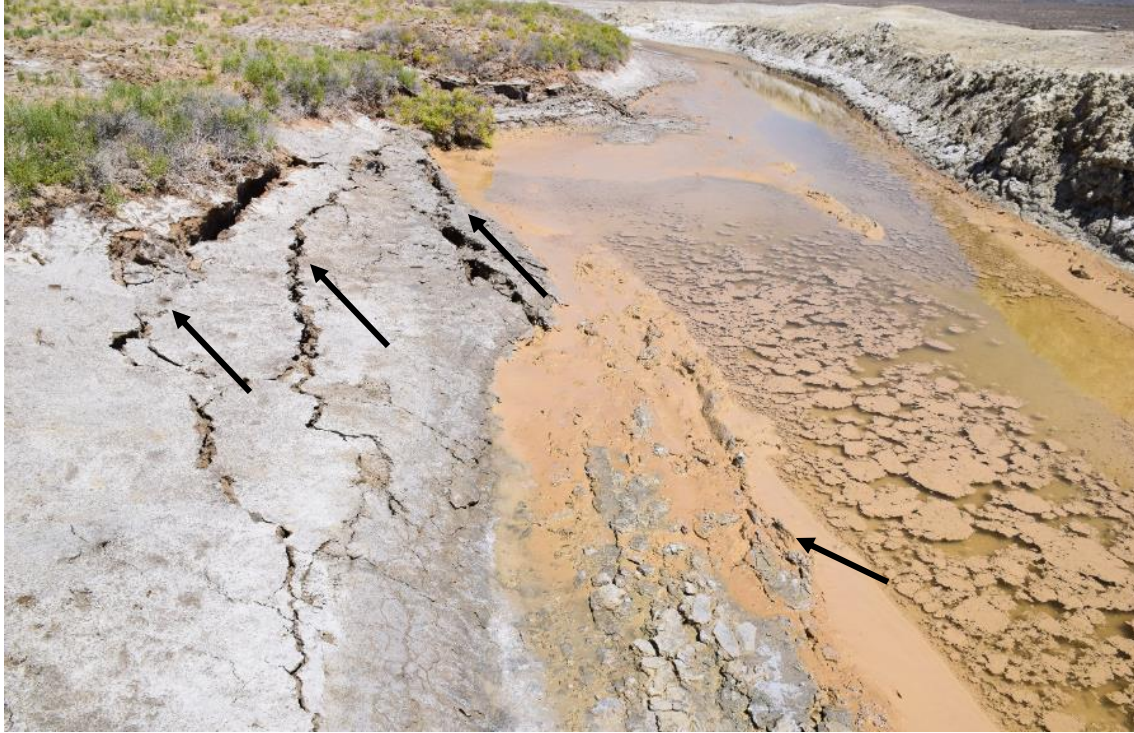
Figure S17. Lateral spread along banks of Salt Wells Valley. Active creek bank free-face failure due to seismic shaking from **M** 7.1 event. Lat. 35.651326°, Lon. -117.485338°. Photo 0408 credit J. Patton, CGS.

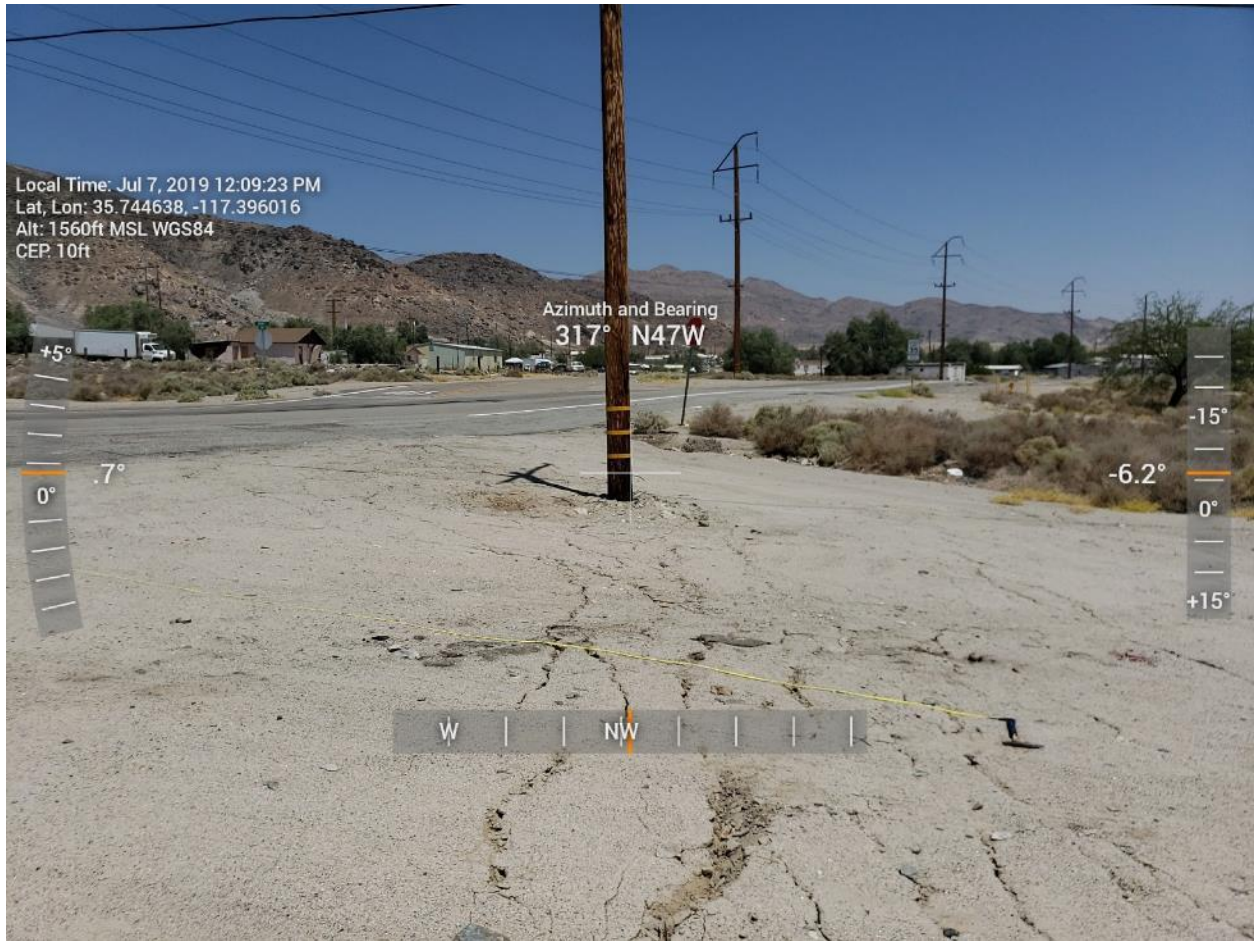
Figure S20. Example Photograph of lateral displacement features along Argus Transect AT1. Lat. 35.744538°, Lon -117.396016°.

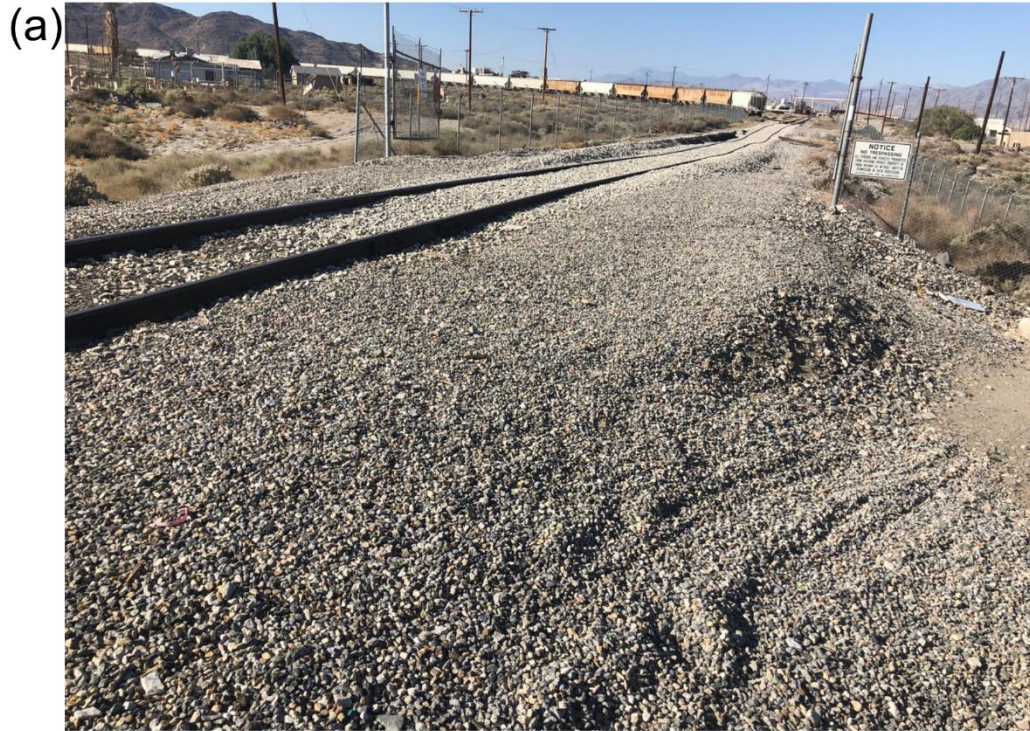
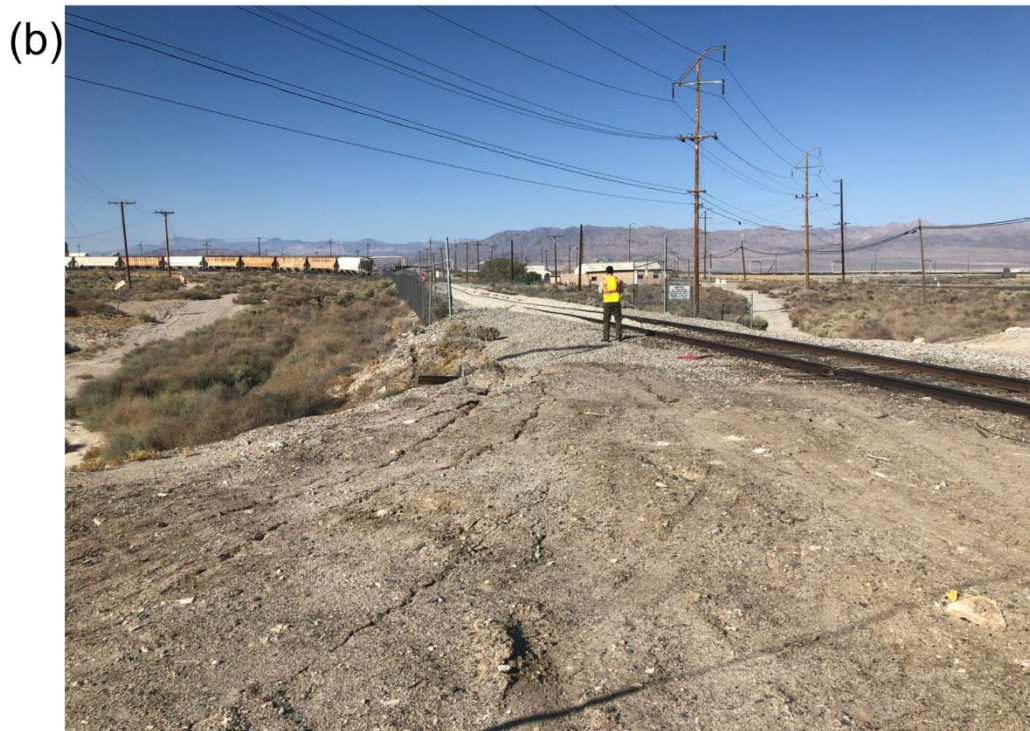
Figure S21 (a, b). Photographs of damaged railroad track area in Argus. Lat. 35.7495°, Lon -117.3903°.
