HAM, MARIE SHARPE. The Renovation and Partial Restoration of the North Carolina Executive Mansion (1974-1976). (1977) Directed by: Dr. Mary Miller. Pp. 213

THE RENOVATION AND PARTIAL RESTORATION
OF THE NORTH CAROLINA
EXECUTIVE MANSION
(1974-1976)

Marie Sharpe Ham

A Thesis Submitted to
the Faculty of the Graduate School at
The University of North Carolina at Greensboro
in Partial Fulfillment
of the Requirements for the Degree
Master of Science in Home Economics

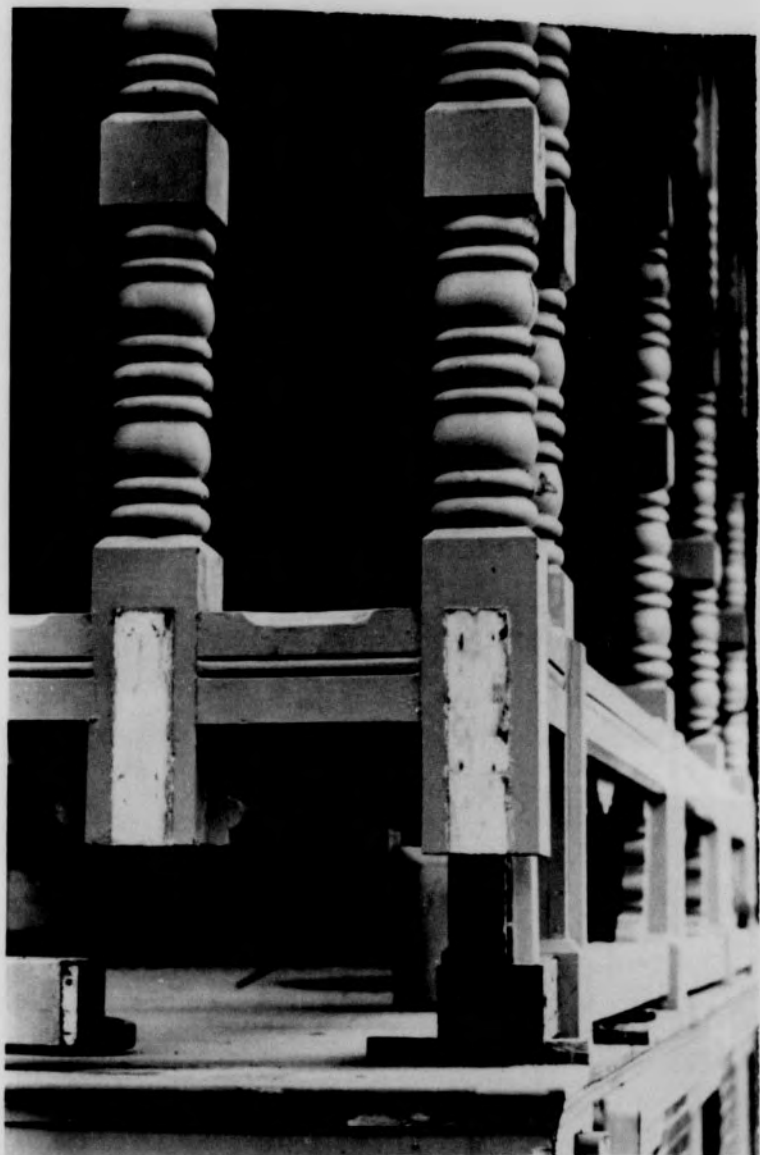
Figure 9. Rotten Wood Cut Out of a Column

The main steamline service pipe, which provided heat and hot water for the residence, entered the Mansion under the South porch. Excessive moisture and steam escaping from the pipe had caused the wood joists and decking to rot.

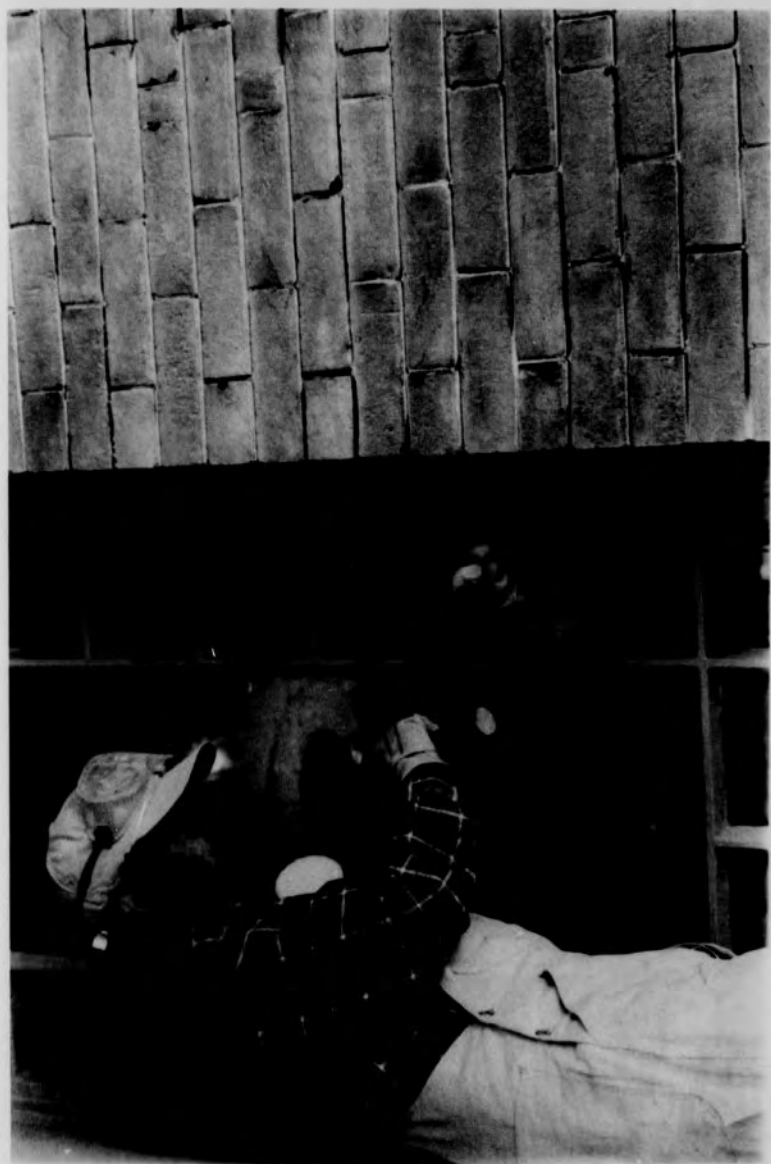
Figure 13. Workman Scraping Masonry Joints in Retuckpointing Process

Chemical and steam cleaning processes were used to remove the accumulated impurities. These processes were preferable to the more common sand blasting treatment because they do not damage the surface of the bricks. Deteriorated bricks were replaced with original bricks salvaged during

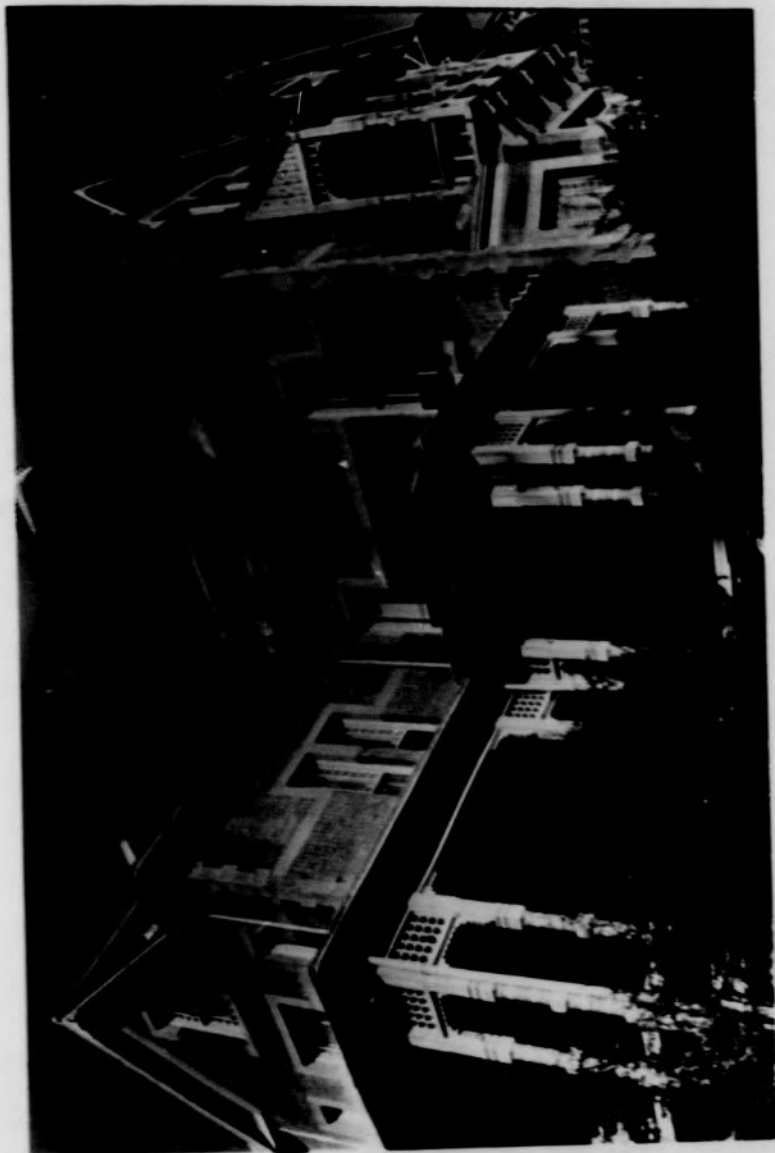
Figure 16. Before View of the Southeast Corner

The only alteration in the exterior facade was the addition of a tower at the Southeast corner (Figures 16, 17). This addition provides a fireproof exit from the second and third floor private family areas to the grounds of the Mansion compound. Prior to this modification, the interior North staircase and the elevator provided the only egress from both floors and the main staircase from the second floor.

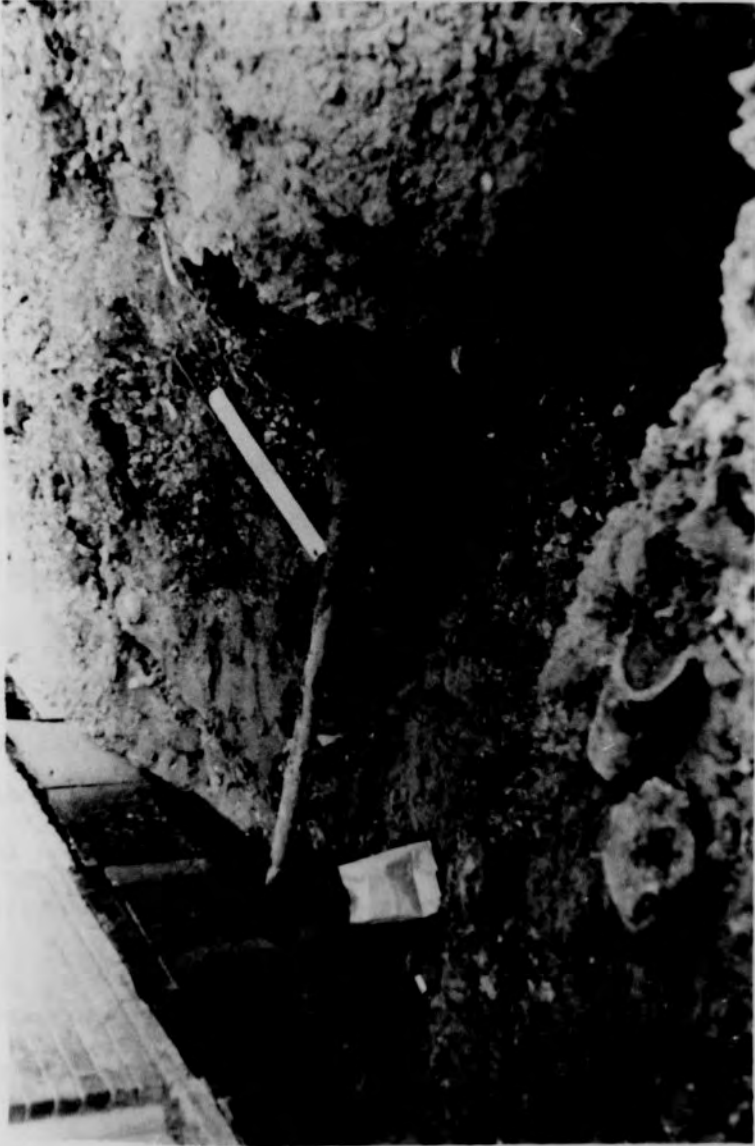
Figure 25. Waterproofing of West Wall and Replacement of Water Main Piping on the Exterior

Water had leaked into the basement through the west or front wall. In order to correct this problem, the soil along the foundation walls was removed and layers of tar and insulated fiberboard were applied to the brick surface. In conjunction with this process, contractors discovered that the main street service pipeline was old, brittle, and

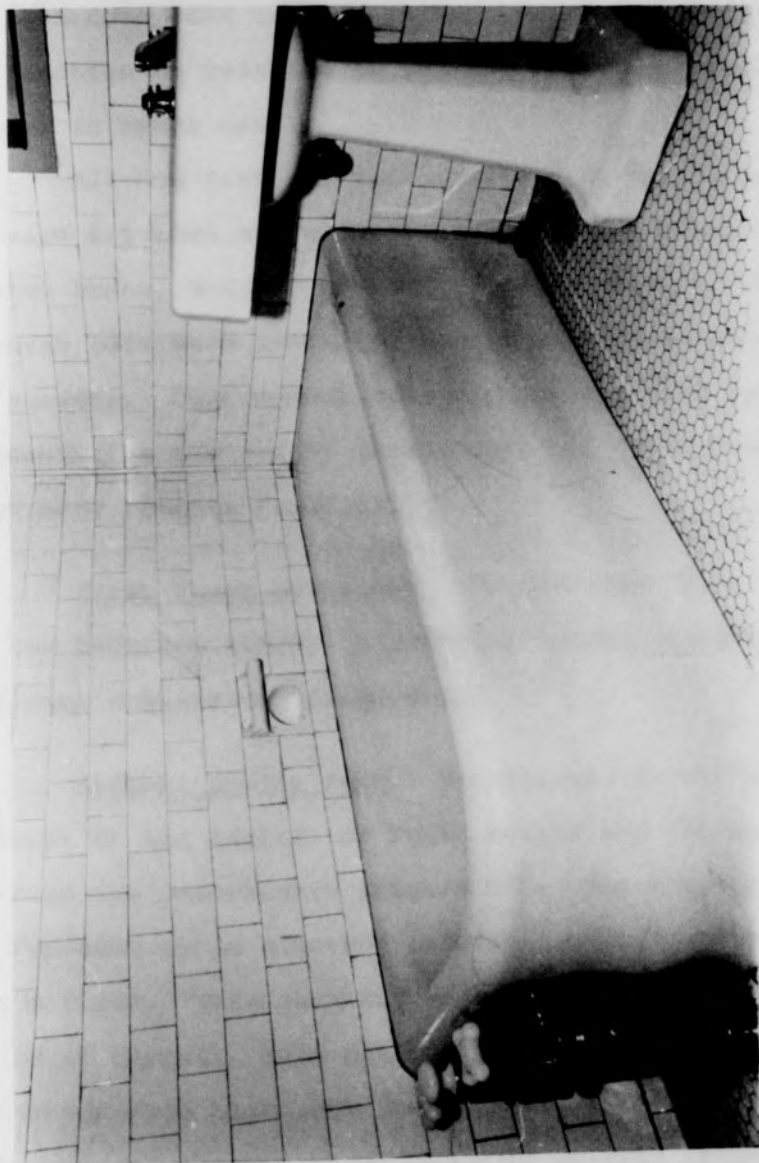
Figure 61. View of an Old Bathroom Showing Tub and Pedestal Lavatory

Twelve bathrooms had occupied space on the four floors. To some degree, these bathrooms had been altered to provide improved space. An institutional approach had persisted with the use of wall-hung lavatories, commercial hardware, and water closets with flushometers. A technique used to vary this look was the specification for gold-plated, exposed waste pipes, where appropriate. The Interior
