Operational Evaluation Test Report on Beaver Micro-Vegetation Cutter

**Operational Evaluation Test Report
on
Micro-Vegetation Cutter**

March 2005

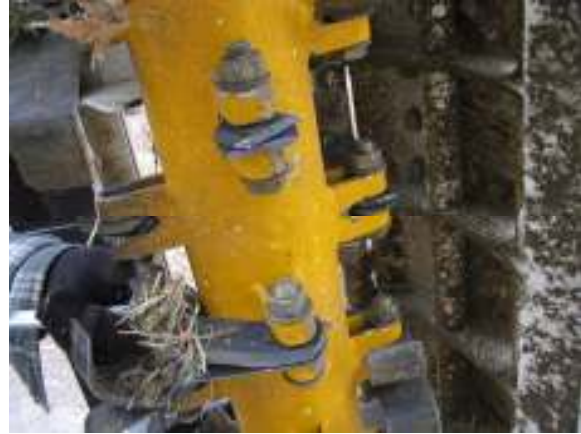
Figure 4: Broken Pre-Test Cutters

- The cutters were notched when they hit the inside bottom edge of the U-shaped cutter mounts. The notch propagated cracks and broke the cutters. The solution was to grind off the sharp shoulder on the U-shaped mount.
- Seven cutters were broken. The time to replace all seven of the cutters was 15 minutes.
- There was a delay between the operator command and the response of the MVC or the cutter. This led to over-control input from the operator. The solution was to adjust the SRCS to shorten the signal-response time.
- The operator had to keep the cutter in the line of sight to know the relation of the cutter to the ground.

- The engine clock for the MVC read 9.8 hours at the start of the day.
- The clearing of the slope continued. During the clearing process, eight cutters broke and one cutter cracked. This issue was resolved by replacing the damaged cutters with new cutters.

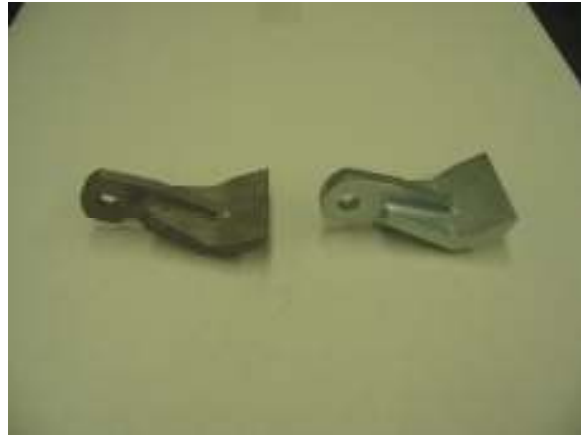
Figure 6: Machined and Cast Operational Evaluation Cutters

operational evaluation test (wt. = 634 grams); and Figure 6 shows the machined cutter (left) and the 4130 heat-treated cast alloy cutter (right) that will be used on future fabricated vegetation cutters (wt. = 756 grams). The weights and materials are shown for each of the cutters as an indicator of each cutter's strength and durability.

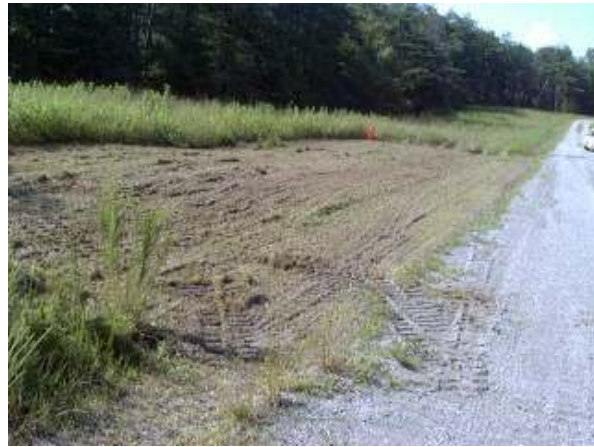
Figure 12: Completed Cutting

The second Category 1 vegetation cut was conducted in a level field bordered by a gravel road. For this cut, the procedure was to cut for 1 hour and then calculate the area that was cut. The cutting front, running parallel to the road, was 25.2 meters long. Cutting started with the Beaver on the road with the boom at 90 degrees to the road. The initial cutting pass was adjacent and parallel to the road, from right to left. At the end of the pass, the Beaver backed up to the starting point on the right hand side and made the second pass. The maximum boom extension allowed for three passes before the Beaver had to be moved into the area just cut. See Figure 11. (In an operational situation, the area cut would be searched for mines before the Beaver would be allowed to continue cutting from the previously cut area.) At the end of the hour, a measurement was taken of the area cut. The length of the area was 25.2 meters. The depth was 7.7 meters on the right side, 8.4 meters on the left side, for an average depth of 8.05 meters. See Figure 12.

The area of the second Category 1 vegetation cut was 202.9 m² in 1 hour.

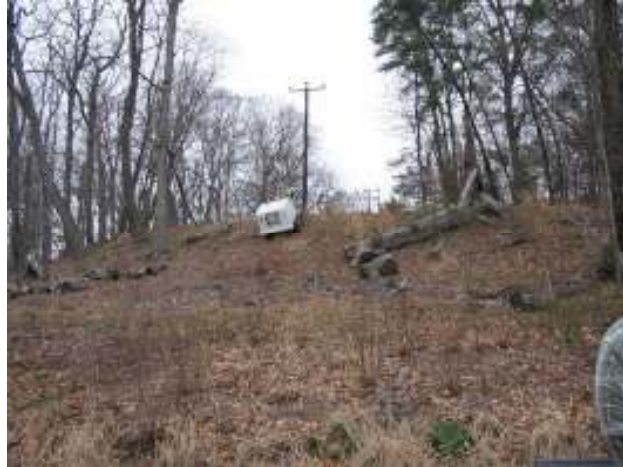
Figure 20: Off-Road Mobility

The off-road mobility test for the Beaver was conducted in three different areas in order to provide a satisfactory range of terrain environments. See Figure 20. One was a watershed track through a hilly, wooded expanse of the military reservation housing the test site. The most critical parts of the test were the ingress and egress. Once into the track, which was rough and gullied from rainwater runoff, neither the Beaver nor the Duck vehicles encountered any operating problems. The maximum slope encountered by the Beaver in entering and departing the run-off gully, which consisted of a mix of raw clay and sand, did not exceed 27 degrees. On a vegetation and mulch-covered slope, the Beaver climbed and descended slopes up to 32.5 degrees. During the vegetation cutting on a hillside, the maximum side slope traversed by the Beaver was 24.5 degrees.

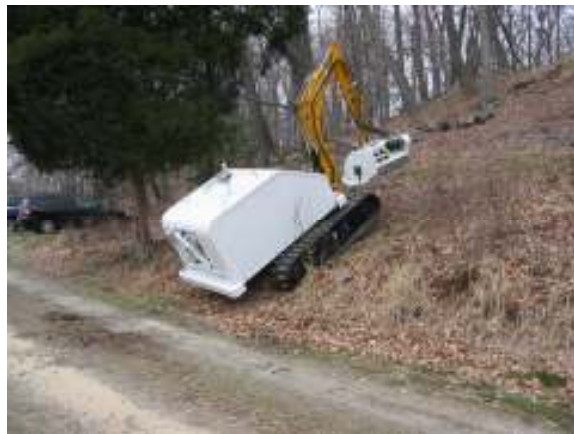
Figure 21: Angle of Approach/Departure

This test was only conducted with the Beaver. The surface cover for the slope climbed was loose soil and gravel intermittently covered with leaf mulch, sparse grass, and low shrubs. The approach and departure angle negotiated, without losing traction, was 32.5 degrees. The Beaver continued to climb the hill, with subsequent grades up to 28 degrees, to a height of about 60 feet without any problems. See Figure 21.

- Hydraulic reservoir filler cap leaked oil in angle of approach and departure test. It is recommended that a redesign be considered.
- The gap at the top of the Duck's front windscreen allows dust to blow in and into the operator's face.
