# The Construction and Impacts of a Groin Lengthening Project at a Southeast US Beach

S. Traynum, T. Kana & H. Kaczowski

Coastal Science & Engineering, Columbia, South Carolina, USA

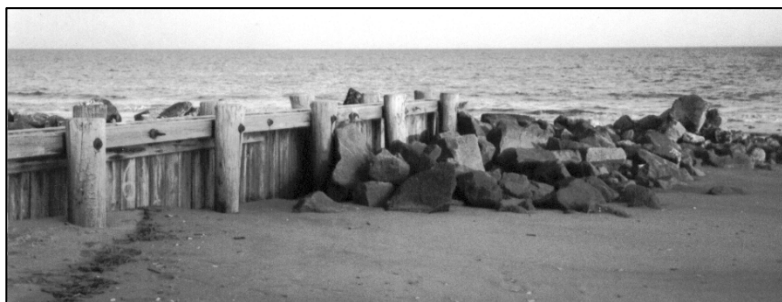
During the next decade, 17 groins were built from north to south in an attempt to halt the loss of sand, or at least to slow its southerly movement. However, erosion continued downcoast of the structures as each group of groins was built, sometimes to “The Point” where houses were washed out (CSE 2001). This prompted construction of more groins up to 1975 (Table 1). Groin 34 (the last one built) is situated along the South Edisto River Inlet shoreline about 1,000 m from Big Bay Creek. Groin 1-27 were constructed of timber sheets and piles, followed by additions of armor stone once the seawards ends of the timber deteriorated. Over time, the armor stone was displaced by settlement and wave impacts, and a project was completed in 1995 to restack the groins and add concrete to the void spaces to solidify the structures. The stones were placed to improve the seaward slope of the structures in an attempt to match the natural beach slope; however, the lengths of the structures were too short to reach the low-tide elevation (Fig 3).

Fig. 3. Example of damaged timber/stone groin prior to 1995 rehabilitation project.

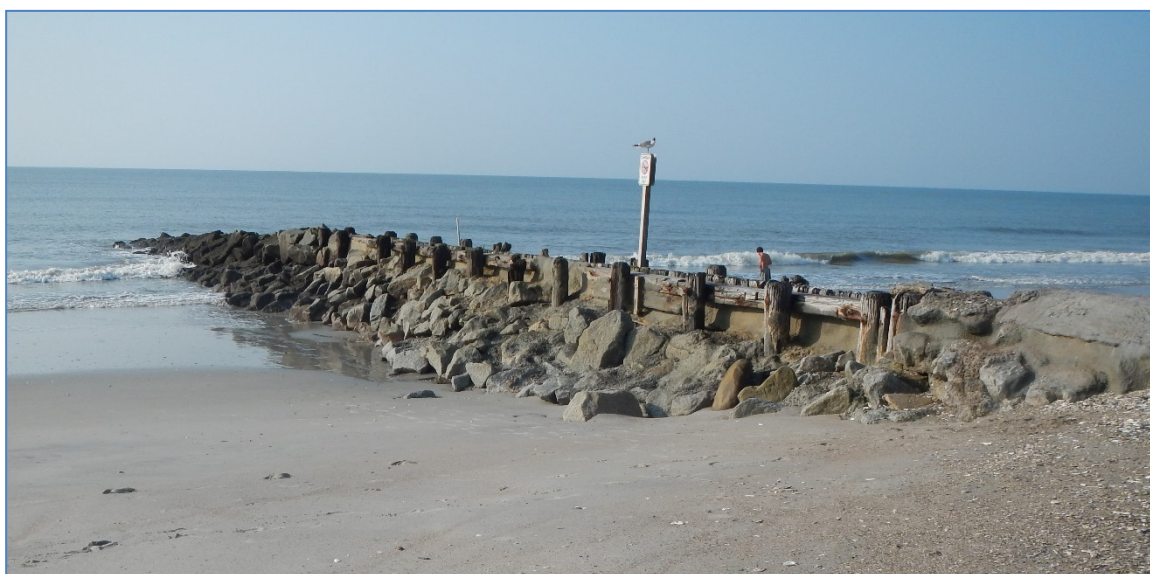
Beach volume analysis showed that following a period of rapid erosion along the northern end of the groin field, the beach volume would stabilize at a similar condition as the pre-project volume. This suggest that the groins were effective at trapping a certain quantity of sand; however, an insufficient quantity to provide suitable protection for ocean-front structures. The authors theorized that the length of the groins along the northern end of the groin field were shorter than required to hold the desired beach width, and were also shorter than areas of the beach historically maintaining a stable dune (Fig 4).

Fig. 4. Typical groin condition prior to the 2017 extension project.

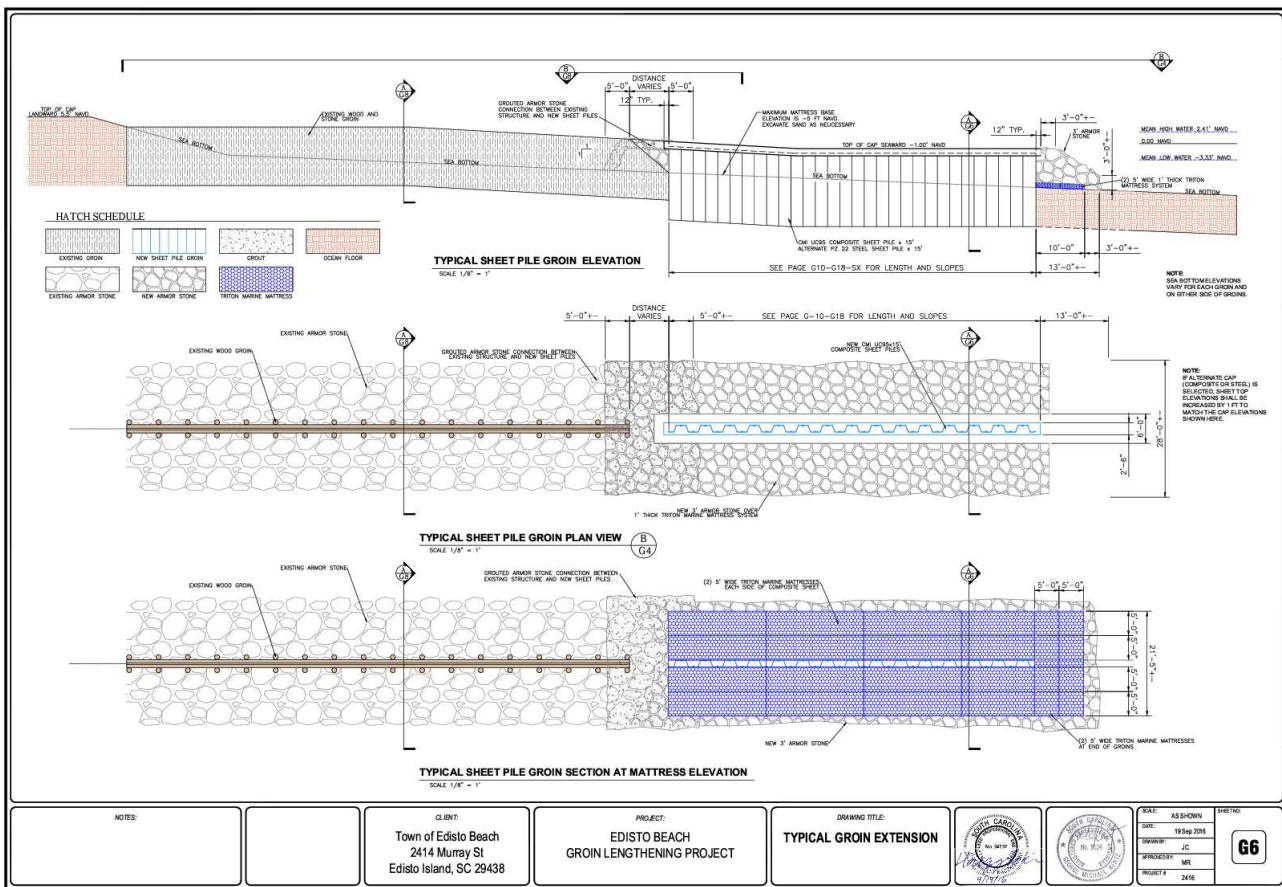
Fig. 6. Groin extension design including marine mattress, armor stone scour protection, and fiberglass/vinyl composite sheet piles.

Sheet piles were capped with a reinforced poured concrete cap. The design called for a 76 cm-wide by 46 cm -deep cap to cover at least the top 15 cm of each sheet. Concrete would be poured in sections up to 12 m in length with expansion joints between sections. Six lengths of rebar ran the length of the cap, and stirrups were spaced 76 cm on center and running through handling holes of the sheets. The top of the concrete cap was crowned to improve water runoff.

South Carolina Department of Transportation (SCDOT) Class F armor stone would serve as scour protection for sheet-pile groins and would serve as the main sand-trapping component of the shorter groins when coupled with grout. Class F stone includes 100% smaller than 1.10 m (1,814 kg), 50% smaller than 0.87 m (907 kg), and 5% smaller than 0.67 m (453 kg). The stone design included a 1 m crest width extending on either side of the cap and a slope extending a total of 4 m on either side of the sheets. With a relatively low freeboard height and large stone sizes, the slope would be fairly insignificant along most of the stone width. Stone would also extend 4 m past the seaward end of the sheet pile in a similar configuration.

The design called for armor stone to be placed on 30 cm-thick marine mattresses manufactured by Tensar®. Marine mattresses were utilized to facilitate proper placement of the bedding stone when working below the low-tide line, as previous projects using filter cloth and loose stone proved difficult to complete working around the ~2m tide range. The mattresses are made of a heavy-duty plastic grid woven together with UV-resistant polypropylene. Mattresses would be filled with granite stone between 5-15 cm diameter. Each mattress section is 1.5 m wide and of a variable length.

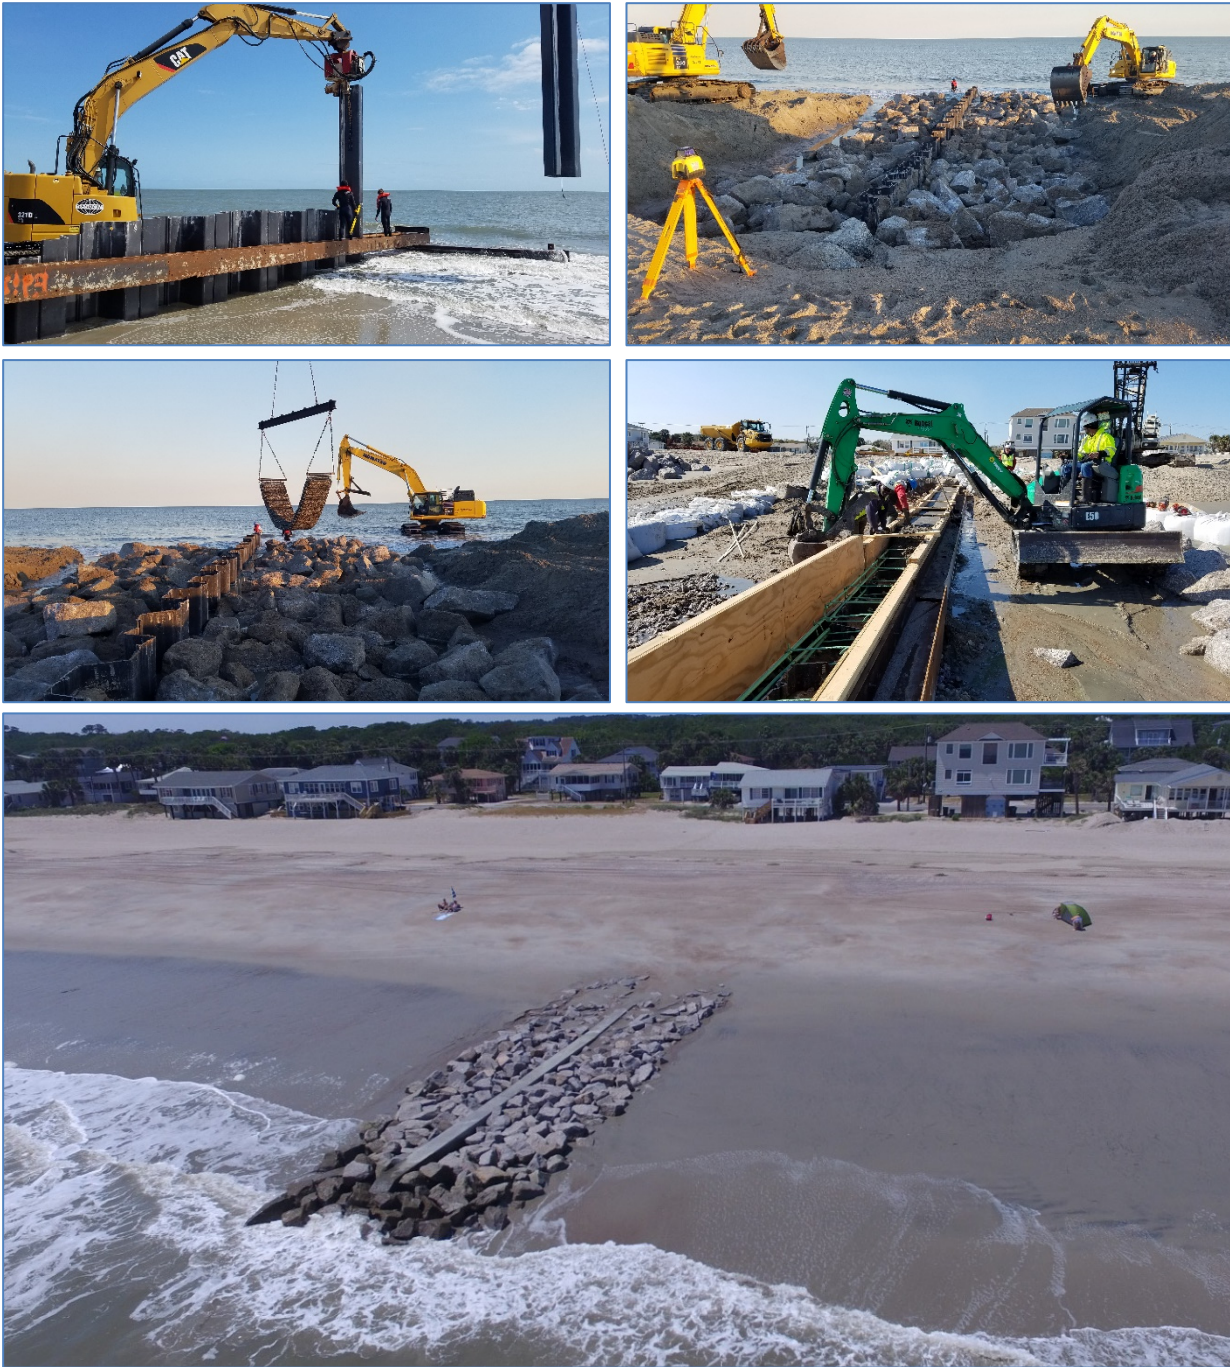
Fig. 7. Photos of groin extension construction showing driving of sheets, placement of marine mattresses and armor stone, forming of concrete cap, and a completed extension.

For the sheet pile groins, the contractor elected to begin at the landward end of the extension and initially used a moveable platform as a guide to drive the sheets; however, they quickly determined that a more robust template would be required to accurately drive the sheets (Fig 7). The contractor constructed a new form out of I-beams that would surround the sheet piles on two sides as they were being driven. The first sheets were driven using the excavator, which proved to be difficult with the composite sheets, as any variation from vertical would result in cracking of the top of the sheet. They switched the vibratory hammer to the crane, and sheet driving improved. The workers would drive a series of sheets until they reached the end of the template, and then would shift the template seaward. Once all of the sheets were driven to an elevation near mean sea level, the operators would drive the sheets to the final grade, checking elevations with a rod and level.

Following installation of the sheet pile, the contractor placed mattresses and a portion of the armor stone alongside the sheets. Once the armor stone was at an elevation near the bottom of the concrete cap design, workers placed forms around the tops of the sheets in preparation for pouring the concrete caps. Concrete pours needed to occur during periods of lower-than-average tides and very calm weather to prevent the concrete from washing away before it could cure. Once the concrete was poured, workers shaped a crown on the surface and the forms were left in place for at least 24 hours to allow the concrete to cure. Once the concrete was cured and the forms were removed, the contractor added additional armor stone to bring the section to the design grade. At that point, the groin extension was complete. Generally, multiple groin extensions were being constructed at any given time.

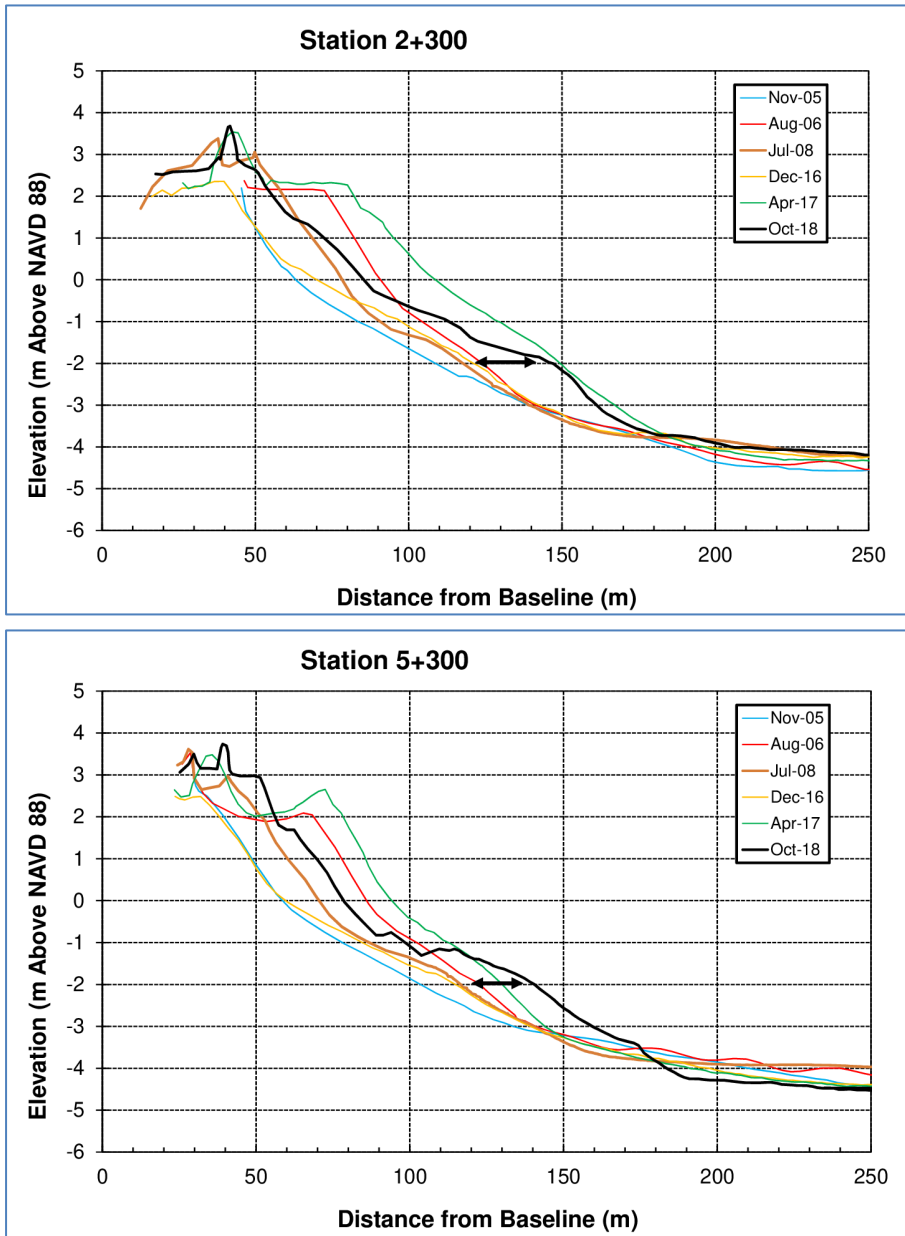
Fig 8 shows beach profiles from the northern end of the groin field from before and after the 2006 and 2017 projects. Each plot includes before and after project profiles, as well as a profile from 1.5-2 years after each project. At each station, the profiles from the 2006 project show that the shallow inshore zone (-2 to -4 m) was eroded to near the pre-project condition by 2008. For the 2017 project (including the groin lengthening), the lower portion of the profile maintained sand, with the -2 m contour ~25 m seaward compared to the earlier project. This compares well with the ~27-30 m groin extension length for the groins extended in this area. The groin extensions in this area were placed at an elevation of -.3 m relative to NAVD, which should have more of a direct impact on the lower beach profile. The goal of the extension was to stabilize the foundation of the profile while reducing the exposure of the groins.

While these results are promising, the authors acknowledge that additional surveys in the future will be necessary to determine if these trends hold over time, or if the sand in the lower profile is a function of recent storm events and overfilling of the trapping capacity. Compared to the previous project, the percentage of nourishment fill remaining in the 2017 project is improved along most of the groin compartments in the northern end of the project area (which was the most erosional area) compared to similar post-project surveys following the 2006 project. The vertical exposure of the groins appears to have improved as well, with typical heights of 1 m exposed in 2018, compared to up to 2.5 m prior to the project.

Fig. 8. Beach profiles from pre-, post-, and ~1 year post 2006 and 2017 project conditions at Edisto Beach. Groin extensions ~27m in length were included in these areas in the 2017 project which appear to be holding the lower portion of the beach profile further seaward than the 2006 project.
