MODEL STUDY
OF THE
CATLIN DIVERSION DAM
CANAL INLET

R. M. Haynie
and
S. S. Karaki

Tipton and Kalmbach, Inc.
Denver, Colorado

November 1962

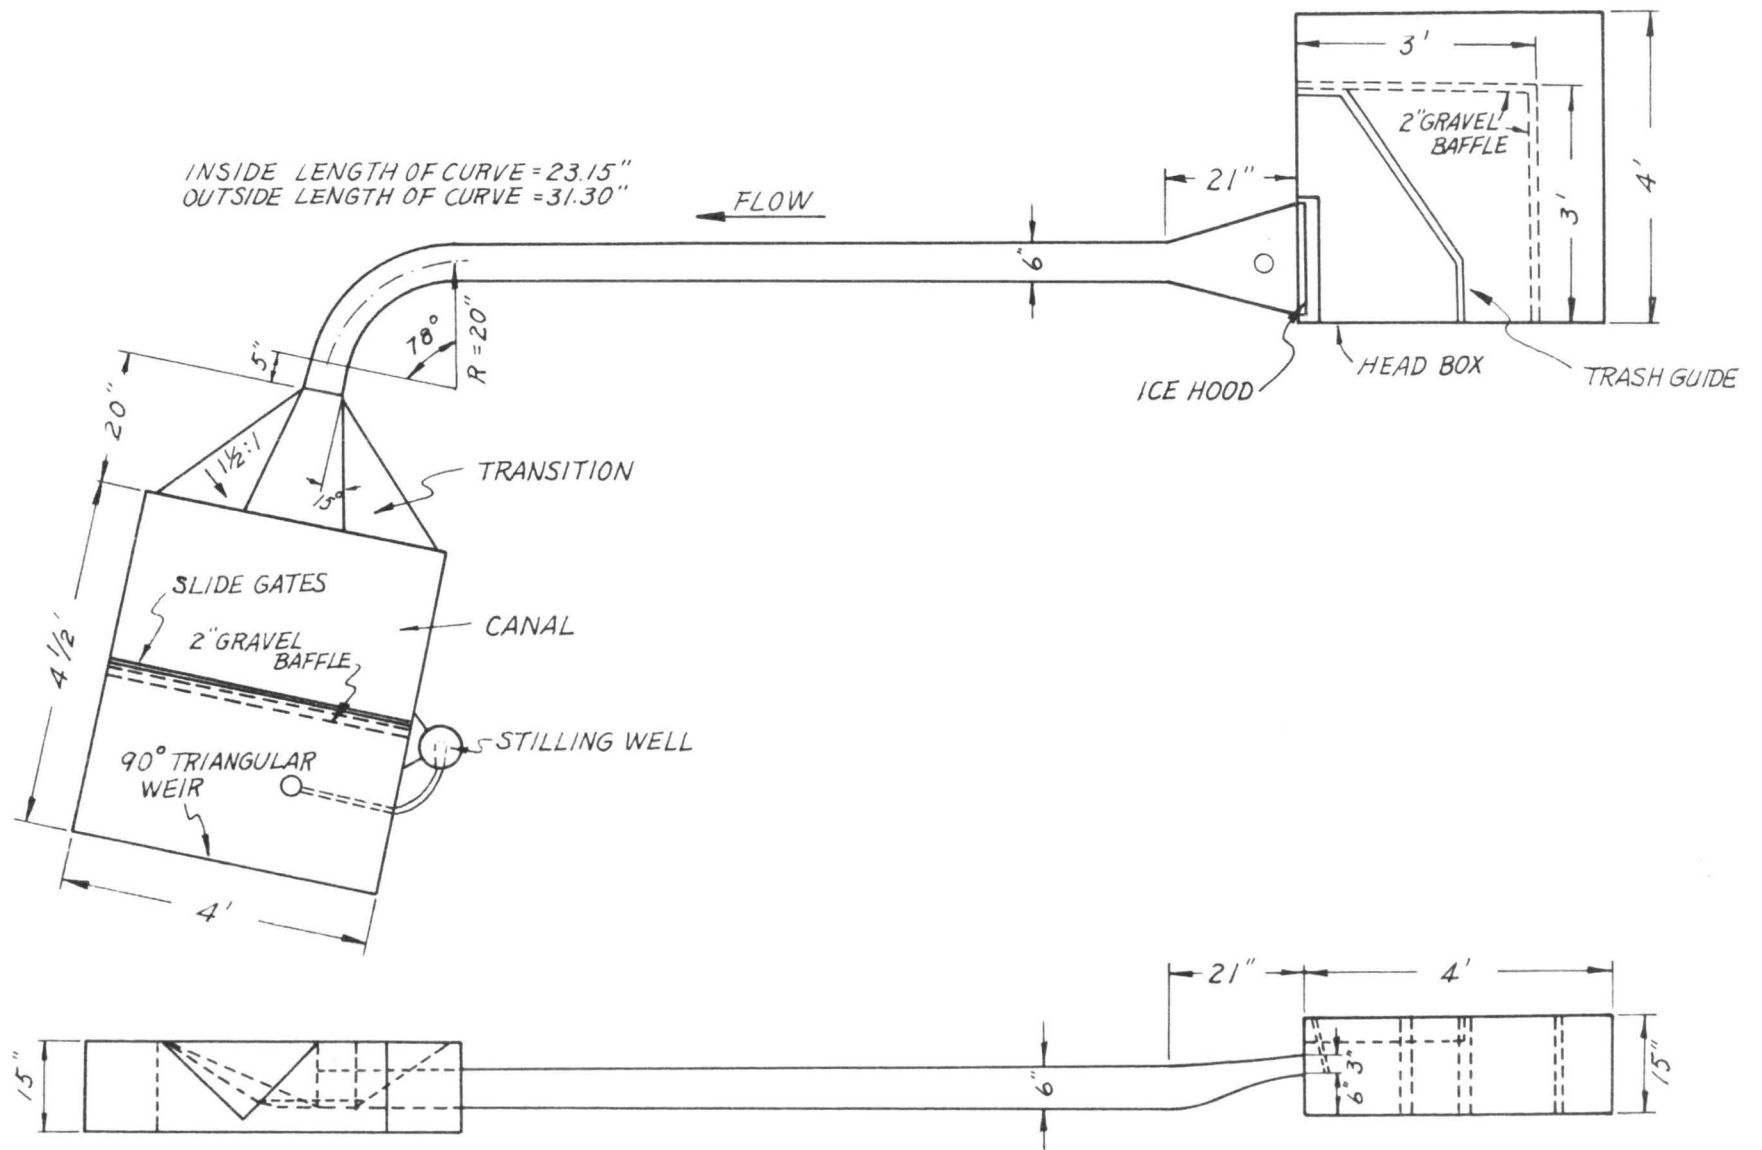
FIG. 1 MODEL OF CATLIN CANAL

The model was limited to the intake structure, the outlet conduit and the outlet transition which leads into the canal (see fig. 1). The sluice gates were not included. The model was constructed to a scale of 1:12, or one inch in the model was equal to one foot in the prototype.

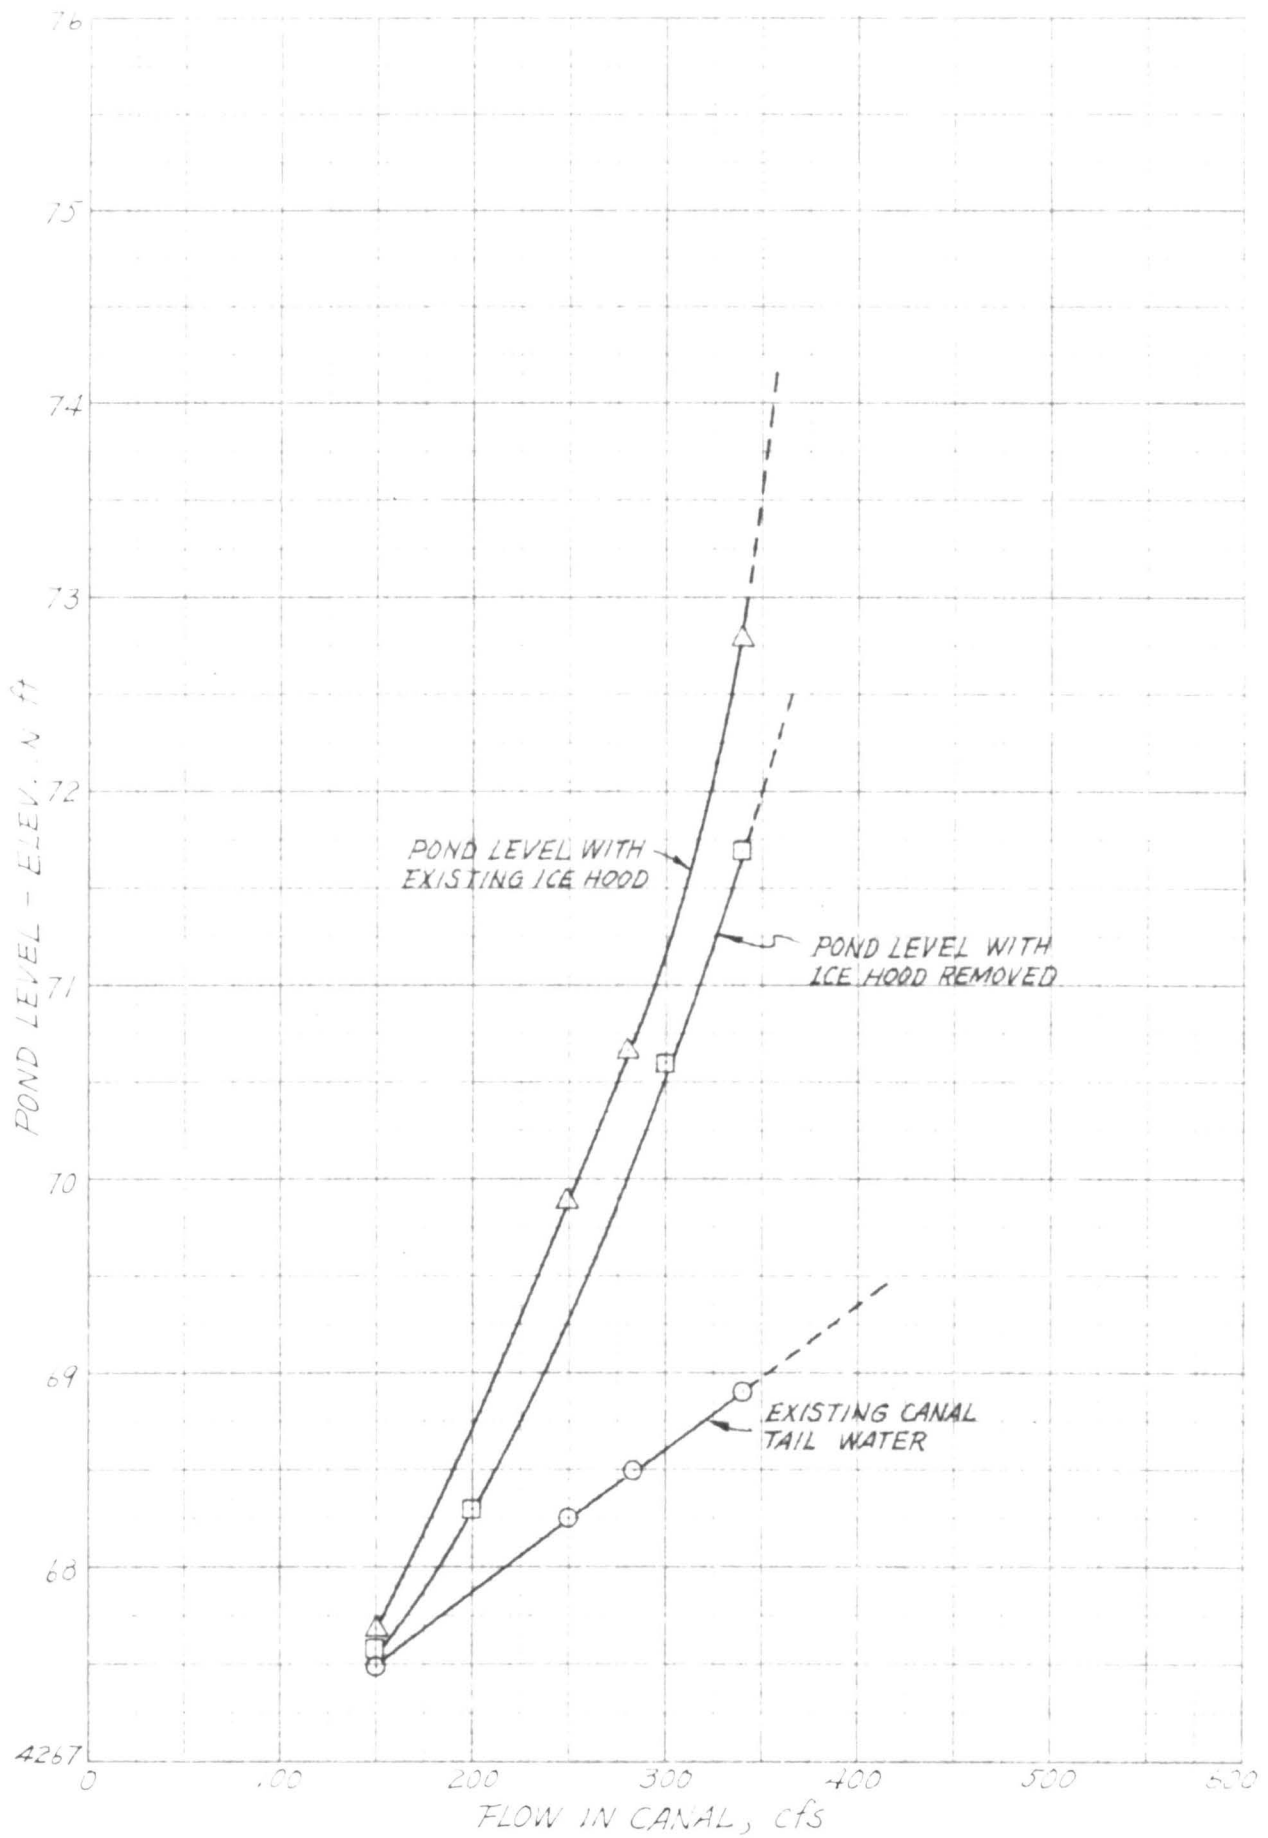
FIG. 2 EXISTING CONDITIONS

Figure 2 shows the water level variations at the pond for different discharges through the inlet. The tail water curve, or canal water level at the outlet transition, was calculated by Tipton and Kalmbach Engineers and used for this study. It signifies existing conditions. As the figure shows, under existing conditions, it would be necessary to increase the pond level to about 4273.5 or greater in order to obtain 350 cfs.

Tests were also conducted to determine to what extent the ice hood was responsible for the reduced discharge. As figure 2 shows, with the ice hood removed, there generally was an increase of about 25 cfs for the same pond level, but even under this condition, the pond level needed to be at about elevation 4272 for 350 cfs to flow into the canal or alternatively, the canal water level should be lowered by about two feet to maintain pond level at elevation 4270.8.

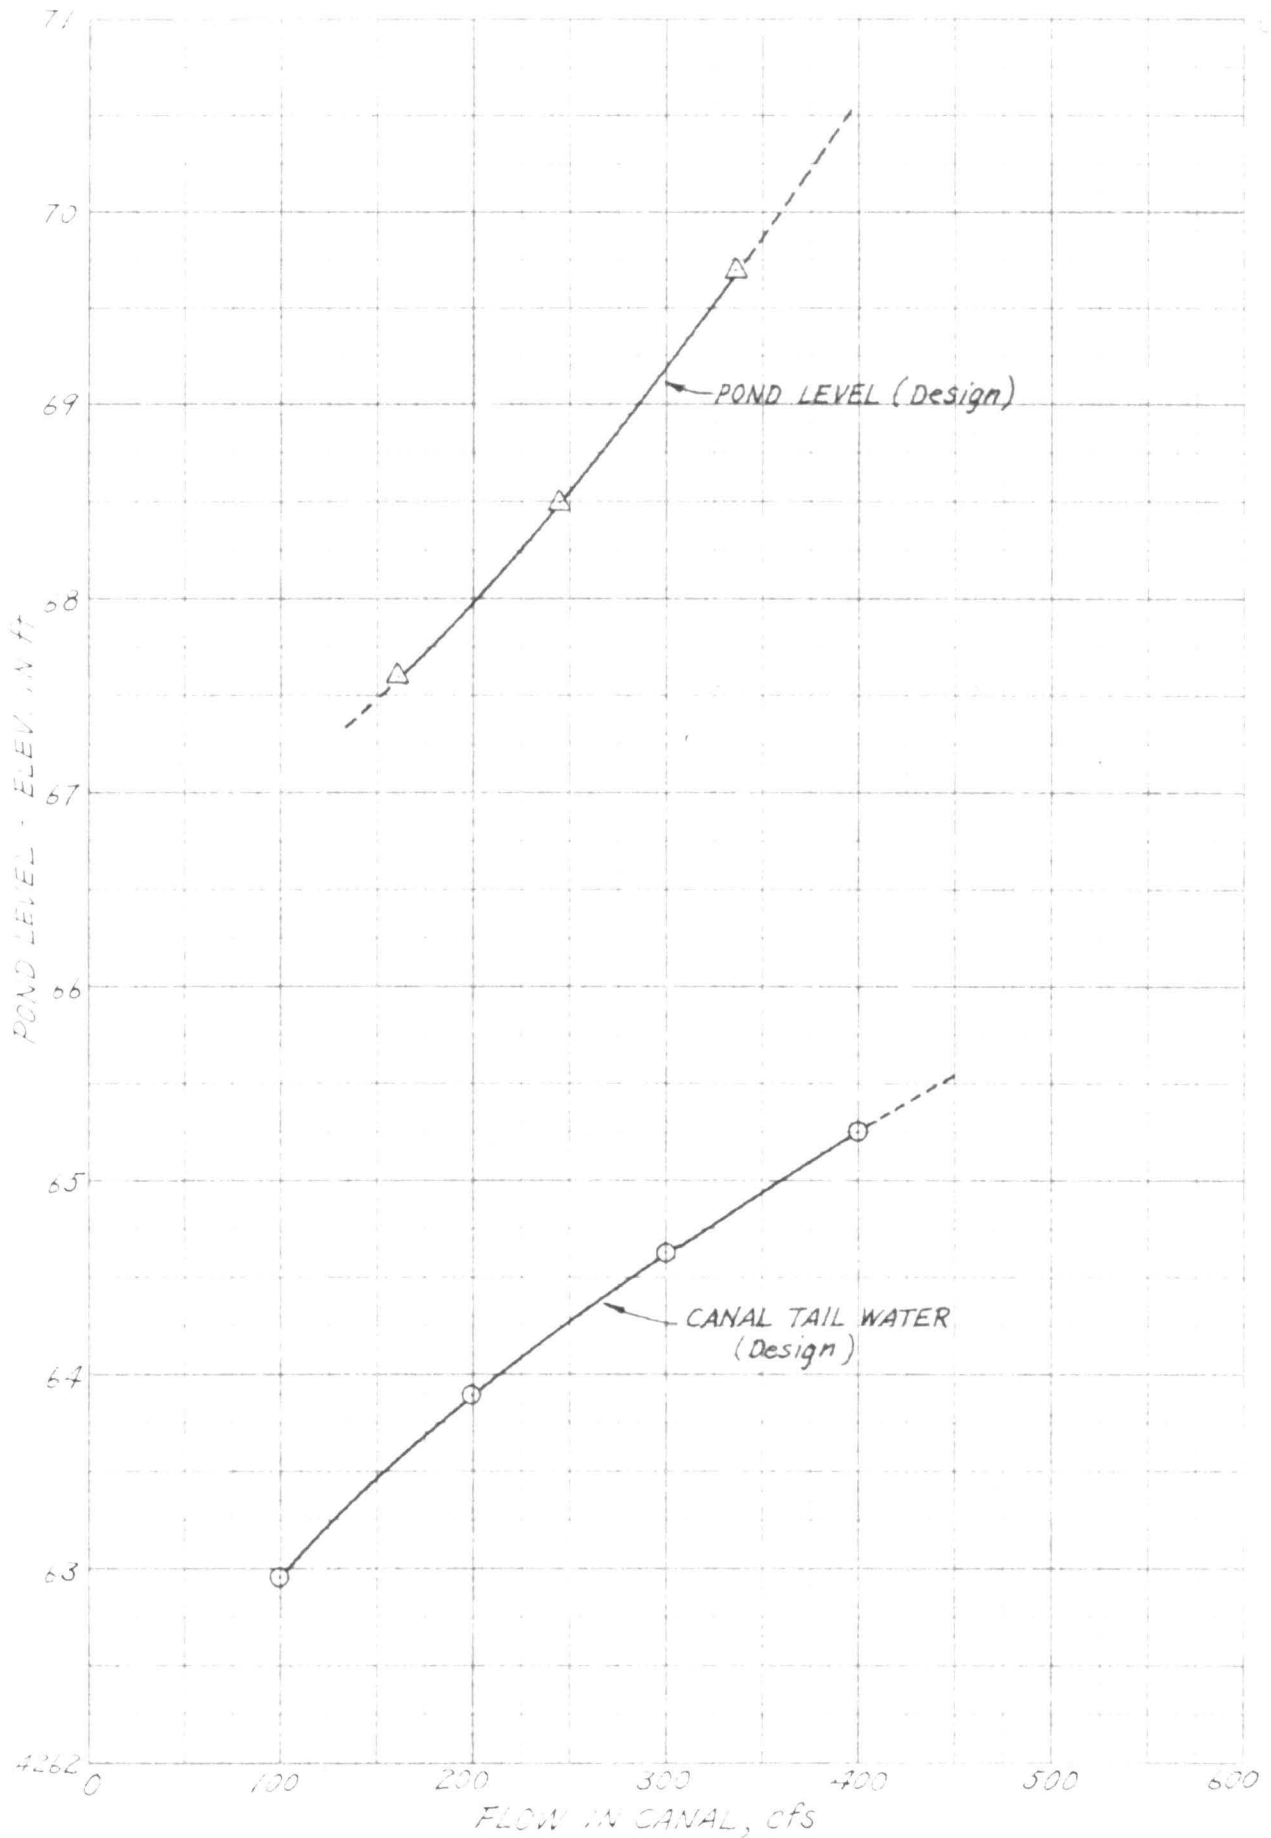
FIG. 3 DESIGN CONDITIONS

Tests were made to determine whether the inlet structure would have been adequate for the design conditions. It was found that with the design canal water level, a discharge of 350 cfs could be obtained with an upstream pond level of 4269.9 as shown in figure 3. It should be noted that the design canal tail water is approximately four feet lower than the existing conditions. The data were taken with the ice hood in place.

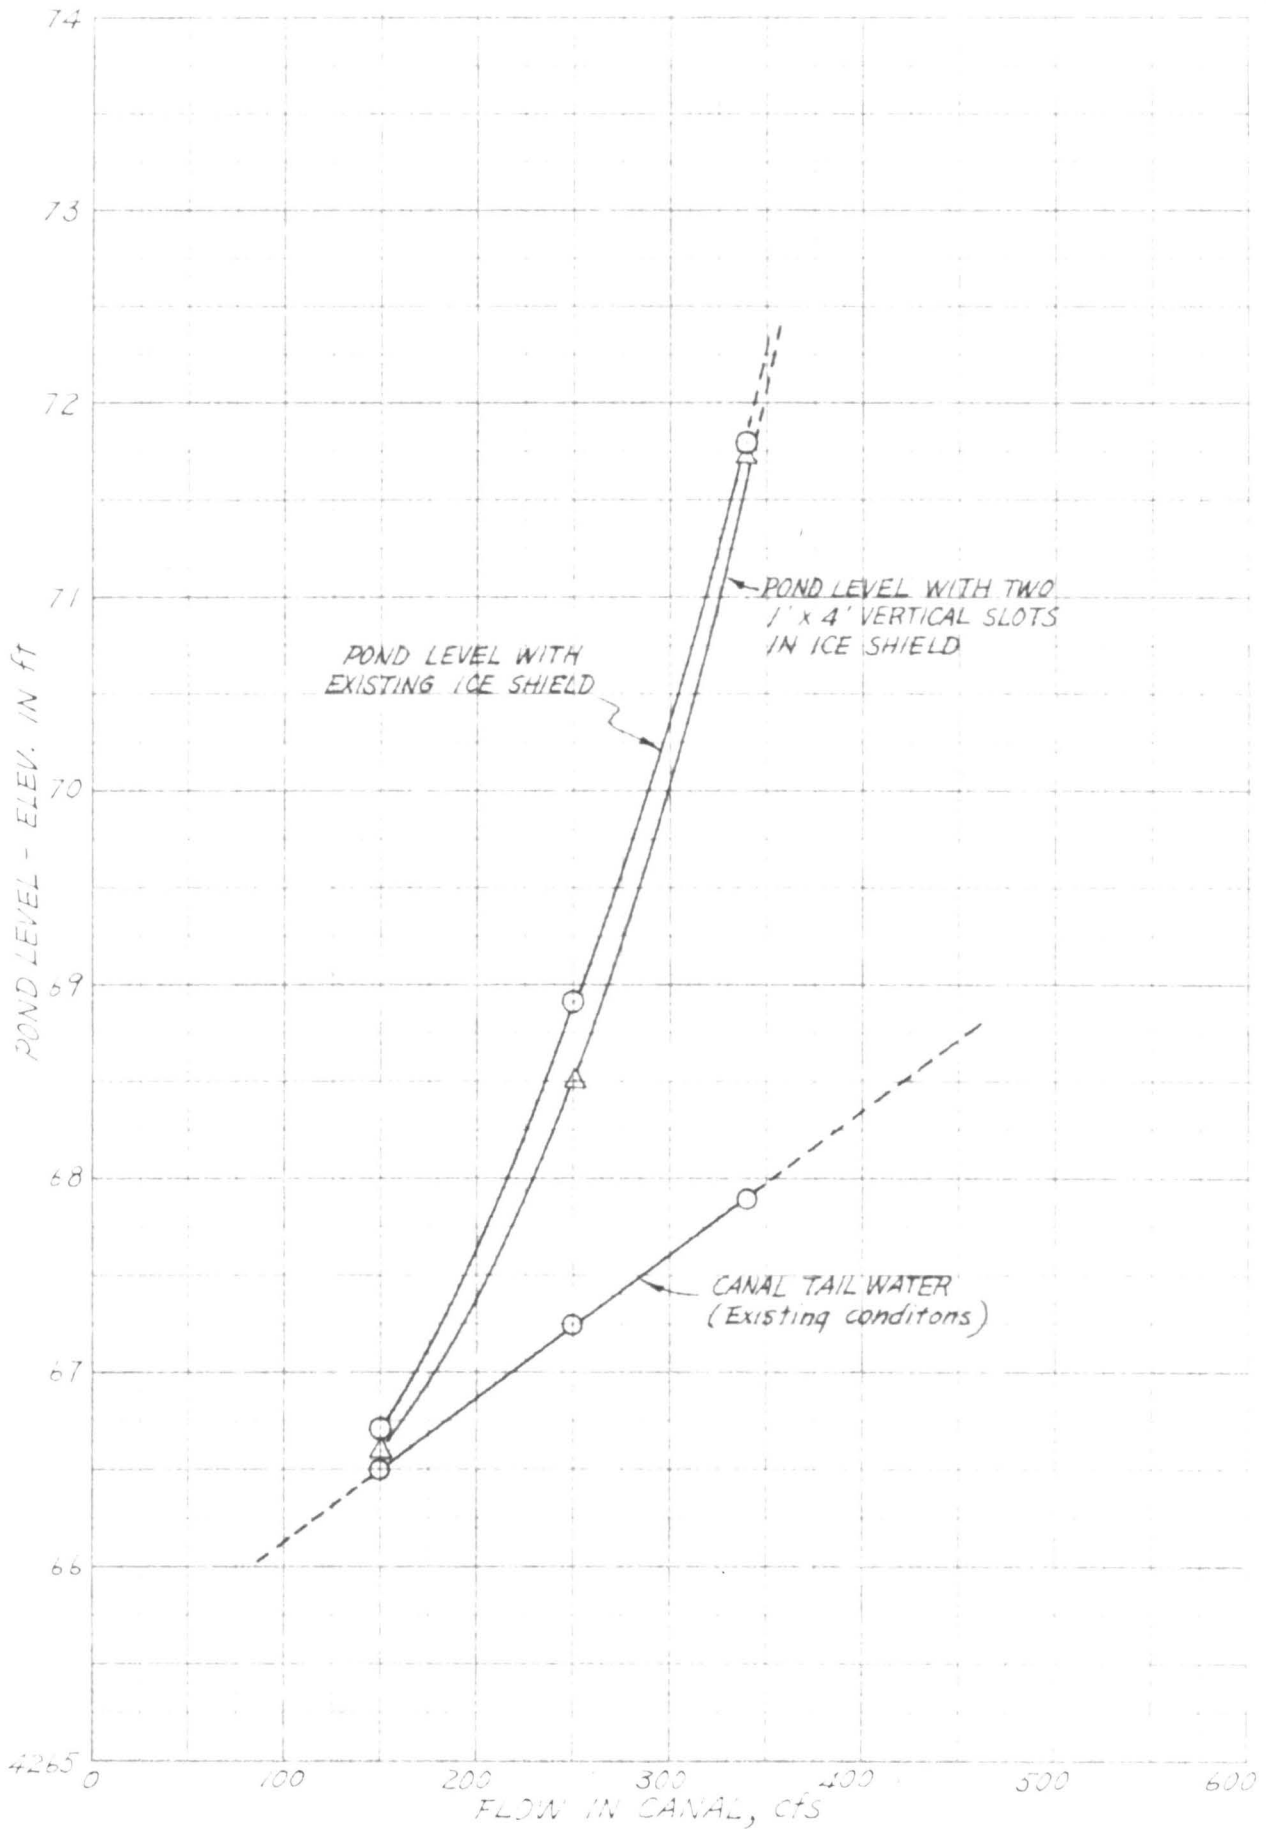
FIG. 4 MODIFICATION OF THE ICE HOOD WITH EXISTING CANAL TAIL WATER

Several different schemes were tested to determine if the oscillations could be eliminated. One idea attempted a number of nine inch diameter holes punched through the face of the ice hood and this successfully eliminated the oscillations, and by so doing, discharge was increased by about 10 cfs for the same pond level. However, this solution seemed impractical for the prototype. Instead of holes in the ice hood, six vertical slots one foot wide and 4 feet high were made through the ice shield. The oscillations were damped but the size of the slots would have structurally weakened the face of the ice hood and again it seemed to be an impractical solution. By trial and error testing, it was found that all six slots were not required. By properly locating two slots, one foot by four feet near both ends of the hood, the oscillations were satisfactorily damped. When the oscillations were damped the discharge increased by about 10 cfs as shown in the graph of figure 4. The canal tail water in figure 4 is for existing canal conditions, and for comparison purposes, the existing pond level, or pond level resulting with the ice hood undisturbed, is also shown.
