Surface rupture displacement on the Greendale Fault during the M_w 7.1 Darfield (Canterbury) earthquake, New Zealand, and its impact on man-made structures

R. Van Dissen¹, D. Barrell¹, N. Litchfield¹, P. Villamor¹, M. Quigley², A. King¹, K. Furlong³, J. Begg¹, D. Townsend¹, H. Mackenzie², T. Stahl², D. Noble², B. Duffy², E. Bilderback², J. Claridge², A. Klahn², R. Jongens¹, S. Cox¹, R. Langridge¹, W. Ries¹, R. Dhakal², A. Smith², S. Hornblow², R. Nicol², K. Pedley², H. Henham², R. Hunter², A. Zajac¹, T. Mote⁴

¹GNS Science, NZ; ²University of Canterbury, NZ; ³Penn State University, USA; ⁴Arup, Australia

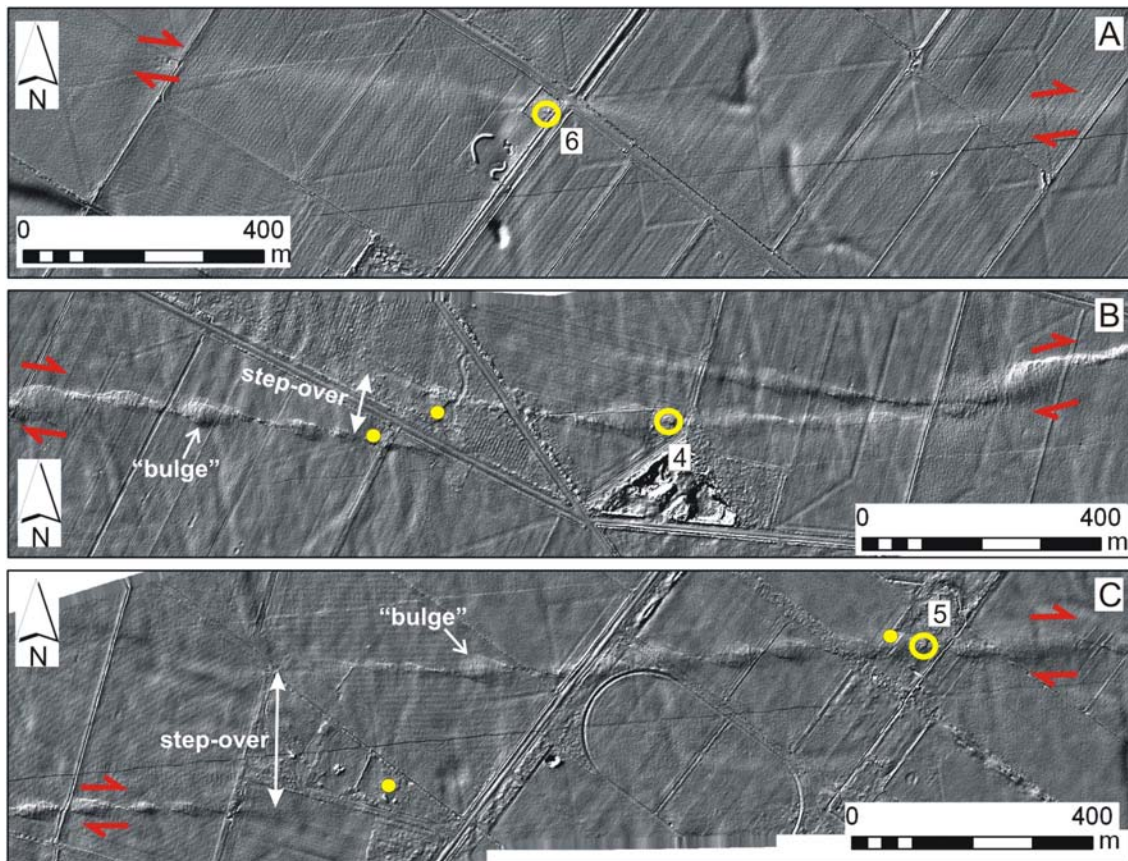
Figure 2. LiDAR hillshade DEMs (illuminated from the NW) of three ~1.8 km long sections of the Greendale Fault (see Figure 1 for locations), showing characteristic left-stepping in echelon rupture pattern (especially evident in B & C), and dextral offset of roads, fences, irrigation channels, hedges and crop rows. Red arrows straddle the surface fault rupture and show the sense of lateral displacement. Representative examples of fault step-overs and push-up “bulges” are identified in B & C. Open yellow circles show the locations of buildings damaged by surface fault rupture that are depicted and discussed in Figures 4-6. Small yellow dots show the locations of other buildings damaged by surface rupture deformation that are not discussed in this paper. The general amount of net surface rupture displacement in A, B, and C is, respectively, 1.5 to 2.5 m (horizontal to vertical ratio ~3:1, south side up), 4 to 5 m (predominantly dextral), and 4 to 2.5 m (predominantly dextral).

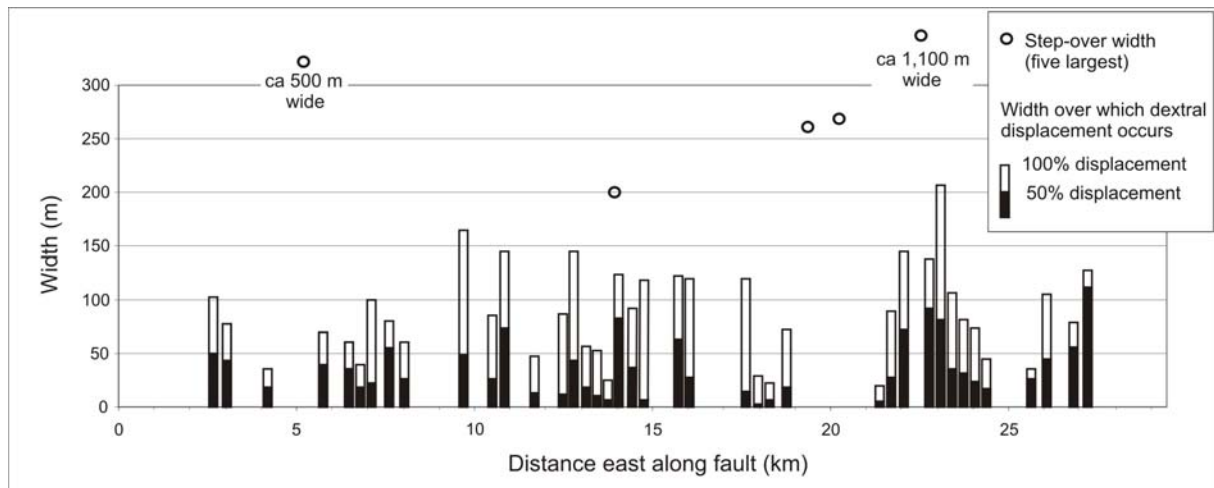
Perpendicular to the strike of the Greendale Fault, surface rupture displacement is distributed across a ~30 to 300 m wide deformation zone (Fig. 3), largely as horizontal flexure. The width of the surface rupture deformation zone is greatest at step-overs, and damaging ground strains developed within these. On average, 50% of the horizontal displacement occurs over 40% of the total width of the deformation zone with offset on discrete shears, where present, typically accounting for less than 25% of the total displacement. Across the paddocks deformed by fault rupture, there is a threshold of surface rupture displacement of ~1 to 1.5 m, greater than this discrete ground cracks and shears occur and form part of the surface rupture deformation zone, and less than this they are rarely present. The distributed nature of Greendale Fault surface rupture displacement undoubtedly reflects a considerable thickness of poorly consolidated alluvial gravel deposits underlying the plains.

Figure 3. Width (horizontal distance) measured perpendicular to fault strike over which it takes to accumulate 50% and 100% of the total dextral surface rupture displacement at 40 sites along the Greendale Fault. 50% widths are centred over the portion of the deformation zone that exhibits the greatest amount of displacement. The average width of the surface rupture deformation zone is about 80 to 90 m, excluding the largest step-overs. It is relevant to note that the true width of deformation, as documented in the field through detailed surveys of deformed fences and the like, is usually several tens of metres wider than the width of deformation evident in hillshade LiDAR images as processed and depicted in Figure 2, and can be over 100 m wider. For example, the eastern ~7 km of surface rupture, across which there is as much as ~1.5 m of dextral and ~0.5 m of vertical distributed deformation, is not visible in hillshade LiDAR images similar to those depicted in Figure 2.

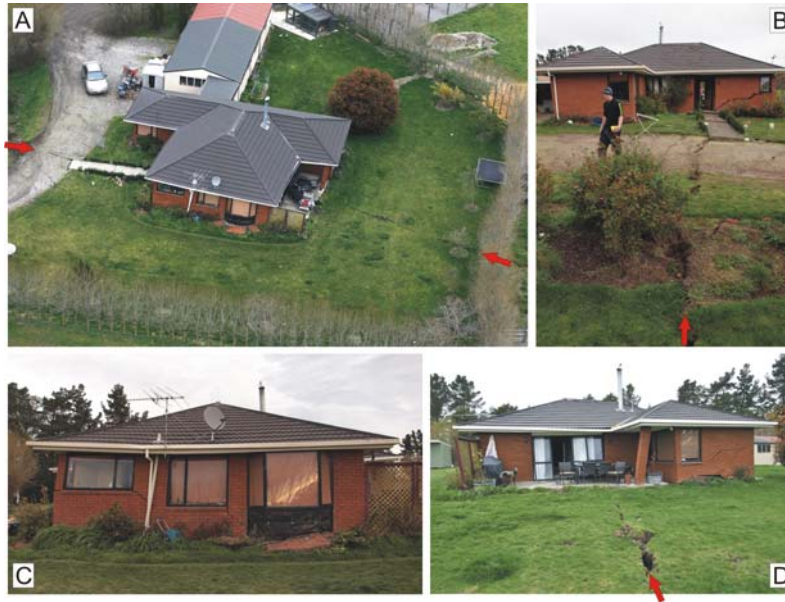
shear extending through/under them (Figs 4 & 5), but all were more damaged than comparable structures immediately outside the zone of surface rupture deformation. Some of the buildings most damaged by fault rupture are scheduled for demolition. From a life-safety standpoint, all these buildings performed satisfactorily, but with regard to post-event functionality, there are notable differences. The houses with lightly-reinforced concrete slab foundations (often also brick-clad) suffered moderate to severe structural and non-structural damage. Three other buildings exhibited more favourable performance and will be potentially more straightforward to reinstate. One had a reportedly well-reinforced concrete slab foundation (Fig. 6). Another had a shallow-seated pile foundation that fortuitously isolated a significant amount of ground deformation from the timber-framed, metal-clad superstructure (Fig. 5). The third, despite having steel piles set in concrete, had a steel and plywood structural system that was exceptionally robust and allowed the house to tilt and rotate as a rigid body (Fig. 7).

Figure 4. Timber-framed, brick-clad house with concrete slab foundation (at most only lightly-reinforced) and light-weight roof that is located within a ~150 m wide deformation zone accommodating 4 to 5 m of dextral displacement. The house is badly damaged by distributed deformation, and ~0.5 m of discrete strike-slip rupture (red arrows) that enters the house through the front door (B), passes through the house's foundation (including living room), and exits through the back door (D). Photos: A by Richard Cosgrove looking S; B by Hayden Mackenzie looking WNW; C by Hayden Mackenzie looking SSW; D by Dougal Townsend looking ESE.

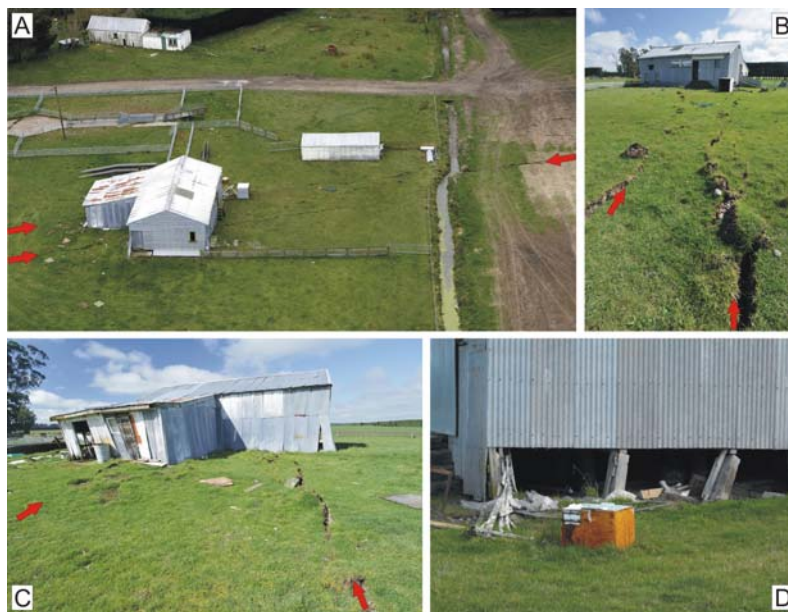
Figure 5. Timber-framed farm shed that is located within a 25 to 50 m wide deformation zone comprising both discrete shears (red arrows) and distributed deformation, and accommodating ~2.7 m of net slip (predominantly strike-slip - note dextral offset of irrigation channel in right-hand side of A). The farm shed is made up of two parts, a larger metal-clad structure with a timber floor that is founded on shallow seated ~700 mm high concrete piles (D), and a smaller lean-to structure attached to the side (A & C). The lean-to is a pole building (part metal-clad and part wood-clad) with an unreinforced concrete floor. The response of the two different construction styles to surface fault rupture was noticeably different. The support poles of the lean-to are set into the ground. Dextral fault rupture under the lean-to led to lateral displacement of the support poles on either side of the rupture, and significant distortion of the walls and roof (C). In contrast, surface rupture deformation under the larger piled structure was, in large measure, isolated from the superstructure by rotation of the shallow seated piles. The timber flooring and framing, and metal cladding proved a resilient structural system that limited internal distortion. It would be a relatively straightforward process to re-level and reinstate this portion of the building. Photos: A by Richard Cosgrove looking NE; B by Dougal Townsend looking W; C by Dougal Townsend looking E; D by Russ Van Dissen looking SW.

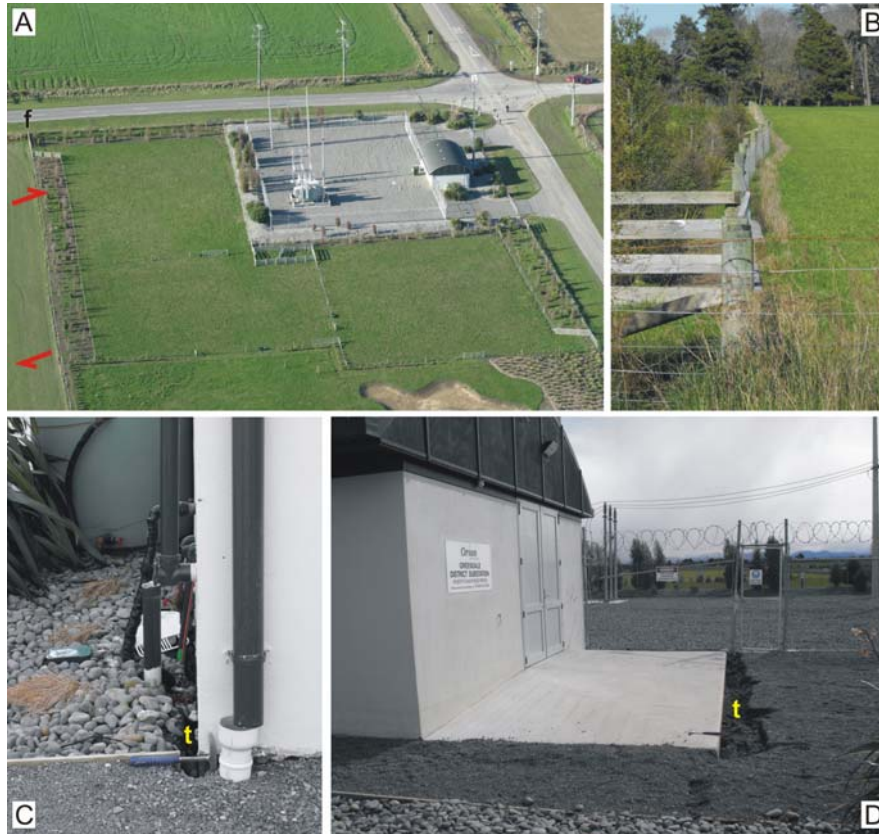
Figure 6. A) Light-industrial building with a reportedly well-reinforced concrete slab foundation is tilted and rotated, but relatively undamaged, by ~ 1.7 m dextral and < 1 m vertical (south side up) displacement distributed across a ~ 100 m wide deformation zone. Red arrows denote location, strike and sense of lateral displacement of the surface rupture deformation zone. Photo by Richard Jongens looking NE. B) Fence line adjacent to site crosses the surface rupture deformation zone and records the amount, width, and distributed style of fault displacement here (camera location for B is shown by black “f” in A). Photo by Russ Van Dissen looking SW. C & D) Long axis of building is oriented $\sim 55^\circ$ counter-clockwise to the general strike of the fault rupture. Distributed displacement imposed tensile ground strains across the site with an orientation roughly sub-parallel to the building’s long axis. The foundation of the building was robust enough to resist these strains (i.e. no cracking of the foundation was evident) and, instead, the soil pulled away from either end of the building’s foundation (yellow “t” in C & D). Photos C & D by Russ Van Dissen looking NW.

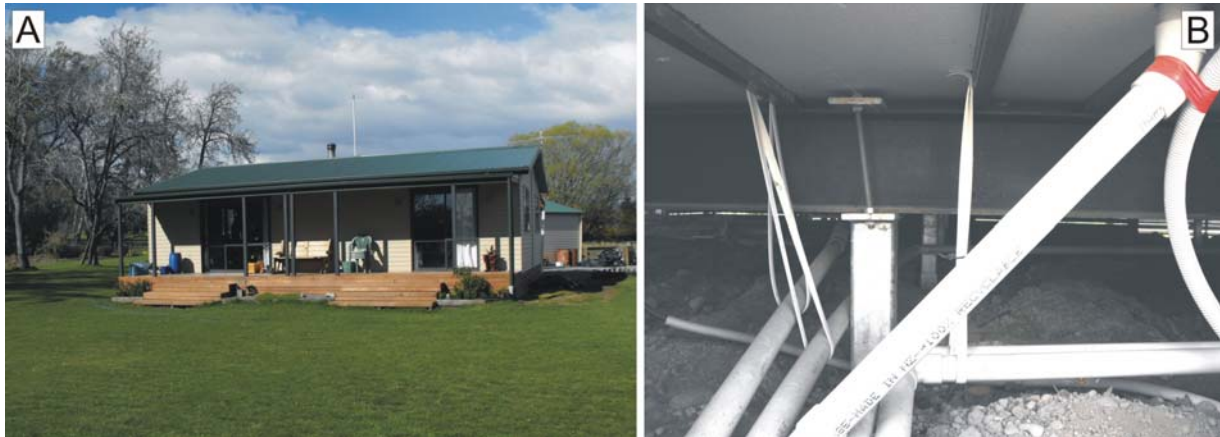
Characterising the hazards associated with surface fault rupture, and developing design strategies to mitigate those hazards have been the focus of a number of publications by J.D. Bray (e.g. Bray 2001, 2009a, 2009b; Bray & Kelson 2006). In these, he consistently highlights four principal means for addressing surface fault rupture hazard: i, land use planning; ii, engineering geology; iii, geotechnical engineering; iv, structural engineering. Depending on fault rupture characteristics and site conditions, he advocates a number of potentially effective design measures that include: establishing non-arbitrary setback distances; constructing earth fills to partially absorb and distribute underlying rupture; isolating foundations from underlying ground movement (e.g. through the use of slip layers); and designing strong, ductile foundations that resist imposed earth pressures. Observations of building response to the Greendale Fault surface rupture are supportive of Bray's recommendations. Those houses with lightly-reinforced concrete slab foundations (e.g. Fig. 4) would have benefited from having foundations that were stronger and more ductile, and/or able to isolate underlying fault rupture from the overlying house. Buildings less damaged by surface rupture deformation were those that had foundations that were strong enough to resist imposed strains (Fig. 6), or isolated ground deformation from the superstructure (Fig. 5). From the perspective of post-event reinstatement, the building that performed best is depicted in Figure 7. It had the capacity to tilt and rotate as a rigid body, suffering very little internal deformation, and will be relatively straightforward to re-level. For buildings that could be subjected to tilting due to surface rupture deformation, design measures that not only limit damage, but also facilitate re-leveling are advantageous and, as this house illustrates, achievable.

Figure 7. A) Light-gauge steel-framed, plywood- and weatherboard-clad house with steel pile foundation, steel I-beam bearers, steel joists and plywood flooring that is tilted, and rotated, but only slightly damaged by ~1 m of distributed vertical and dextral fault rupture spread over several tens of metres width. Photo by Russ Van Dissen looking E. B) Close-up of pile, bearer and deformed bolted connection. Photo by Russ Van Dissen looking WNW. Despite this house being essentially “locked” into the ground (piles are concreted to ~1 m depth into the ground), it suffered only slight damage because surface rupture deformation was distributed and relatively evenly spread across the site, and because the structural system was strong and stiff enough to tilt and rotate as a rigid body. Given this structure’s resilient, and somewhat uncommon, construction style, it should be a relatively straightforward process to re-level and reinstate the house. This building was subjected to both surface fault rupture and epicentral-strength strong ground shaking, and performed in a fashion that not only greatly exceeded life-safety objectives, but will also greatly facilitate post-event reinstatement. However, if the building had been subjected to greater amounts of deformation, especially discrete displacement, the pile foundation may have been able to transfer enough deformation into the superstructure to damage it. Design modifications to potentially mitigate this, yet still retain the building’s noteworthy resilience, could be to: i) use piles specifically designed to yield during surface fault rupture, and/or ii) use two sets of bearers with one set attached to the piles and oriented parallel to the strike of the fault, and another orthogonal set on top, onto which the floor joists are attached. With due geological and engineering consideration both these options could conceivably be employed to successfully isolate ground rupture from the superstructure and still retain the advantageous ease of re-leveling qualities of this type of construction.
