3 **Strike-slip ground-surface rupture (Greendale Fault) associated with the 4th**

4 **September 2010 Darfield Earthquake, Canterbury, New Zealand**

16 **Abstract:** This paper provides a photographic tour of the ground-surface rupture

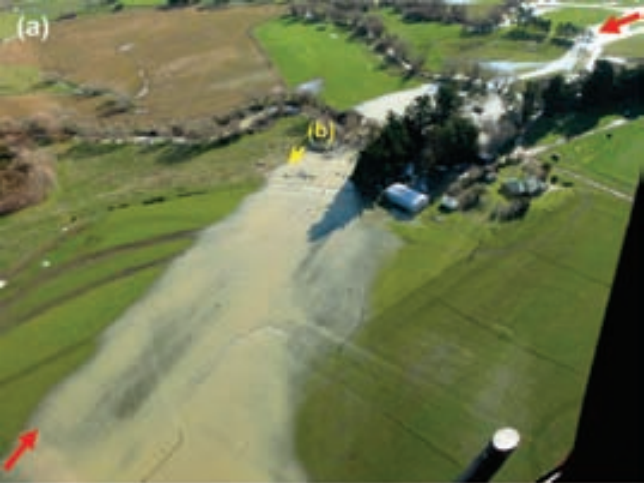
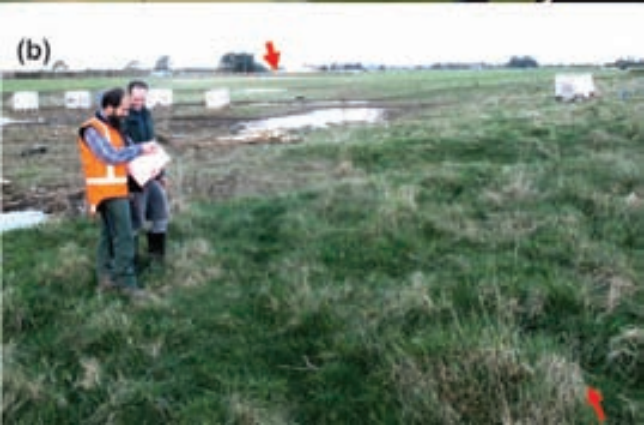
225 **Fig. 2.** **(a)** The sinuous course of the Hororata River, flowing from upper right to upper
226 left, is crossed by the fault in this westward view, taken 4th September. A significant
227 portion of the river's flow is diverted towards the lower left, along the downthrown side
228 of the fault. **(b)** In this view southeast from location (b) shown in Fig. 2a, taken 15th
229 September, the broad rise up to the right is the fault, which here has bent rather than
230 broken the ground. Excavation of the river channel has stemmed the overflow across
231 farmland.

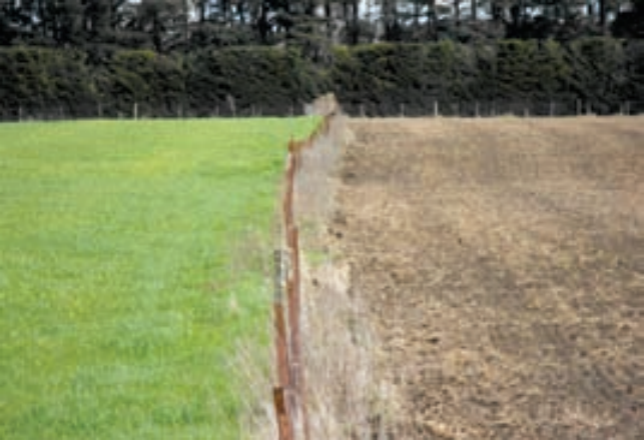
233 **Fig. 3.** This view south along an originally straight fence in a formerly flat field
234 illustrates the oblique right-lateral (~1 m) and up-to-south (~1 m) ground flexure that
235 characterizes the western end of the Greendale Fault.

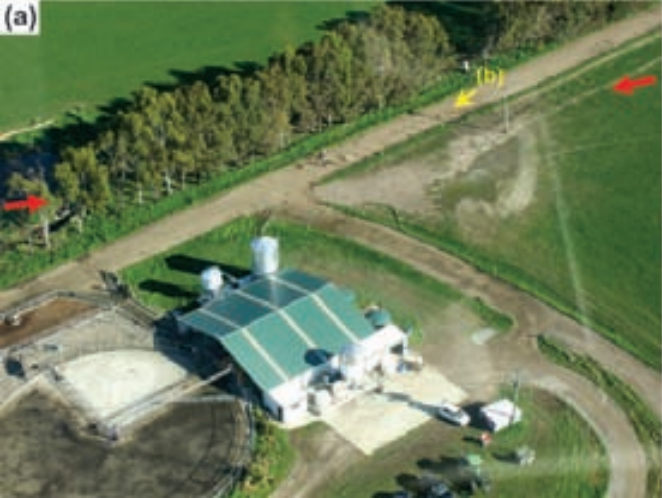
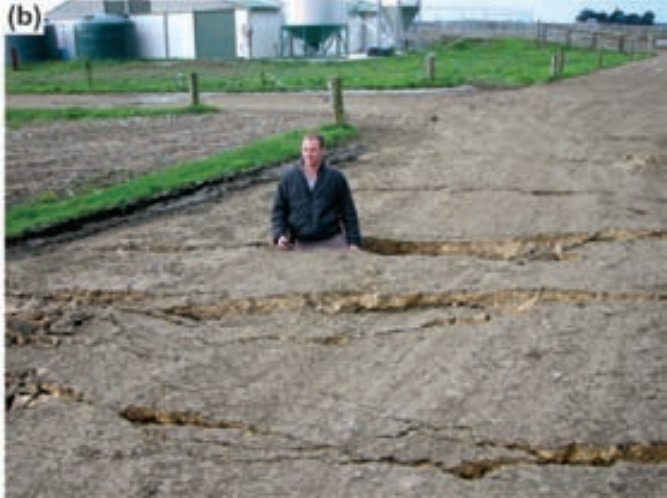
237 **Fig. 4.** **(a)** Progressing eastward, where the horizontal flexure exceeds 2 m, ground
238 cracking became increasingly evident, as seen across the farm lane in this view to the

239 south. **(b)** Detail of the form and depths of tension cracks seen in Fig. 4a, looking
240 northeast, on 5th September.

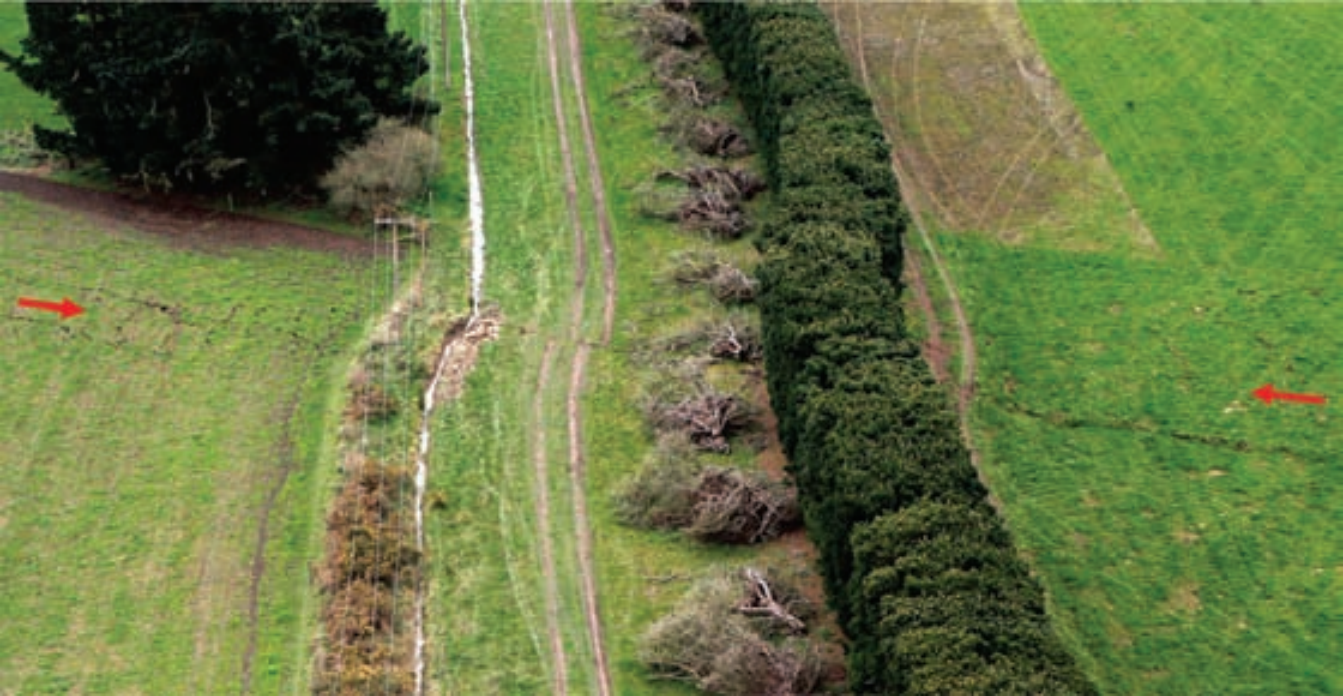
242 **Fig. 5.** This northward aerial view at Stranges Road highlights Reidel shears, at a low
243 angle to the strike of the fault, each with as much as 1 m lateral offset, as seen across the
244 vehicle ruts. However, most of the ~4.5 m right-lateral displacement is by horizontal
245 flexure, as shown by the hedge row and irrigation ditch. Flow in the ditch was impeded
246 by slight upthrow to the south, but the ditch had been deepened prior to this photograph
247 on 9th September.

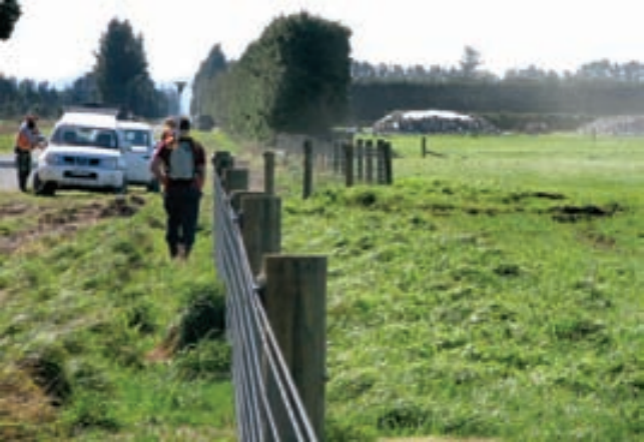
249 **Fig. 6.** At Courtenay Road, this northward view shows team members carrying out a
250 precise Real-Time Kinematic GPS survey of a right-lateral offset (~4.3 m) of the
251 formerly straight fenceline. The deformation occurred over a ~35 m wide zone, and the
252 ground is broken by discrete shears right of centre.

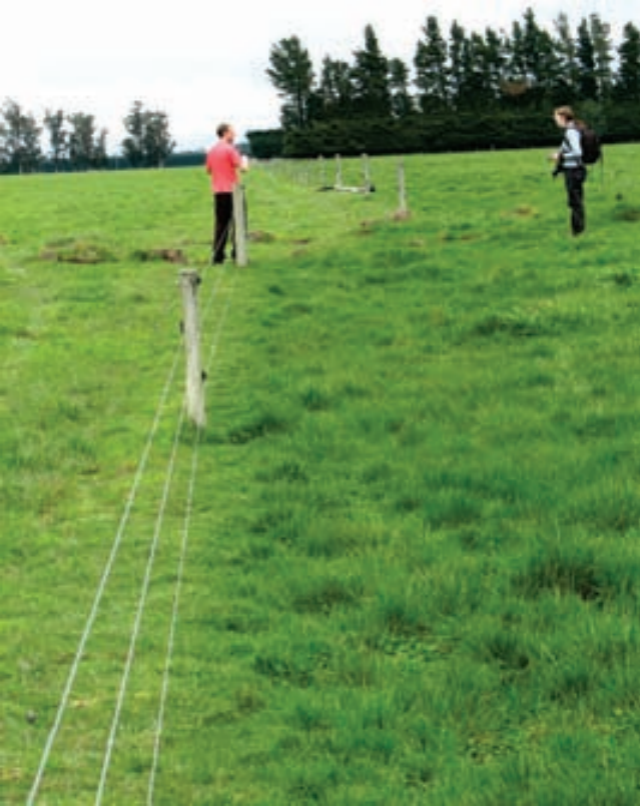
254 **Fig. 7.** This view looking south shows the surface fault rupture where most of the lateral
255 displacement (~4.6 m) is concentrated within a narrow zone, with ‘mole tracks’
256 (displaced turf) evident along shears that displace the fenceline.

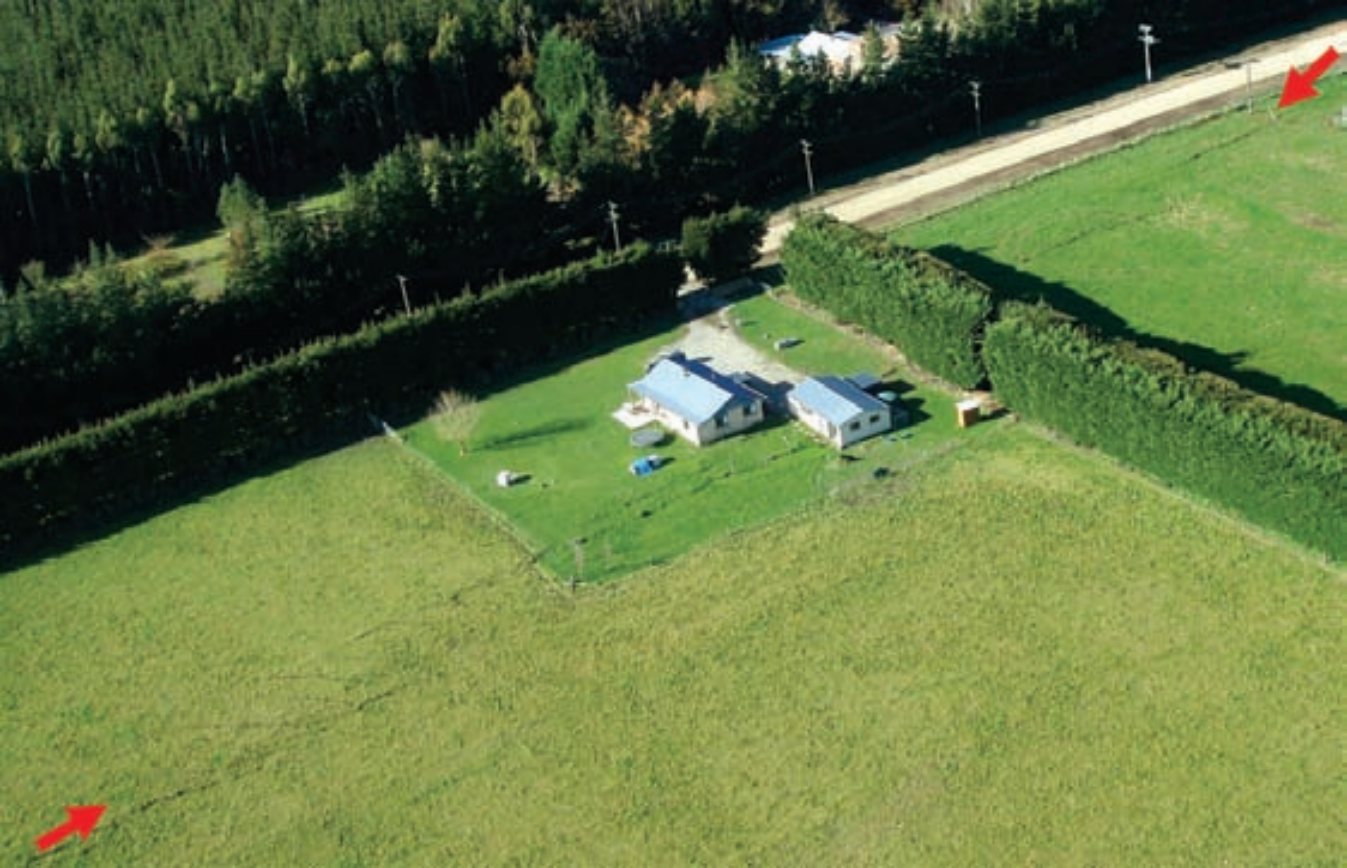
258 **Fig. 8.** An aerial view looking northeast showing en echelon Reidel shears that narrowly
259 miss a house, but pass through its garage.

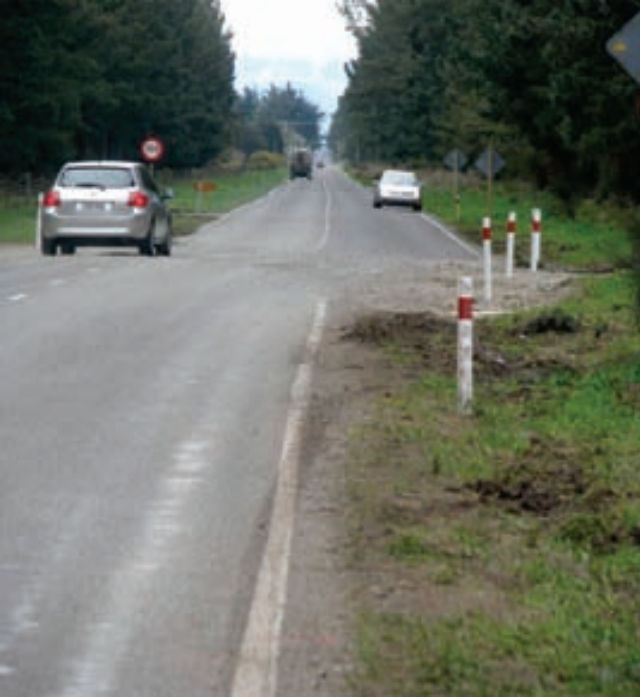
261 **Fig. 9.** In this telephoto view north along Telegraph Road, the busiest road to have been
262 crossed by the fault rupture, the Greendale Fault has displaced the road right-laterally by

263 approximately a lane width. Being a major rural thoroughfare, initial repairs were
264 undertaken on the day of the earthquake.

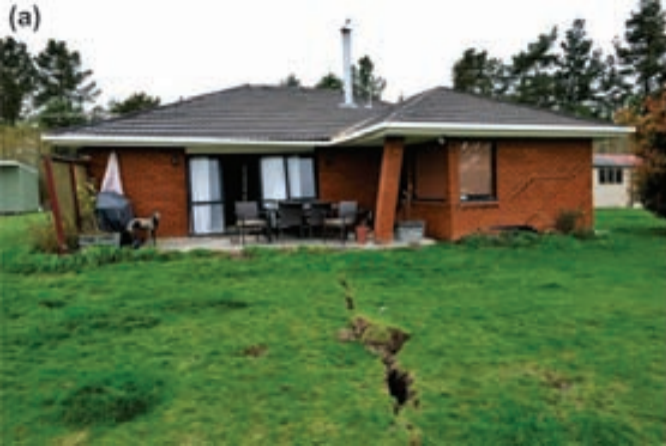
(a)

266 **Fig. 10. (a)** A shear with about 0.5 to 1 m of right-lateral displacement passed through
267 this modern, timber-framed, brick-clad farm house. Despite suffering severe structural
268 damage, the house remained standing and its occupants were unharmed. **(b)** A view
269 looking west at the opposite side of the house shown in Fig. 10a.

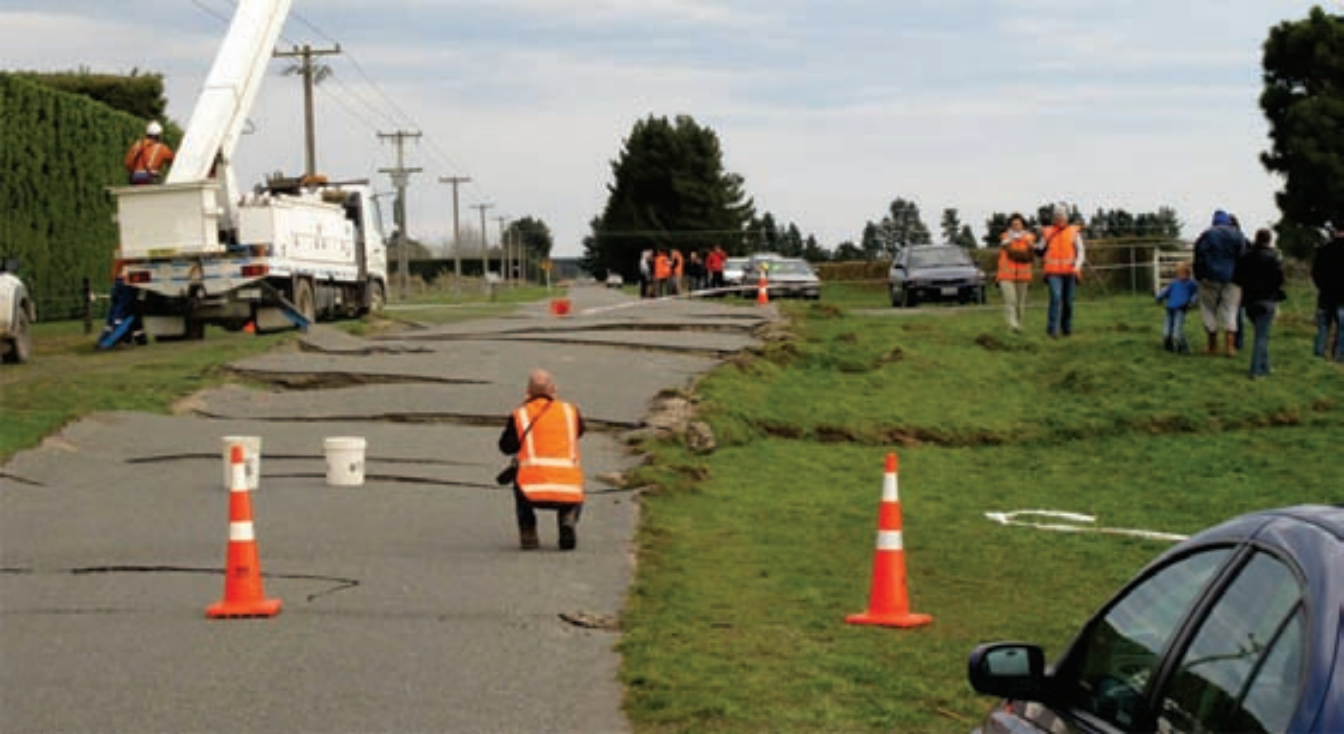
271 **Fig. 11.** A view south down Highfield Road, the second of only two tarsealed roads to
272 have been crossed at a high angle by the fault in its high-displacement central section.
273 Being a minor road, several days passed before repairs were made to the spectacular
274 array of shears and cracks across the tarseal. In the meantime, the site became a local
275 tourist attraction because it was one of the few fault rupture locations that was both
276 undisturbed and publicly accessible. Here, localized bulging resulted in an upthrow of
277 more than 1 m, creating a visual phenomenon in concert with the ~4.5 m right-lateral
278 offset of the carriageway, roadside fences and hedge-rows.

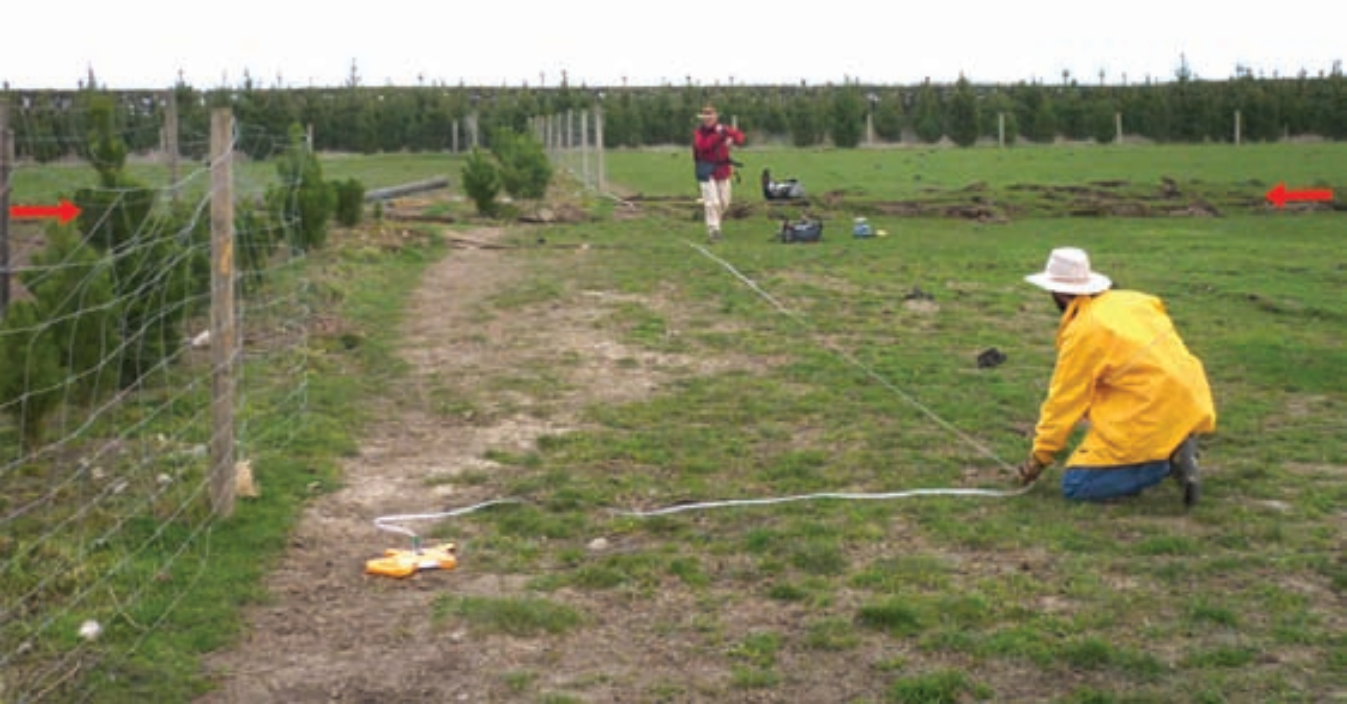
280 **Fig. 12.** Members of the fault rupture reconnaissance team measure offsets (~3.6 m) of
281 a fenceline a few hundred metres east of Highfield Road, view looking south.

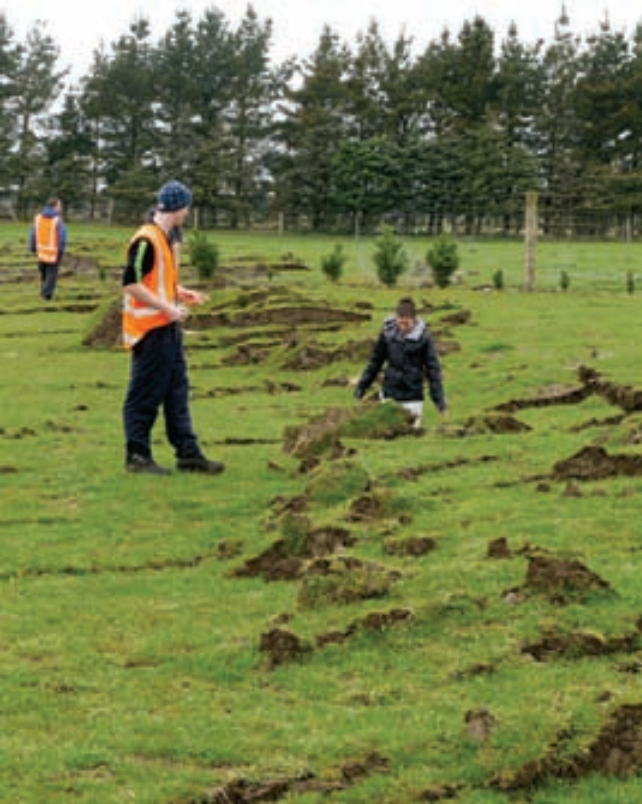
283 **Fig. 13.** This view east along the fault displays a spectacular pattern of conjugate Reidel
284 shears at a high angle to the strike of the fault, which curves off towards the upper left.
285 The fence in the mid-ground is the same one shown in Fig. 12.

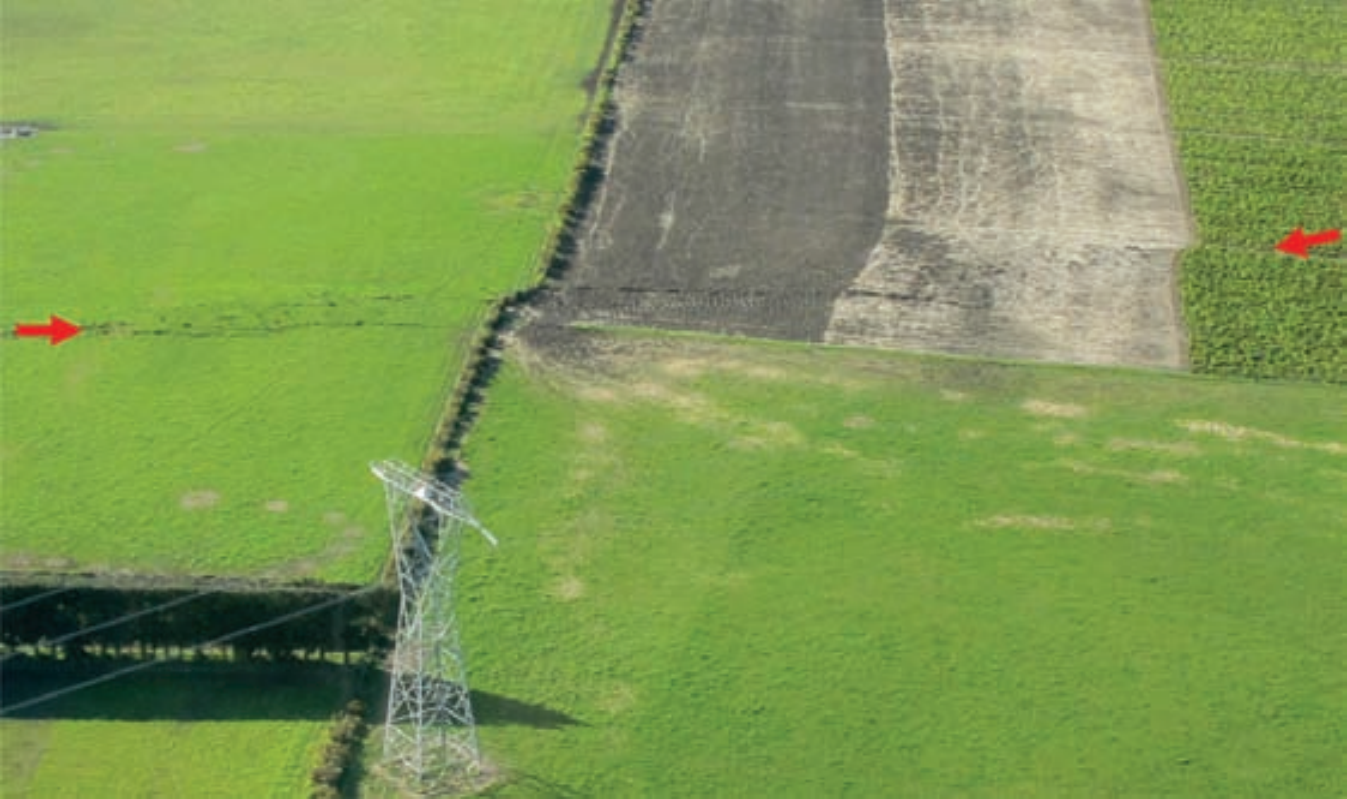
287 **Fig. 14.** A northward aerial view of a narrow fault zone (left) diffusing into a broad
288 flexure across the ploughed fields, then narrowing into a shear near the crops to the
289 right. Total right-lateral displacement of these features is ~4.5 m.

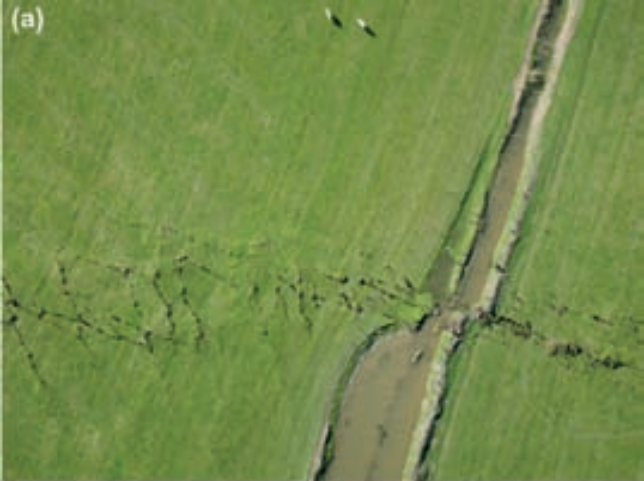
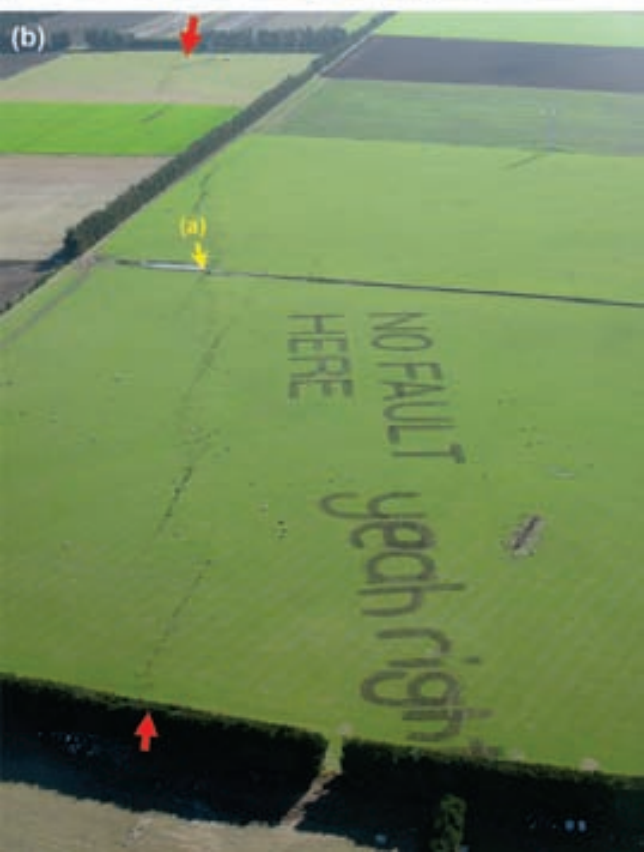
291 **Fig. 15. (a)** Arrays of shears and localized bulges are seen in this aerial view looking
292 north. The irrigation ditch is displaced laterally by ~3.5 m. **(b)** Following initial science
293 reports to the media, stating that there was no prior knowledge of a fault in this area, a
294 landowner ploughed these words into this field. The words reference a nationwide
295 billboard advertising campaign for a brand of beer, in which a bold statement is made,
296 alongside of which are the words ‘yeah, right’, indicating that a sensible person would
297 not believe the statement. The view is southwest, and the features shown in Fig. 15a are
298 upper left from centre.

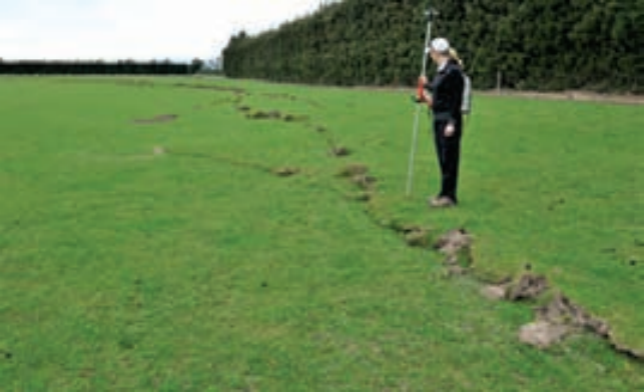
300 **Fig. 16.** A close-up view of shears within a field. Their expressions are particularly
301 clear on account of the very short grass. The total right-lateral displacement at this site
302 is ~3.5 to ~4 m.

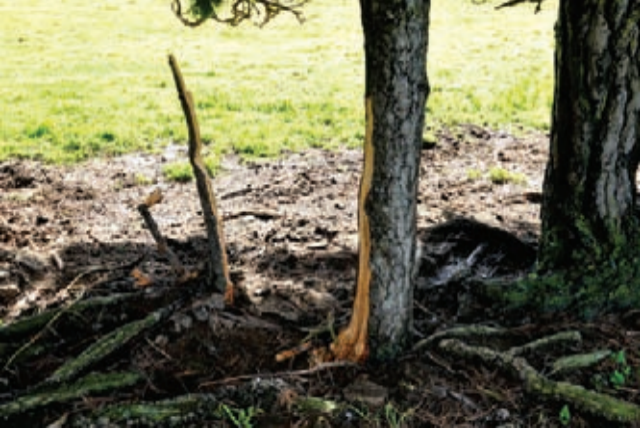
304 **Fig. 17.** Where shears crossed belts of trees, commonly the trees were loosened from
305 the soil, or uprooted. This was one rare instance where a shear split a tree in two, in this
306 case a juvenile *Pinus radiata* with trunk diameter of ~0.15 m.

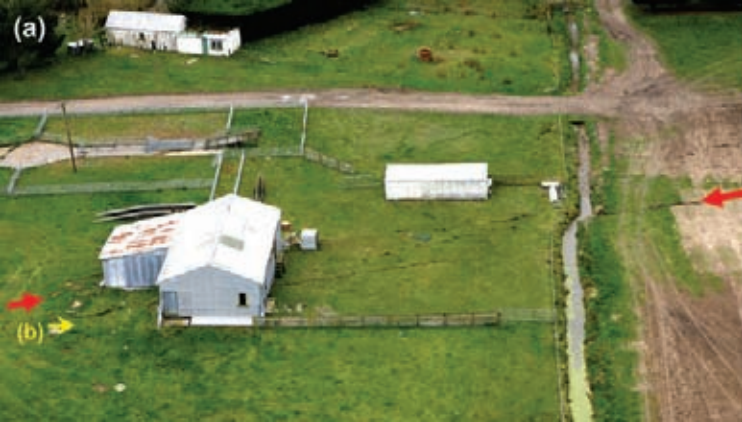
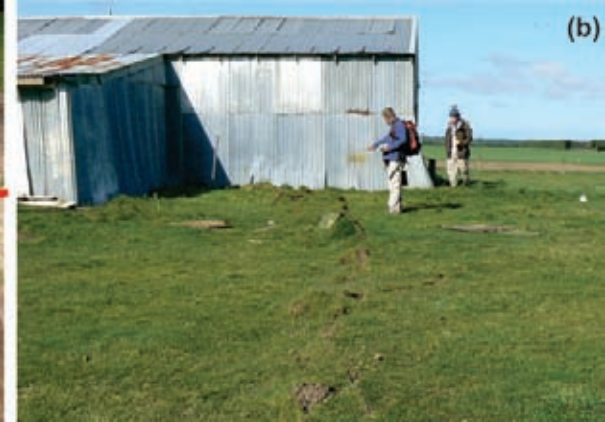
308 **Fig. 18. (a)** An aerial view north showing shears crossing an irrigation ditch (right-
309 lateral offset of ~2.6 m) and passing through a farm shed. The left-hand side of this
310 building is shown in Fig. 18b. **(b)** Members of the fault rupture reconnaissance team

311 measure the effects of a shear, its mole track evident in the foreground, on the farm
312 shed.

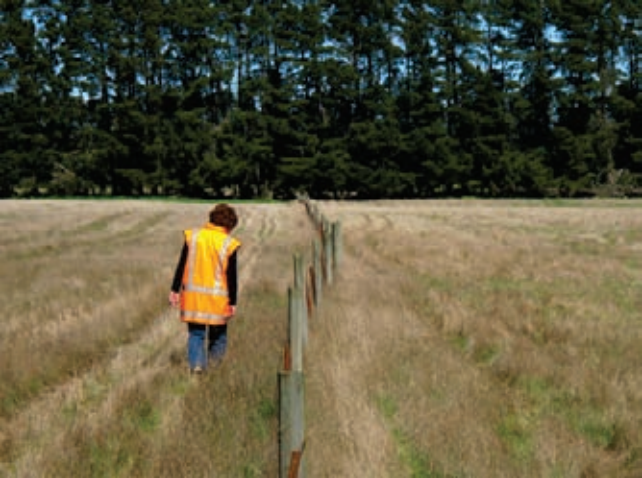
314 **Fig. 19.** On the eastern strand of the fault, deformation comprised horizontal flexure,
315 with very little cracking of the ground. For the most part, cracks were evident only
316 where the fault crossed a relatively brittle feature such as a tarsealed road. In this view
317 southward, the fence reveals a right-lateral flexure of about 1.3 m.

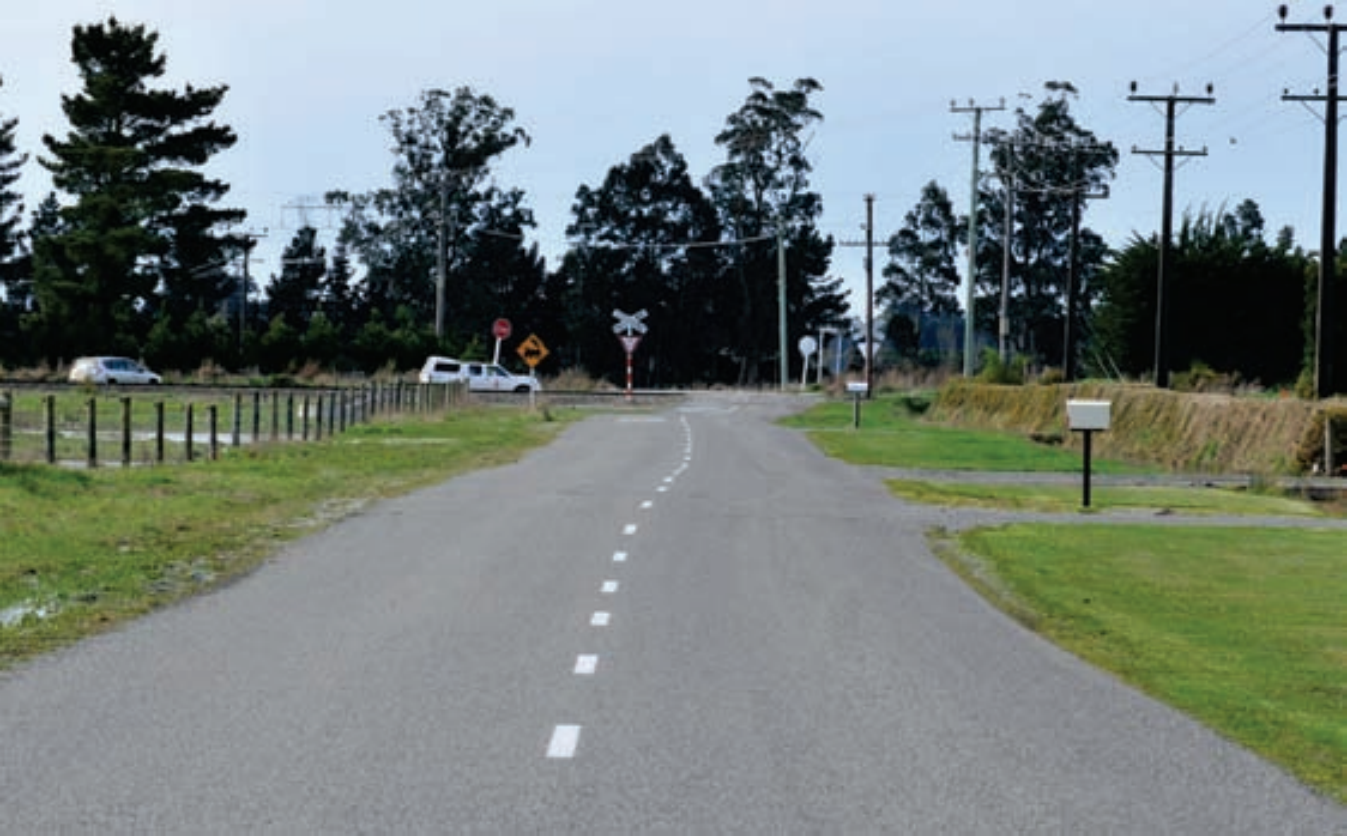
319 **Fig. 20.** In this view northeastward, the painted centreline of Kerrs Road displays a
320 right-lateral flexure of about 1.5 m. An array of minor cracks formed across the road in
321 the flexure zone. Without straight linear features such as roads and fences, this
322 deformation would be indiscernible.

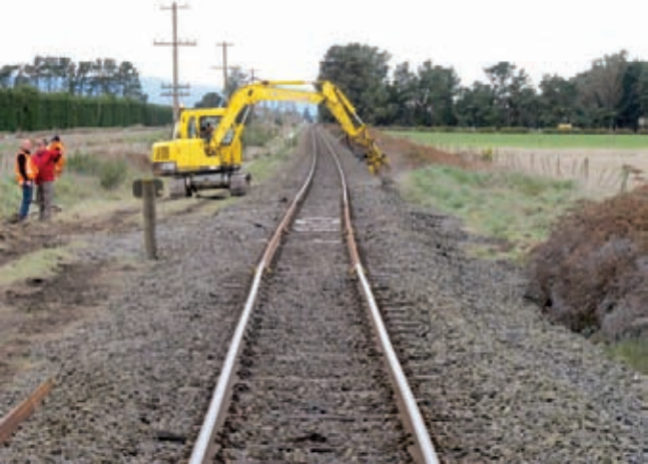
324 **Fig. 21.** Near the eastern limit of recognised deformation, the fault crossed the South
325 Island Midland Railway. This view southward illustrates a broad right-lateral flexure of
326 ~1 m of the line of the rails. As the rail embankment tends to smooth over the minor
327 natural fluvial irregularities of the plains, the rails were an excellent datum for
328 estimating the vertical component of offset. Precise GPS surveying indicated
329 approximately 0.4 m of upthrow to the north at this location. During the earthquake, one
330 section of the rails was kinked sideways to the left (east). This photograph was taken on
331 5th September, immediately after replacement of the kinked rail section. The new rails
332 are rusty as they have yet to be polished by train movement.
