# **BUILDING AND BRIDGE POUNDING DAMAGE OBSERVED IN THE 2011 CHRISTCHURCH EARTHQUAKE**

## **SUMMARY**

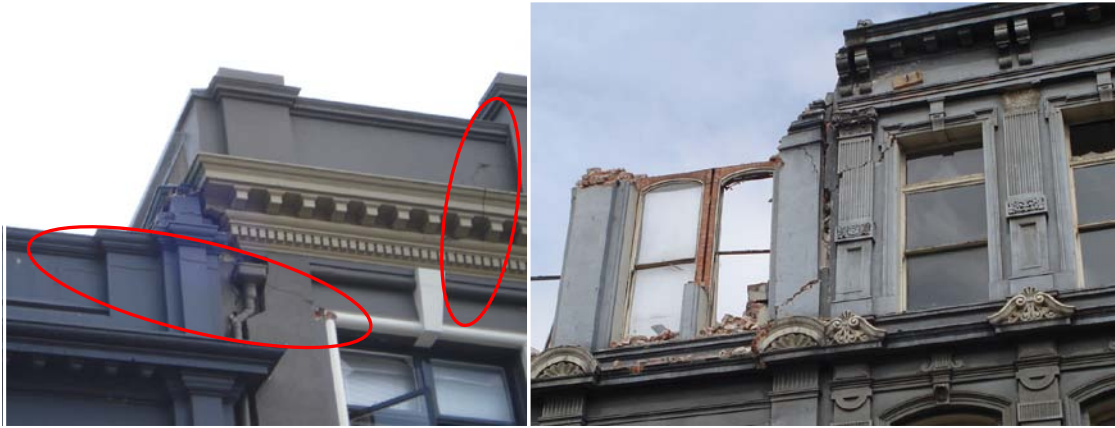
**Figure 1: Examples of URM pounding damage. Left: minor damage. Right: major damage partially caused by pounding**

Pounding damage to URM buildings (for example, Figure 1) occurred sufficiently frequently to enable identification of common damage patterns (Figure 2). Masonry cracking typically extended from the topmost point of contact between two buildings to the nearest window arch or lintel in each building. Cracking frequently extended further from the window opening through to the top of the building's parapet, although this parapet damage was not usually attributed to pounding. Multistorey buildings occasionally also presented damage at lower floors, although this damage was observed to be progressively less severe as the distance from the topmost point of contact increased. Cracking was also observed to concentrate in stiff lateral elements, such as wall sections with wide spacings between window penetrations (Figure 2a). Occasionally, local crushing of masonry units was observed at the point where two floors collided. When buildings of differing height collided, the floor immediately above the topmost point of contact also frequently suffered notable cracking. Figure 2b presents an idealised load path diagram, which also reflects the typically observed masonry damage distribution. In reality the damage 'struts' were not oriented at 45 degrees. This angle was instead governed by the building's wall penetrations.

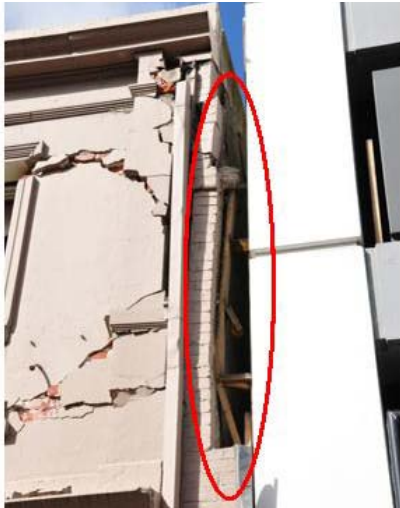
Modern buildings generally suffered less pounding damage. This is attributed to the greater building separations adopted in newer buildings and the presence of weaker adjacent buildings (for example, if a concrete reinforced frame building collided with a URM building, damage is more likely to occur first in the URM building due to its weak, brittle properties). The primary source of pounding damage in modern buildings with separation was instead observed where building separations were infilled with cosmetic flashings (Figure 3). While flashings are intended to cover the gap between adjacent buildings, the detailing of some flashings created stiff and strong elements, which transferred significant force between the two buildings. In some instances the flashings caused failure of adjacent building elements, while in other instances the entire flashing detached from both buildings. Flashing detachment can cause a sizable amount of falling debris when the buildings have multiple storeys. Furthermore, this form of damage can be simply avoided by designing flashings to compress/crush and ensuring they are adequately anchored to one building only. Five instances of significant damage resulting from force transfer through building flashings were observed within the CBD.

**Figure 3: Building damage caused by framed flashing**

- Modern buildings were primarily endangered by pounding when flashings between buildings were constructed with stiff and strong materials that allowed force transfer across building separations. This hazard can be mitigated by using compressible flashings attached to one building (but not both).

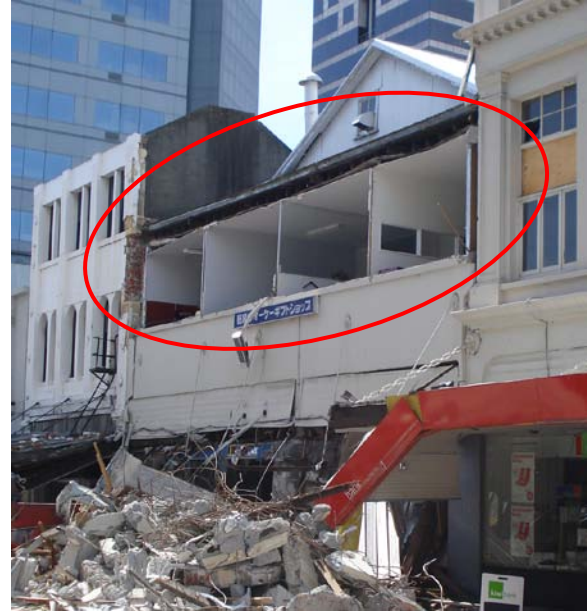
Three instances of buildings apparently being crushed from either side by adjacent buildings were also observed (Figure 4). This was evidenced by façade collapse and localised crushing damage at the points of contact with adjacent

buildings. It is noted that some engineers have expressed some doubt to the first author that the adjacent buildings contributed to this failure. However, an alternative explanation for the observed damage at the contact points has thus far not been presented. If pounding did contribute to these collapses, it is a particularly dangerous consequence for any pedestrians in the vicinity when an earthquake occurs, in addition to potentially compromising the building's overall stability. The illustrated example's façade was constructed of reinforced concrete, which typically performed very well elsewhere in the CBD. This further highlights the potential danger of this type of damage.

**Figure 4: Facade loss attributed to building crushing**

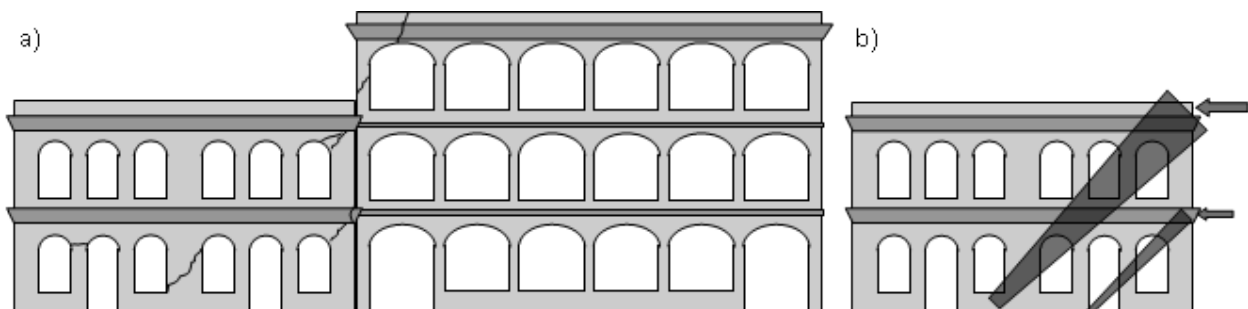
**Figure 2: Damage to URM buildings. a) Typical pounding damage. b) Idealized masonry strut damage. Arrows denote floor collision points of the adjacent building. Width of the shaded zone indicates approximate severity of damage. Figure reproduced from [4].**

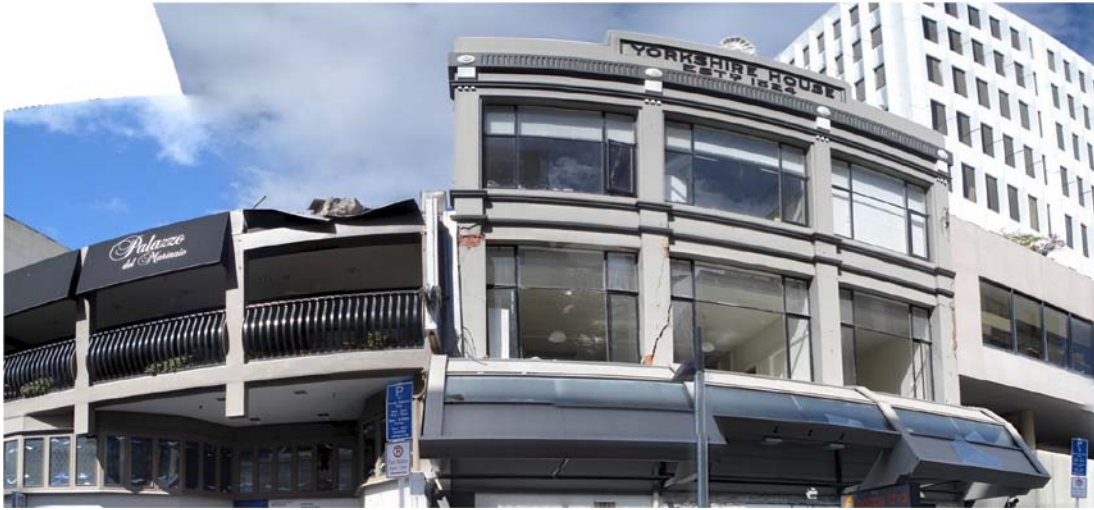
*Figure 5: Pounding damage caused by buildings with greatly differing heights. Note image is distorted due to panoramic photography*

As was also observed in the Darfield earthquake, very little pounding damage was observed between buildings of greatly differing overall heights. This is again primarily attributed to the greater separations that generally surround taller buildings. However, Figure 5 presents one building configuration where extensive pounding damage did occur. Pounding between the central building and the taller rightmost building also occurred in the Darfield earthquake. The damage in the Darfield earthquake was minor, although it was noted that this damage occurred in the vertical elements of the primary gravity structure [3].

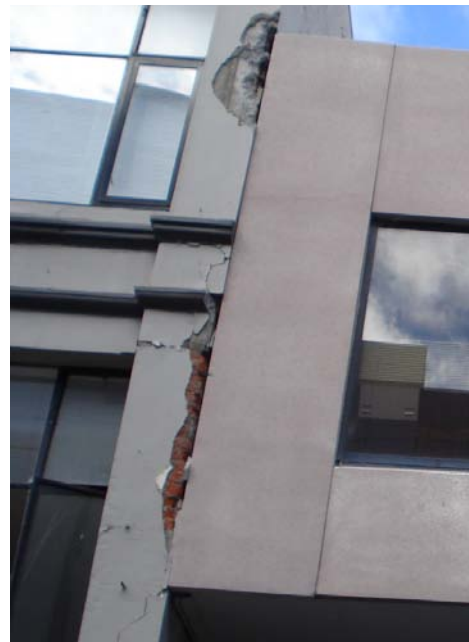
*Figure 6: Damage between central and rightmost building*

The Christchurch earthquake significantly increased the damage in the central building, and also caused damage at the boundary with the leftmost building. At the right interface of the central building the observed damage is predominantly spalling (Figure 6), although cracking also extended below the contact interface. The damage at the left interface is more severe. The masonry column of the central building has been offset approximately 30 mm due to collision with the left building. It is considered that the central building was crushed by the surrounding buildings, primarily due to the greatly differing earthquake response of the taller rightmost building.

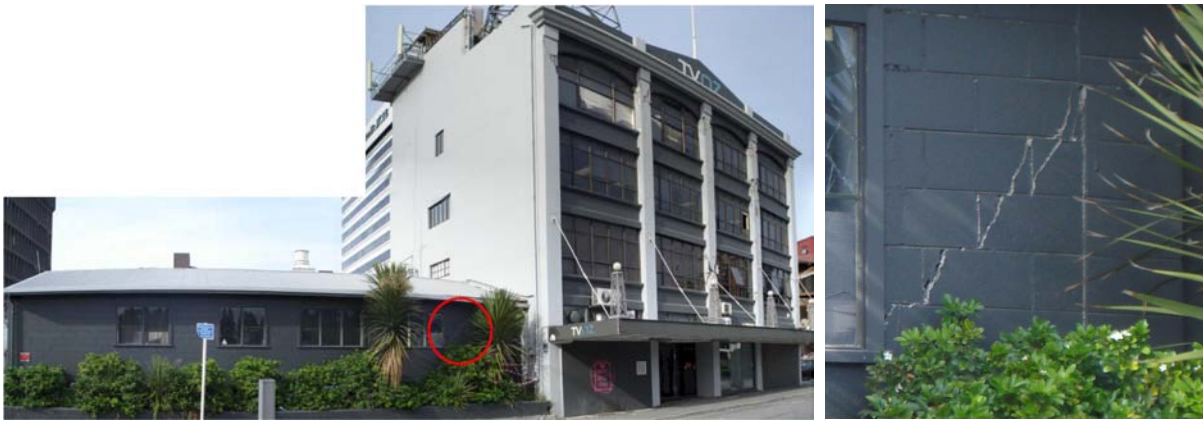
**Figure 7: Pounding between 1 storey and 4 storey buildings. Damage to four storey building not attributed to pounding**

The range of buildings affected by pounding sometimes extended to buildings where pounding would not normally be anticipated. One single storey building was observed to suffer substantial pounding damage as a result of contact with a neighbouring four storey building (Figure 7). The neighbouring four storey building was substantially damaged during the Christchurch earthquake, however this damage is not attributed to pounding. As a result of this damage, the lateral stiffness of the neighbouring building reduced, causing greater building deflection. It is considered that this effect has increased building damage, although its significance is unknown. Approximately 10 mm building separation was observed between these buildings.

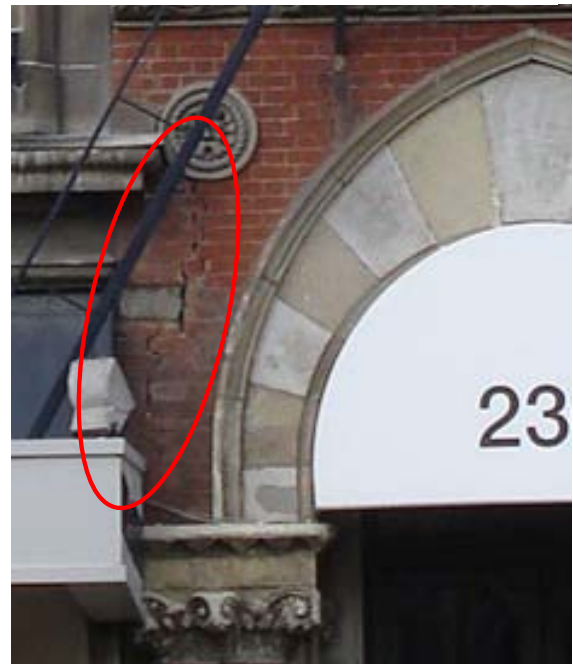
**Figure 9: Masonry damage after the Darfield earthquake**

The second building configuration suffering collapse was also documented after the Darfield earthquake, as shown in Figure 9 (see also Figure 2 in [3]). Figure 10 displays the damage following the Christchurch earthquake. Figure 9 is located at the first floor between the left and central buildings, and is quite possibly the initiation point of the global collapse.

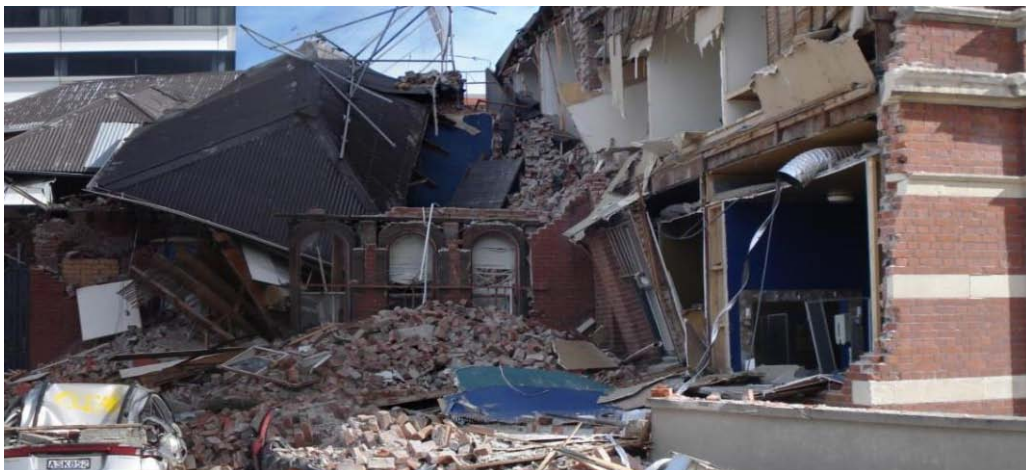
Two building collapses within the CBD are partially attributed to pounding. Both these cases involve URM buildings that were constructed circa 1900. Figure 8 illustrates the damage caused to a two storey URM building that sustained pounding during the Christchurch earthquake (shown on the left). Significant damage has also been sustained by the adjacent right building. These buildings were externally surveyed after the Darfield earthquake and were found to be separated by approximately 50 mm at ground level, but were in contact at roof level. It was concluded that the two storey building had begun to lean, although whether this was due to the Darfield earthquake could not be determined. As these buildings were in contact, pounding undoubtedly occurred during the Christchurch earthquake. However, the primary cause of collapse is attributed to the URM construction. Whether pounding appreciably contributed to this collapse is very difficult to determine, due to the level of destruction that has occurred.

**Figure 8: Two storey building collapse involving pounding. Primary cause of collapse is attributed to URM construction**

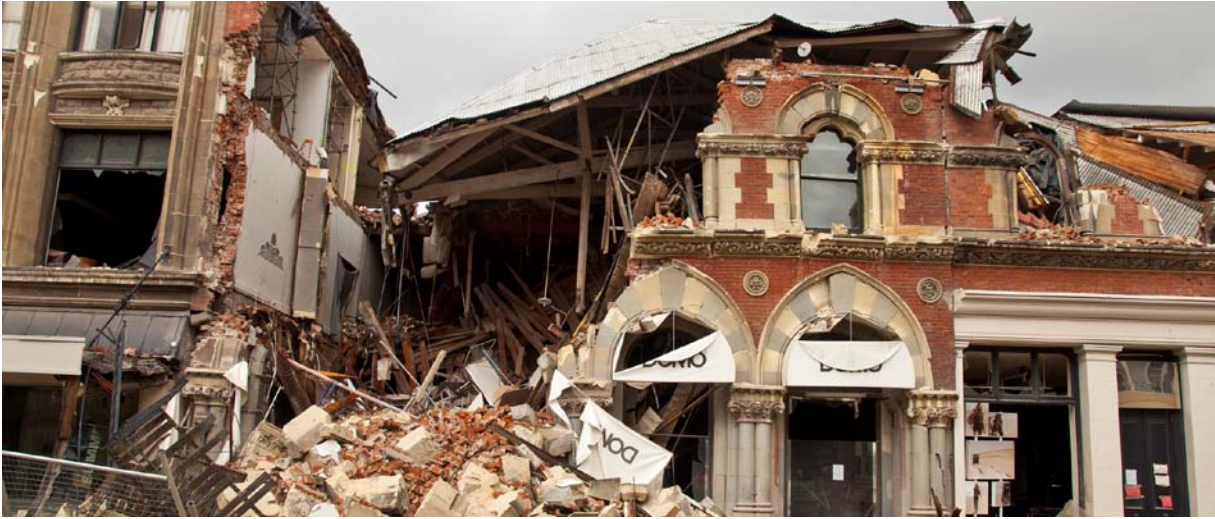
**Figure 10: Building collapse involving building pounding. Primary cause of collapse is attributed to URM construction. Photo courtesy of Colin Monteath, Hedgehog House.**

The damage shown in Figure 10 indicates that the central and leftmost buildings were likely to be constructed with a shared party wall. This can be observed where wall sections remain standing at the building interface. At the second level, a 100 mm thick brick wall appears to have supported both buildings. This evidence is also supported by the interior finishings that can be observed on the 'exterior' of this wall. Nevertheless, localised damage consistent with pounding is present between the central and rightmost buildings. Once again it is difficult to discern the level of influence pounding has had on the presented collapse. The primary cause of collapse is attributed to the URM construction. However, it is credible that the severity of this damage would have been greatly reduced if adjacent buildings had not been present.

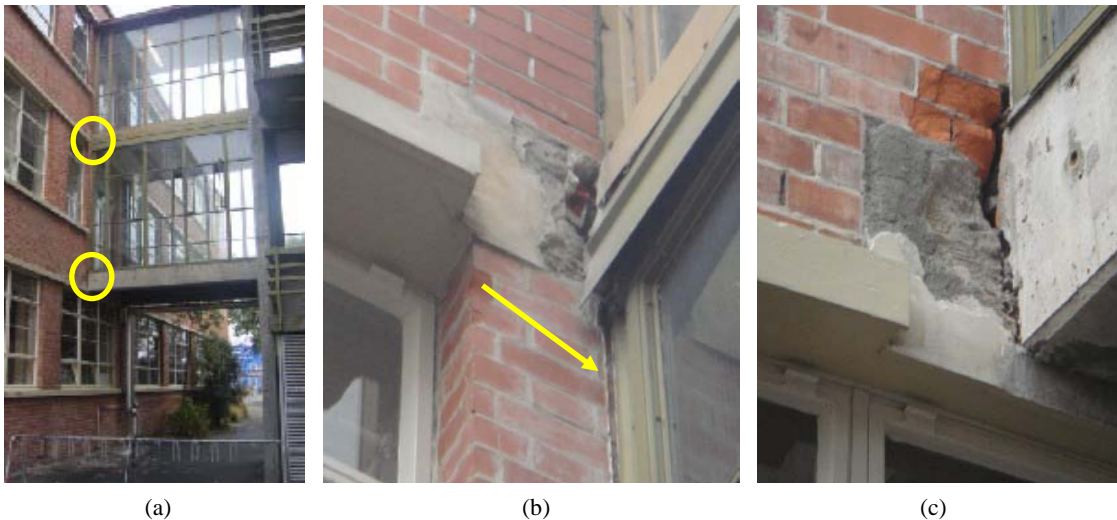
**Figure 11: Pounding damage to buildings at the Christchurch Polytechnic Institute of Technology. (a) Adjacent buildings with pedestrian bridges, (b) upper and (c) lower pounding locations.**

Pounding between adjacent buildings can be avoided if a sufficient gap exists. In some cases, however, although the adjacent buildings are well separated, pounding can still take place. This is the case when the buildings are linked by pedestrian bridges as the buildings at the Christchurch Polytechnic Institute of Technology along the Madras Street in Figure 11(a) show. The upper and lower pounding locations are indicated by the circles. The damage due pounding of the upper floor of the pedestrian bridge is displayed in Figure 11(b). The residual opening relative movement can also be clearly seen indicated by the arrow. Figure 11(c) shows the damage to the unreinforced masonry wall due to pounding of the lower RC floor of the pedestrian bridge. In the case considered both adjacent buildings have different fundamental periods owing to their dissimilar building configuration, and thus different oscillation pattern are to be expected. Previous studies on pounding responses between buildings linked by pedestrian bridges in near-source earthquakes have shown that neglecting of soil-foundation-structure interaction can underestimate pounding potential and also the induced vibrations in the buildings [6].

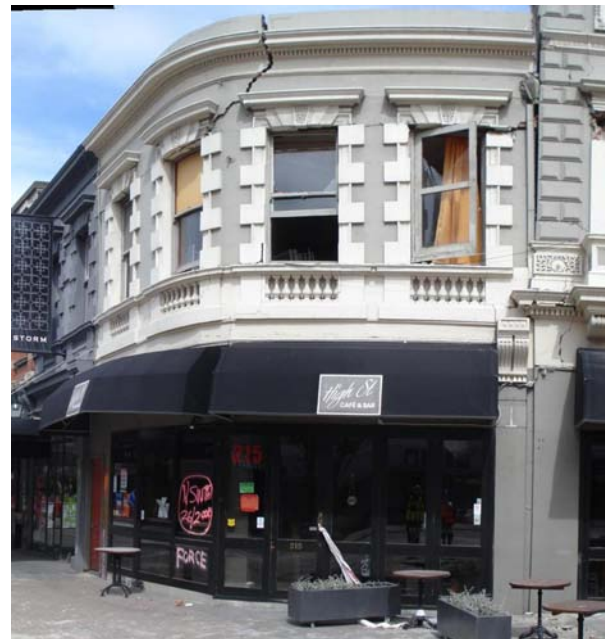
Figure 12 Possible torsional building pounding due to irregular plan layout

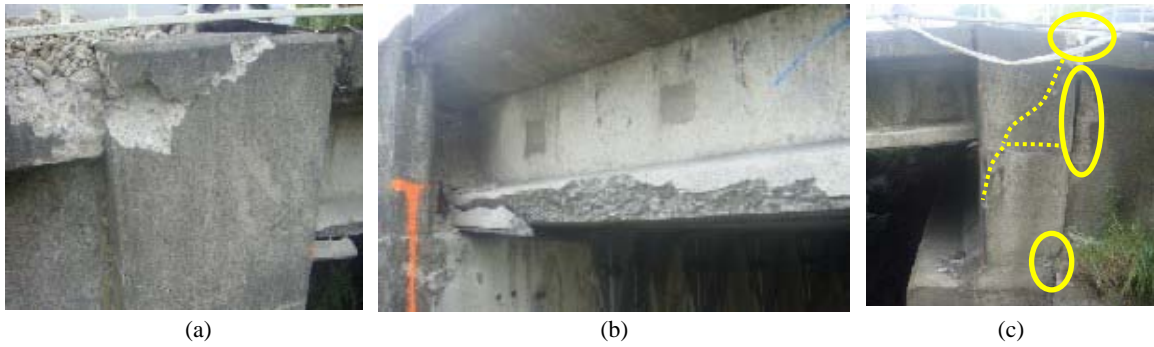
**Figure 13: Fitzgerald Avenue Bridge. Pounding damage (a) at the abutment, (b) to the immediate adjacent girder and (c) to the other abutment.**

Although the Christchurch earthquake did not cause spectacular damage to bridge structures due to their relative movement, i.e. bridge collapses due to pounding and unseating of the bridge deck such as observed in the 1995 Kobe earthquake in Japan [9], the 1999 Chi-Chi earthquake in Taiwan [10] or the 2010 Maule earthquake in Chile [11], the very short but strong pulses still caused pounding damage to a number of bridge structures in Christchurch and surroundings. Figure 13(a) shows the pounding damage to the abutment of the Fitzgerald Avenue Bridge. The damage to the immediate adjacent girder can be seen in Figure 13(b). The pounding caused a spill of the edge of the girder. Damage to the other abutment in Figure 13(c) occurred even along the entire height of the abutment wall as indicated by the circles. The cracks of the wall are indicated by the dotted lines. It should be noted that lateral spreading of the ground surface due to soil liquefaction occurred in the surroundings. This spatial variation of the ground movements might have amplified the relative movement between the two bridge structures and contributed to the poundings.

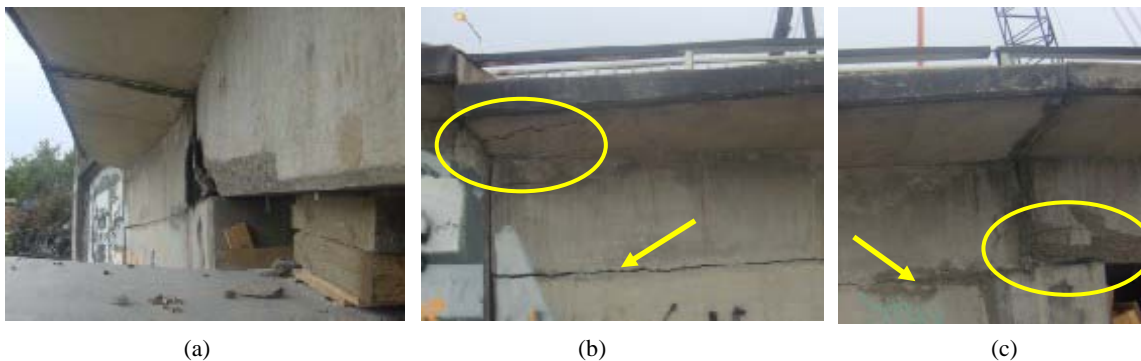
In Figure 14 the significant damage to the Ferrymead Bridge can be observed. The bridge is very valuable since each day approximately 30,000 vehicles were using the bridge that links Christchurch and Lyttelton. Severe soil liquefaction has been observed in the area, and thus behaviour similar to the Fitzgerald Avenue Bridge was expected. Figure 14(a) shows pounding induced spalling at the edge of the girder of the Ferrymead Bridge, which is similar to that observed at Fitzgerald Avenue Bridge (Figure 13(a)). The effect of the unequal soil settlement might also have amplified the closing relative movement as one can observe in Figure 14(b). The damage due to pounding to the upper deck is indicated by the circle. The closing relative movement caused a large horizontal crack at the interface between the upper deck and the supporting abutment as indicated by the arrow. Direct damage at the pounding location can be seen in Figure 14(c) (marked by a circle). The horizontal crack in the abutment due to the pounding is indicated by the arrow.

**Figure 14: Ferrymead Bridge. Pounding damage (a) to girder, (b) at abutment and (c) at girder-abutment location.**
