Geotechnical Aspects of the M_w 6.2 2011 Christchurch, New Zealand Earthquake

ABSTRACT

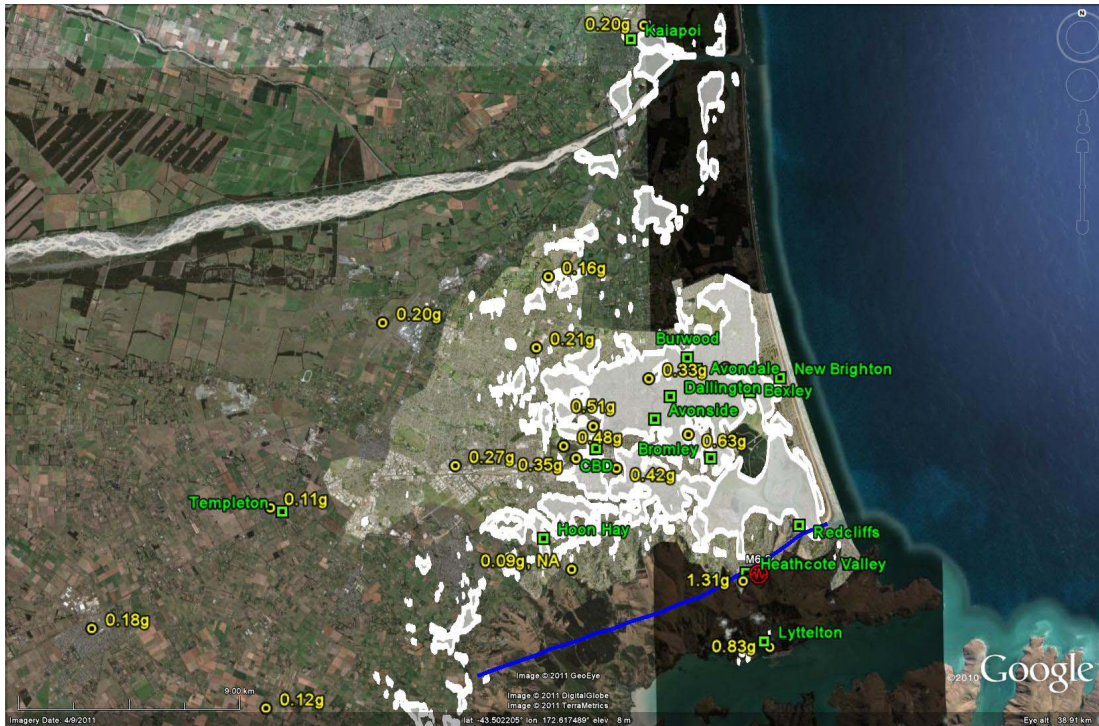
As shown in Figure 1, the earthquake motions were recorded by a network of strong ground motion stations distributed throughout the region. Representative geometric means of the recorded peak horizontal ground motion accelerations (PGAs) were 1.31 g in the epicentral region, 0.42 g in the CBD, 0.20 g in Kaiapoi (north of Christchurch), and 0.11 g in Templeton (west of Christchurch).

Figure 1. Aerial image of Christchurch showing the ruptured Port Hills fault segment, epicenter, strong ground motion stations and the geometric means of peak horizontal accelerations, and zones that liquefied (white shading).

As shown in Figure 1, the Christchurch earthquake caused widespread liquefaction in the eastern part of Christchurch and in Kaiapoi (Green et al., 2011a; Orense et al., 2011). The induced liquefaction during this event was more widespread and severe in developed areas than it was during the Darfield earthquake. Of particular significance is that liquefaction occurred in portions of the CBD during the Christchurch earthquake that did not liquefy during the Darfield earthquake (Cubrinovski et al., 2011a).

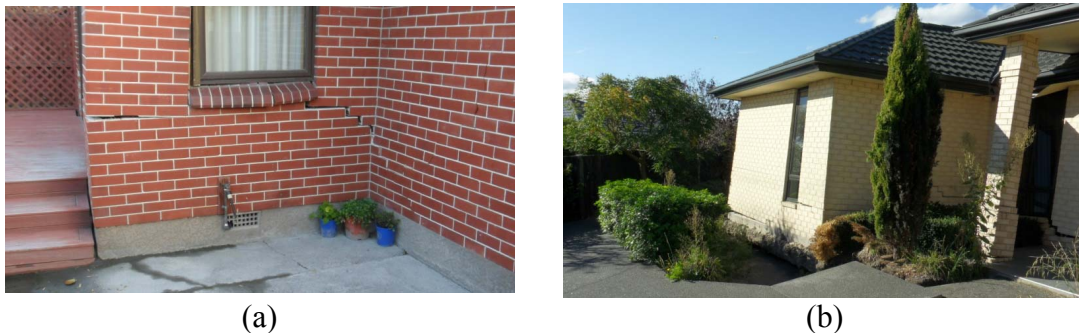
In total, nearly 15,000 residential houses and properties were severely damaged due to liquefaction and lateral spreading, with more than half of these damaged beyond economical repair. As shown in Figure 2a, the severity of the liquefaction led to large settlements of many houses including differential settlements that caused foundation and structural damage. Lateral spreading also damaged many residences, as shown in Figure 2b for example. (Note that the houses in Figure 2 were initially damaged during the Darfield earthquake and further damaged during the Christchurch earthquake, as were many residences throughout the region.). Lateral spreading ranged from a few tens of centimeters, up to 2 m at river banks and extended as far as 200-300 m inland from waterways.

Figure 2. Examples of liquefaction damage to houses in: (a) Hoon Hay with differential settlement, and (b) south Kaiapoi with lateral spreading.

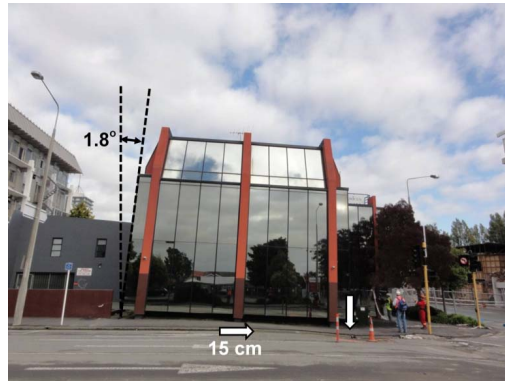
Figure 3 shows a three-story building in the CBD founded on a shallow foundation that was damaged by liquefaction. The building translated and rotated towards an abandoned channel of the Avon River (Cubrinovski et al., 2011a). The

photograph was taken facing west and the abandoned river channel is north (or to the right) of the building. There was a large volume of sand ejecta at the northern part of the building. Ground tension cracks propagating east of the building and in the rear car-park are consistent with the lateral movement towards the north. The building has since been razed.

Figure 3. Three-story building in the CBD that was adversely impacted by liquefaction and has since been razed.

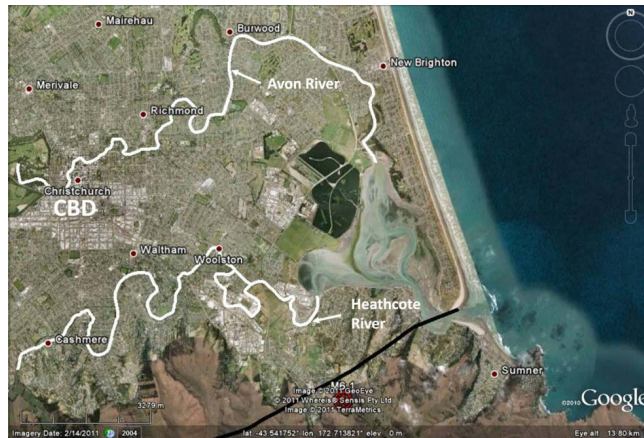
spreading, compression or slight slumping of approach material, and minor cracking in abutments. All bridges were single span and all were passable to recovery vehicles soon after the event. Compared to the Avon River bridges, those crossing the Heathcote River (Figure 4) suffered much less damage. Apart from the Ferrymead Bridge at the mouth of the Heathcote, all bridges were either undamaged or experienced only minor damage. Typical damage was approach settlement, with little impact on the bridge abutments and superstructure.

Figure 4. Aerial image of Christchurch with the Avon and Heathcote Rivers.

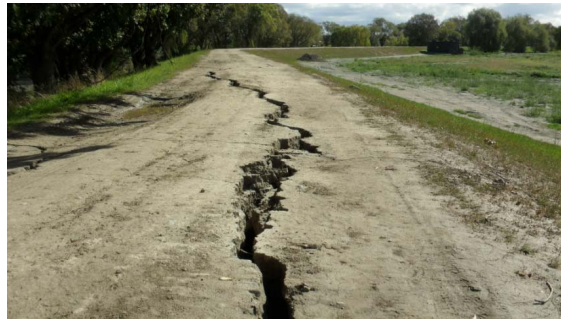
The majority of the damage to the levees during the Christchurch earthquake was a consequence of liquefaction in the foundation soils that resulted in lateral spreading, slumping, and/or settlement (Green et al., 2011b). Longitudinal cracks were observed along the crest of the levees (e.g., Figure 5). Transverse cracks in the levees were less commonly observed than longitudinal cracks and were often associated with sharp bends along the length of the levees and/or slumping of the embankment. Because these cracks provide a direct seepage path from one side of the levee to the other, they can severely impact the functionality of the levees. Even transverse cracks having minor widths could potentially rapidly enlarge due to

internal erosion and piping at high river levels and lead to the failure of that section of the levee.

Figure 5. Example of longitudinal cracks running along the crest of the levee.

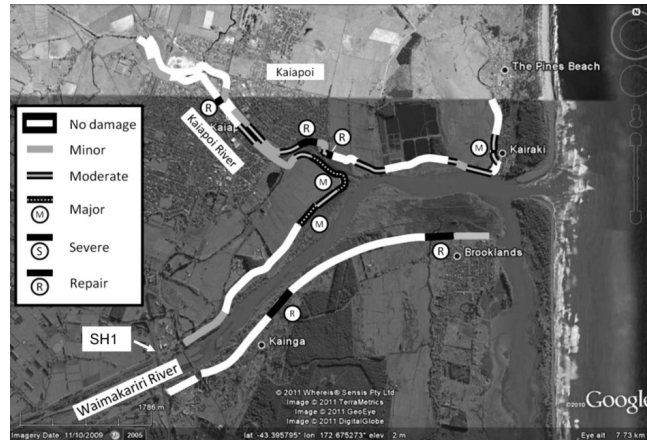
The majority of levee damage from the Christchurch earthquake occurred east of State Highway 1 (SH1) as shown in Figure 6. In this figure, damage severity is categorized using the scale developed by Riley Consultants (2011). The scale has five grades that range from No Damage to Severe Damage, as summarized in Table 1. The damage patterns shown in Figure 6 are very similar to those from the Darfield earthquake, but are in general less severe for the Christchurch earthquake. Note that some portions of the levees were already under repair by the time of the authors' reconnaissance inspection following the Christchurch earthquake. In these cases, the authors supplemented their field observations, to the extent possible, with both observations from high-resolution aerial images taken the day after the Christchurch earthquake and field observations made by ECan consultants, Riley Consultants (2011).

Figure 6. Observed damage to levees following the Christchurch earthquake. (Adapted from Green et al., 2011b and Riley Consultants, 2011).
