## Liquefaction Impacts on Pipe Networks

# **LIQUEFACTION IMPACTS ON PIPE NETWORKS**

## **Short Term Recovery Project No. 6 Natural Hazards Research Platform**

**December 2011**

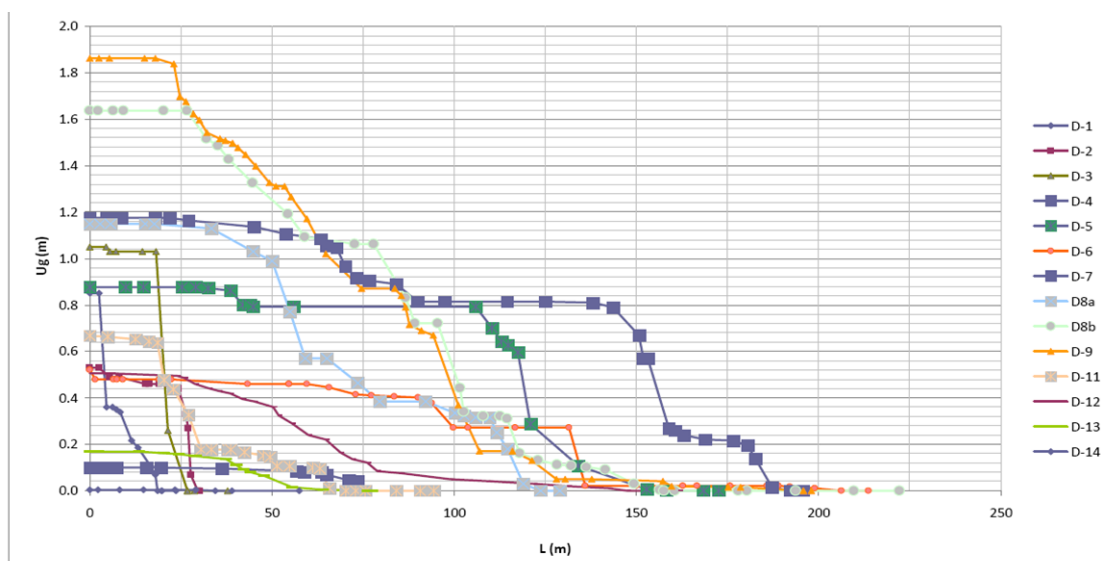
Figure 9 shows measured lateral spreading displacements along Avon River in Dallington due to the 4 September 2010 earthquake. They illustrate that at some locations the banks of the river moved laterally as much as two metres. The magnitude of spreading displacement typically decreases with the distance from the waterway and the spreading extended up to a distance of 100-250 m from the waterway.

**Figure 9. Permanent lateral ground displacements due to spreading along Avon River in Dallington caused by the 4 September 2010 earthquake (plotted as a function of the distance from the waterway)**

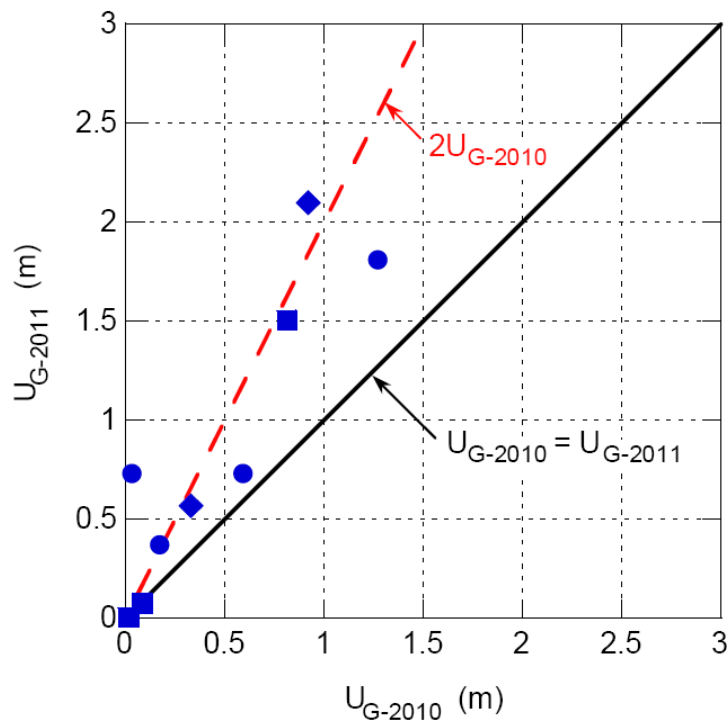
After the 22 February 2011 earthquake, the ground surveying measurements were repeated at 25 locations to quantify the additional lateral ground movements due to spreading induced by the February event. Figure 10 comparatively shows the spreading displacements induced by the two earthquakes at nine locations along Avon River. Here the horizontal axis indicates the displacement induced by the 4 September 2010 earthquake while the vertical axis indicates the cumulative displacements due to both earthquakes. The contribution of all aftershocks preceding the 13 June earthquakes to the cumulative displacements shown in the vertical axis is considered negligible. The results indicate that the lateral spreading displacements along Avon River induced by the 22 February 2011 earthquake where of similar magnitude with those induced by the 4 September 2010 earthquake.

**Figure 10. Comparison of permanent lateral ground displacements along Avon River (Avonside, Dallington, Bexley) caused by the 4 September 2010 earthquake (horizontal axis) and cumulative displacements due to the 4 September 2010 and 22 February 2011 earthquakes (vertical axis)**

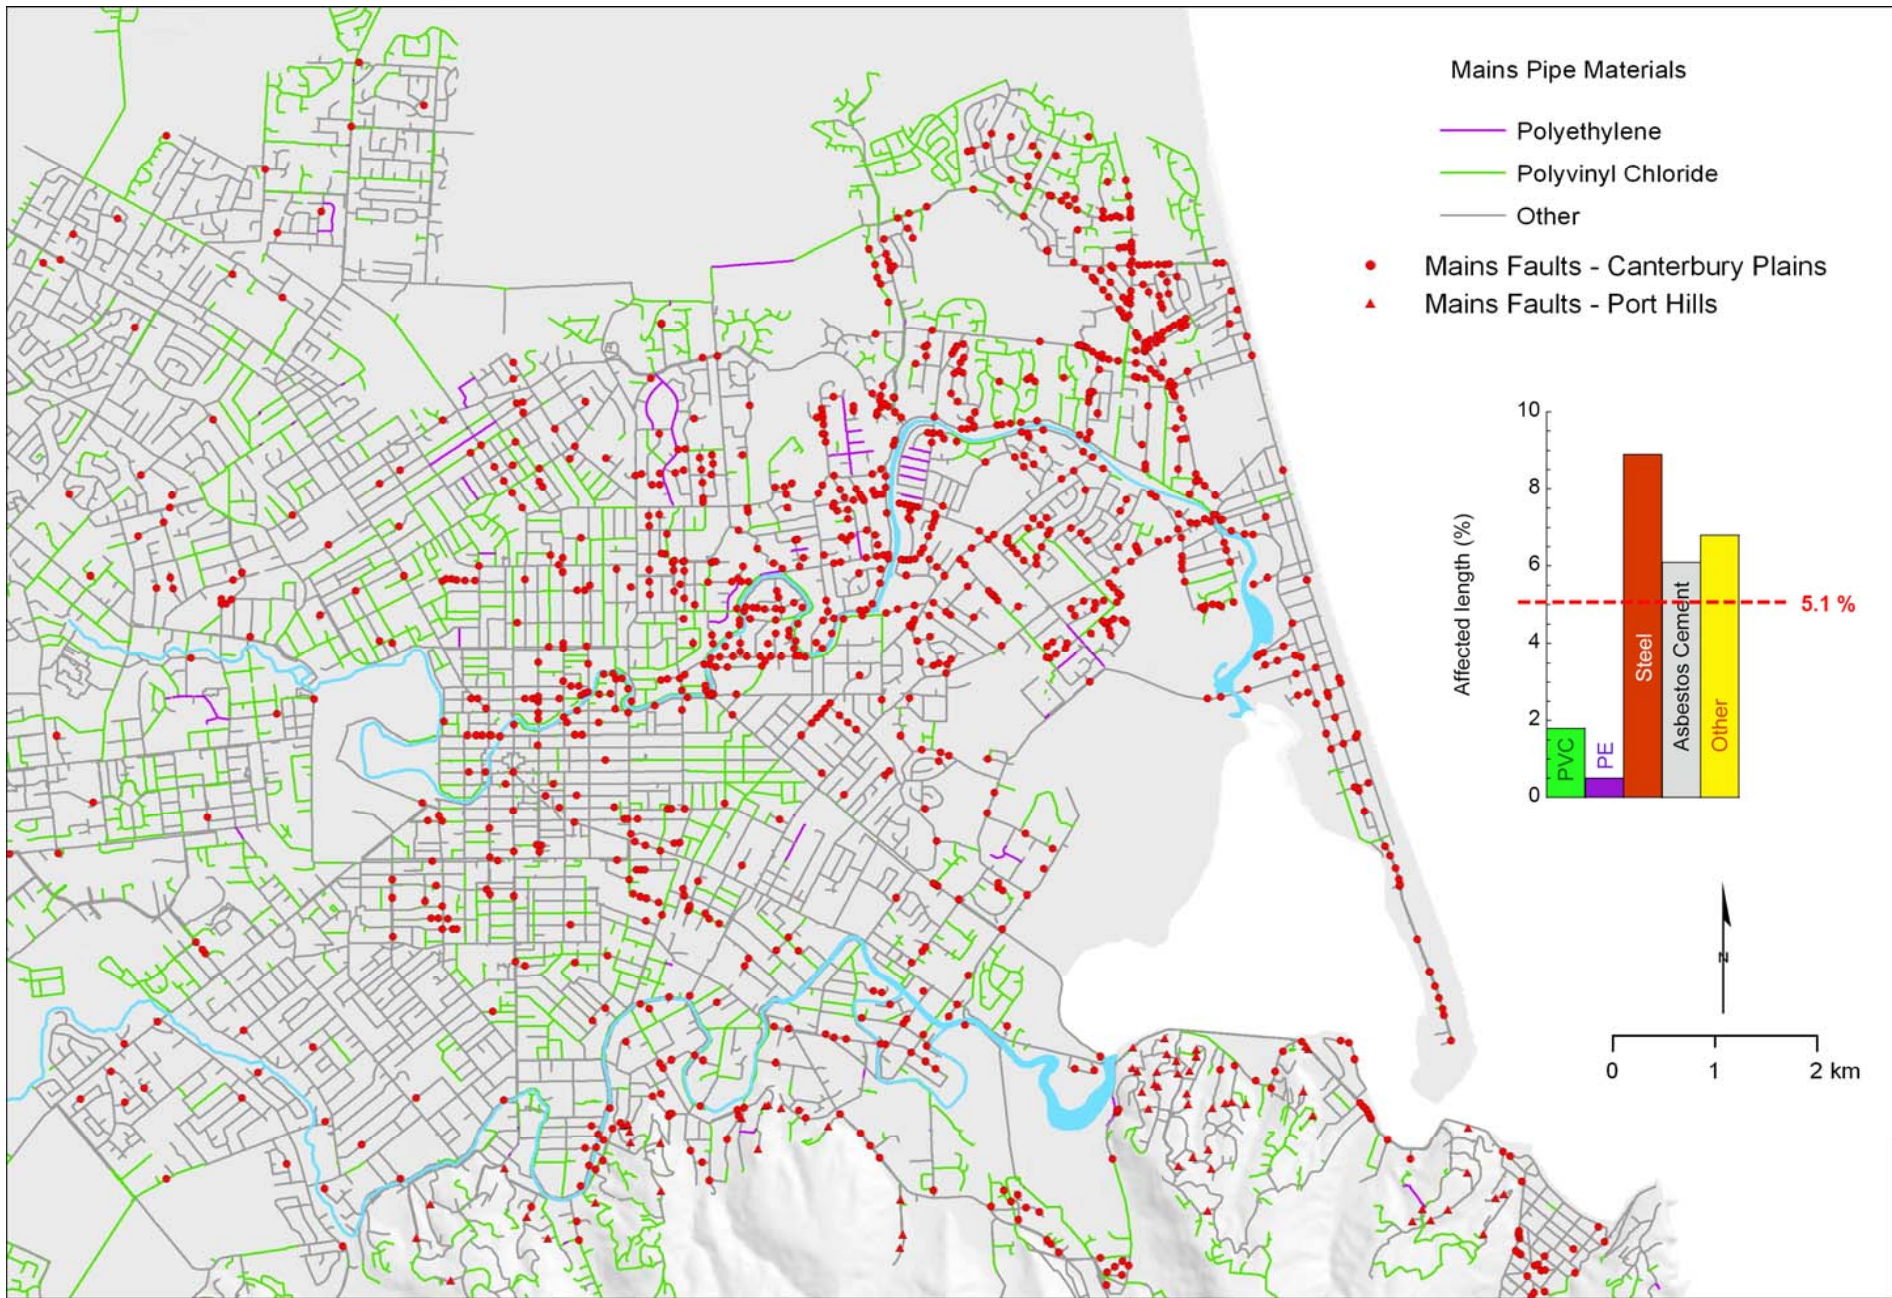
Figure 16 shows the location of repairs/faults on the watermains network following the 22 February 2011 earthquake. In the background GIS layer the pipe materials are indicated with different colours. In the inset of the figure, the performance of different pipe materials is summarized with a bar chart (for areas in the plains, excluding the hills). It shows that 5.1% of the total length of watermains was damaged, or 77.5 km out of 1511 km considered in the analysis. Steel pipes suffered the largest damage (8.9%), followed by AC pipes and other material pipes (6.1% and 6.8%, respectively), whereas much better performing were the PVC (1.8%) and PE (0.5%) pipes. The results of the analyses are summarized in Table 2. It is noted that the sample lengths of PE and S pipes are considered insufficient for a robust statistical analysis and hence the respective results should be treated with caution.

Figure 16. Locations of repairs/faults (indicated by red symbols) on the Christchurch watermain network following the 22 February 2011 earthquake

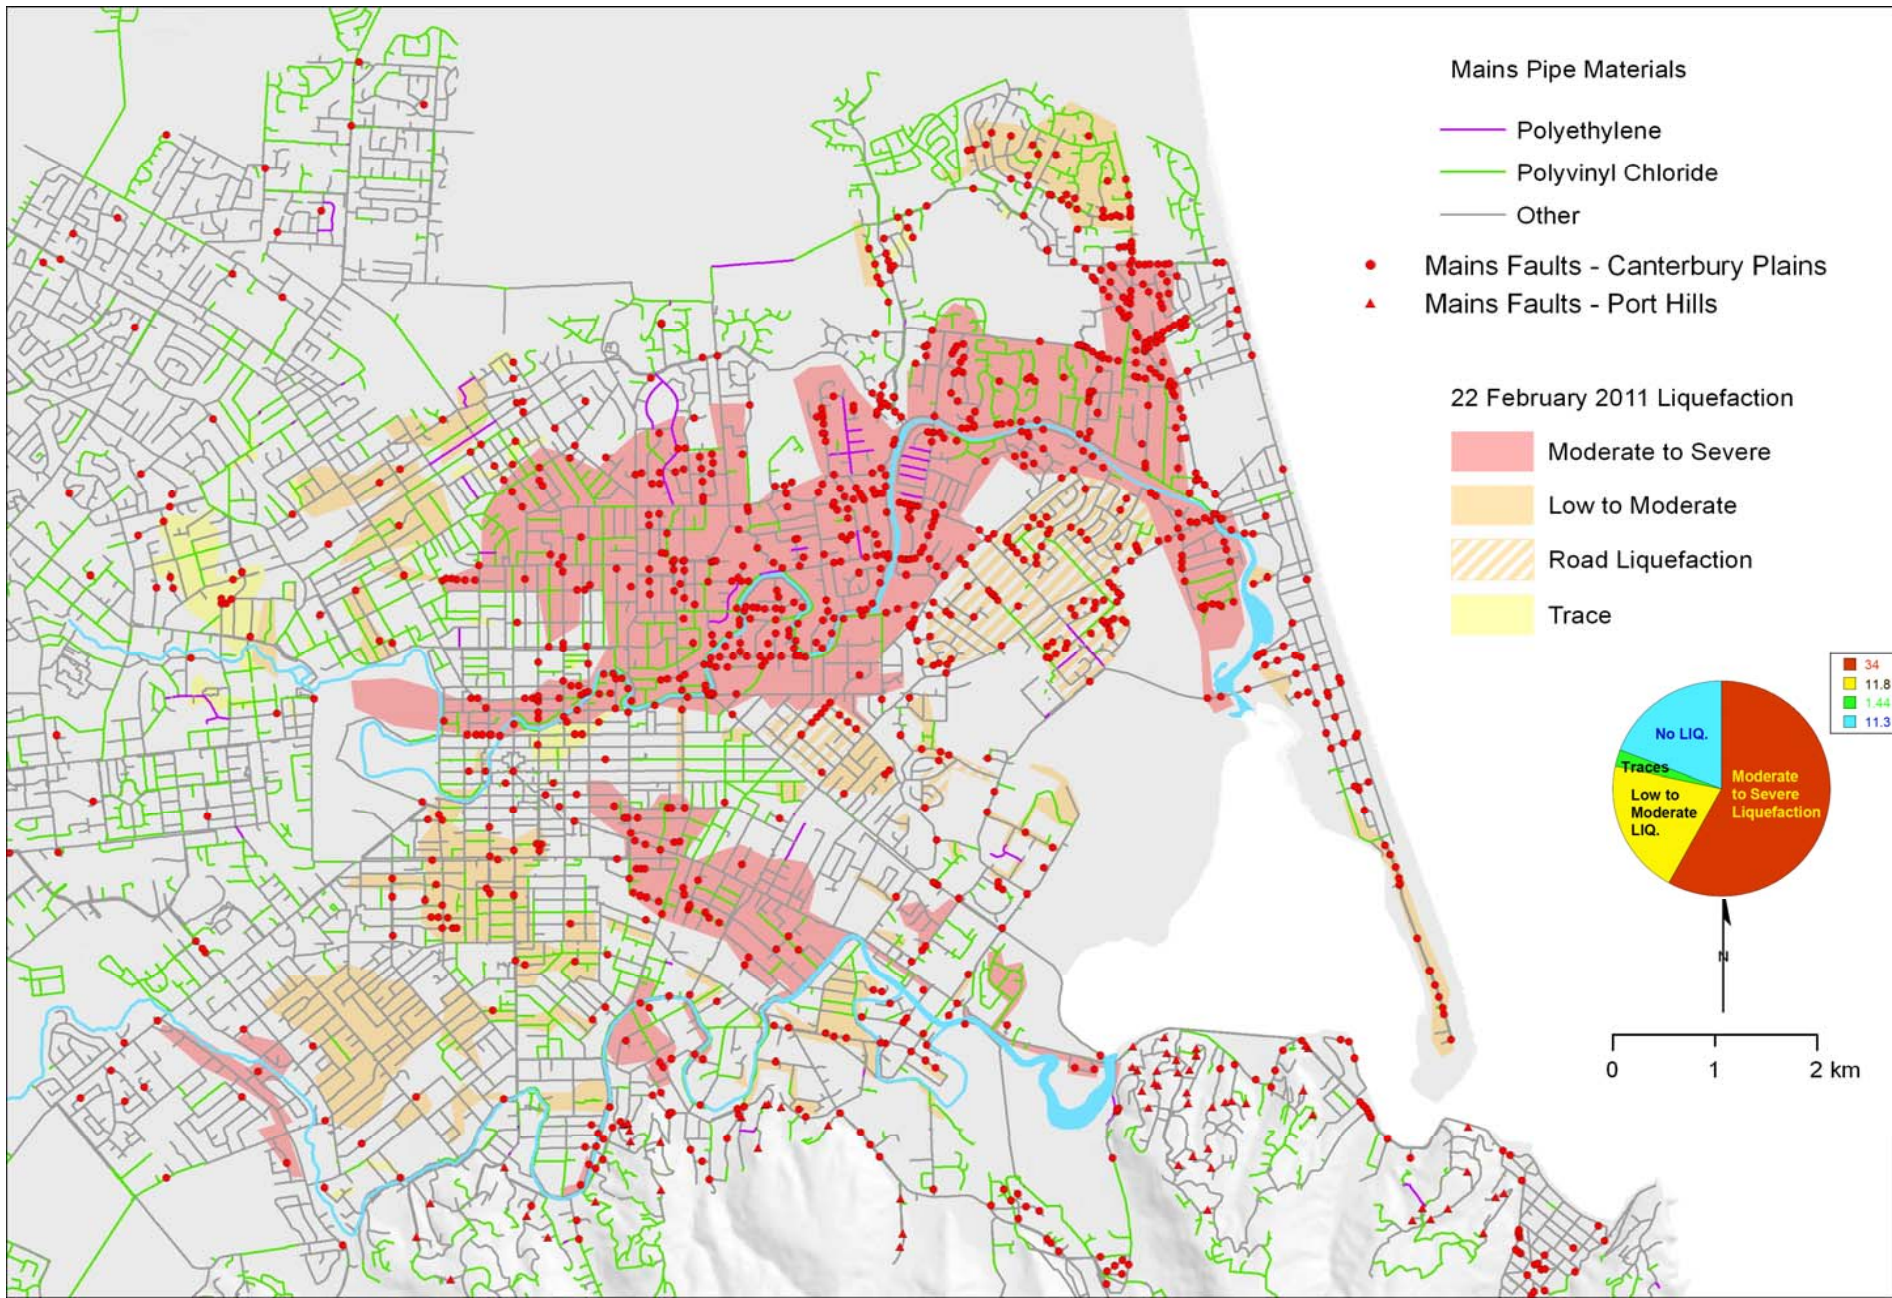
Figure 17 shows the same repairs/faults data for the watermains network and 22 February earthquake with the liquefaction map (Figure 6) shown in the background. Using this setup in the GIS framework, it was possible to calculate and correlate the pipe damage with the observed severity of liquefaction. The pie chart shown in the

inset of Figure 17 indicates that 34 km of the damaged pipes or 58% of the damaged length in the area covered by ground surveying (Figure 6) was in areas of moderate to severe liquefaction, 20.2% were in areas of low to moderate liquefaction, 2.5 % in areas where traces of liquefaction were observed and 19.3% in areas where no signs of liquefaction were observed. Hence, there is a clear link between liquefaction severity and damage to the pipe network. To further scrutinize the correlation between the damage to pipes and liquefaction severity, the results are summarized separately for different materials in Table 2 and with a series of bar charts shown in Figure 18. These results indicate the following:

Figure 17. Locations of repairs/faults (red symbols) on the Christchurch watermains network and areas of liquefaction following the 22 February 2011 earthquake

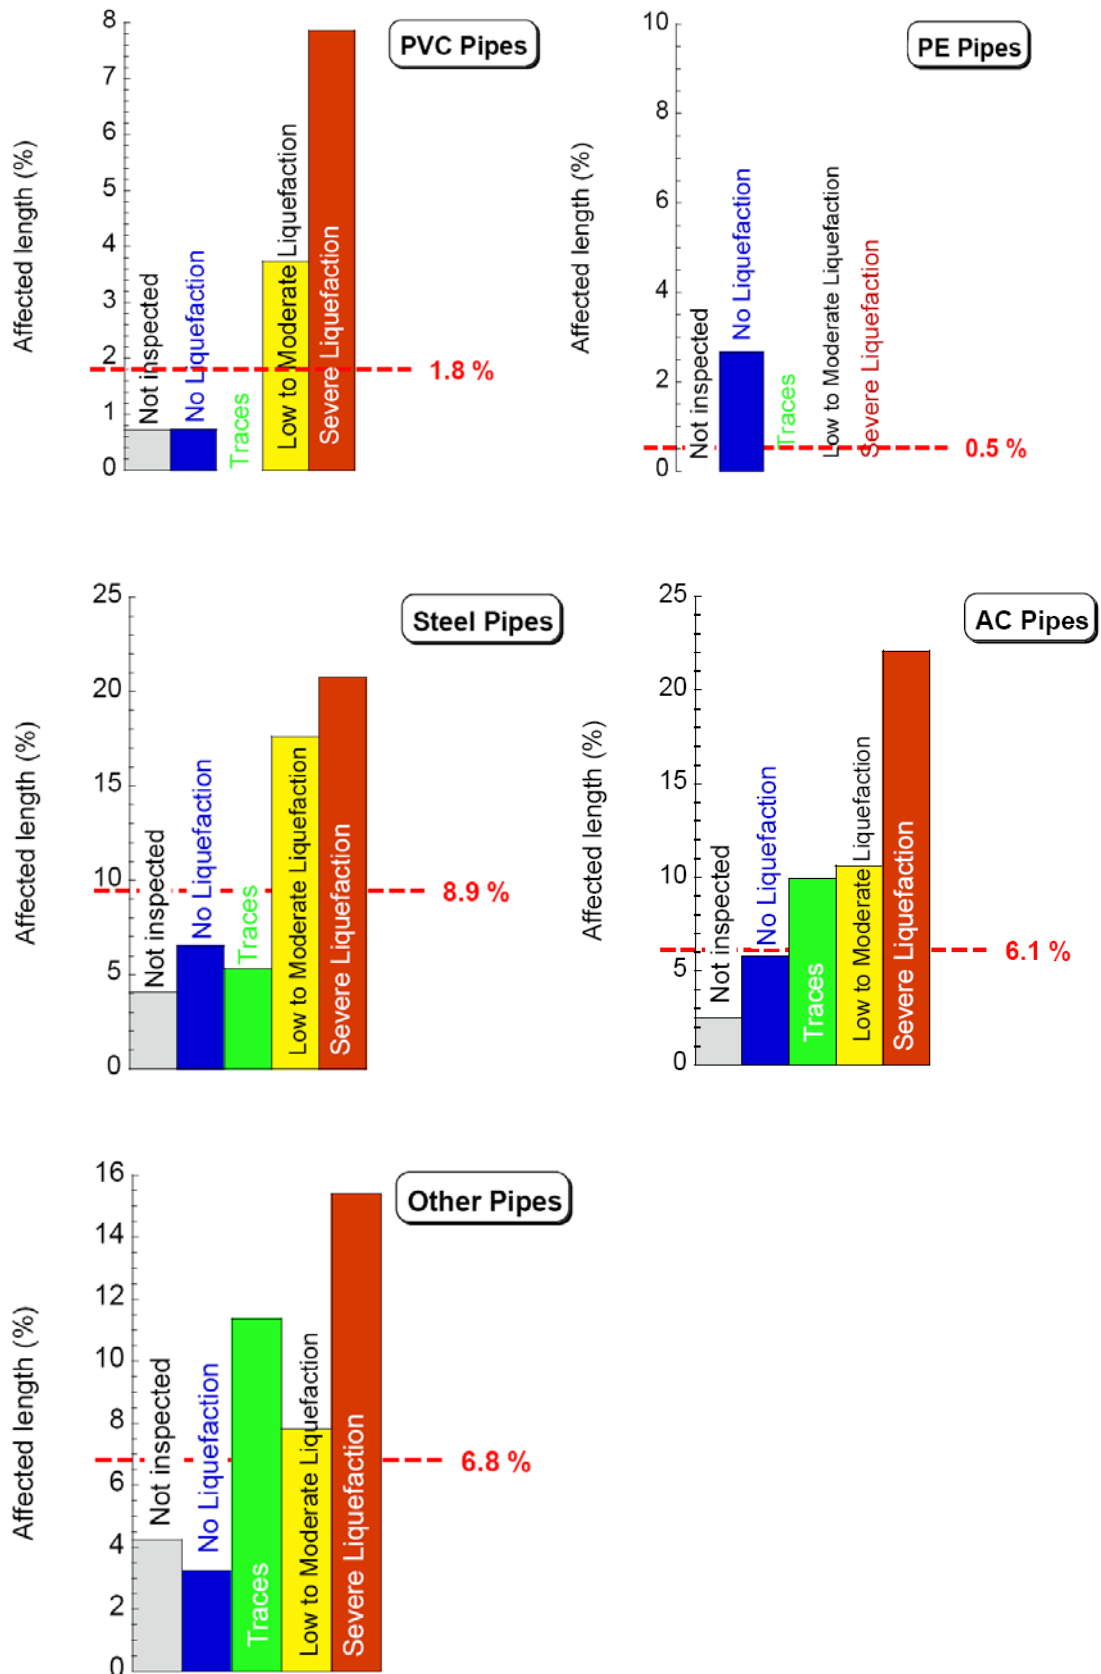
- For all pipe materials except PE pipes, there is a clear increase in the affected length (percentage of damage) with increasing liquefaction severity

- For S, AC and other materials pipes, the percentage of damaged pipes in areas of severe liquefaction was very high, between 15% and 22%.
- PVC pipes suffered two to four times less damage than S, AC and other material pipes

- There is an indication that PE pipes performed well though the sample is too small for any definitive conclusions. For the same reason, the “anomalous” result obtained should be ignored until data and details/reasons for the failure/repair of the short pipe segment of PE pipe in the no liquefaction area are available/clarified.

- The level of pipe damage in no liquefaction and not inspected areas are similar indicating that ground displacements/performance were similar in these areas (with general absence of liquefaction manifestation).

Figure 18. Percentage of length damaged for water mains due to the 22 February earthquake, for different pipe materials and liquefaction severity (dashed red lines represent the average affected length across all ground damage levels).

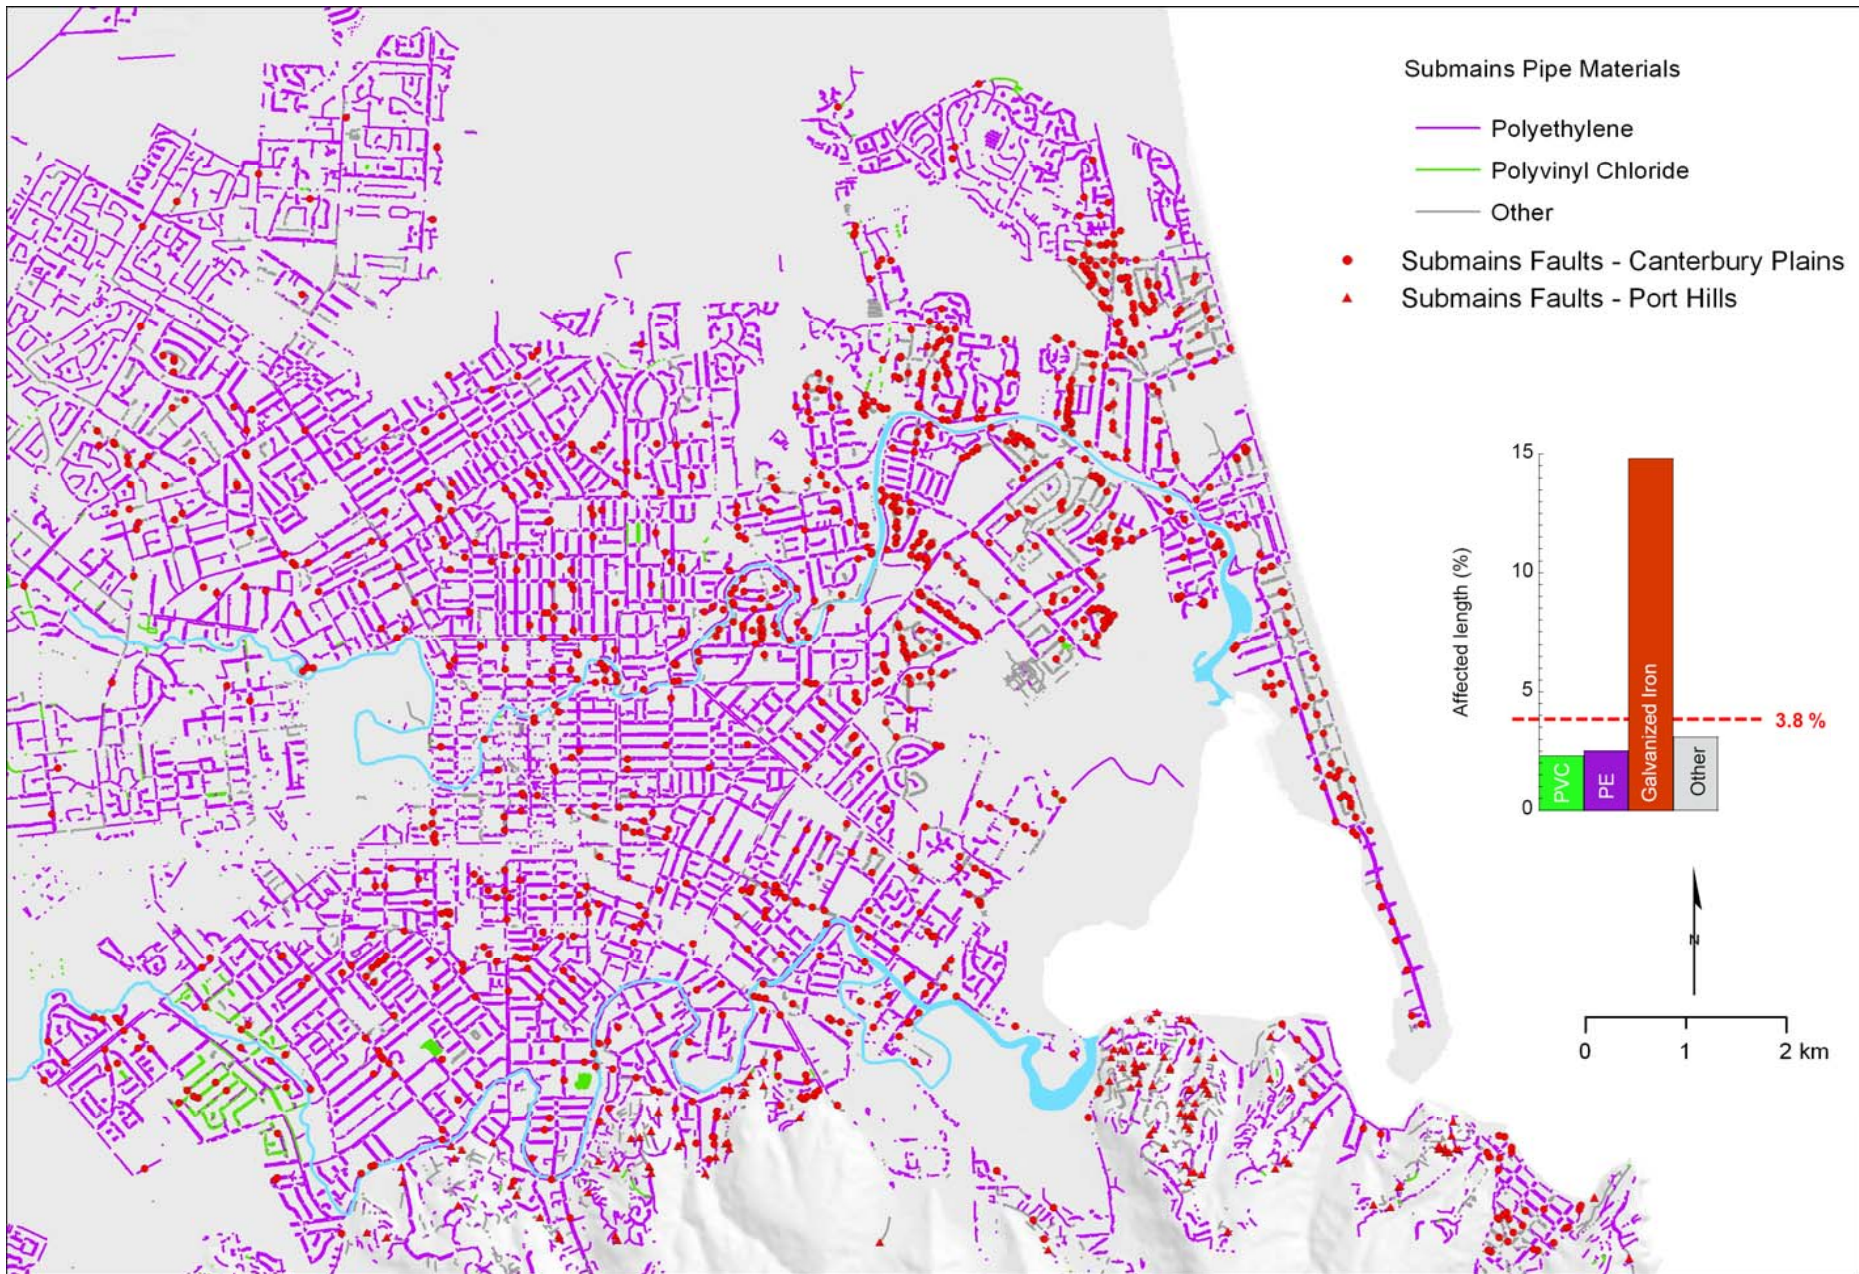
Figure 19. Locations of repairs/faults (red symbols) on the Christchurch submains network following the 22 February 2011 earthquake

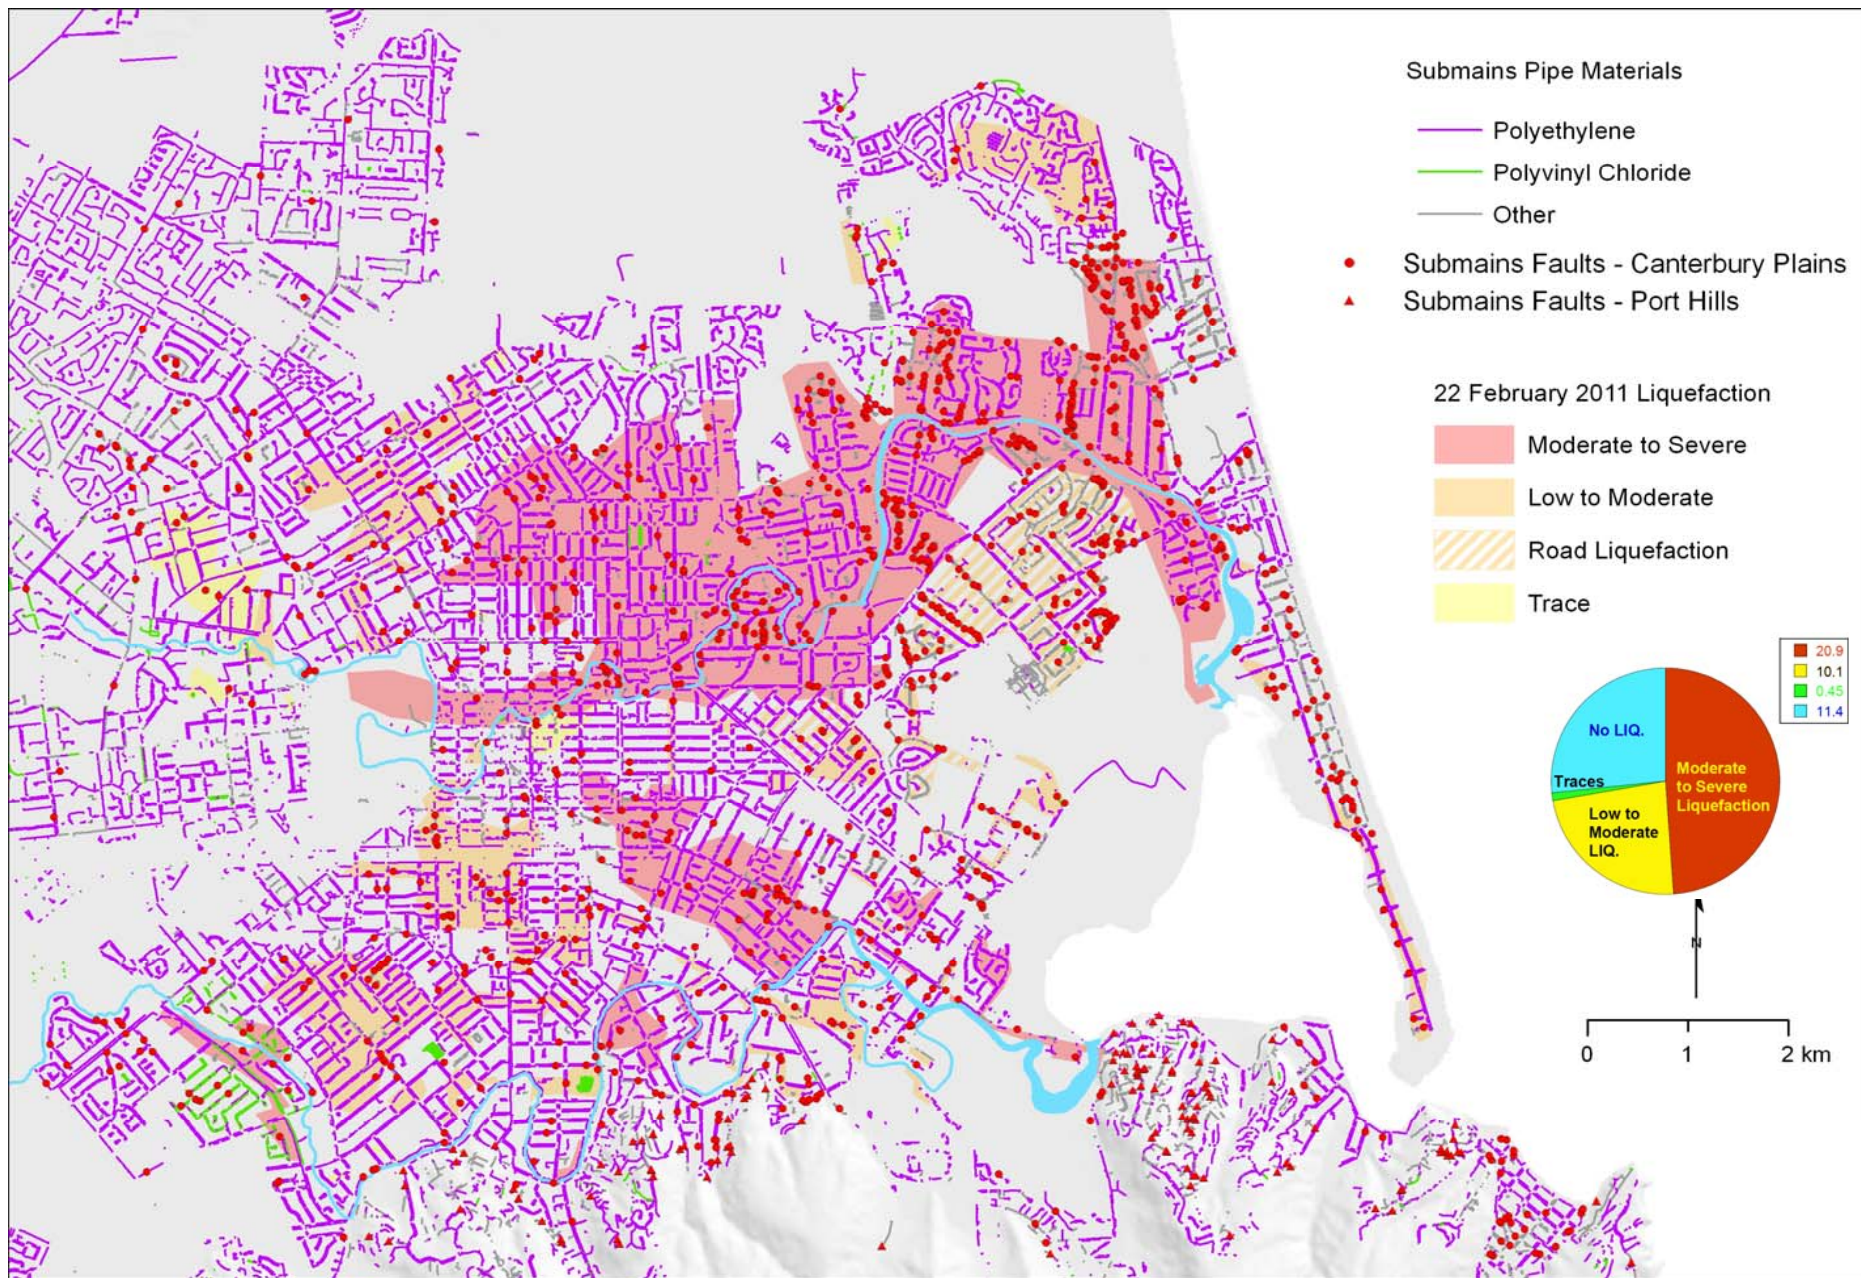
Figure 20. Locations of repairs/faults (red symbols) on the Christchurch submains network and areas of liquefaction following the 22 February 2011 earthquake

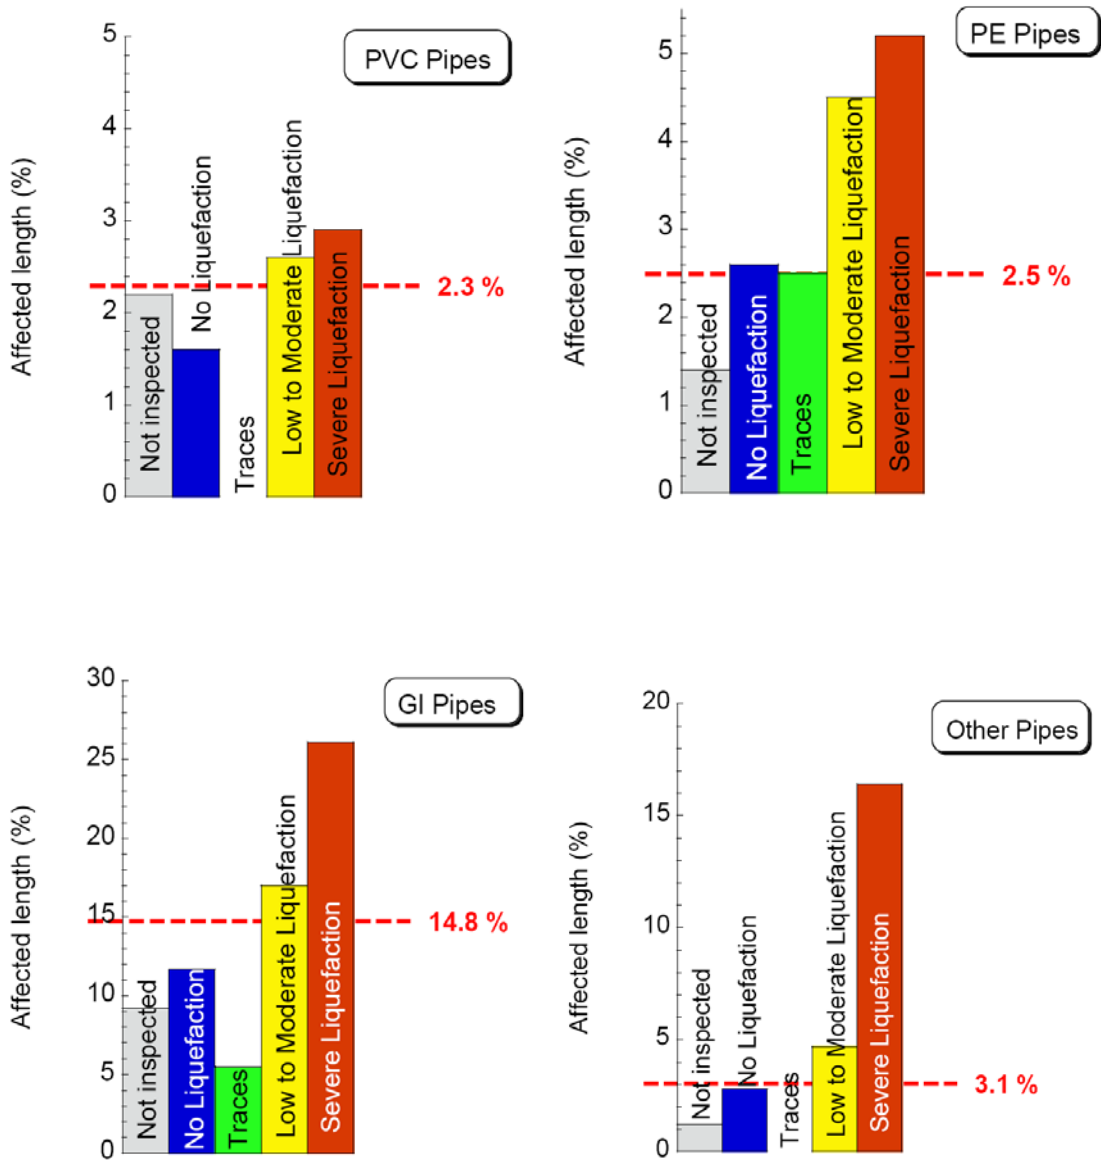
**Figure 21.** Percentage of length damaged for submains due to the 22 February earthquake, for different pipe materials and liquefaction severity (dashed red lines represent the average affected length across all ground damage levels).

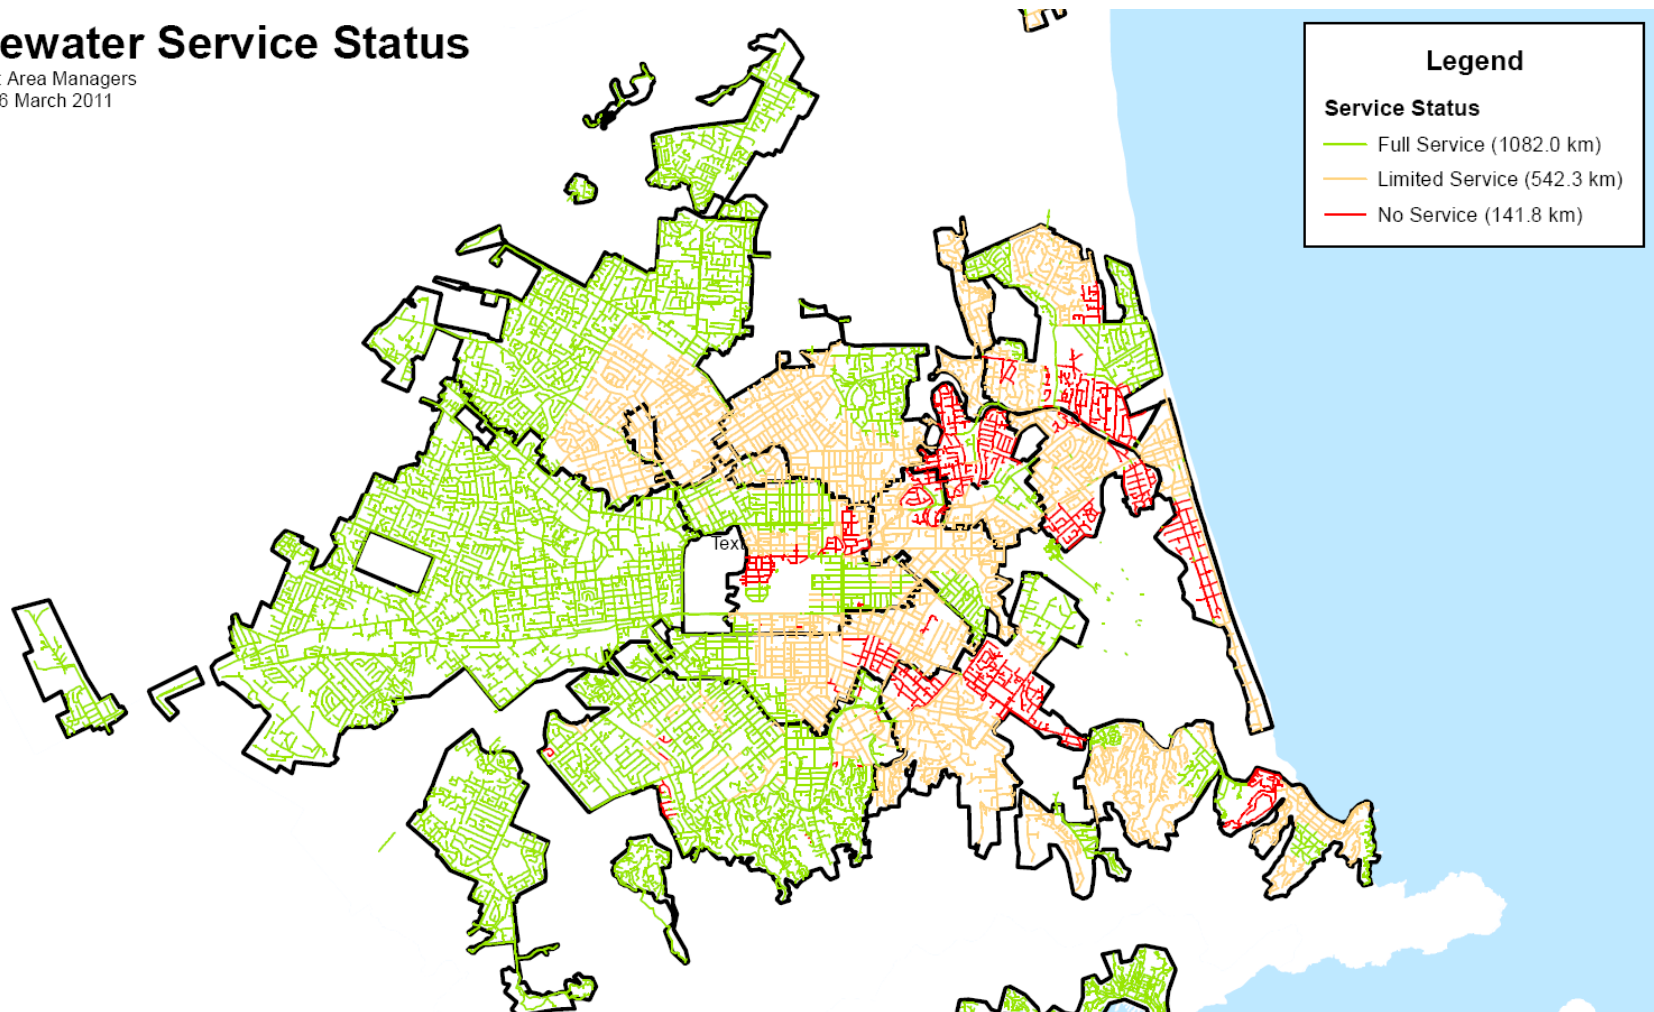
Figure 22. Wastewater network status as of 16 March 2011 illustrating distribution and severity of damage inflicted by the 22 February 2011 earthquake

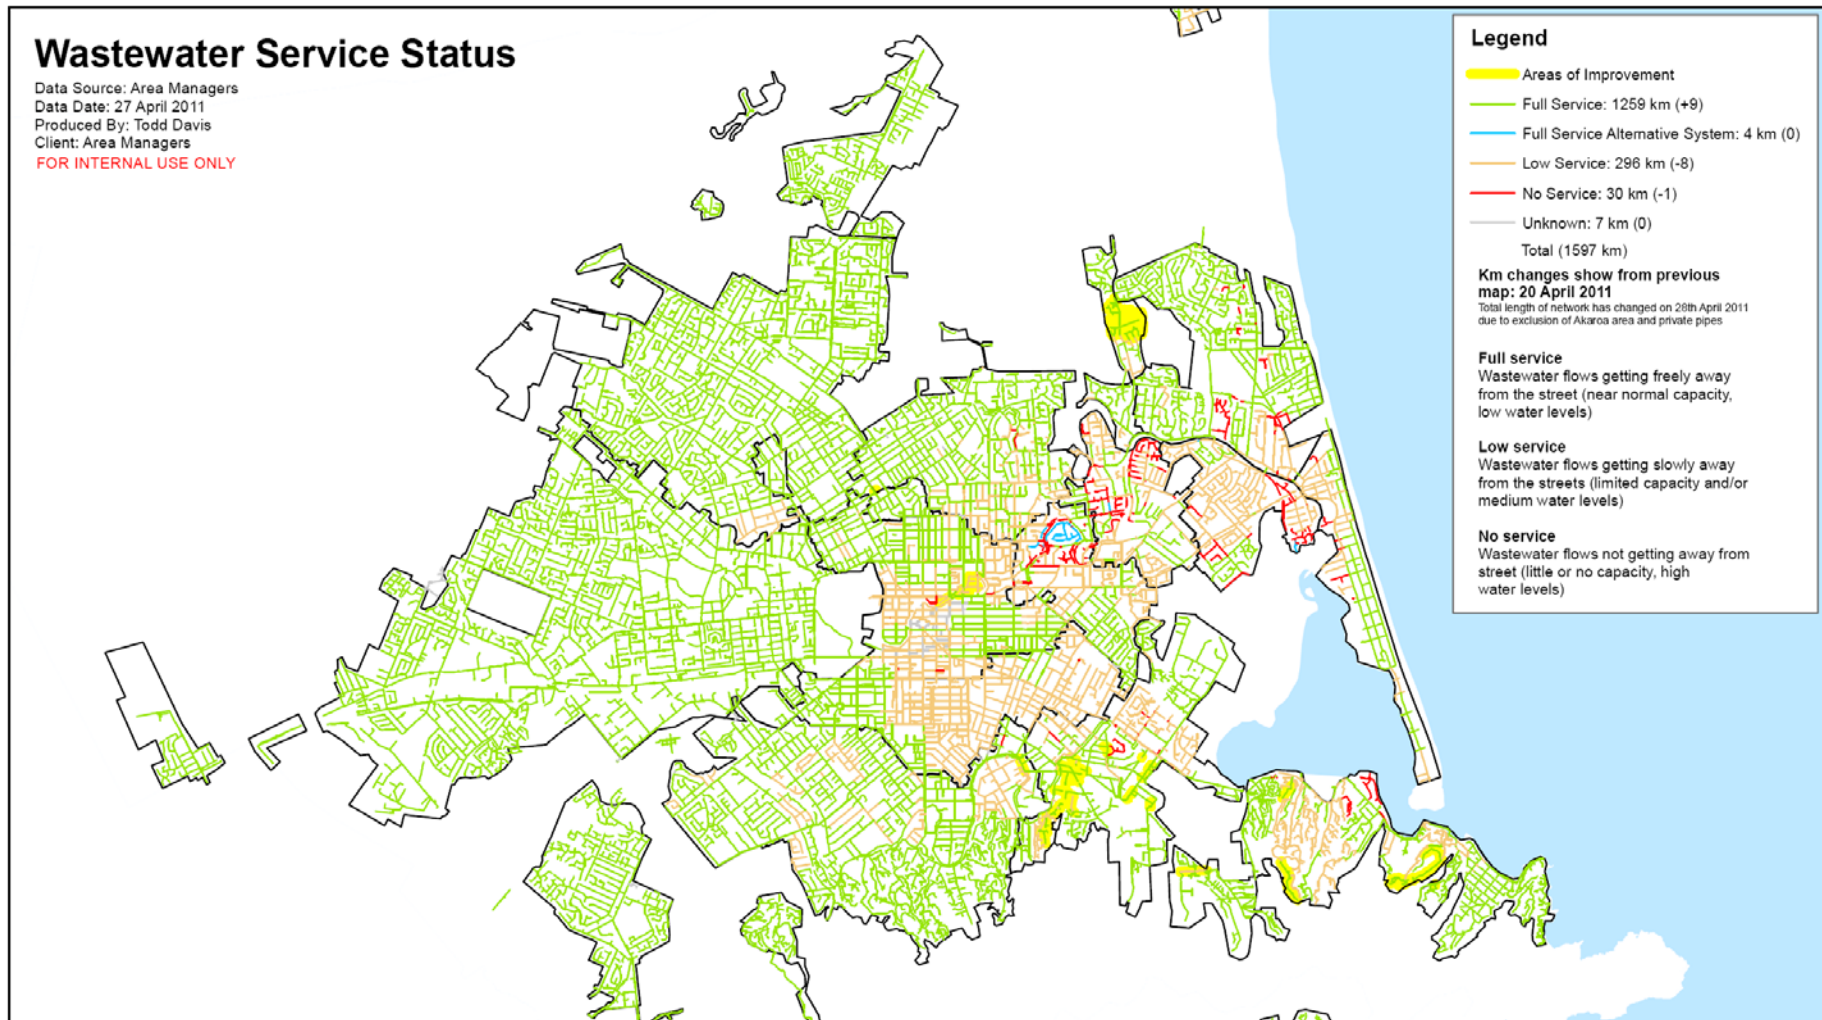
Figure 23. Wastewater network status as of 27 April 2011 indicating the speed of reinstatement of services in conjunction with the status map shown in Figure 22
