Effects of Earthquakes on Buildings in the Ibero-Maghrebian Region

José Antonio Aparicio Florido

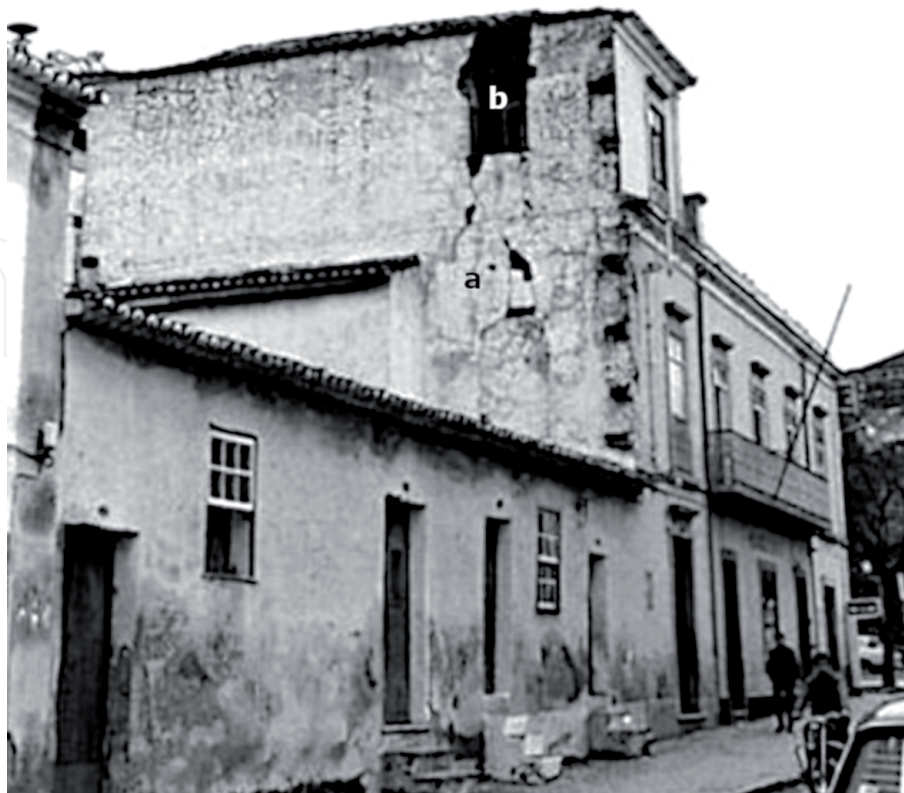
Figure 1.
Silves, building of class B with damage of grade 3: (a) shear cracks with detachment of little pieces of plaster; (b) partial toppling of external wall. Source: IPMA.

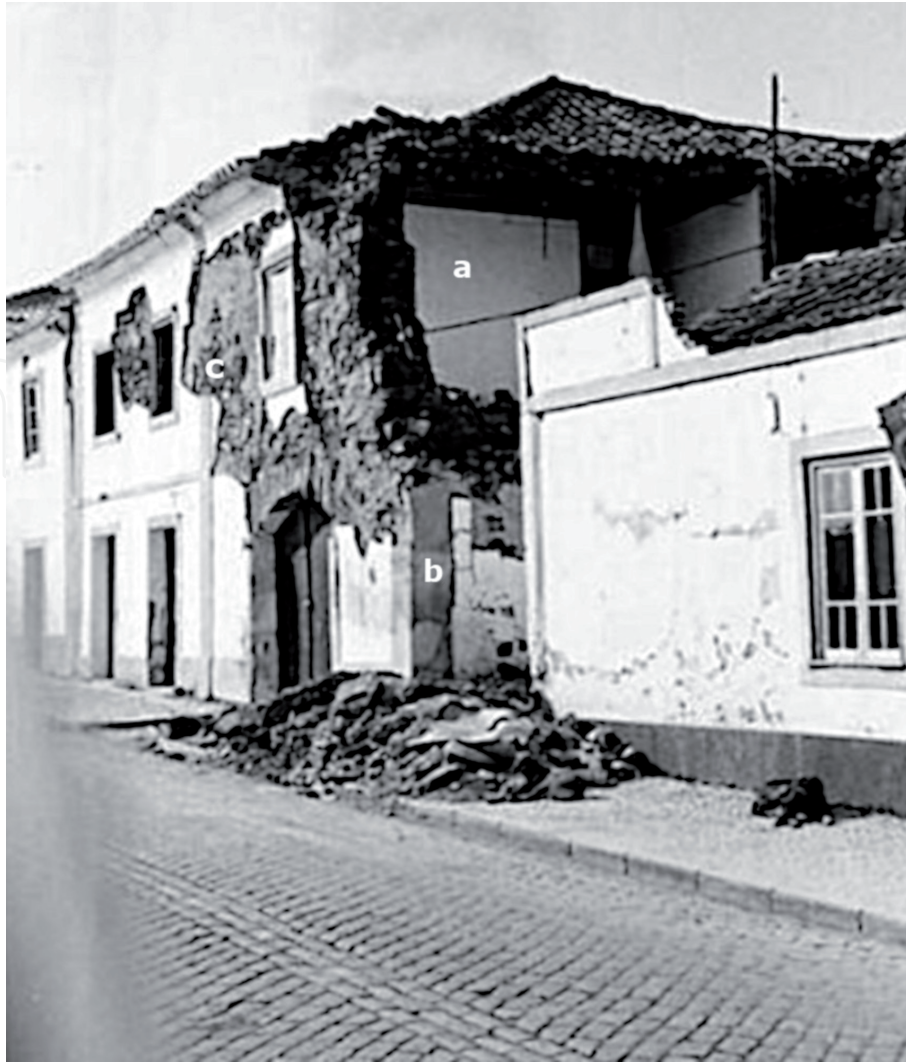
Figure 2. Bensafrim, building of class A with damage of grade 4: (a) advanced corner failure and toppling of external wall with partial roof collapse; (b) loss of connection and drift between load-bearing walls; (c) generalized detachment of plaster. Source: IPMA.

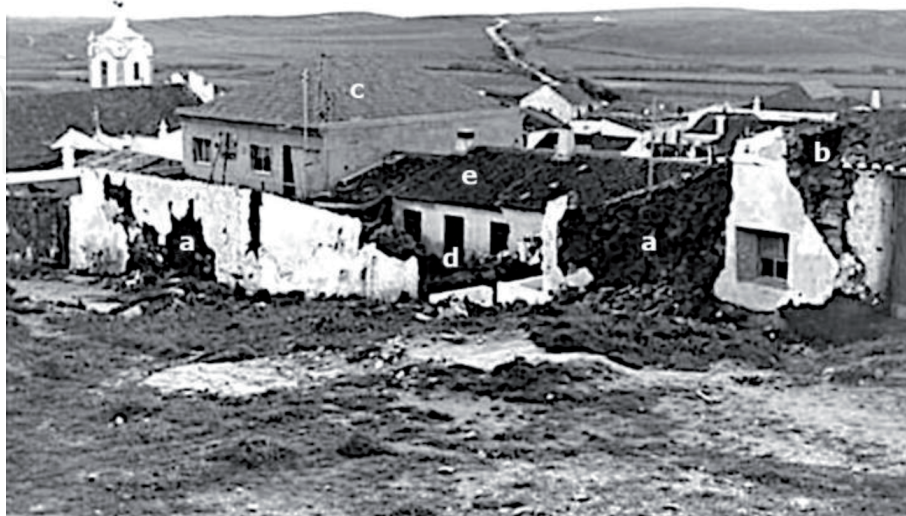
In Vila do Bispo, 8 km from Sagres, many houses of class A were partially or completely collapsed and turned into rubble (**Figure 3**), with a level of destruction similar to Bensafrim. **Figure 4** shows an example of *façade* overturning pulling down the roof and causing a complete collapse of the structure (grade 5). In other photographs we can clearly observe damage of grade 3 in corner failures (**Figure 5**) and grade 4 in the toppling of external wall, seriously affecting the roof (**Figure 6**). Also, the upper body of the church tower of Nossa Senhora da Conceição, built with massive stone, ashlar and burnt clay/sand bricks showed a progressive X-shaped

Figure 3. Vila do Bispo, general overview: (a) loss of the outer leaf of load-bearing walls and detachment of plaster; (b) partial toppling of façade wall, pulling down part of the roof; (c) good behavior of a recent construction (class B); (d) simple overturning of a freestanding masonry wall; (e) adobe house without apparent damage. Source: IPMA.

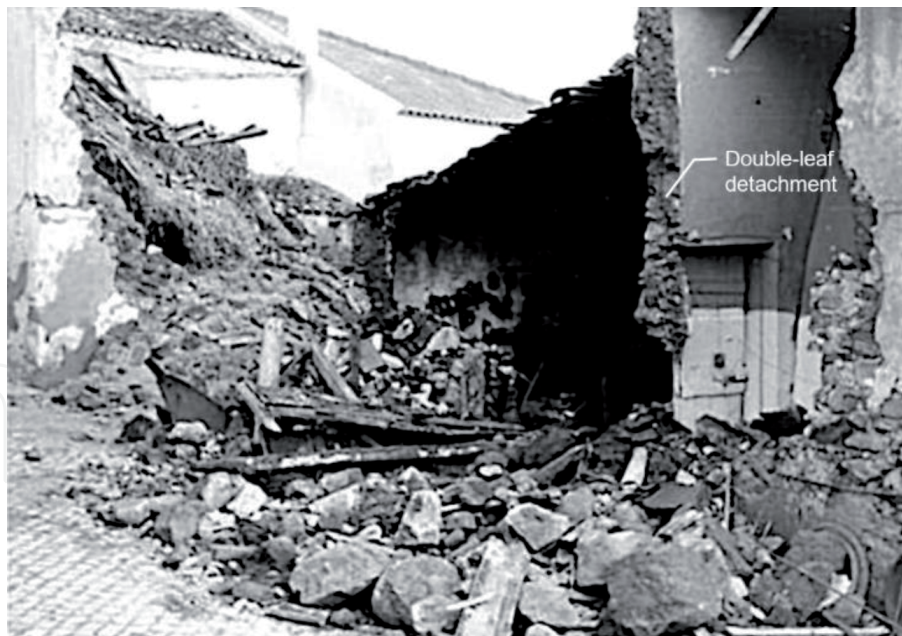
Figure 4. Vila do Bispo, total collapse of building of class A made of mixed fieldstone and adobe masonry, mud or clay mortar and roof supported by wooden logs and bed of reeds (grade 5). See the double-leaf shape on an interior load-bearing wall remaining standing. Source: IPMA.

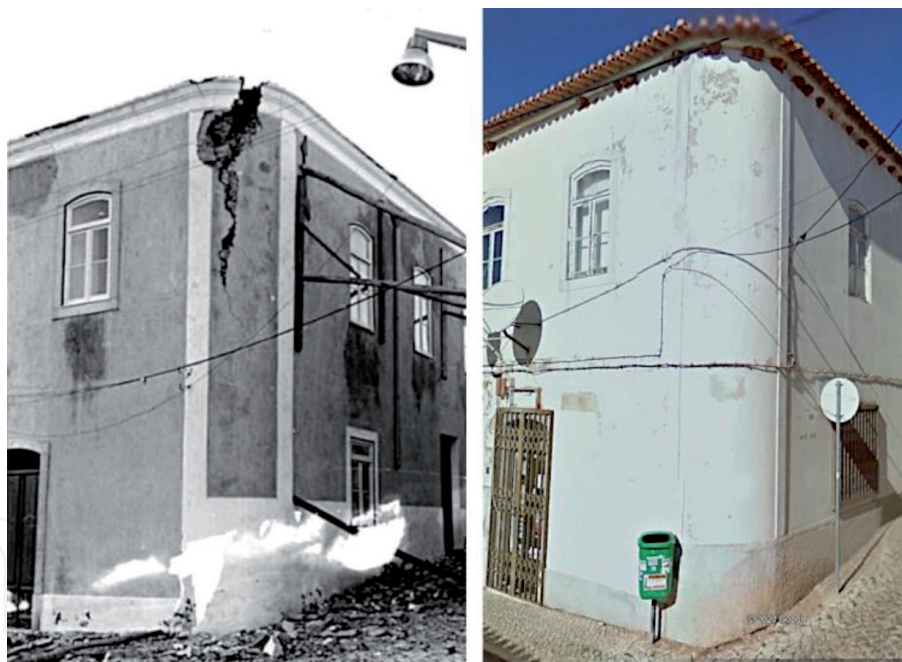
Figure 5. Vila do Bispo, building of class A with damage of grade 3 due to loss of connection between load-bearing walls and corner failure (left). This two-story house was repaired and is currently in use (right). Sources: IPMA/Google Earth.

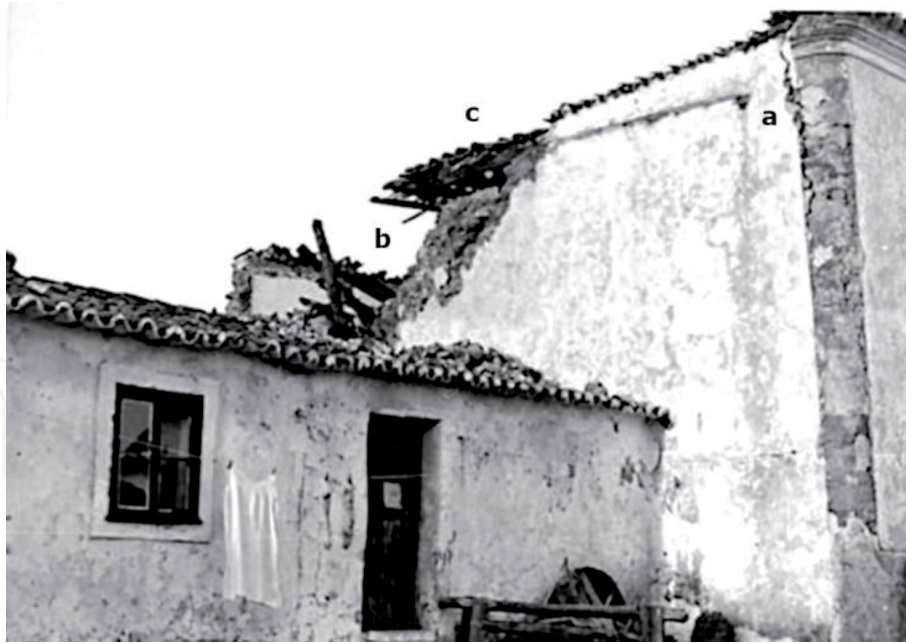
Figure 6. Vila do Bispo, building of class A with damage of grade 4: (a) loss of connection between load-bearing walls; (b) toppling of external wall; (c) collapse of roof made of wooden logs and bed of reeds. Source: IPMA.

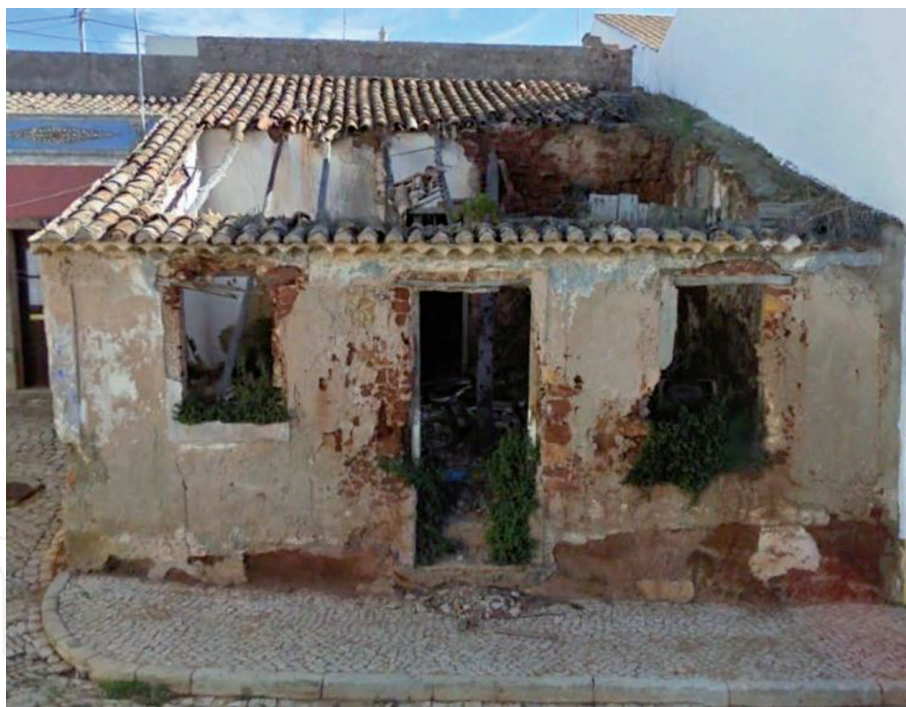
crack and fall of pinnacles [15], which means damage of grade 3 in buildings of class B. In summary, the traditional construction techniques based on adobe masonry and clay mortar showed a high vulnerability and weakness (**Figure 7**).

Figure 7. Vila do Bispo, typical house of vulnerability class A built with raw materials: load-bearing walls made with adobe bricks, doors and windows with lintels, and wooden logs supporting a tiled roof over a bed of reeds. Source: Google Earth.

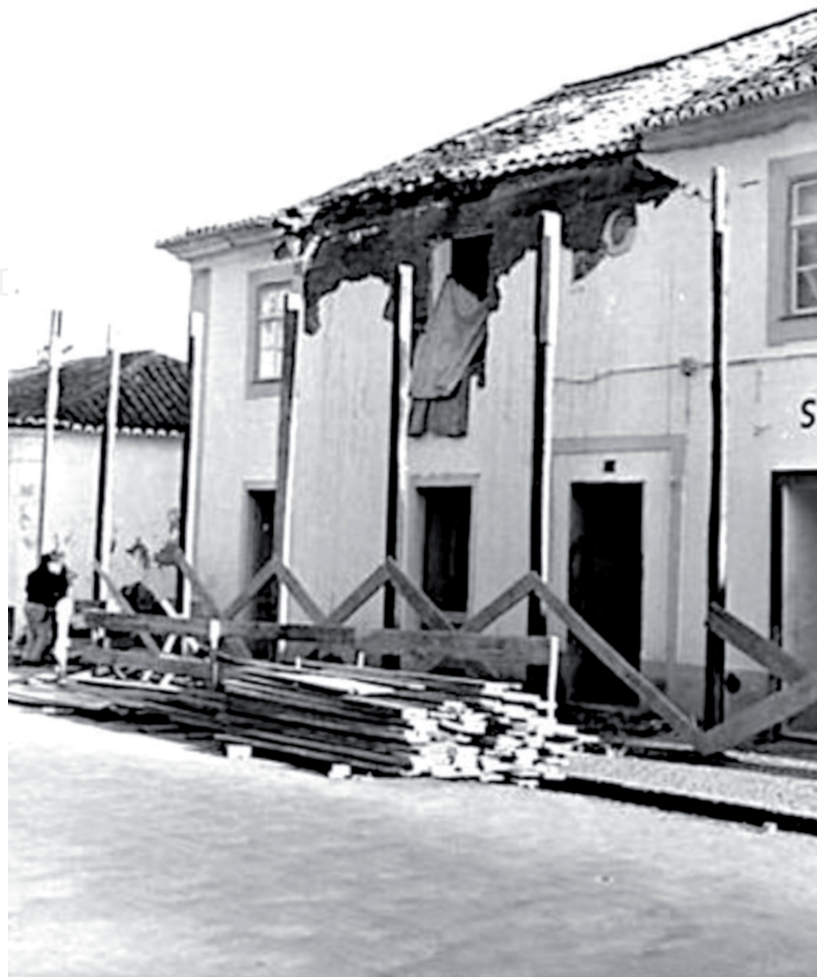
Figure 9. Portimão, two-story building of class B with detachment and toppling of the outer leaf of the external wall on the second floor, due to a hammering effect between the wooden joists supporting the roof and the top of the load-bearing walls (grade 3). The lack of shear cracks indicates a ground displacement from back to front. Source: IPMA.

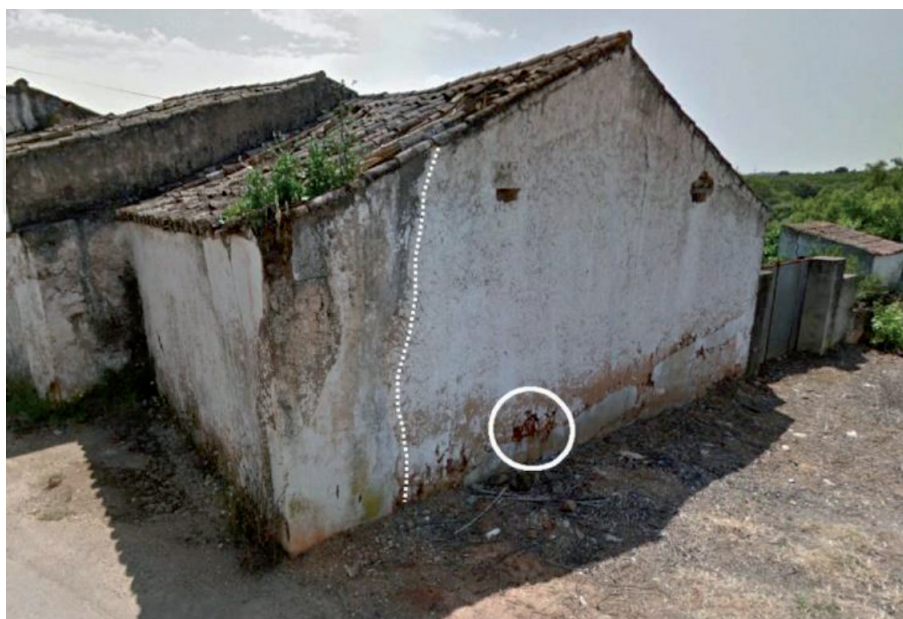
Figure 10. Fonte de Louzeiros, building of class A rebuilt after the 1969 earthquake, showing the repair mark of a corner failure (dotted line). Inside the white circle is visible the red color of the clay used to join the adobe masonry. Source: Google Earth.

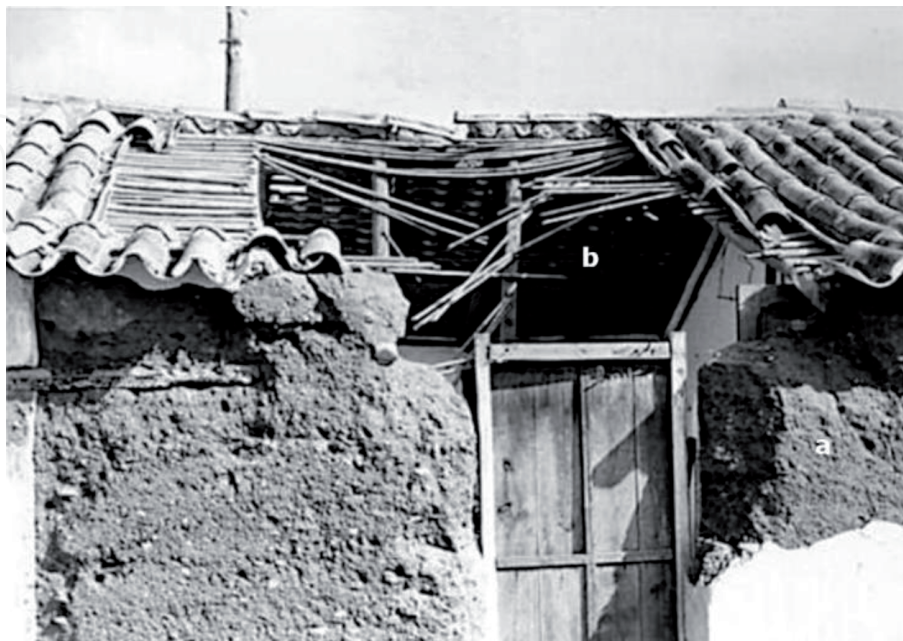
intensity VII, or VI-VII in the Lisbon district. In São Teotónio, Longueira, Vila Nova de Milfontes, Cercal and Sines, midway between Cape St. Vincente and Setúbal, many houses of class A collapsed. The rural village of Longueira, completely built with the same construction techniques of the Algarve, was razed; and the same situation occurs in Vila Nova de Milfontes and Cercal, where only the RC buildings (class C) performed well. In Odemira, partial roof collapse can be observed in buildings of class A (grade 4), due to the hammering effect of the wooden logs supporting the roof against the top of the load-bearing walls, to which they were not well anchored (**Figure 11**).

Figure 11. Odemira, damage of grade 4 in adobe masonry house of vulnerability class A: (a) detachment of plaster; (b) partial roof collapse due to the strong pounding of wooden logs against the top of the load-bearing wall. Source: IPMA.

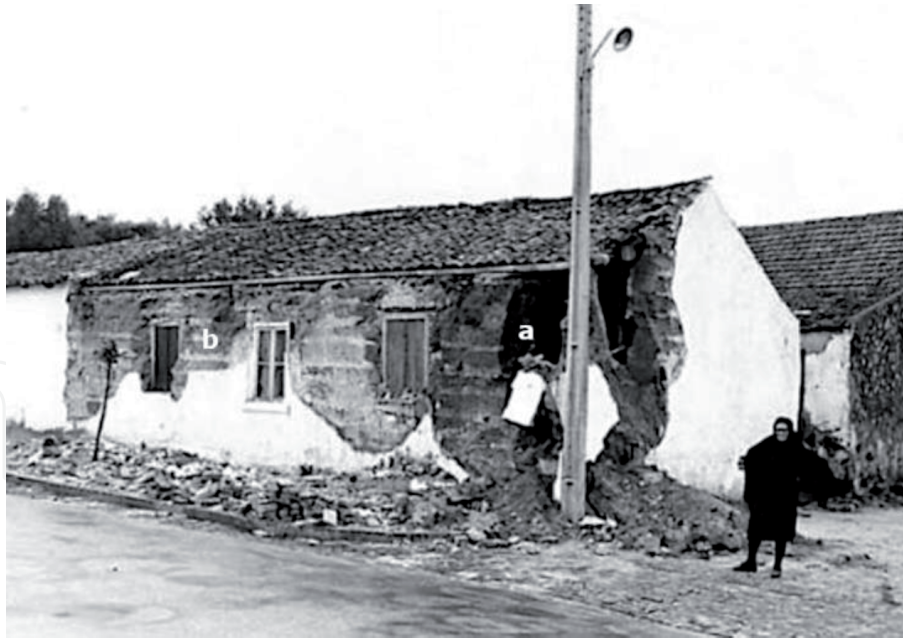
Compared to the previous locations, the city of Sines felt abnormally strong vibrations of soils, probably influenced by geological conditions and site effect. Some houses of class A or B total or partially collapsed (grade 4 or 5) and other buildings of class C as the City Hall, the church of São Salvador and the hospital suffered significant damage with fall of apparently non-structural elements. Further north along the coast, in Grândola, 38 km northeast, buildings of class B (simple stone) had a good behavior with some shear cracks and detachment of non-structural elements (grade 1 to 3), but twenty houses of class A (adobe masonry) had to be rebuilt or demolished because of corner failures, overturning of load-bearing walls, roof collapse and fall of plaster and cornices (**Figure 12**).

Figure 12. *Grândola, damage of grade 4 in a house of class A (adobe masonry): (a) advanced corner failure not compromising the roof; (b) general detachment of plaster. Source: IPMA.*

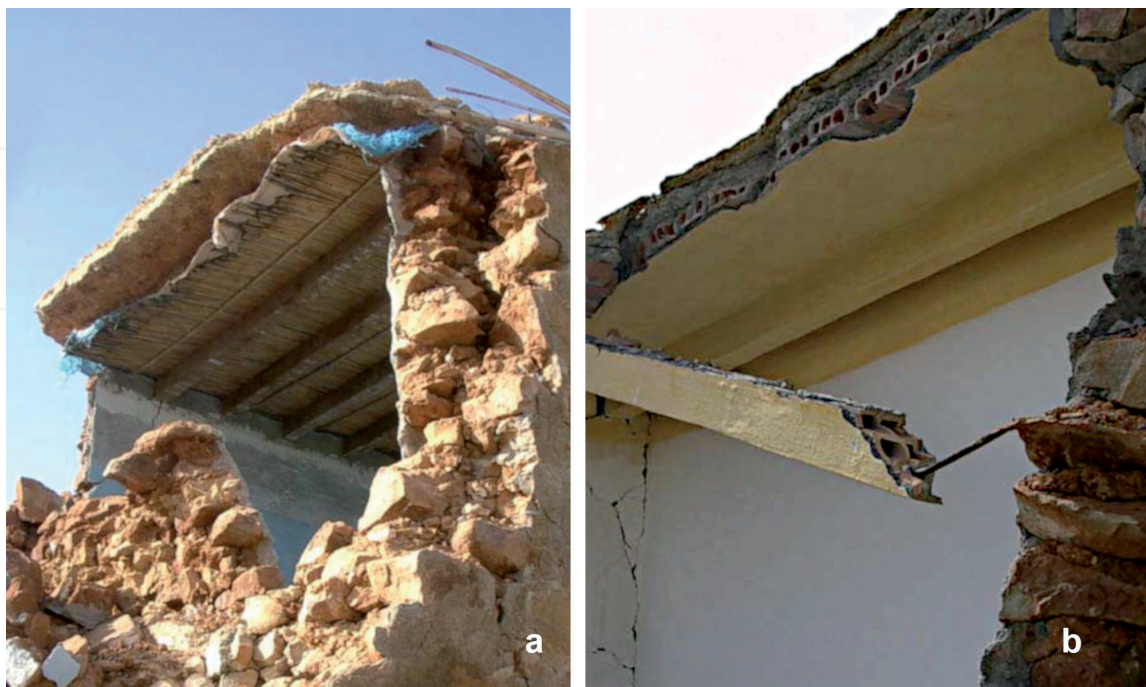
This earthquake hit the province of Al Hoceima, especially the city so named, the municipality of Imzourem and the villages of Ait Kamra and Izemmouren. The rural houses in this geographical area of Morocco, most of them of vulnerability class A, were built using the traditional construction pattern, very similar to those we have just highlighted in the most rustic areas of the Algarve, with more emphasis in Fonte de Louzeiros: single-story load-bearing walls made with unworked raw logs and unskilled masonry techniques, supporting a brittle roof of wooden logs in parallel under a bed of reeds tied together with rope or wire, all covered by a layer of water-repellent mortar and, occasionally, with a plastic film interposed acting as waterproof element (**Figure 13a**). The load-bearing walls were made up

Figure 13. Ait Kamra, traditional house pattern: (a) partial collapse showing the doble-leaf load-bearing walls, fieldstone masonry bonded with mud mortar and roof of wooden logs and canes covered with a plastic film (blue) and layer of water-repellent mortar (grade 4, class A); (b) handmade joist of hollow bricks assembled with a single steel rod. Source: P Murphy.

of two faces of field stone masonry (double-leaf) not anchored between them, and poorly bonded with high porosity and low adhesion mud mortar. The bending of the walls in both directions due to reverse horizontal forces caused the inner detachment of the double-leaf masonry and the subsequent bowing, peeling, and overturning or collapse of the external skin. Shear cracks also caused widespread wall collapses and massive corner failures and fall of roofs, pulling down huge amounts of debris (**Figure 14**). The use of hollow bricks assembled with a single steel rod to form a handmade joist as reinforcing element for the roof did not provide greater rigidity or better connection between roofs and load-bearing walls (**Figure 13b**).

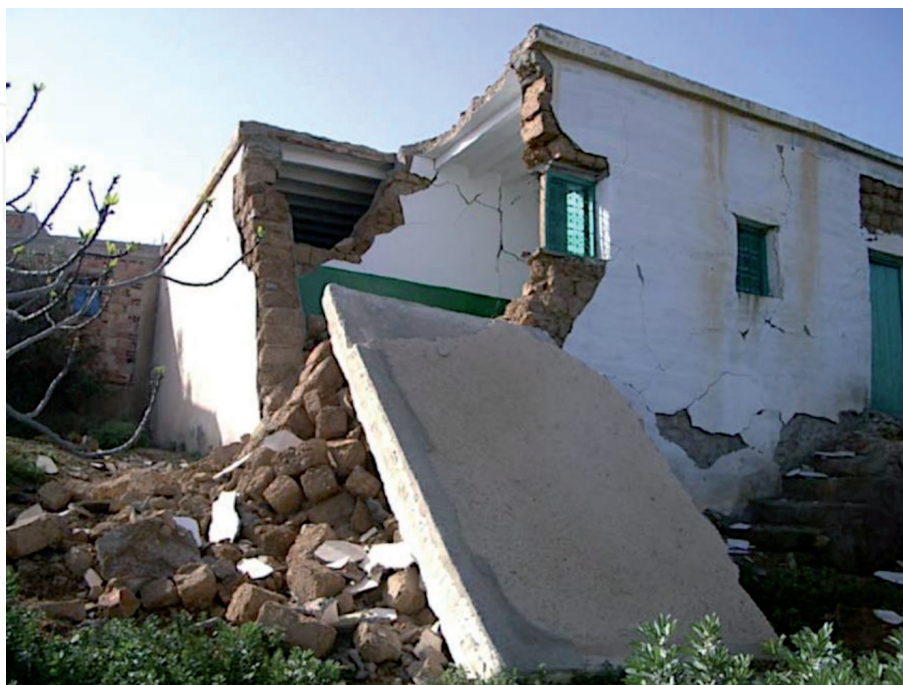
Figure 14.
Ait Kamara, corner failure pulling down the roof slab (grade 4, class A). Source: P Murphy.

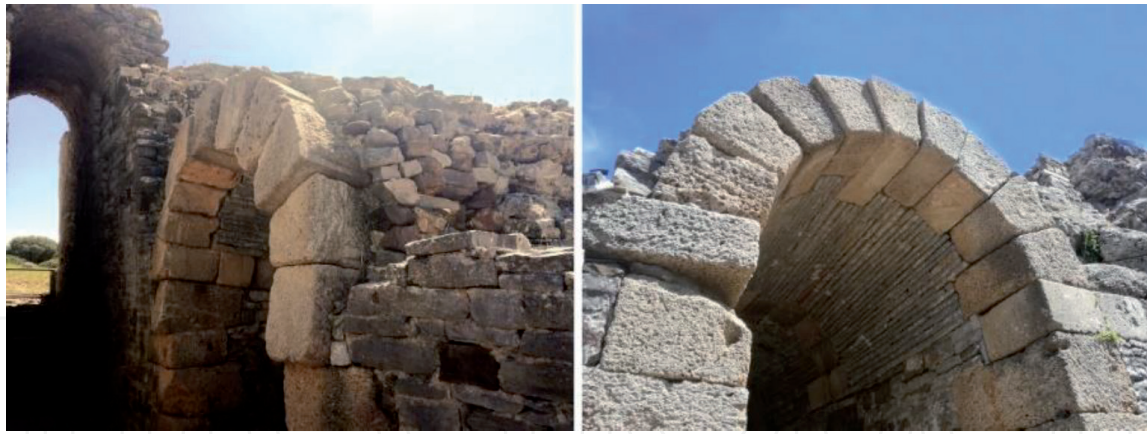
Figure 15. *Baelo Claudia, roman ruins (theatre): bowing of a vomitorium wall (left) and expulsion of voussoirs near the parascenium (right), which show a tensile stress in the direction of the slope. Source: J A Aparicio.*

effects can be explained by the instability and slope of the ground, as well as a bad combination between the weight of the structure, the insufficient foundations, and the progressive and slow landslide.

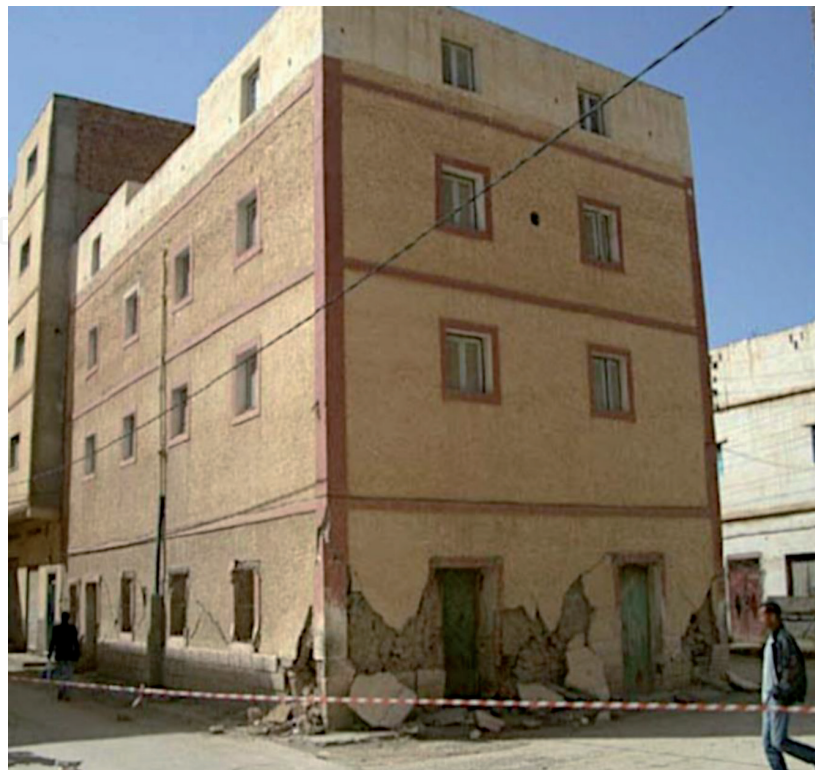
A single shear crack only proves the existence of a one-way displacement force. However, X-shaped cracks are unmistakable signs of lateral and reverse forces that result in a very characteristic diagonal crack pattern. The best candidates are earthquakes due to the effect of S-waves and surface waves, particularly Love waves, which transmit loads in opposite directions. In Al Hoceima, this type of damage is found in any vulnerability class buildings (A, B or C). **Figure 16** shows a very striking case, where the X-shaped damage completely surrounds the load-bearing walls on the ground floor of a four-story residential building of vulnerability class B in Imzourem (grade 3). There are no shear cracks on the upper floors, which is a clear indication

Figure 16. *Imzourem, X-shaped damage completely surrounding the load-bearing walls on the ground floor of a four-story residential building of vulnerability class B (grade 3). Source: P Murphy.*

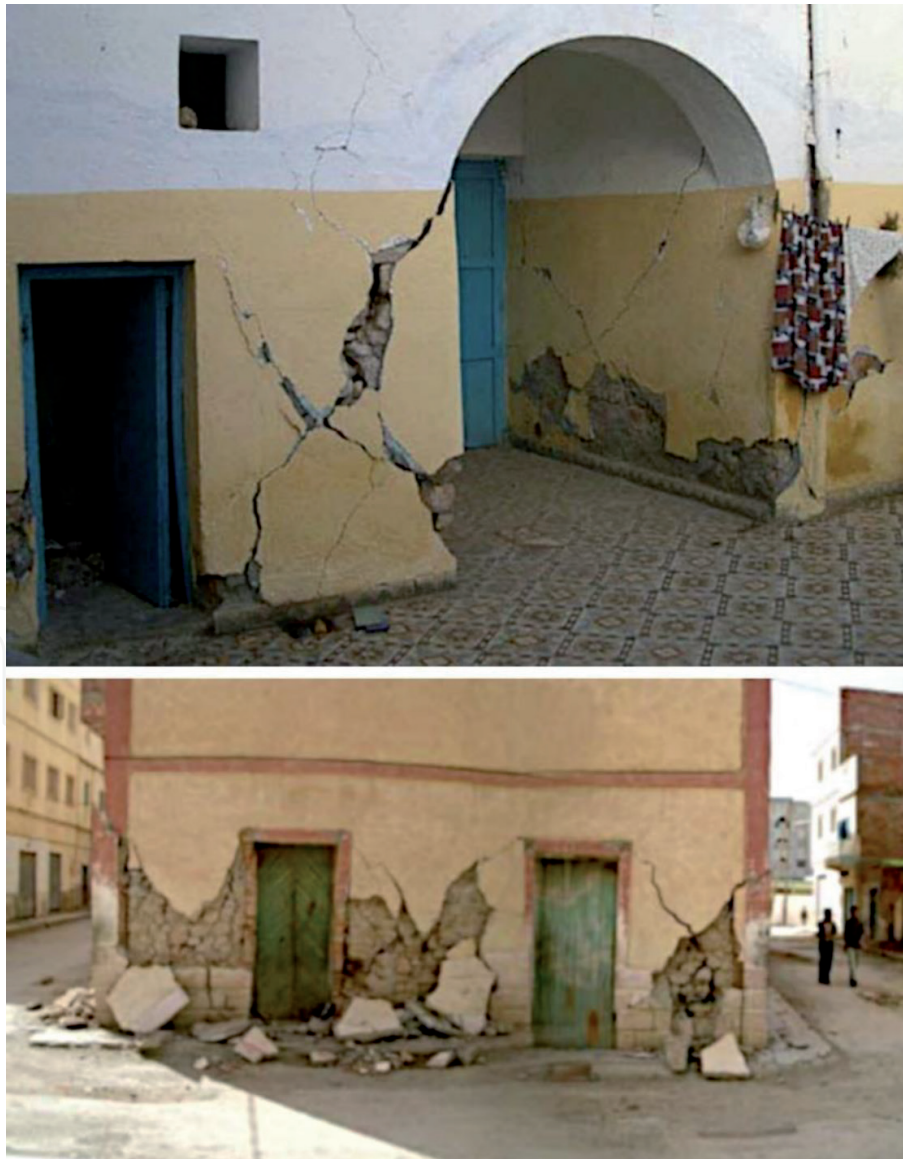
of a soft-story damage, which will be discussed later. X-shaped cracks are sometimes blurred by the loss of outer leaf or toppling of the external walls (**Figure 17**).

Figure 17. Examples of X-shaped damage clearly visible in a single-story class A house (above) and blurred by loss of outer leaf in a four-story residential block (below). Source: P Murphy.

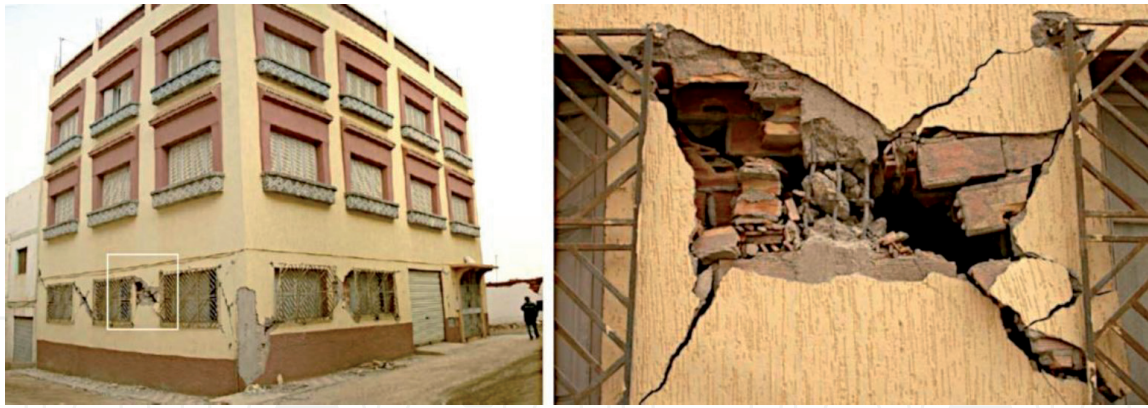
Figure 18. Imzourem, short column effect in a three-story residential block of vulnerability class C (grade 4). On the right, a detail of the damage is shown. Source: P Murphy.

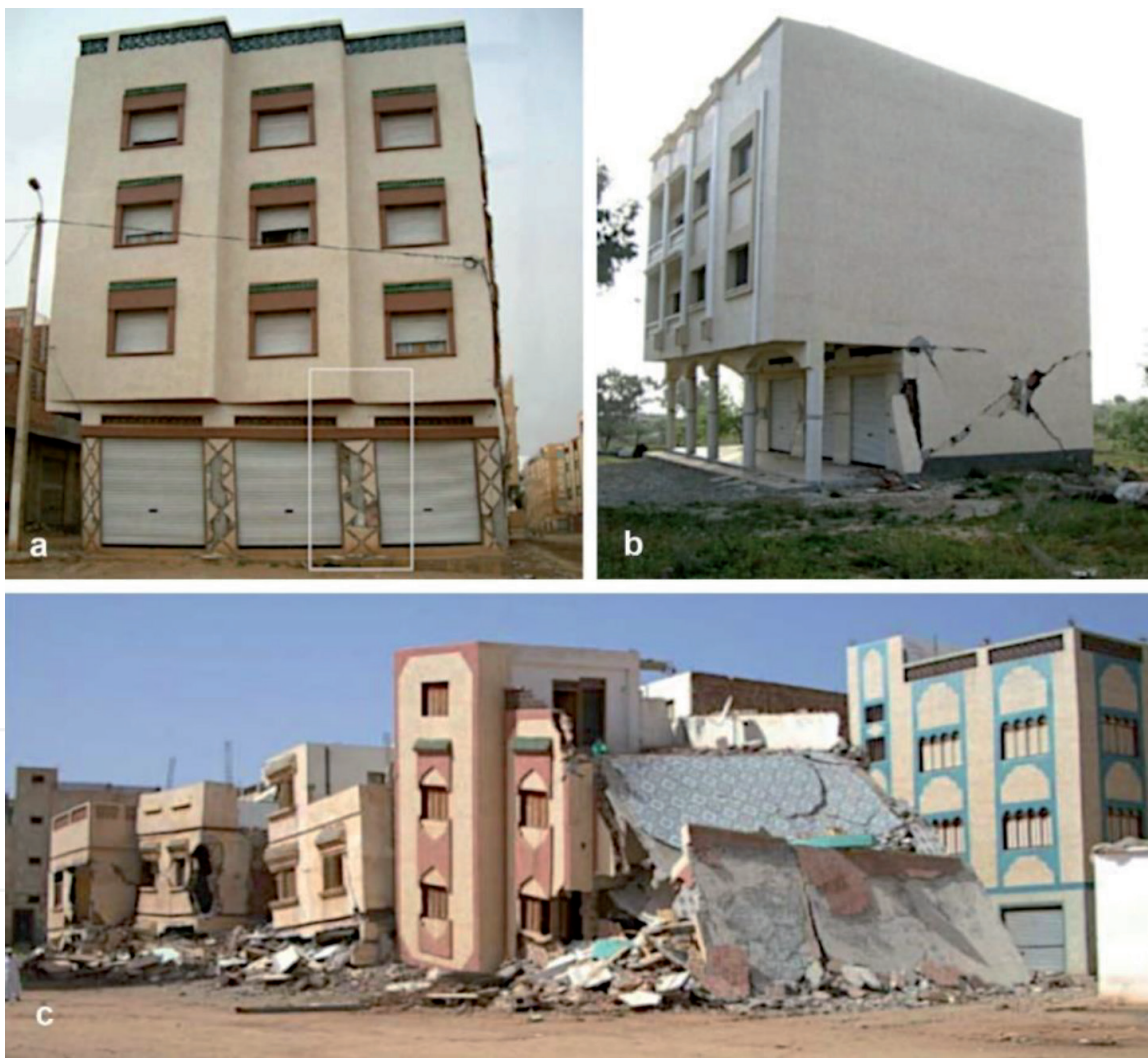
Figure 19. Alhucemas, soft-story failures: (a) tilting of RC frames on the ground floor; (b) soft-story damage with clear X-shaped crack on the infill wall; (c) collapse of ground floor due to a previous soft-story damage. Source: P Murphy.

But the most damaging and characteristic construction pattern of the 2004 Al Hoceima earthquake is undoubtedly the soft-story failure. The distribution of the residential buildings was as follows: four or five floors high, densely partitioned in upper flats by interior infill walls embedded between the RC frames and a ground floor less partitioned or completely diaphanous for use as garage in most cases or as small stores. These walls help to stiff the RC frames, reducing the bending of the columns under horizontal displacements of the structure. In areas of moderate to high seismic risk, the upper floors, which are highly rigidized, perform like a unique and solid block that sends all the elastic stress to the ground floor frames. As a consequence, the connections between the column heads on the first floor and the slab on the second floor come under load. If the column-slab joint is not reinforced with the stirrups needed, the column would be excessively bended, producing a type of failure called “plastic hinge” [21]. As a consequence, irreversible tilting of the structure or collapse can occur (**Figure 19a**), transferring the damage in many cases to the upper floors, due to the strong impact during the fall (**Figure 19c**).

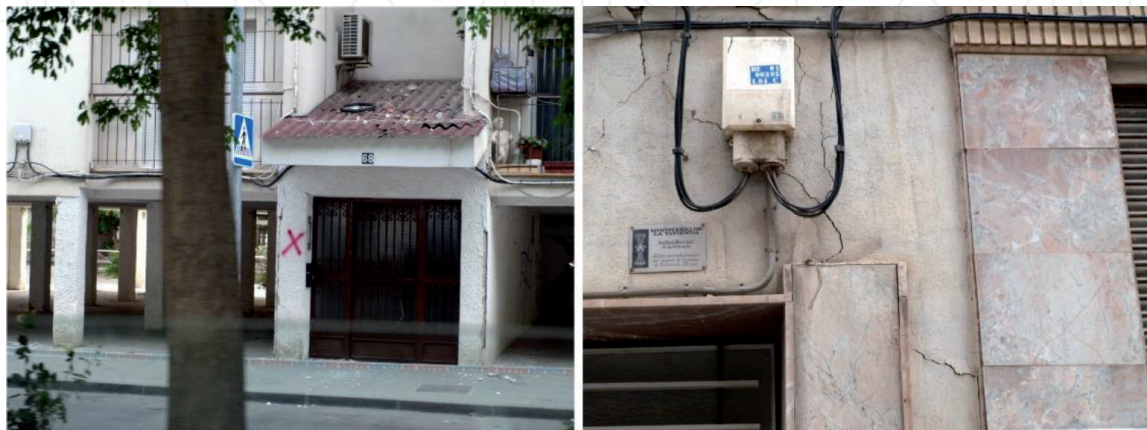
However, although it seems difficult to explain, older RC buildings did not suffer a greater damage than those built after the 2002 standard. In **Figure 20** we can appreciate slight shear cracks in the façade of pre-1968 RC buildings, not showing apparent structural damage or deformations of RC frames on the ground floor, despite the lower stiffness due to the lack of infill walls (grade 3, class C). Paradoxically, in **Figure 21** we have the complete collapse of the four-story residential block mentioned above, built during the transition period to the 2002 earthquake-resistant standard. This means that improving rules does not always implies improving resistance.

Figure 20. Lorca, shear cracks in pre-1968 RC buildings of class C (grade 3). There is apparently no evidence of structural damage, and on the ground floor (left) the columns forming an evident soft story have no sign of tilting. Source: IERD.

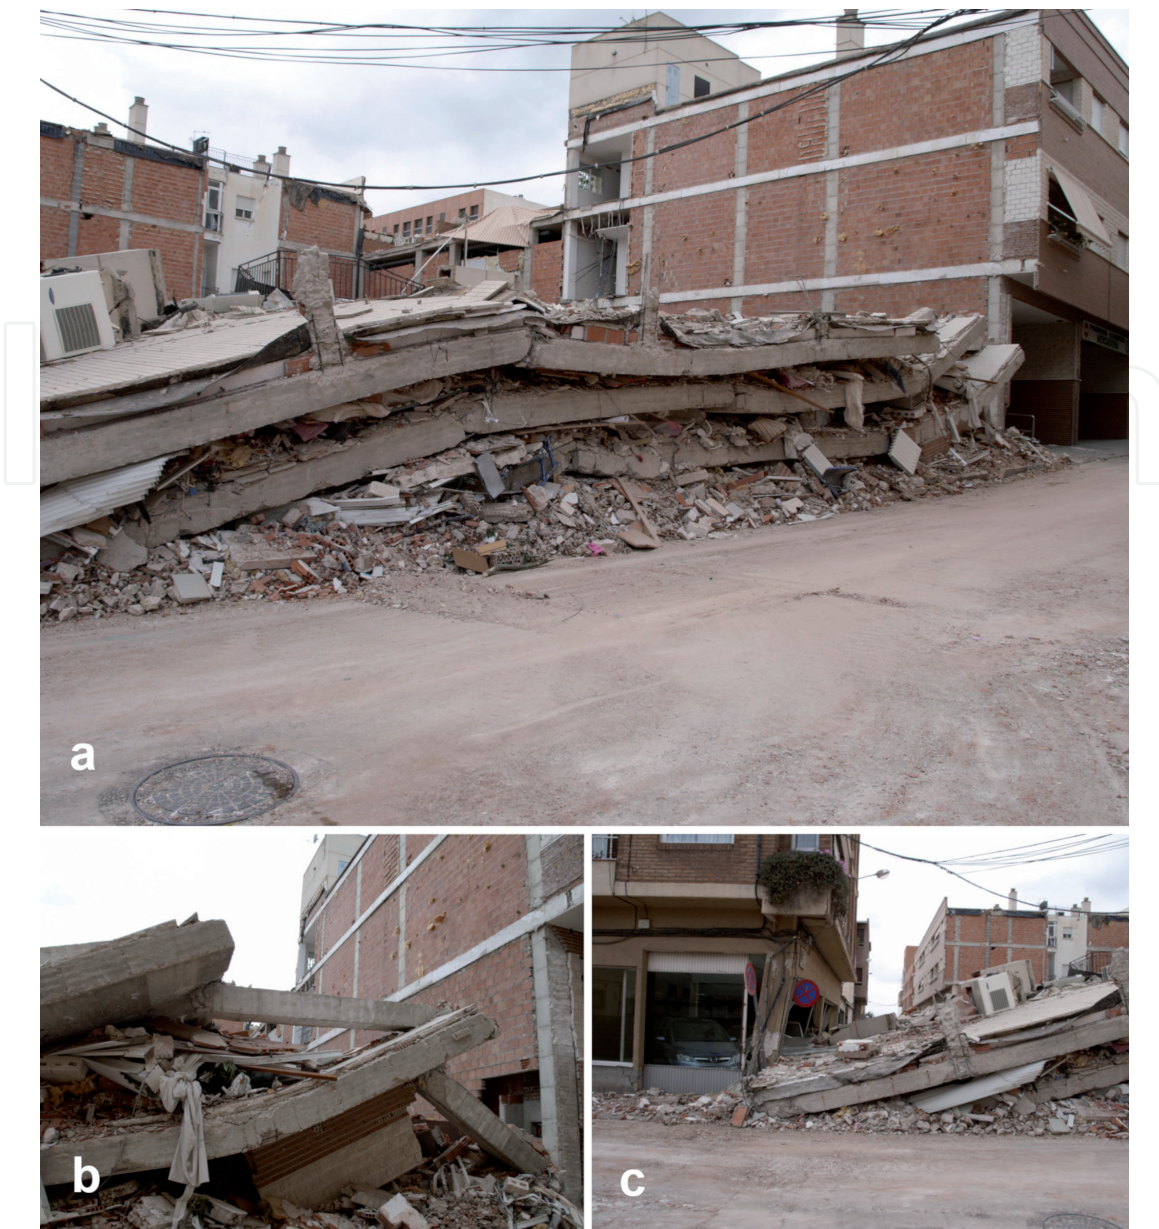
Figure 21.

Lorca, complete collapse of RC residential building (grade 5) designed under the earthquake-resistant standard prior to the 2002 standard: (a) the three slabs are completely collapsed without any gap to allow survival; (b) plastic hinges and overturning in the direction of the slope of the street; and (c) plastic hinge in the adjacent building caused during the collapse, wedging against the base of the column. Source: IERD.

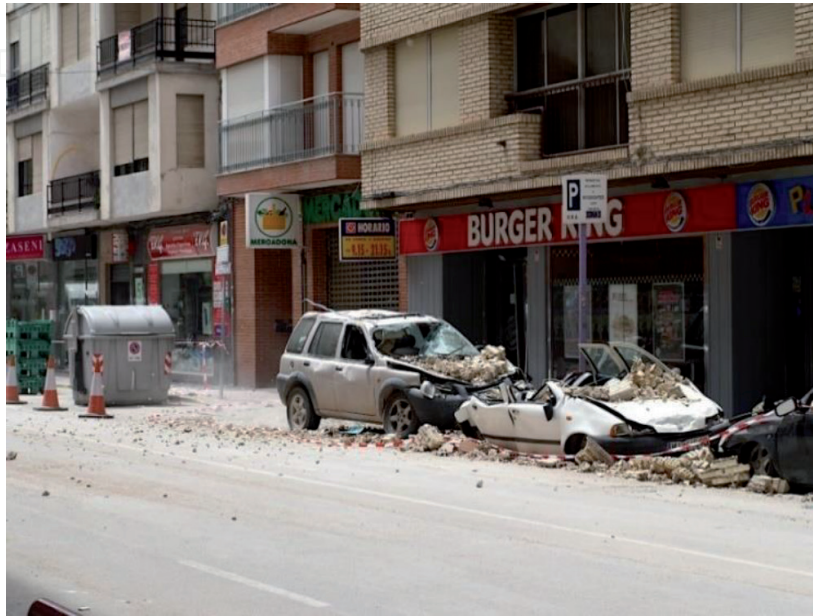
Figure 22.

The 2011 Lorca earthquake caused nine fatalities due to the fall of these non-structural elements from façades (**Figure 22**) and the evident cause-effect relationship led to a conclusion that became an axiom: non-structural elements also

Lorca, debris fallen on vehicles and sidewalk. The center of the street is free of danger. In Lorca, people died while walking or looking for protection near the façades. Source: IERD.

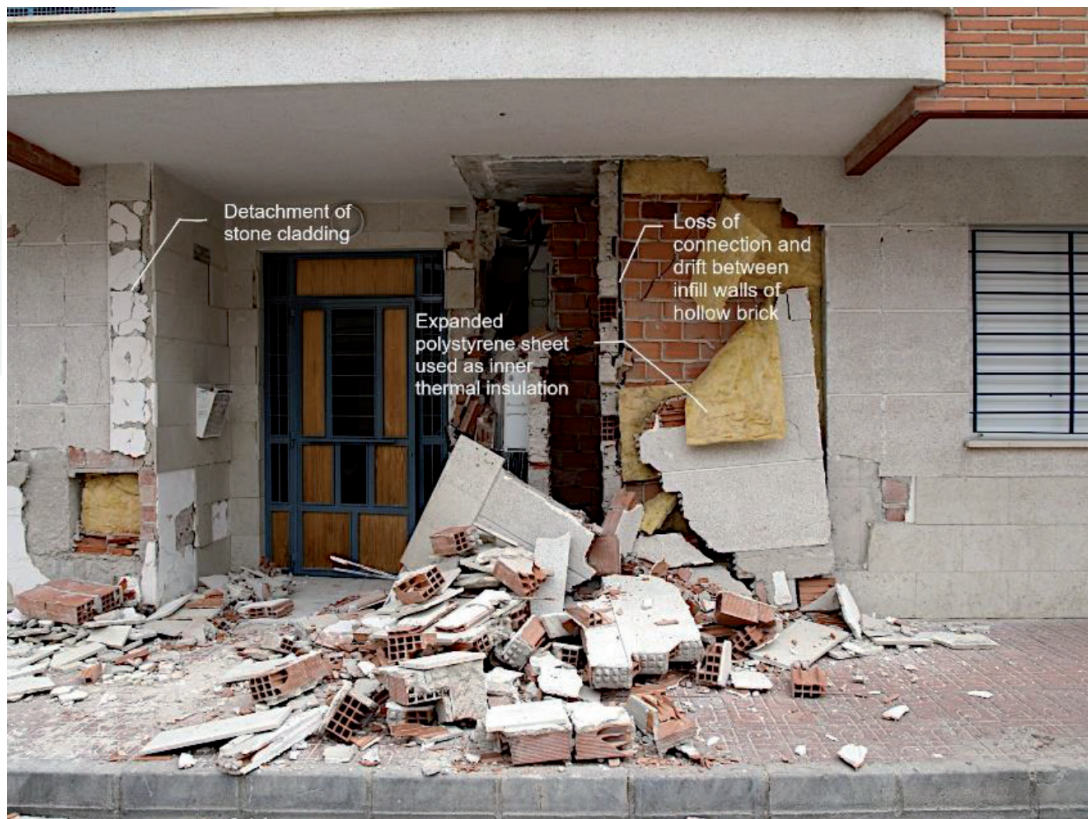
Figure 23.

Lorca, shear cracks caused the detachment and loss of stone cladding and the toppling of the outer leaf of the brickwork wall (grade 3, class C). Source: IERD.

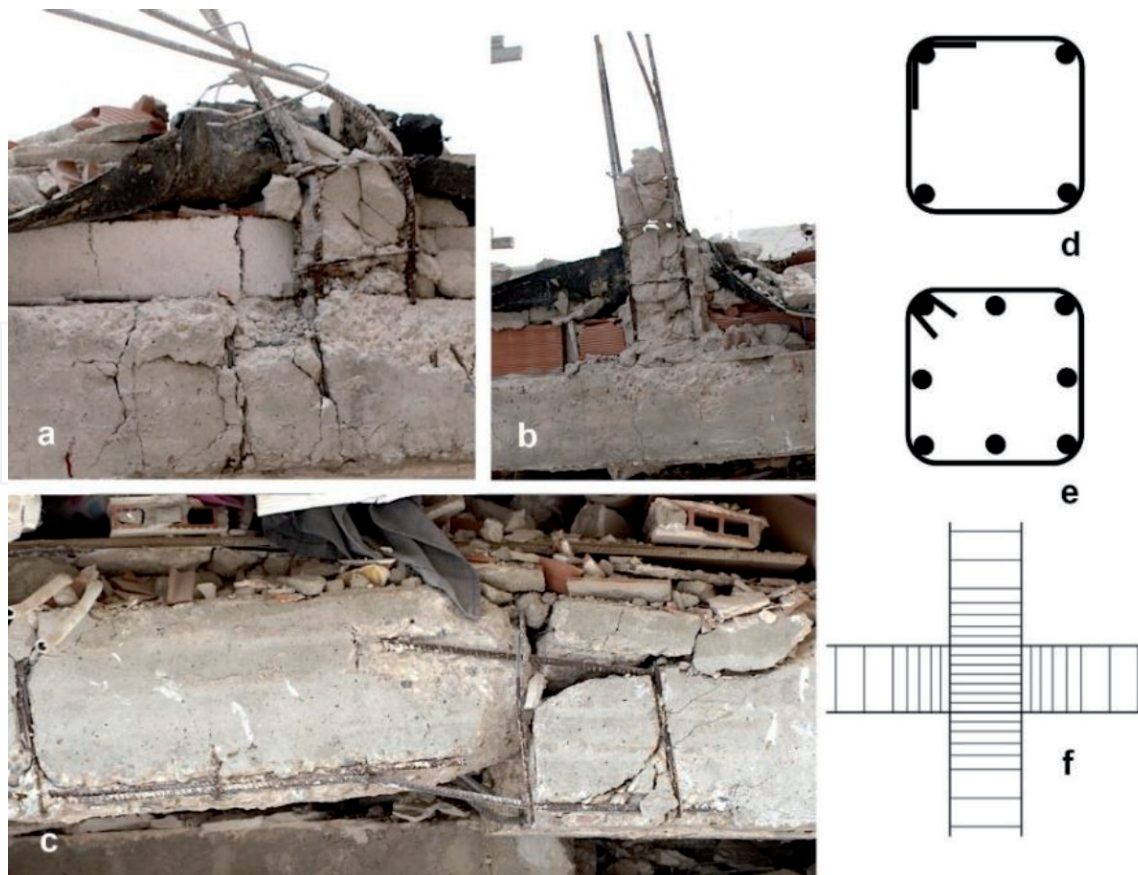
Figure 25.

Lorca, details of the RC residential block collapsed in Lorca, showing the four-rebar cores of beams and columns: (a) and (b) show the regular equidistance between the stirrups near the column-beam joints; (c) beam with similar arrangement of rebars; (d) drawing of the four-rebar longitudinal distribution used in this building with stirrup ends bent at 90°; (e) more adequate design for seismic resistance, with eight rebars and stirrup bent at 135°; (f) correct way to reinforce the RC column-beam joints. Source: IERD.

The damage to the column-beam joints of RC frames is consequence of the lack of steel reinforcement at the coupling node. As shown in **Figure 25**, the stirrups have a regular equidistance along the column as in the beam-column joints; as a result, the RC structure plastifies. A greater number of stirrups in the coupling node, progressively reducing the distance between them towards the intersection core, would increase the structure resistance and distribute the displacement energy along the full length of the columns, not transferring all the cyclic reversal of loads to the column-beam joints (**Figure 25f**). In addition, in areas with a moderate to high level of seismicity the stirrups should be anchored to the longitudinal rebars, overlapping 135° hooks [24] to avoid the opening of the closed-loop and

outward bending of the rebars (**Figure 25e**). The Turkish Earthquake Code 2007 and Indian Standard IS13920-1993 are two examples of the implementation of these earthquake-resistant requirements.

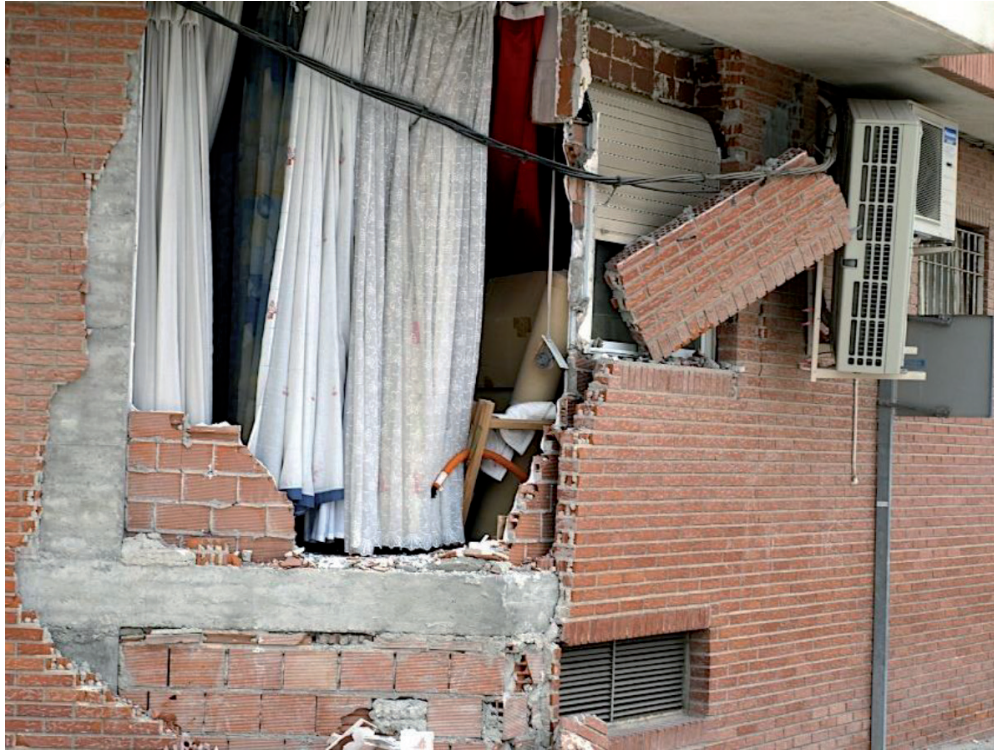
forces. As an example of better structural behavior, in **Figure 26** we can observe a complete damage in a double-leaf infill wall in a housing block with overturning of internal and external faces, but without apparent cracks in the RC frame and with no signs of plastic hinges or deformation in the column-beam joint (grade 3, class C). On the contrary, in **Figure 27** the loss of cladding allows us to clearly appreciate the occurrence of shear cracks at the base of the column-beam connection of the second floor, implying in all cases a moderate structural damage. It is due to the much more stiffness of the slab, which overloads the column resistance by sending all the energy of horizontal forces to the column base, not reinforced with an adequate seismic-resistant design. This damage, although less frequently, is not exclusive to the column-beam or column-slabs joints and can also occur in the middle body of the column (**Figure 28**), especially in case of short-column effect.

Figure 26. *Lorca, complete overturning of double-leaf wall with overturning of both brickwork faces, but without apparent cracks in the RC frame. Source: IERD.*

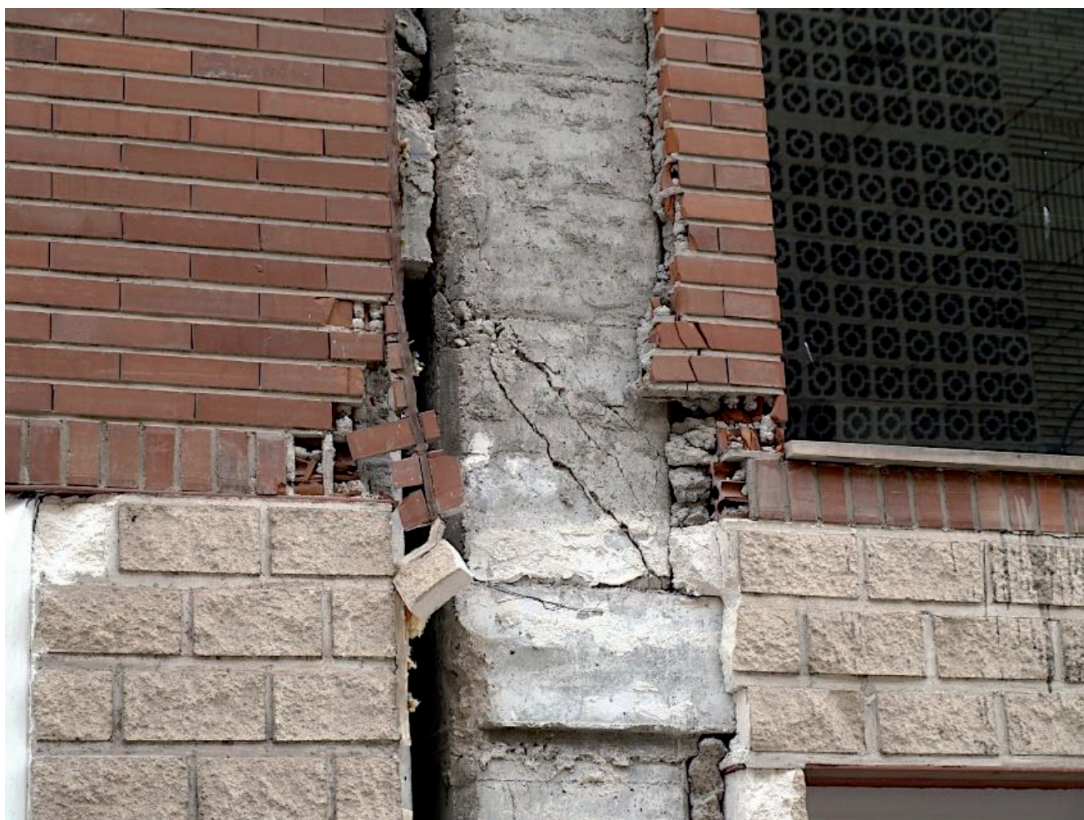
Figure 27. *Lorca, cracks in the column-beam base suggest the incipient formation of a plastic hinge. The loss of cladding is due to a hammering effect with the adjacent building. Source: IERD.*
