Effects of Earthquakes on Buildings in the Ibero-Maghrebian Region

José Antonio Aparicio Florido

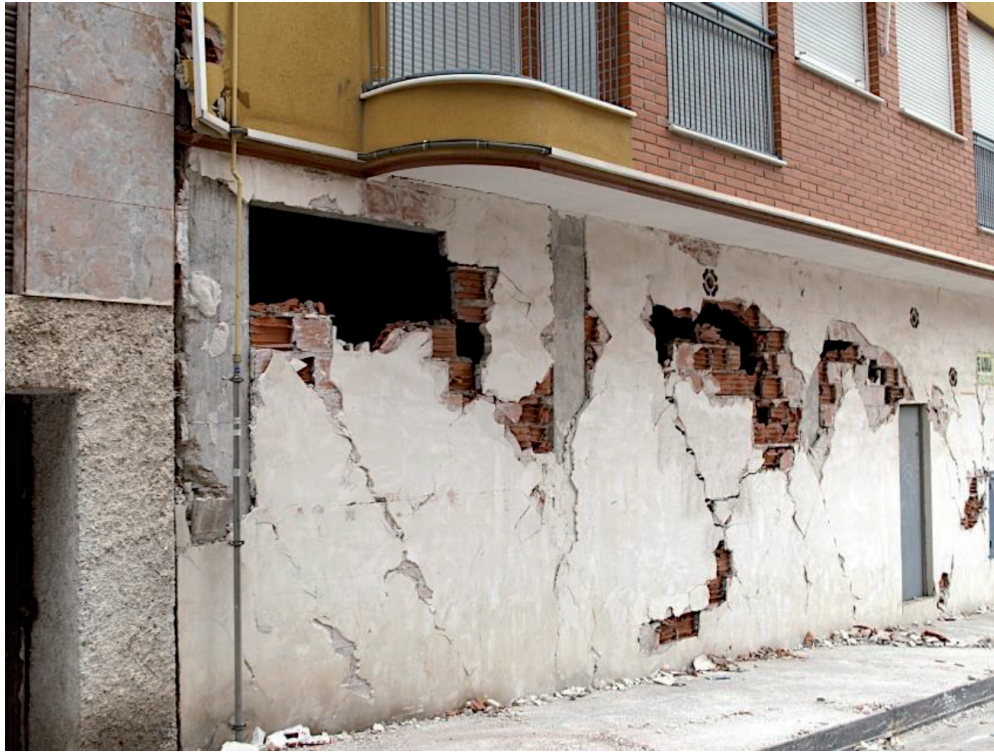
Figure 28.
Lorca, X-shaped cracks in infill walls and loss of concrete in the middle body of the RC column suggest a soft story effect. Source: IERD.
