An Integrated Approach to Initiate Preventive Strategies for Workers Exposed to Teflon Pyrolytic Gases in a Plastic Industry

(*J Occup Health* 2000; 42: 297–303)

Key words: Teflon, Pyrolytic gases, Accident investigation, Preventive strategy

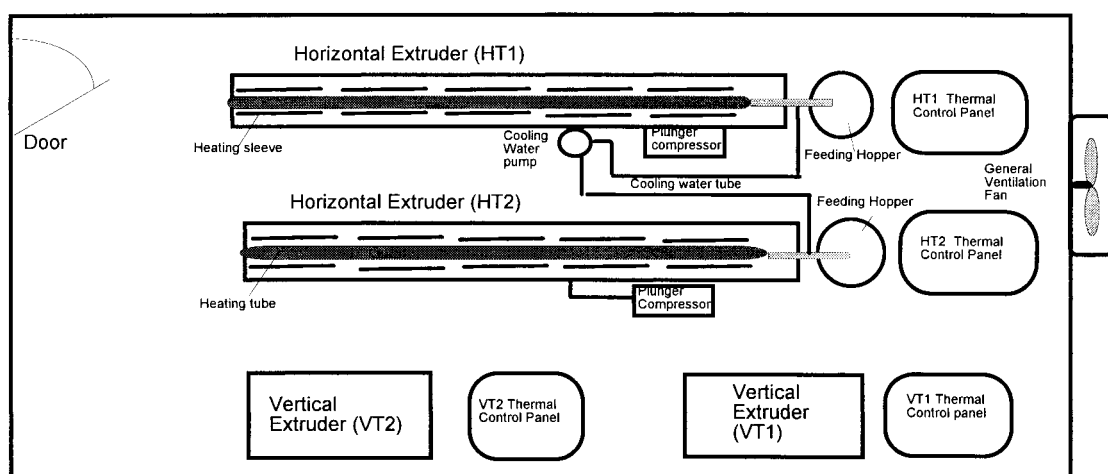
Fig. 1. The layout of the Teflon room.

be released from the end of heating tube, but could be generated in the heating tube, and delivered via the throat to the feeding hopper, and then finally released into the workplace atmosphere. Since a general exhaust fan was installed on the wall near the hopper of the HT₂ extruder (see Fig. 1), it was expected that workers working around the hopper might be exposed to higher concentrations than workers who worked elsewhere. It is therefore not surprising that molder A who worked near the hopper would be most exposed and died after the event, whereas molder B and the foreman who were not restricted to being near the hopper were hospitalized but recovered.

- a. Installing a local exhaust ventilation system in addition to the general exhaust ventilation system that is currently used in the Teflon room.
- b. Checking the flow rate of the cooling water system at the beginning of each work shift.

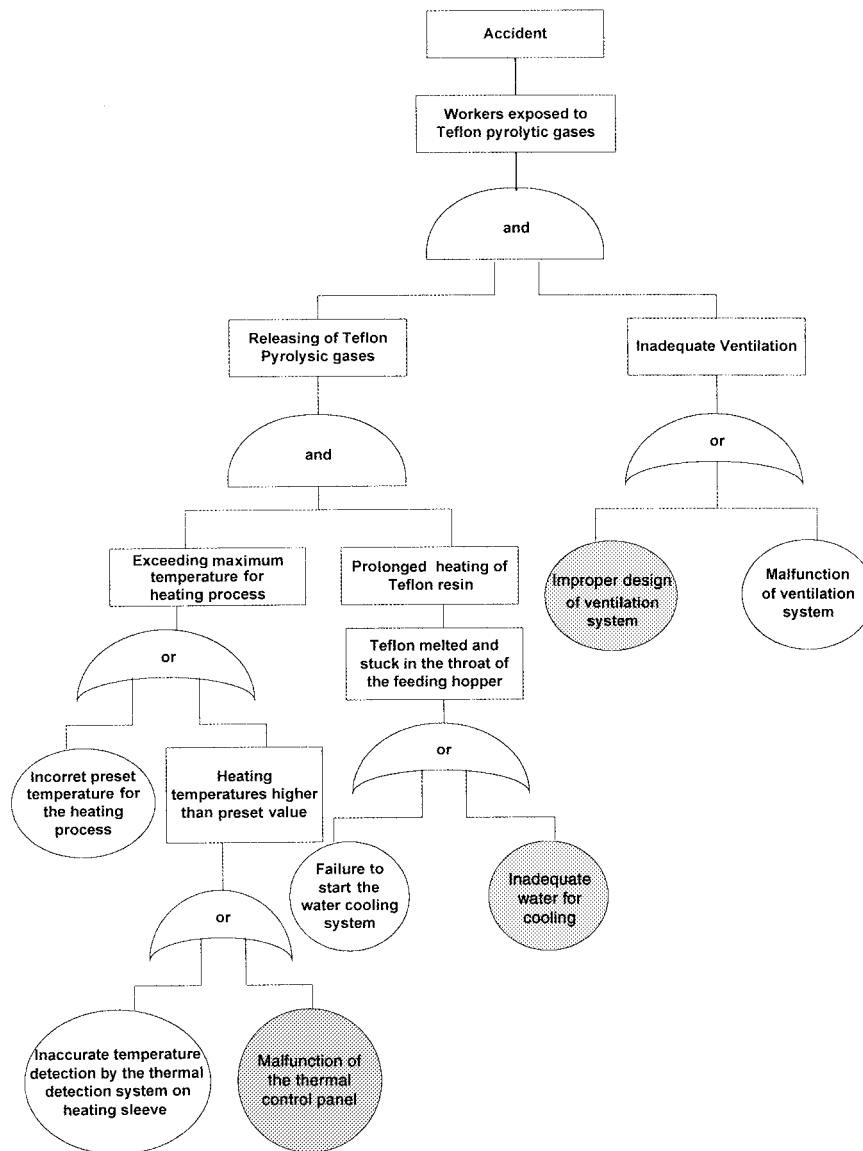
To find the causes of the accident, the logistic accident investigation technique of fault tree analysis (FTA) was adopted in this study. The technique involves first the identification of all possible cause elements (as seen at the bottom of the fault tree in Fig. 2), then grouping relevant cause elements to investigate intermediate cause elements via the logistic determination process, then repeating the above process until it reaches the occurrence of the accident scenario. The detailed FTA result for the given event is shown in Fig. 2. In this study, it should be noted here that the analysis of the causes of the event are not limited to those which are directly relevant to this special event. Instead, potential causes that might lead to the occurrence of similar exposure scenarios are taken into account. It is concluded that three basic causes (the cause elements with the hatched area) are found directly relevant to the event, including:

- (1) Improper design of the ventilation system.
- (2) Inadequate water supply for the cooling water system during the resin charging process.
- (3) Malfunction of the thermal control panel.

In addition, four potential causes (the cause elements with no hatched area), though not directly relevant to the event, might result in similar exposure scenarios, were found in this study, including:

- (1) Malfunction of the ventilation system.
- (2) Failure to start the cooling water system during the resin charging process.
- (3) Inaccurate temperature detection by the thermal detecting system.
- (4) Incorrect preset temperature for the heating process.

Fig. 2. The result of fault tree analysis (FTA) for the accident reported in this study. Circles and rectangles shown in the fault tree represent the possible cause elements, and the intermediate cause element, respectively. The possible cause elements with a hatched area represent those causes which are directly relevant to the event, the possible cause elements with no hatched area are regarded as potential causes which might result in the occurrence of a similar accident.
