Characterisation of lead pipes used in the water industry: extrusion processing, alloy microstructure and their role in service failures

N. Starling*^{1,2}, H. M. S. Belmonte¹, M. A. Shepherd¹, M. J. Mulheron² and P. A. Smith²

Keywords: Lead, Condition assessment, Microstructure, Mechanical properties

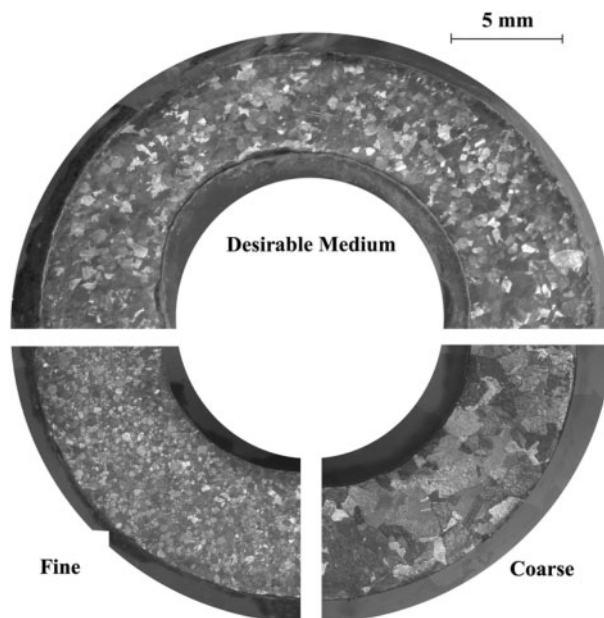
4 Variation in grain size observed in lead pipe samples

The grain size was found to vary significantly. Figure 4 shows a number of partial cross-sections from pipes with a range of microstructures; one section exhibits the

'desirable medium grain size' (~ 0.5 mm) specified by the British Standard, while the others exhibit the extremes of coarse and fine grain sizes that were seen.

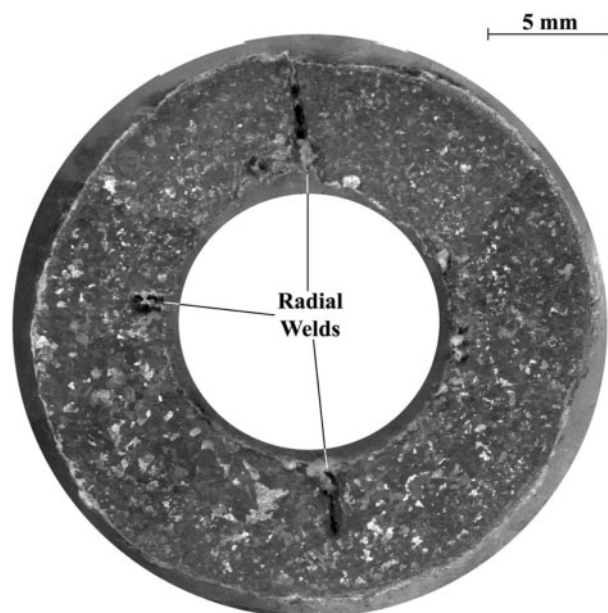
Another defect that arises as a direct result of the extrusion process is particular to those presses which utilise a bridge die. In such a set-up, the mandrel bar is connected to the die by spider arms, which can range in number from one to four. This can cause problems because the radial welds, which are formed as the lead reunites after the extruded section has passed the spider arms, are often of an imperfect nature. This is exacerbated if oxide and dross contained in the charge are drawn out behind the arms on extrusion, as this will

8 Lead pipe sample with longitudinal splits resulting from improper welds at spider arms

certainly inhibit the formation of a strong weld between the two joining parts. In extreme cases the use of a bridge die may lead to the formation of longitudinal splits from the sites of the joins. A transverse section illustrating poorly formed welds is shown in Fig. 8.

Many of the defects seen in the extrusion process are often ascribed to the extrusion temperature being too low. This prevents the oxide and dross in the melt from rising to the surface of the charge and so promotes the formation of internal defects. It has been noted already that many of the microstructural defects associated with the extrusion process can be avoided by using a method of continuous extrusion. It was also observed by McKeown and Hopkins¹⁴ that the grains in lead pipes extruded on the continuous press were uniform in size and structure, while those produced on the hydraulic press produced a grain structure that was more irregular in size and structure. Therefore it would seem that those pipes produced on a continuous extrusion press would tend to exhibit a more desirable grain structure as well as containing fewer defects.
