Case Report

A Case of a C-Stem Fracture at the Head-Neck Junction and a Review of the Literature

David Morley, Ian Starks, and Justin Lim

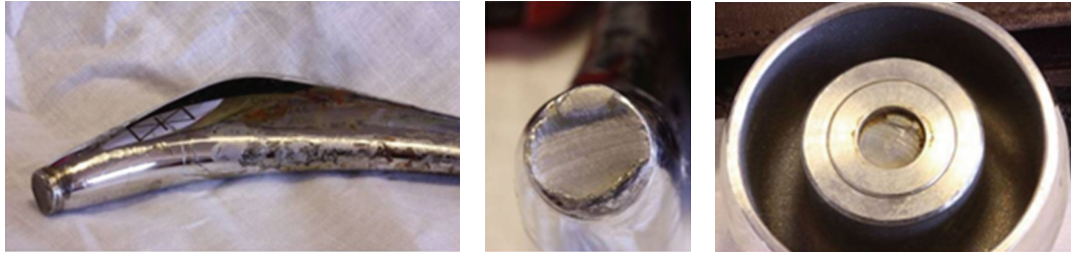
The explanted femoral component was sent to DePuy for further examination. The report showed fatigue failure of the component. The fracture surface was very deformed, particularly around the point of fracture initiation, suggesting that the failure occurred over an extended period of time, allowing separation of the two parts of the taper and damage to occur on the fracture surface/edge. The report also noted signs of metal oxides on the inside of the taper around the fractured edge. This was felt to be compatible with corrosion.

FIGURE 2: Photographs of the explanted femoral component, demonstrating the fracture at the head-neck junction (left to right: proximal femoral stem, cross section of the fracture site, under surface of the femoral head).

It is not possible to draw firm conclusions from this single case. However, we propose that the cause of the fracture at the head-neck junction in this patient was a combination of cyclical loading stresses, increased frictional torque generated by the use of a large femoral head on a stem with a small diameter taper, and a corrosive element at the taper adaptor.

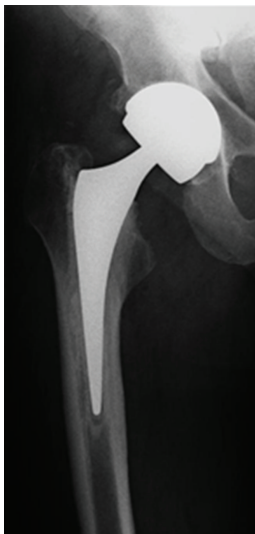
The patient made an uncomplicated recovery and was asymptomatic at 6 weeks followup. Postoperative check radiographs are shown in Figure 3. In January 2011, inflammatory markers and radiographs of the right hip were unremarkable, and chromium and cobalt ion levels showed a downward trend as compared to levels measured in October 2010.

FIGURE 3: Anteroposterior radiograph following revision surgery using C-stem AMT.
