DESIGN ANALYSIS: MODULAR REVERSE TOTAL SHOULDER PROSTHETIC FAILURE
WITHOUT PROXIMAL BONE SUPPORT¹Farzana Ansari, MS, ¹Carol Major, ²Stephen B. Gunther, MD, ³Tom R. Norris, MD, ⁴Michael Ries, MD, and ¹Lisa Pruitt, PhD¹ Department of Mechanical Engineering
University of California, Berkeley
Berkeley, California 94709
USA² Department of Orthopedic Surgery
Martha Jefferson Hospital
Charlottesville, VA 22911
USA³ Department of Orthopedic Surgery
San Francisco Shoulder, Elbow and Hand Clinic
San Francisco, California 94115
USA⁴ Department of Orthopedic Surgery
University of California, San Francisco
San Francisco, California 94122
USA

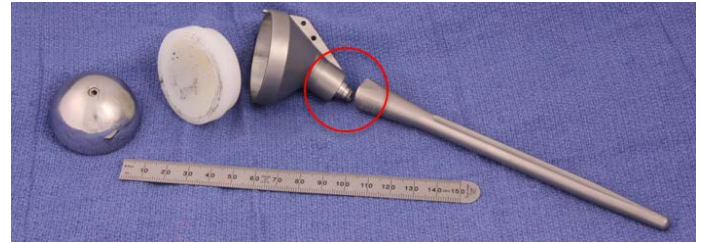
A modular Tornier Aequalis RSA which relies on screw fixation of the proximal body to the distal stem was retrieved (August 2011) from the left shoulder of a 60 yr old male patient (**Figure 1**). At the time of implantation (March 2007), the proximal bone was noted as deficient above the metaphyseal-diaphysis junction. The patient experienced episodes during which his shoulder was caught in external rotation and had to be manually rotated back in place to restore function. The device failed when the screw junction between the metaphysis and diaphysis fractured while the patient was golfing. The implant was immediately retrieved. Extensive metallosis was observed throughout the soft tissue and down the humeral canal. The fracture occurred just above the remaining humeral bone shaft. Grade II scapular notching was noted. There was no bone or soft tissue support fixed to the implant above the metaphysis-diaphysis junction.

Optical and metric analysis of the retrieval confirmed that unscrewing occurred before fracture of the metaphyseal screw. Measurements of the remaining screw lodged in the diaphysis and of the fractured screw exposed a gap between the superior surface of the humeral stem and the inferior mating surface of the metaphyseal component just before fracture. Removal of the remaining screw from the humeral stem revealed that the fracture had occurred at a 3mm diameter through-hole in the metaphyseal screw (**Figure 3**). Optical microscopy of the screw revealed some fretting wear of threads which may have contributed to the extensive metallosis observed at retrieval.

Figure 1 | The retrieved TSR, in which fracture occurred at the metaphyseal-diaphysis screw junction (circled).

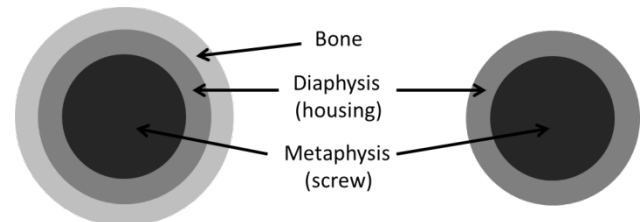
Composite beam analysis compared stresses in the humeral stem (assuming no unscrewing had occurred and ignoring any stress concentrations due to the through-hole) with and without proximal bone support. Under the same dimensions and bending moment

applied, proximal bone deficiency was shown to increase stresses in the implant by 60%. Unscrewing would reduce the cross section geometry and thus exponentially decrease the moment of inertia of the humeral stem, presumably driving the stresses even higher as shown by Eq. 1. Addition of a through-hole could elevate stresses threefold in tension [7]. SEM of the fracture surface revealed brittle mechanisms consistent with an overload event with no evidence of fatigue crack propagation.

Figure 2 | Cross sectional geometry used in composite beam analysis.

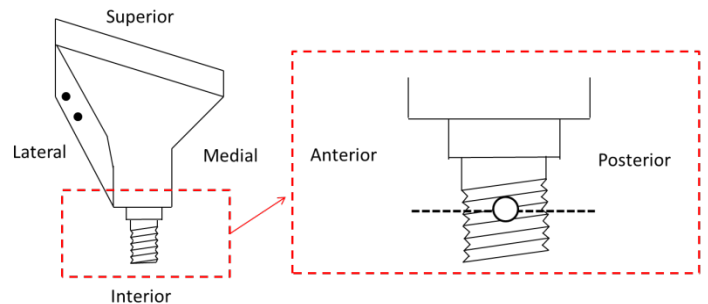
The extensive degree of metallosis observed suggests that even minimal metal debris from fretting wear can widely impact periprosthetic tissue. Optical analysis revealed that fracture occurred at the site of a through-hole in the metaphyseal screw. Composite beam analysis confirmed an increase in stress due to a lack of proximal bone support in a fully intact stem. This internal implant stress was increased by the effects of unscrewing on the geometry and moment of inertia. All three of these factors including the through-hole, the lack of proximal bone support and the unscrewing mechanism contributed to the weaker interface which predisposed the implant to failure during an overload event such as the golf swing. Observations during retrieval and optical analysis provided evidence for the failure mechanism presented in Figure 4.

Figure 3 | Illustration of metaphyseal component. The fracture (dotted line) occurred at a through-hole incorporated in the screw design. The through-hole was filled with a nylon plug.

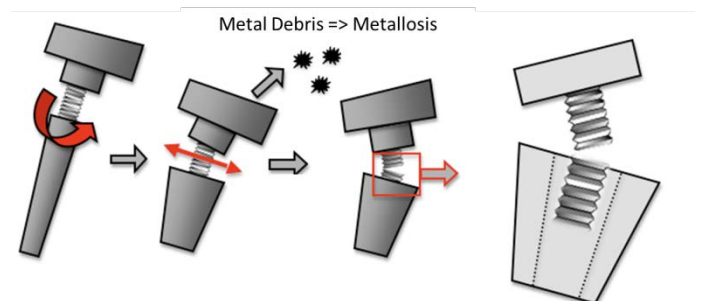
Figure 4 | Optical analysis suggests the following failure mechanisms: unscrewing, fretting wear (metallosis), and fracture due to overload.

This case demonstrates that both clinical and design considerations contributed to a premature failure of a modular RSA. Previous literature has suggested several clinical measures to prevent unscrewing of modular implants *in vivo*, including the use of an allograft composite or retentive humeral cup to reduce torsional instability in patients with proximal humeral bone deficiency [4,6]. While clinical actions can prevent unscrewing, our work shows that designs that include stress concentrations can significantly reduce mechanical integrity, especially during daily patient activity.
