BLADING VIBRATION AND FAILURES IN GAS TURBINES PART D: CASE STUDIES

Cyrus B. Meher-Homji
Boyce Engineering International, Inc.
10555 Rockley Road,
Houston, Texas.

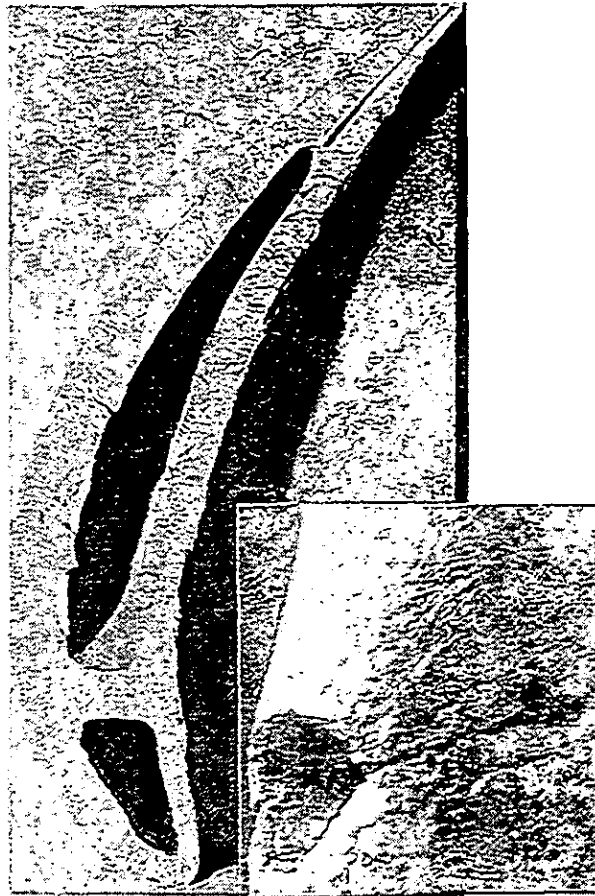
- 1) The fracture surface of a particular 1st stage blade indicated fatigue.
- 2) Blade material was confirmed to be IN 738 with chrome diffusion coatings
- 3) There was evidence of sulphidation.
- 4) There was no evidence of over temperature.

The observation that the aft portion of the fracture surface on a first stage blade was caused by fatigue, suggested that a fatigue mechanism was present. Observations of the Trailing Edge (TE) region of another 1st stage blade, indicated that hot corrosion damage had reduced the pressure side wall of the lowest cooling hole to an extreme thinness. This, in conjunction with the fact that the plane of maximum bending stress coincided with this hole, explained the nucleation and propagation of a fatigue crack. Photographs shown in Figure 1 depict the failure.

Figure 1. Fracture surface bisecting bottom of TE cooling hole (upper photograph) and cooling hole crack on another blade at 10X (lower photograph insert)

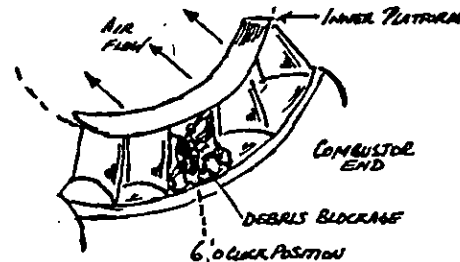
Figure 2. Sketch showing brick trapped in nozzle segment.

2.4.5 Blockage of the Nozzle Section and Its Effects on Blade Vibration. Observations made after the failure indicated that pieces of the combustor firebrick had lodged in the lower nozzle segment causing a blockage of approximately 80% (of that vane space). This occurred in the 6 O'clock position. It is possible that the blockage may have been far more severe in terms of percentage of nozzle area blocked prior to failure.

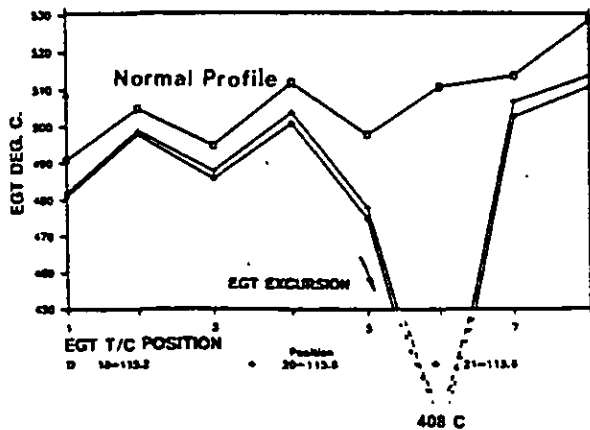
2.4.2 Exhaust Gas Temperature Profiles. A graphical plot was made of the EGT profile based on the eight exhaust temperature thermocouples and is presented in Figure 3. In general, the pattern held reasonably well except for an excursion in the data a few days prior to the failure. Of considerable significance was the fact that for two consecutive hours, thermocouple No. 6 exhibited a significant drop in temperature to 405 °C, when the expected value was 490°C.

Figure 3. EGT Temperature profile excursion due to stator nozzle blockage.

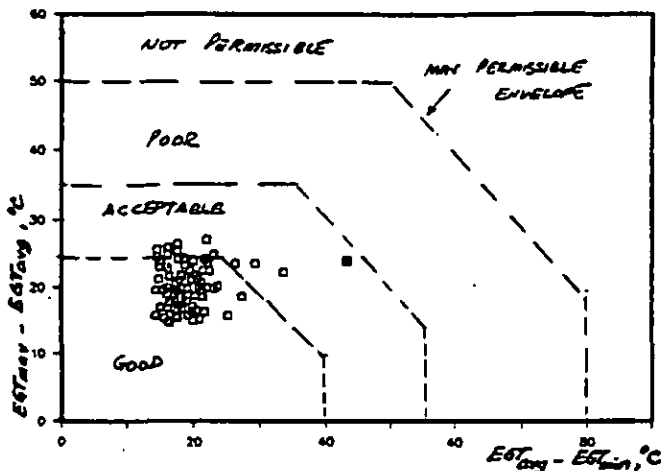
on the abscissa and $(EGT_{Avg} - EGT_{max})$ on the ordinate. This is shown in Figure 4. It is interesting to note that whereas all the data was within an "acceptable zone" defined by the OEM, there was a significant excursion on the day of the failure. All other data points were highly clustered around coordinates of (20,20).

Figure 4. Excursion of Exhaust Temperature Spread.

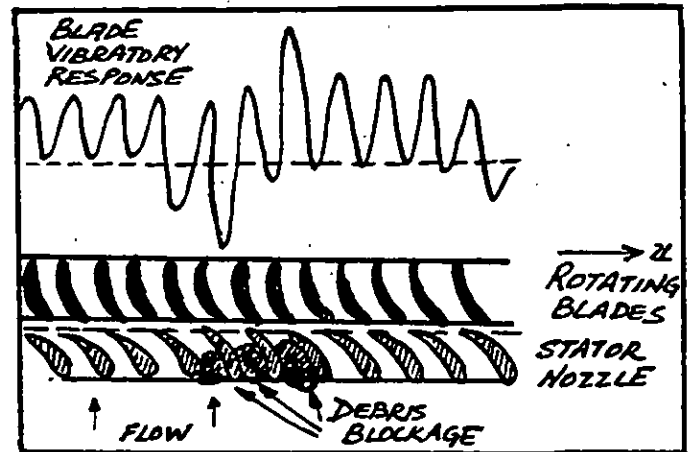
The effect of the blockage was to increase vibratory stresses on the blades resulting in abrupt loading/unloading as the blades traversed this position as shown in Figure 5. This situation is analogous to partial admission shock loading in a steam turbine. Due to the blockage, the localized Mach number and pressure drop affected rotating blade loads. It is difficult to analytically predict the effects of blockage as the severity would depend on the excitation magnitude and the damping associated with the excited mode. However, it is common knowledge that blockage of this nature can promote fatigue failures. Impulse harmonics and weakening of the blade due to sulphidation worked in unison to promote the failure.

Figure 5. Increase in blade vibratory stresses due to blockage.

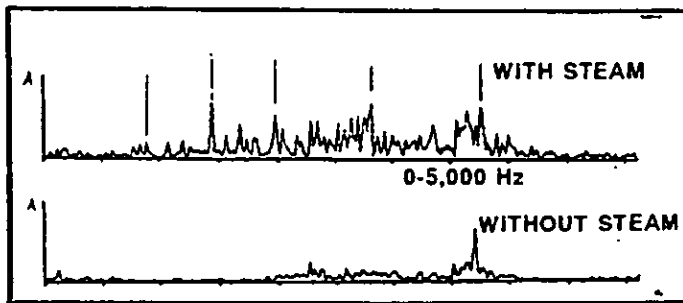
Figure 6. Vibration response with and without steam injection.

It was recommended that the expander be operated close to its design speed and flow. After a detailed study of blade material capability, a determination was made that steam injection provided minimal cooling benefits and was detrimental in terms of exciting blade resonances. A recommendation was made to discontinue the use of steam for blade cooling and to avoid operation in a particular speed zone. With these recommendations implemented and careful ongoing vibration monitoring program, an uninterrupted run of over 20,000 hours was achieved.

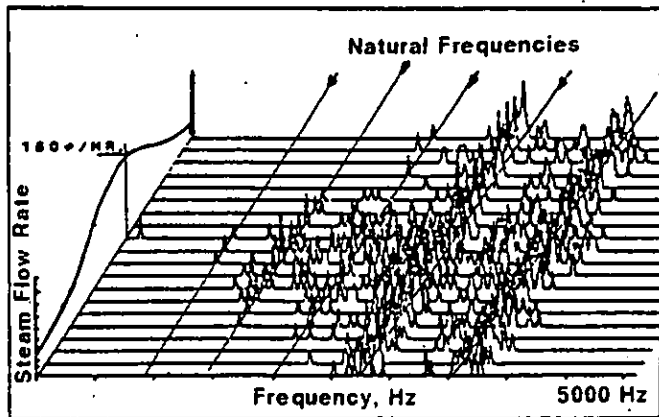
Figure 7. Accelerometer Based Vibration Cascade Showing Response with Steam Injection.

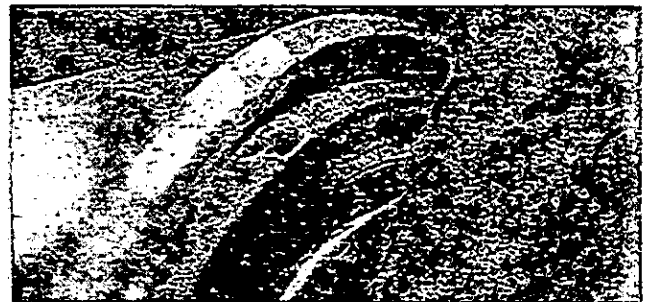
Figure 8. Broken blade lands (Upper photo) and standby corrosion damage to drum blade attachment region (Lower photo).

1. One blade in the 4th stage had migrated and was found cocked axially. This blade was found to have suffered a total failure in the leading edge T-root section (both lands).
2. Severe damage was found in the 6th stage blading with two blades being found broken approximately 1.25" from the base. Fracture surfaces were typical of fatigue.
3. Severe blading damage was found in the 7th stage (DOD).
4. Vanes in row 6 and 7 were severely damaged (DOD).
5. Upon deblading and subsequent NDT inspection, it was found that cracks were present at the T-root sections of the 2nd through 5th stages blading.
6. The blade attachment regions in the drum type rotor indicated wear and corrosion, with the 1st and 7th stages being in the worst condition.

4.4.6 Blading Materials and Standby Corrosion. Another important factor that contributed to the problems was standby corrosion in the blade root attachment region. This is a problem that commonly afflicts peaking gas turbines. Corrosion products which accumulate in the blade attachment areas act as abrasives and increase clearances. In the presence of corrosives possibly from airborne salt, uncoated airfoils often develop corrosion pits which could progress into cracks.

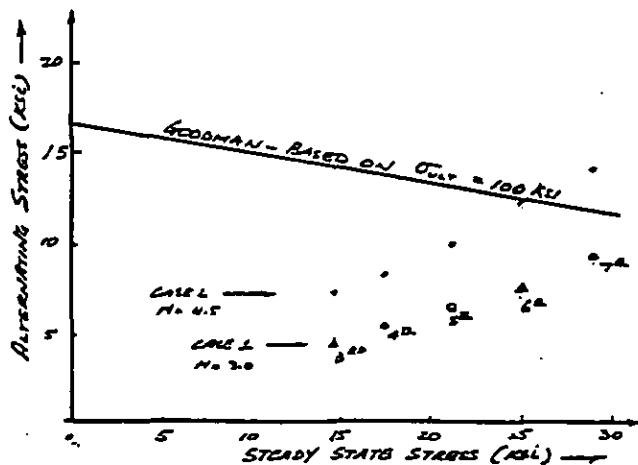
4.4.4 Evaluation of Vibratory Stresses. Figure 10 shows a Goodman Diagram created for the 3rd through the 7th stage blading. All of the stage materials have a UTS of approximately 100 KSI. The steady state stress was considered the sum of the gas bending stress and the centrifugal stress. The alternating stress is determined by applying a magnification factor of 3 to the gas bending stresses (Scalzo, 1991)

Figure 10. Goodman Diagram

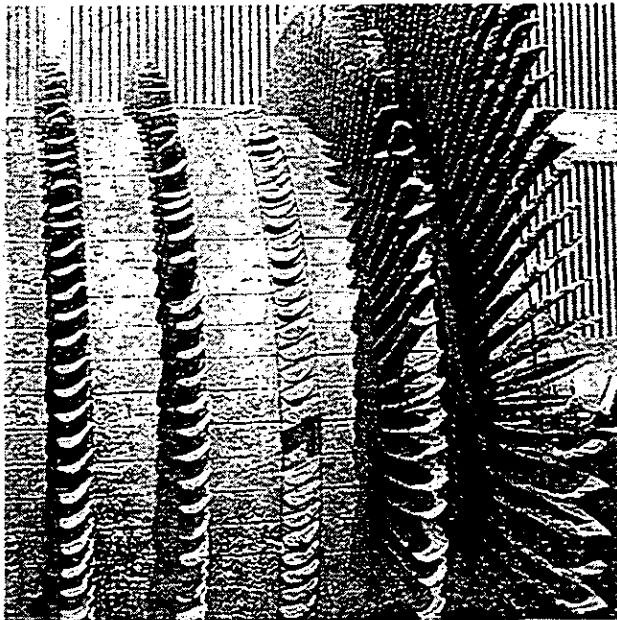
All five (5) turbine stages were severely damaged with fracture damage being indicative of impact overload. The stator nozzles, the rotor blades, and drum were badly battered. Several blades from the first three stages had been cropped with the 3rd stage rotor blades being totally wiped out. Several blades in this row had broken at the root near the cooling hole. The compressor section and bearings were not damaged. A few compressor stages indicated tip rubs probably caused by the tremendous unbalance forces that resulted with loss of turbine blading. The rubs occurred at the center of the rotor where deflection would be the greatest. The turbine section was totally destroyed and is shown in Figure 11.

Figure 11. Destruction of the Turbine Section.

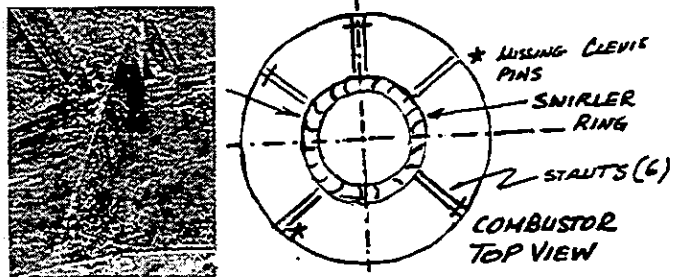
Figure 13. Missing clevis pin.

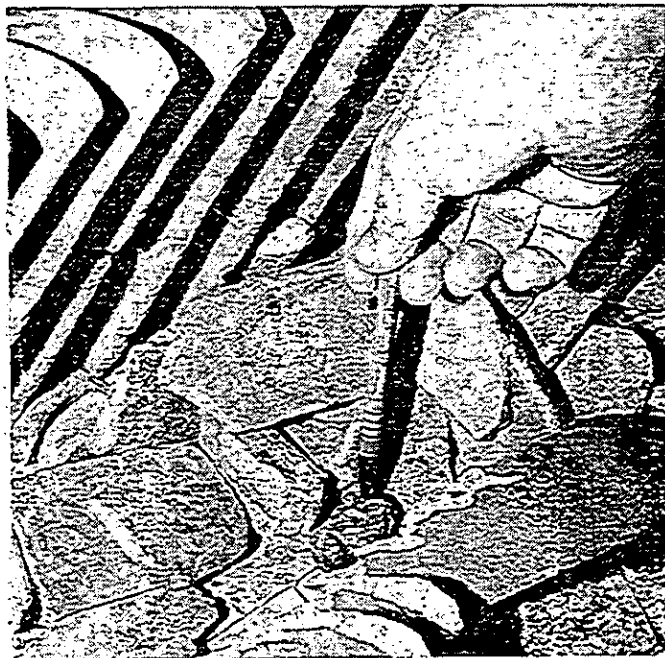
The massive turbine failure was the result of ingestion of a clevis pin, which had been liberated from the top of the silo combustor. The dislodging was the result of fretting damage, which disintegrated a cotter pin, used for retention of the clevis pin. In the light of this finding, it is entirely possible that the earlier failure, was also caused by the liberation of a clevis pin from the top end of the silo burner. The low alloy steel globules on the 1st stage stator airfoil surface found during the first failure metallurgical study were definitely low alloy steel, and in all likelihood were derived from an ingested clevis pin. This case stresses the importance of a thorough search of debris for telltale clues.

Figure 12. Pin found in turbine debris.
