# HALT Evaluation of SJ BIST Technology for Electronic Prognostics

James P. Hofmeister, Sonia Vohnout, Christopher Mitchell

**Abstract**—This paper presents the design, test, and results of a highly accelerated life test (HALT) evaluation of a soft-core called Solder Joint Built-in Self-Test™ (SJ BIST™), a method for detecting faults caused by solder-joint fractures in monitored input/output (I/O) pins of field programmable gate array (FPGA) devices, especially those in ball grid array (BGA) type of packages. Modern electronics utilize large FPGAs packages attached to electronic boards by means of solder joints, such as solder balls, between the package and the board. Thermo-mechanical stresses – primarily heat and vibration – cause fatigue damage and eventual fracture failure of one or more balls, which causes intermittent operational faults leading to catastrophic failures in critical systems. Such intermittent faults are difficult to reproduce on a test bench and many field returns of electronic modules with intermittently failing solder balls are diagnosed with code "no trouble found/could not reproduce." The SJ BIST soft-core offers a solution because it detects faults in mo

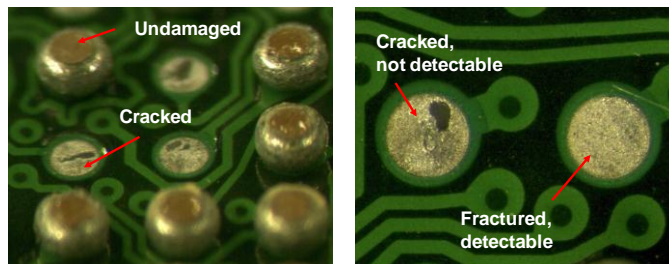
Figure 1. Damaged and undamaged solder balls.

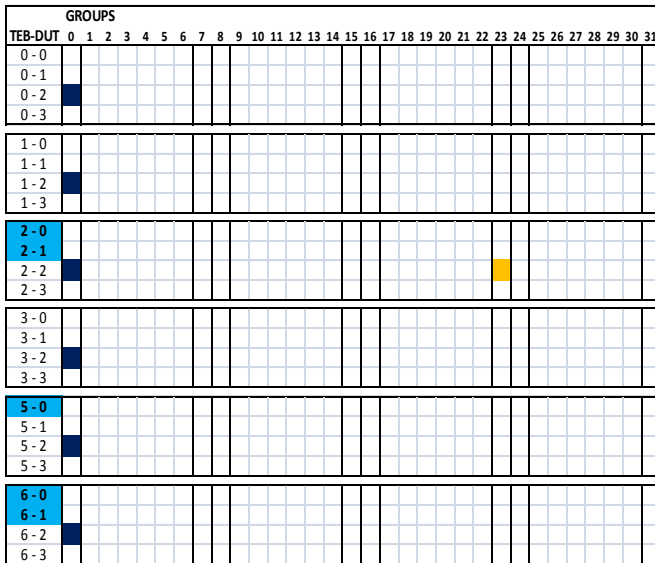
Figure 10. HALT status for cycle 4.

Five of the 24 FPGAs were found to be nonresponsive prior to starting the HALT: Board 2, FPGAs 0 and 1; board 5, FPGA 0; and board 6, FPGAs 0 and 1. Because of time and budget constraints, we elected to not fabricate replacement boards. The logged data for HALT cycle 4 (HC4) confirmed the null responses from those FPGAs.

In addition to reporting a null response from FPGA 0 and 1, the data log (see Fig. 9) for board 2 showed pin group 0 of FPGA 2 had a hard error on both pins. This same error occurred on FPGA 2 on all boards. The data log also indicated that both pins in group 23 of that FPGA were open: subsequent cycles indicated that group experienced intermittent faults. The “POWER ON” record indicates this is the first log after the board was powered on.

Fig. 10 is a graphical view of the HALT status: ■ = no response from the indicated FPGA, ■ = solid error(s) in the indicated pin group, ■ = intermittent faults in the indicated pin group, ■ = no data written, and ■ = over 100 intermittent faults in the indicated pin group. The eight outlined groups are those nearest a corner of a DUT.

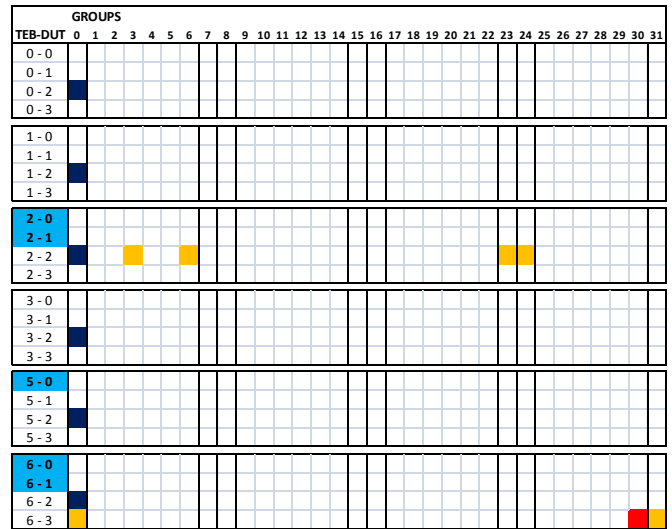
Continuous HALT cycling began 16 November and on 20 November the logged data for cycles 5 through 23 were sent to Tucson for analysis to verify the firmware and software to collect and log data were working correctly. Fig. 11 shows intermittent faults occurring in six additional pin groups.

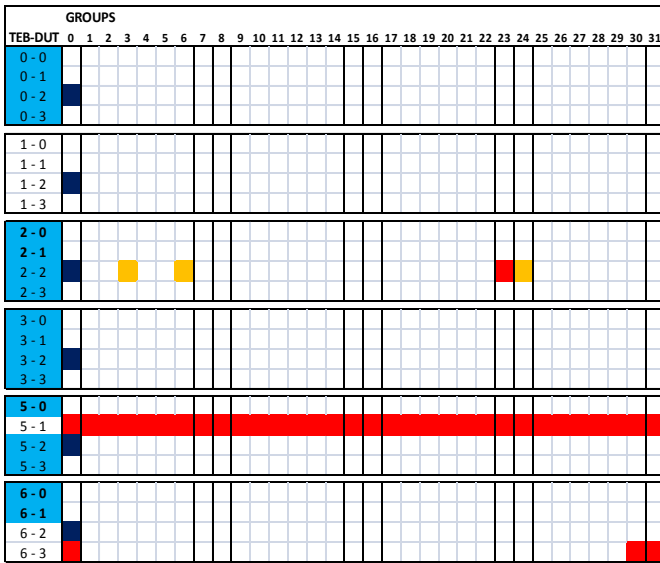
Figure 13. HALT status at end of cycle 72 (30 November).

On 25 November, it was noticed the 5A 5VDC power supply was going into current-limiting mode. We decided to reduce the oven temperature to 85°C (see Fig. 12) until we could replace the original with a larger power supply. When we examined the logged data records, and we determined the previous damage to boards 2 and 6 had increased as shown in Table III, Table IV, and Fig. 13:

HC 35	Logged Record
1 Board 2, FPGA 2, group 23: hard open	0202170F00010001
2 Board 6, FPGA 3, grp 30: high intermittency	06031E0F00050F0F

HC 72	Logged Record
1 Board 1 and 6: no change	
2 Board 5: FPGA 0, 2, and 3	NULL FPGA RESPONSE
3 Board 5: FPGA 1 - all pins broken (suspicious)	050100050F0F0F0F
4 Board 0, 2, and 3	NO SIGNAL

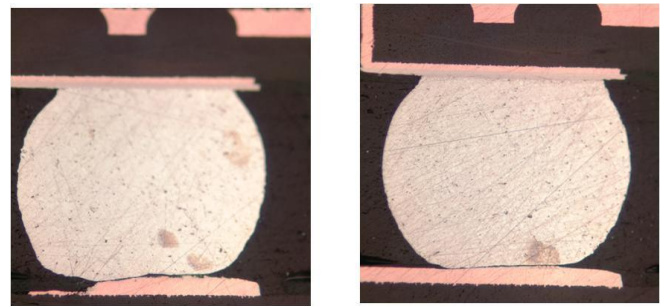
Figure 19. Pins C1 (left) and G1 (right), board 6, FPGA 3.

We cross sectioned 48 pins and examined 103 images. We concluded the following: pins that SJ BIST reported as having faults were fractured (no false alarms), an example of two pins C1 from group 31, board 6, FPGA 3 and G1 from group 30, board 6, FPGA 3 are shown in Fig. 19. Both balls are fractured, and referring to Fig. 17, SJ BIST detected high number of faults. With one possible exception (see Fig. 21), no fractures were found in pins SJ BIST reported as healthy. Fig. 20 shows two pins monitored by SJ BIST and for which no faults were reported: those pins were not fractured.

This apparent fracturing with no detectable occurrence of faults is an example of the intermittent nature of solder-joint caused faults. Another example is cycle 54: SJ BIST reported the occurrence of only two faults each for board 6, FPGA 3, group 31, pins C1 (which Fig. 19 shows is clearly fractured) and C2. There were a total of 270 billion – yes, billion – writes of a ‘1’ bit to each of those two pins in that 3-hour HALT
