# THE IDENTIFICATION AND ANALYSIS OF LATENT ESD DAMAGE ON CMOS INPUT GATES

Jim Colvin  
Consultant  
36217 Worthing Dr.  
Newark, CA 94560  
jbcolvin@pacbell.net

## Abstract

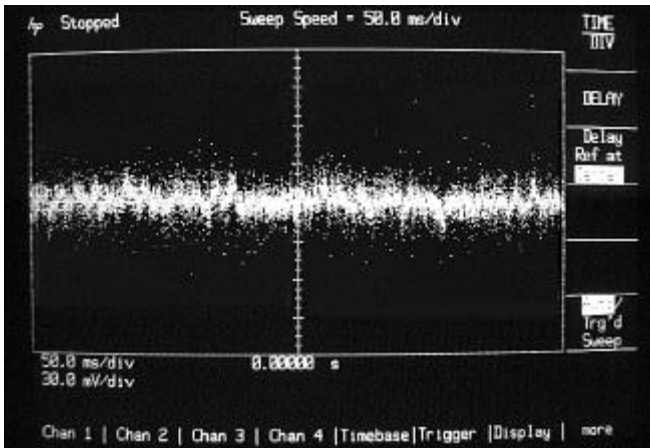
Damaged oxides, which have not been electrically overstressed, act very much as spark gaps. The resultant oxide noise signature (ONS) is easy to identify against the background noise as shown in photo 1.

**Photo 1** is from a Digital Oscilloscope connected to the pin leakage. Notice that some of the noise peaks are as high as 90 mV for an input pin with compromised gate oxide.

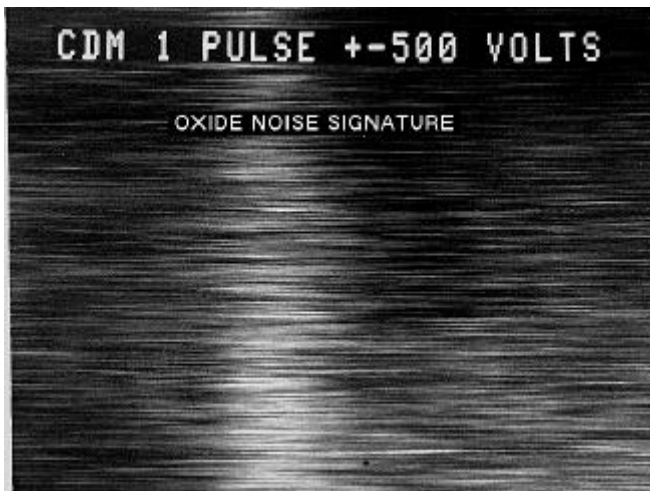
The signal was amplified with subsequent op/amp stages and fed into the external input of the slow scan camera of the SEM without synchronization. Photo 2 shows a failing input with an evident oxide noise type signature. A normal input is shown in photo 3. The vertical band in photos 2 and 3 is a 60 Hz artifact associated with shielding issues and can be ignored.

**Photo 2** Typical Oxide Noise Signature associated with an input pin leakage of 220 nA at 6 Volts. Slow scan rate is 30 seconds.

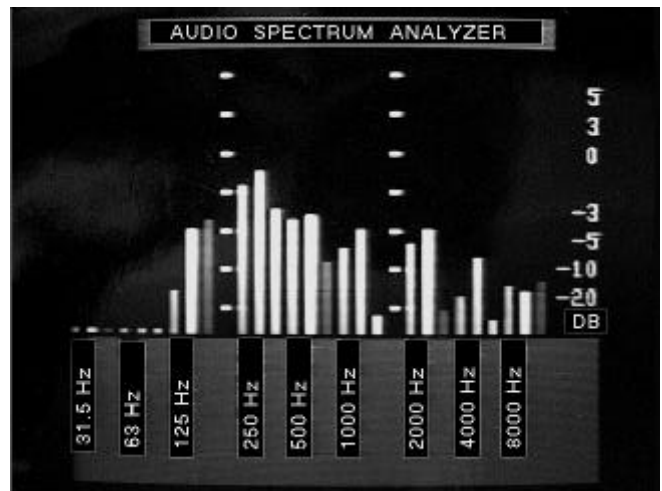
A spectrum analyzer was utilized to view the audio spectrum of this oxide noise, (see Photo 4). Notice that frequencies below 100 Hz are heavily attenuated due to AC coupling and that the spectrum rolls off gradually after 2000 Hz.

**Photo 4** Audio spectrum of the Oxide Noise Signature.

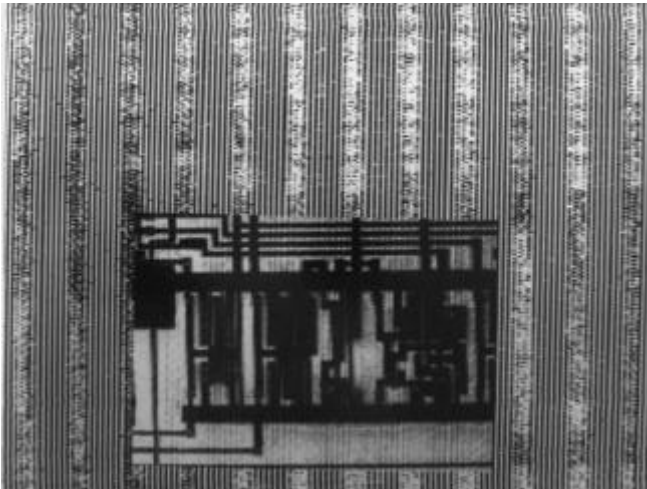
**Photo 5** is an OBIC image and inset in the center is an image integrated scan of the OBIC signal over a known oxide integrity defect. Nothing was obtainable through the OBIC signal besides the noise signature.

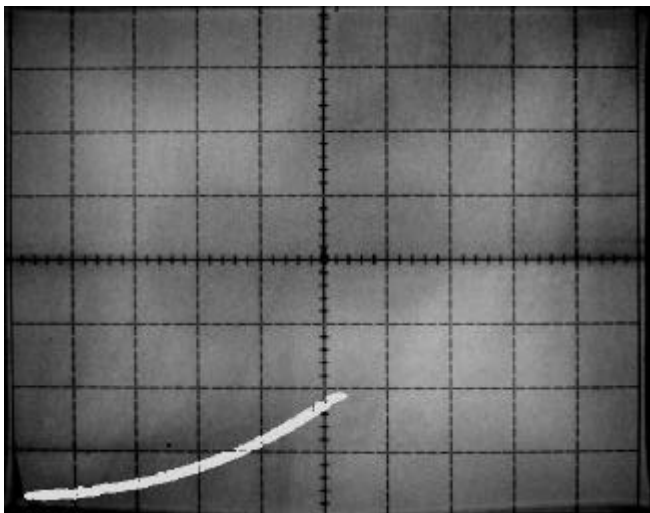
**Photo 6** Curve characteristics of typical LESD.  
Settings: 1 Volt/div. horizontal 50 nA/div. Vertical

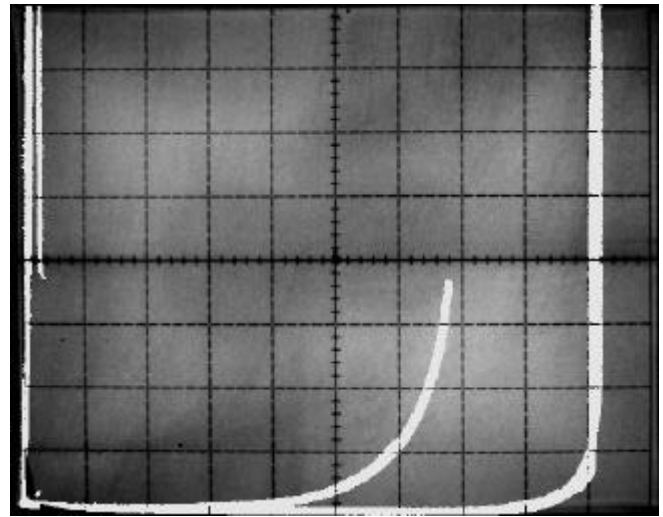
To confirm this latency or walking-wounded phenomenon of the gate oxide, the voltage was gradually increased. Eventually the oxide ruptured. Typically the oxide rupture occurred anywhere from 13.5 to 16 volts as shown in photo 7.

**Photo 7** Curve characteristics of the latent leakage and subsequent rupture at 13.8 volts as compared to a reference pin.  
Settings: 2 Volts/div. horizontal 5  $\mu$ A/div. vertical

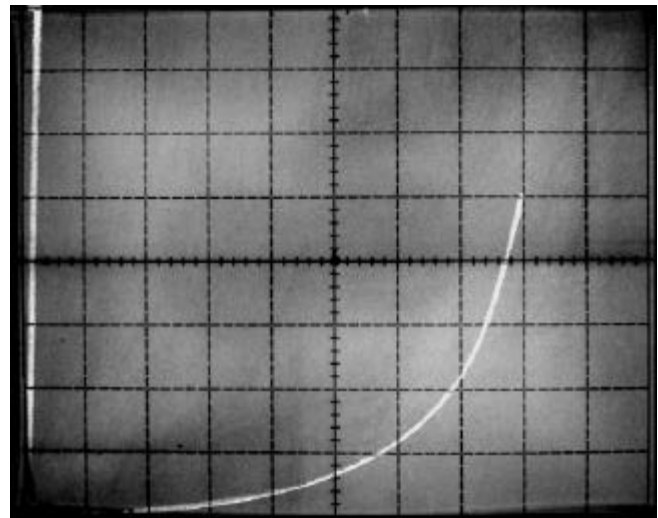
**Photo 9** Curve characteristics of the latent leakage and subsequent rupture at 16 volts. This part was CDM stressed at  $\pm 700$  volts 5 pulses. Settings: 2 Volts/div. horizontal 10  $\mu$ A/div. vertical

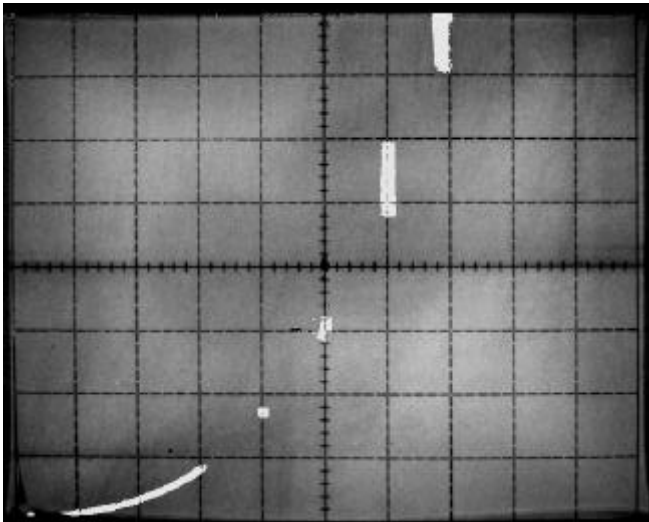
mechanical stress can be viewed as being analogous to a spark gap. The spark gap theory matches the results seen both in terms of the sporadic readings on the curve tracer and the noise spectrum acquired with the spectrum analyzer when the input leakage was driven with a constant current source. The time variant nature of this type of LESD is shown in photo 10.

**Photo 10** Curve characteristics of the time variant nature of the latent leakage at ambient. The curve tracer is set to dc+ mode. The curve was set at 4, 5, 6, and 7 volts respectively for 1 minute. The resulting vertical lines are a result of the variant leakage at each fixed voltage value. This part was CDM stressed at  $\pm 500$  volts 1 pulse. Settings: 1 Volt/div. horizontal .1  $\mu$ A/div. vertical (pin 3).

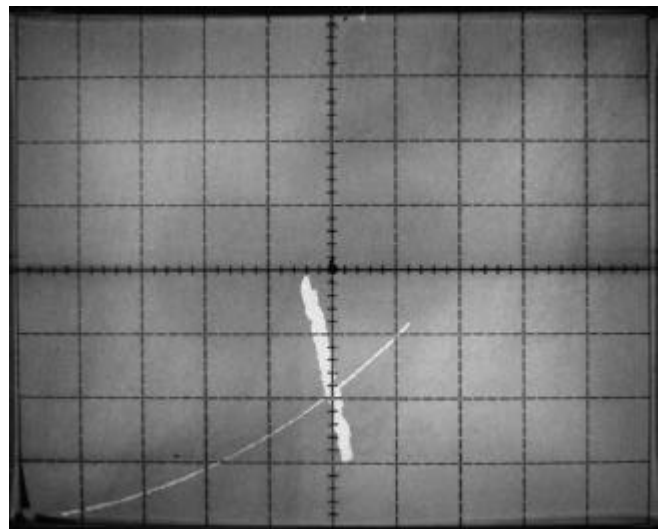
**Photo 12** Curve characteristics of the temperature variant nature of the latent leakage after the second iteration of temperature cycling. The exponential curve is from the sweep taken on the device prior to the second iteration of temperature cycling. This part was CDM stressed at  $\pm 600$  volts 1 pulse. Settings: 1 Volt/div. horizontal 2  $\mu$ A/div. vertical

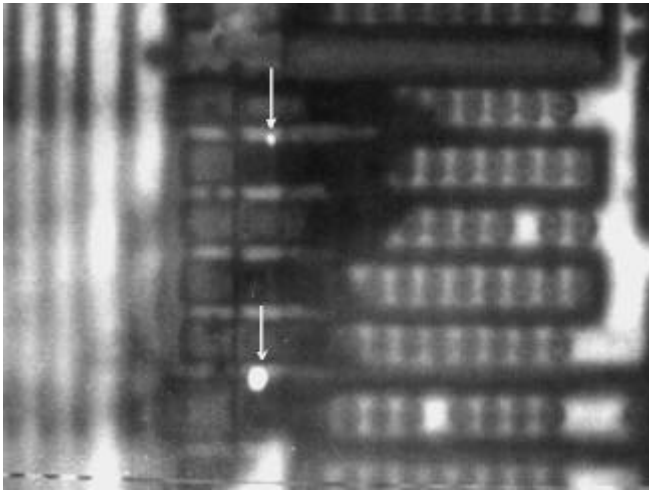
Emission microscopy was performed and two emission sites associated with this one particular input pin were identified. The bias voltage was 10V. The reasons for this high bias voltage were that no emission sites could be identified at lower voltage ranges and this voltage value was prior to any permanent damage being done to the gate. The two emission sites had varying intensities as seen in photo 13.

**Photo 13** Two emission locations were identified on the input gate responsible for 110 nA of leakage at 5 Volts. The drive voltage was 10 volts with a CCD acquisition time of 400 seconds.

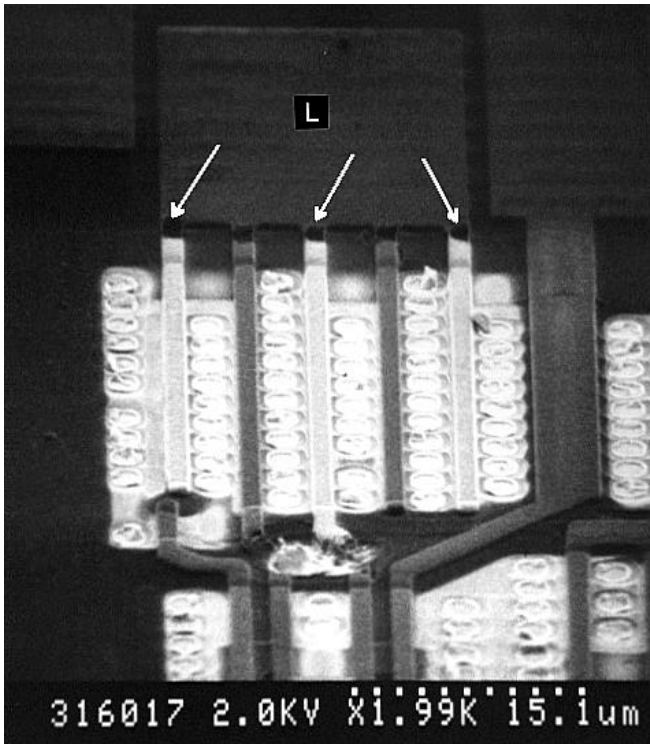
**Photo 16** SEM PVC image which shows latent leakage on the two end fingers and the middle finger of the Laser isolated input structure. This gate is labeled "L".

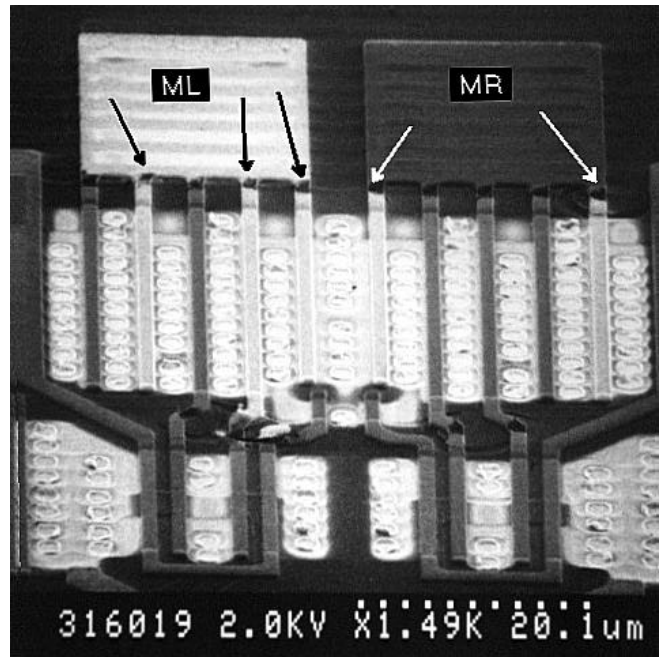
**Photo 17** SEM PVC image which shows latent leakage on two adjacent gate structures labeled "ML" and "MR" respectively. "ML" has three illuminated fingers with leakage, "MR" has two.

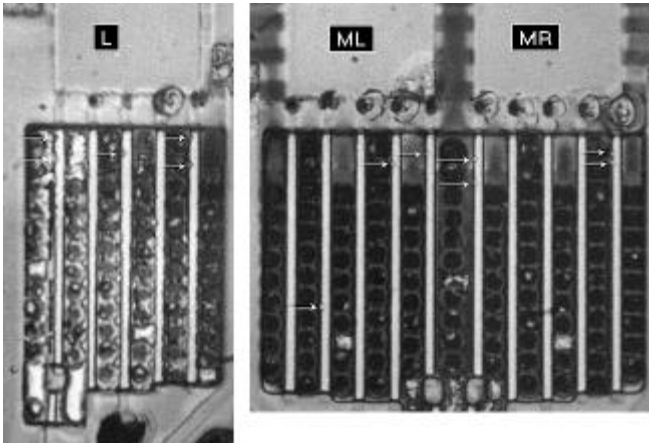
**Photo 20** Optical image of the exposed gate oxide for locations "L", "ML", and "MR". The arrows identify the rupture sites.

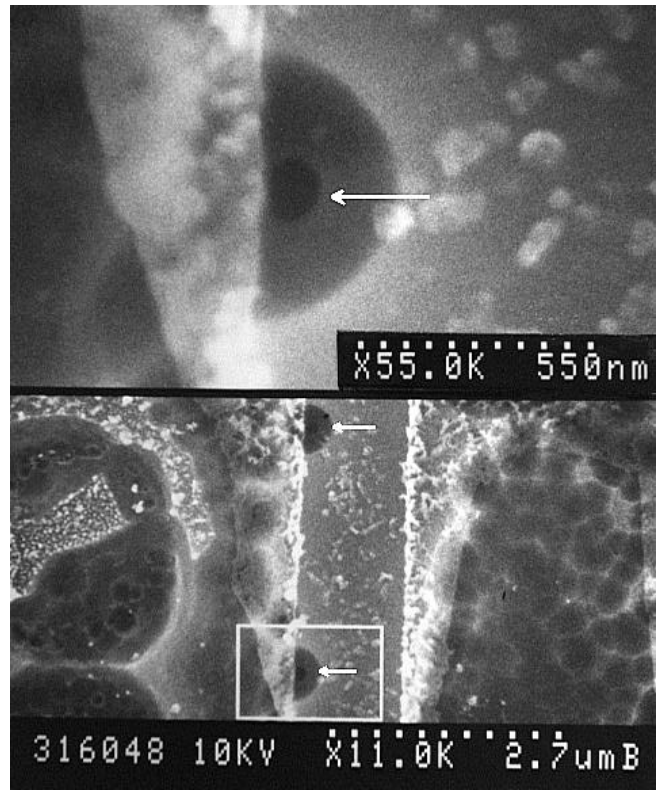
Photos 21-24 are the corresponding SEM photographs which show from 3 to 5 LESD damage areas. Photo 21 provides detail of the damage site. Note the hole within a hole. The outside dark ring is due to some plasma undercut which removed the underlying channel radially from the rupture. The size of the inner hole ranges from  $.15 \mu m$  to  $.26 \mu m$  in the Y direction and from  $.12 \mu m$  to  $.19 \mu m$  in the X direction for various samples. Note the oxide spacer sidewalls are still present even though polycide is removed. This is due to two factors:

**Photo 21** SEM high magnification split view of the LESD damage sites. Note the hole within a hole. The outside dark ring is due to plasma undercut which removed the underlying channel radially from the rupture. The size of the rupture ranges from .15  $\mu\text{m}$  to .26  $\mu\text{m}$  in the Y direction and from .12  $\mu\text{m}$  to .19  $\mu\text{m}$  in the X direction for various samples.

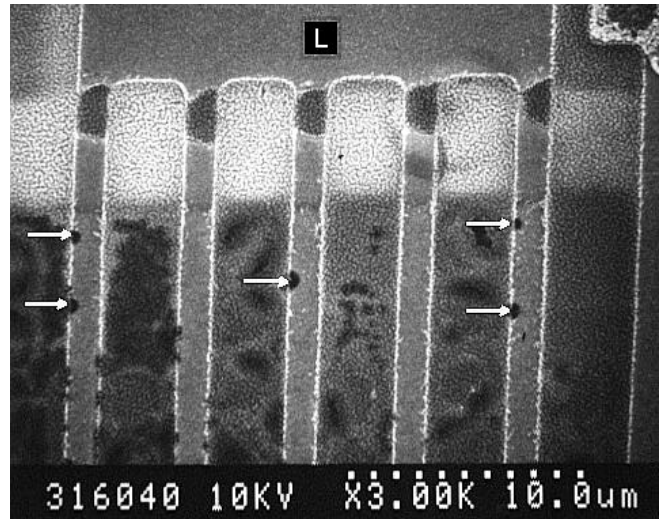
**Photo 22** SEM view of the LESD damage sites associated with location "L". 5 damage sites have been identified corresponding to photo 16. Some areas have evidence of irregular gate undercut due to thinning of the ink protecting the diffusion. High magnification inspection confirmed those areas as undercut only.

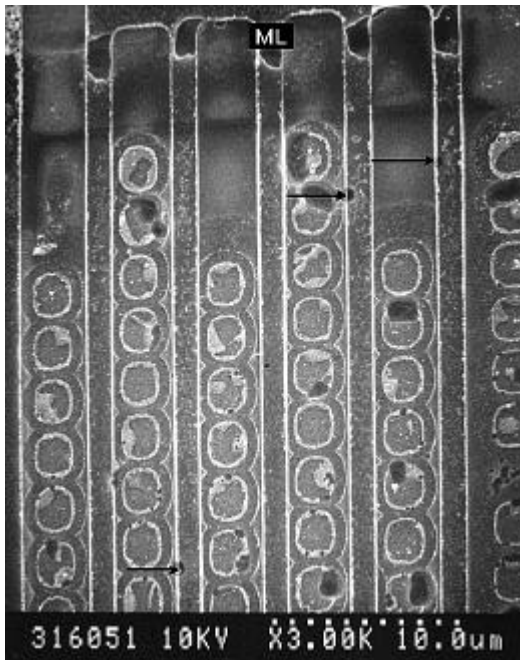
**Photo 23** SEM view of the LESD damage sites associated with location "ML". 3 damage sites have been identified corresponding to photo 17. One area had evidence of irregular gate undercut on the left finger due to thinning of the ink protecting the diffusion. High magnification inspection confirmed this area as undercut only.

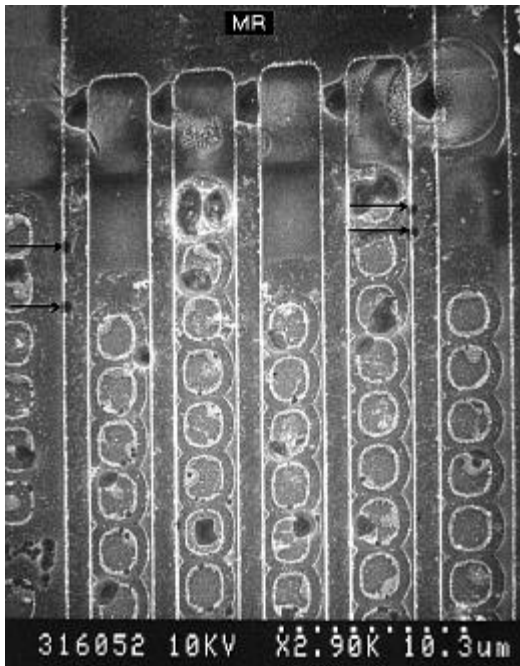
**Photo 24** SEM view of the LESD damage sites associated with location "MR". 4 damage sites have been identified corresponding to photo 17. One area had evidence of irregular gate undercut on the second from the left finger due to thinning of the ink protecting the diffusion. High magnification inspection confirmed this area as undercut only.

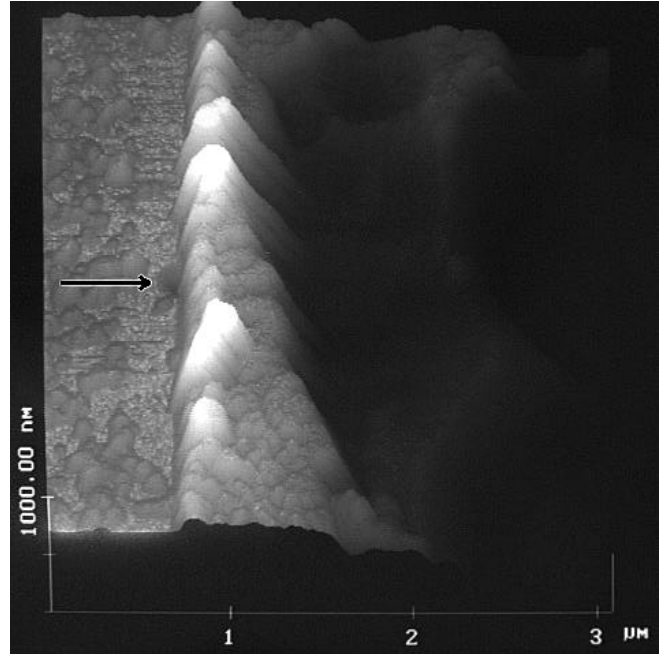
The LESD damage site from photo 21 was analyzed using a Digital Instruments Atomic Force Microscope (AFM).<sup>9</sup> Photos 25 and 26 are AFM views of the LESD rupture. Photo 25 shows the location of the hole associated with the oxide sidewall. Photo 26 shows the hole to be cone shaped. This is due to tip convolution as the edges of the tip enter the LESD hole. The edges of the hole were measured to be: Y = .19  $\mu\text{m}$ , X = .14  $\mu\text{m}$ . Notice that the etch undercut ring from photo 21 is not visible in the AFM images since the AFM reveals the true surface profile.

**Photo 25** Atomic Force Microscope Image of an LESD damage site. Compare the appearance of the oxide sidewall to the SEM image in photo 21.

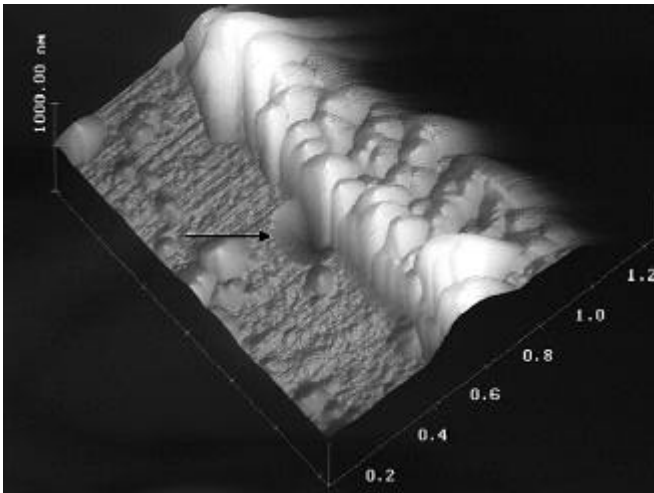
**Photo 26** Atomic Force Microscope Image of an LESD damage site at increased magnification.
