REPORT OF A COATING FAILURE ON A 16-INCH OIL PIPELINE UNDER WET CO₂ SERVICE

Klaus E. Kueter
InterCorr International, Inc.
14503 Bammel-N. Houston, Suite 300
Houston, TX 77014

David E. Hendrix
The Hendrix Group
15823 North Barker Landing
Houston, Texas 77079

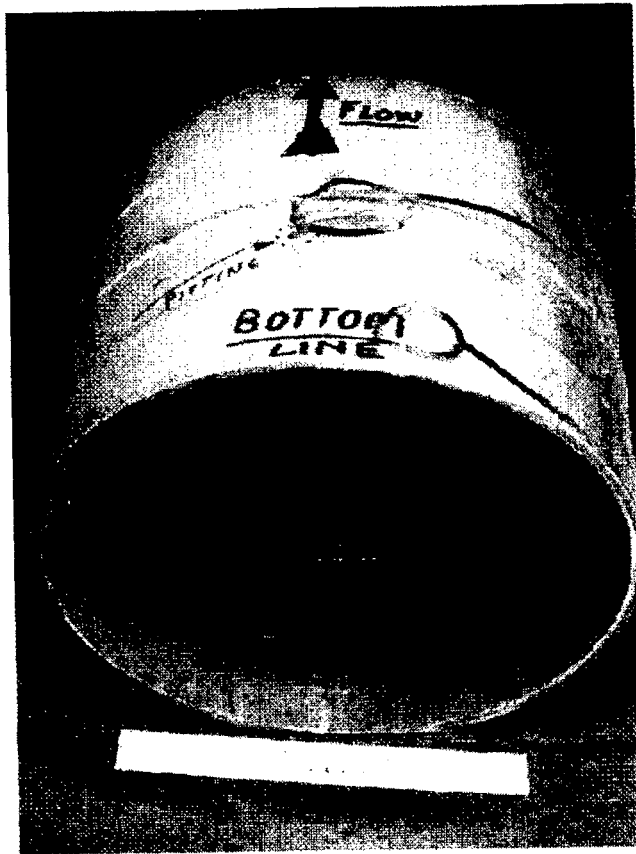
An approximately 15-inch long pipe sample was received for analysis (Figure 1) containing the failure area. An elongated, through-wall pit was present on the bottom of the pipe at the shop/field-coating interface (Figure 2). The pipe O.D. at the through-wall hole is shown in Figure 3.

Figure 1 - Sample, approximately 15-inch long pipe containing the failure area.

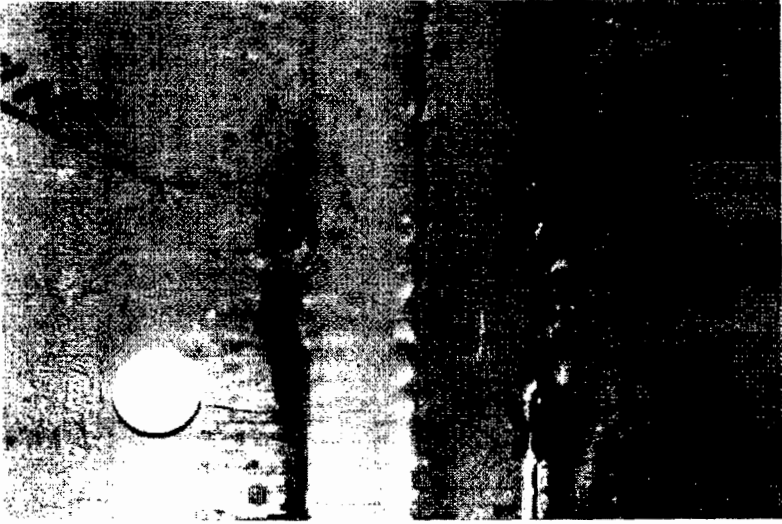
Figure 5 shows a close up view of representative I.D. coating damage and a through-wall pit. The pit initiated at the shop/field coating interface on the upstream side of the sample butt weld. Similar, less severe damage was observed at the interface on the other side of the weld. Small, pinhole porosity can be seen in the I.D. coating at the weld. The cut-back area of the coating on the pipe (area between the butt weld and the shop coating) was approximately one inch wide on either side of the weld; however,

Figures 5 - Close up view of elongated pit shown in Figure 1.

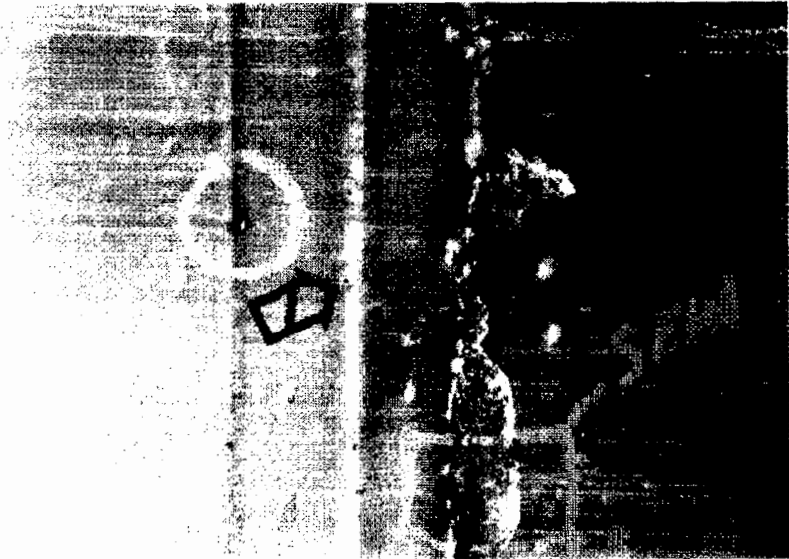
in some locations it was less. Figure 6 shows damaged coating on the opposite side of the through-wall pit after removing part of the disbanded coating with a knife blade. A black material was found under the coating. Several blisters were also present. A blister, after opening, also contained a black material. Prying with a knife revealed that the black material was on top of the shop coating.

Figure 6 - Damaged coating on the opposite side of the through-wall pit after removing part of the disbonded coating with a knife blade

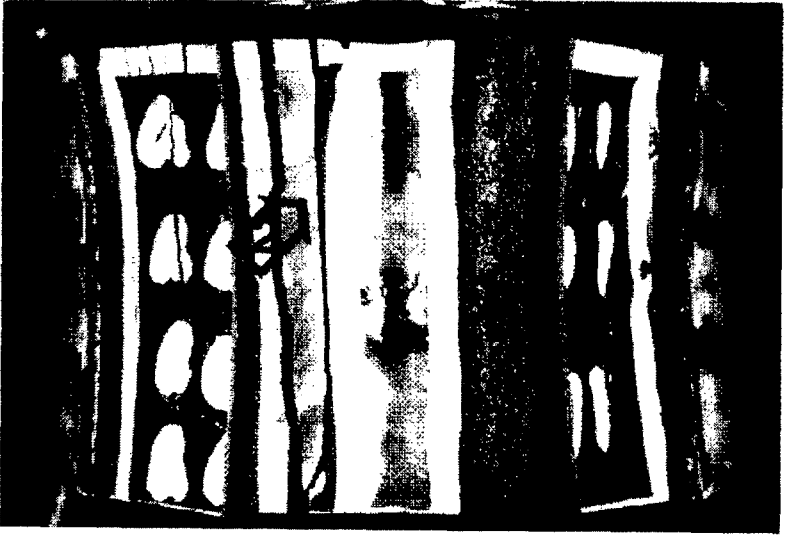
A full length strip from the top and bottom of the pipe sample was bent 180 degrees over a mandrel at -20 F (-29 C) in an attempt to fail non adherent or loosely bonded coating and to check for contamination under the shop and field coating. Figure 7 shows the bottom bend sample. The field coating was observed to separate from the base metal in large pieces. Both separations at the base metal/coating interface and intra-coating delamination were noted. A large area of delamination at the base metal occurred. The pipe sample I.D. contained an oily sheen underneath the field coat. Visual examination of the pipe side of a paint chip that separated at the weld (See Figure 8) showed that it contained a black foreign material and an oily residue. The part of the chip that delaminated from the base metal did not exhibit any anchor profile.

Figure 7 - Bottom bend sample after bending at -20F (-29C)

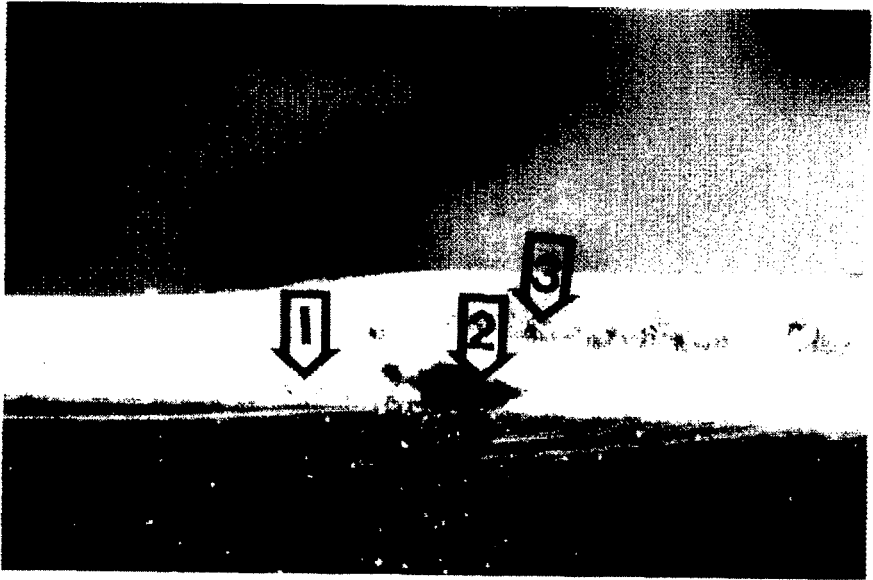
Figure 11 shows another shop/field coating interface cross section. The coating at this location contains foreign material between the shop and field coating overlap, including steel shot, and contamination beneath the shop coating. A third location is shown in Figure 12. The field coating is beneath the shop coating at this location, clearly showing that the edge of the shop coating was not bonded when the field coating was applied.

Figure 11 - Shop coat/field coat interface showing foreign material at edge of shop coat.

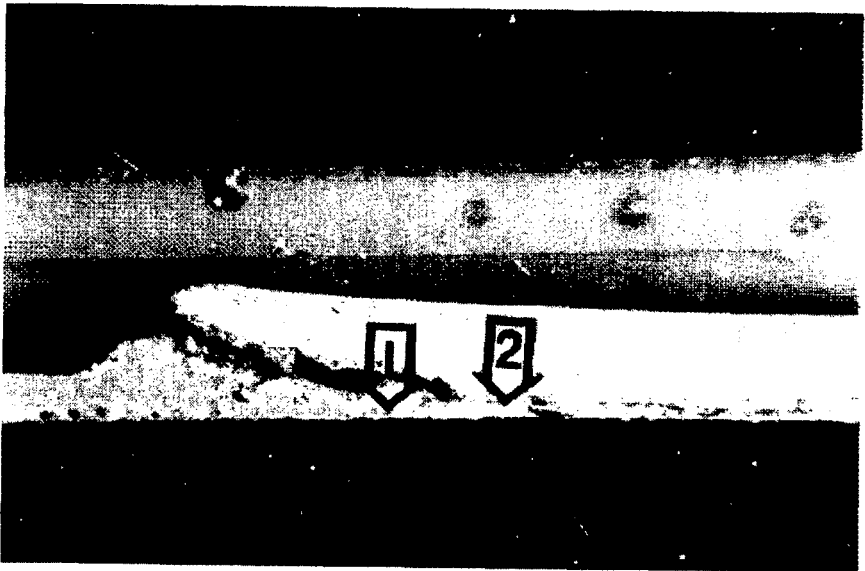
Figure 12 - Sample at cut back showing field coating underneath the shop coat (1), and foreign material underneath the shop coat (2)
