GT2004-53461**Metallurgical Analysis of Rainbow Rotor Coatings: Analysis of Fleet Blades**

ABSTRACT

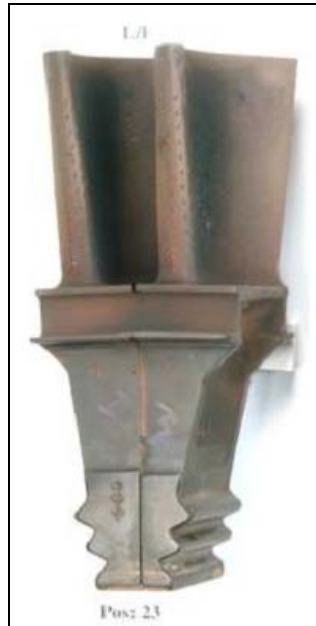
During the initial visual inspection of this coating it appeared to be one of the better performers of this rotor. On the first stage blades, there appeared to be no signs of substrate penetration with minor corrosion visible on the concave surface. It was decided that the majority of the blades with this coating would be reinstalled because of the general performance. Figure 1 is a representation of the appearance of the blades.

During the metallurgical evaluation, the sample blade pair analyzed showed evidence of base metal attack with the worst areas being seen on the concave side at the 80% span near the trailing edge. The documented amount of base metal attack was 50.8 μm to 76.2 μm for the one blade examined. It is believed that the blade pair used during the analysis might have not been a true representation of all blades with that type of coating based on the results and classification of the original visual inspection. This substrate attack appeared only in very localized areas (Nagaraj, 2003).

Figure 1: Typical PBC-22 Coated 1st Stage HPT Blade After 7,192 Hours

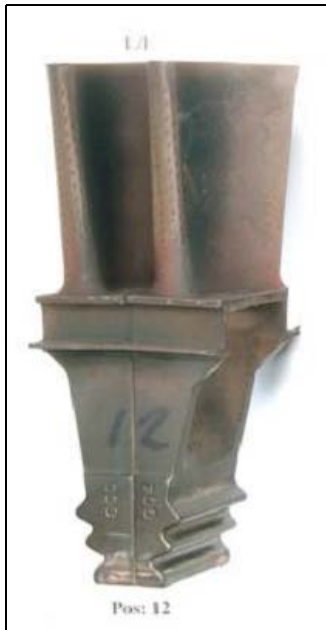
As the visual inspection results indicate, this coating was classified as having no coating damage. In this rotor, this coating was one of the most effective coatings in protecting the blades

from corrosion. During the metallurgical evaluation it was found that there was no substrate attack on the lead or trailing airfoil and the corrosion seen on the convex and concave surfaces of the blades still had about 50.8 μm of coating remaining on the substrate (Nagaraj, 2003). The composite plated BC-22 coating was previously evaluated in an Industrial LM2500 Rainbow rotor. That evaluation was in a predominantly oxidizing environment and the performance of the composite plated coating was equal to or better than that of plasma sprayed BC-22 coating (Nagaraj et al., 1995).

Figure 2: Typical BAJ BC-22 Coated 1st Stage Blade After 7,192 Hours

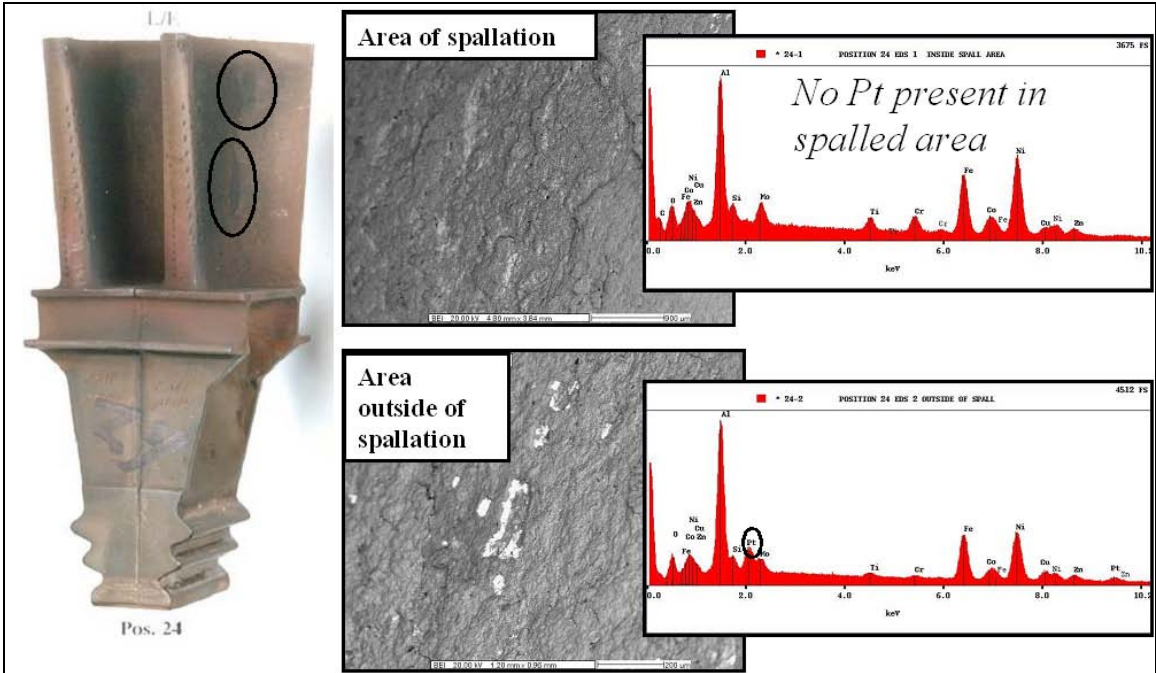
The blades with this coating were classified as M1 with spalling present on the leading edge near the tip of the concave surface. The scanning electron microscopy (SEM) report shown below, Nagaraj, 2003, prior to destructive testing indicated that there was no platinum present in the spalled areas. Due to the visual classification and the SEM report, it was determined that none of the Chromalloy PtAl coated blades would be reinstalled.

The metallurgical evaluation yielded results indicating that the corroded/eroded regions were missing base material on the concave surface ranging from 35.6 μm to 88.9 μm deep (Mocaby, 2003 and Rampolla, 2003). The areas of corrosion appeared to be worst at the 80% span near the trailing edge. There were also coating cracks present on the convex side of the blade.

Figure 3: Results of SEM Report for Chromalloy PtAl Coating (Nagaraj, 2003)

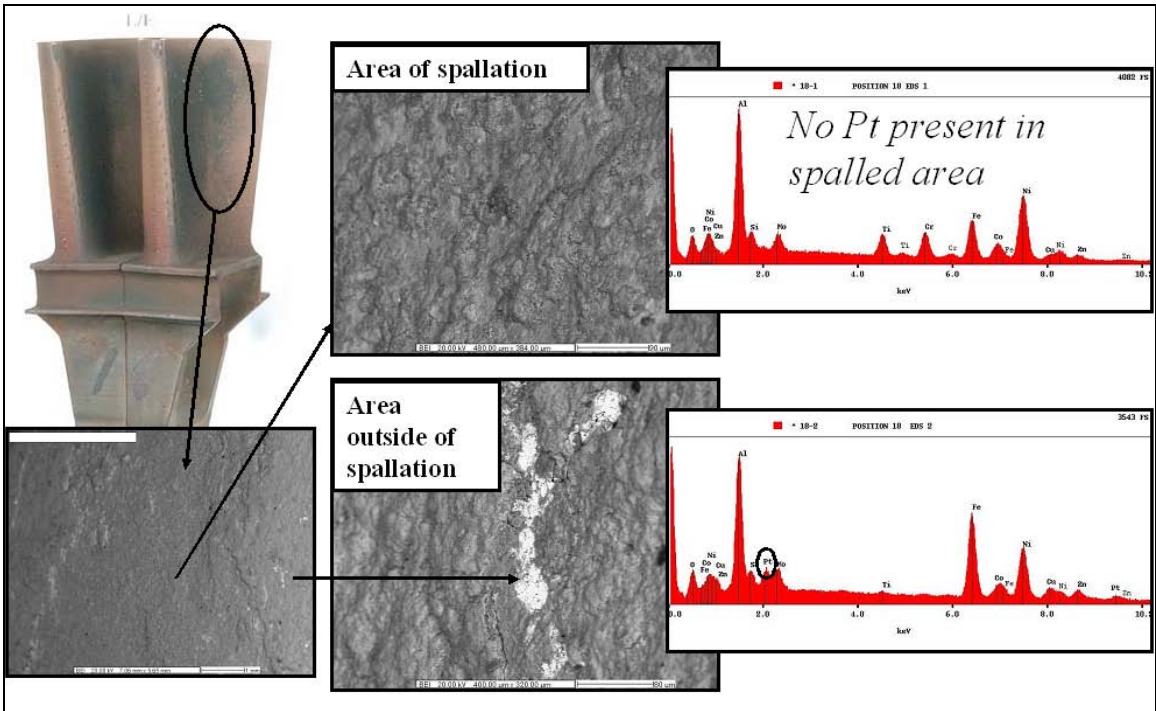
The composition of this coating is identical to the Chromalloy PtAl, differing only by manufacturer. The performance of the coating was also very similar to the other tested PtAl. Again, this PtAl was classified originally in the M1 category and from learning of the results from the provided SEM report, shown in Figure 4, the blades with this coating were kept from reinstallation.

Metallurgical analysis by two different parties indicated corrosion present on both the concave side and leading edge with the heaviest degradation seen on the 80% span near the trailing edge on the concave surface. In general, substrate attacks were seen at all spans near the trailing edge on the concave side. There were also coating cracks found on the convex side of the airfoil. Maximum penetration into the substrate was 98.0 μm .

Figure 4: Results of SEM Report for Howmet PtAl Coating (Nagaraj, 2003)

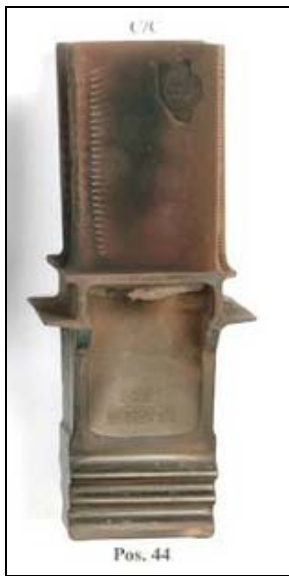
This was the only coating that was visually categorized in the M2 category and had the most visible spallation present. Figure 6 shows a typical TBC coated first stage HPT blade.

Metallurgical analysis reveals that at the 80% span there were areas of TBC spalling with base metal attack ranging from 20.3 to 76.2 μm . At the 20% span however, there was no spalling or base metal attack.

Figure 6: Typical TBC Coated 1st Stage Blade After 7,192 Hours

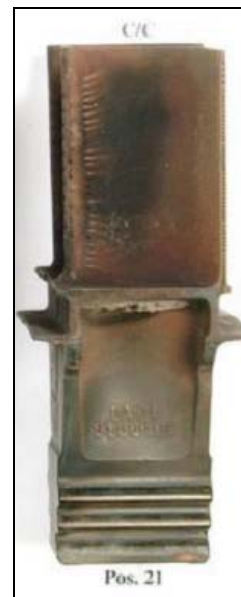
On average, more than 61 μm of SermaLoy J remained on the first stage airfoil surface (88.9 to 114.3 μm was the original coating thickness). The most damage to this blade was seen on the 80% span near the trailing edge of the blade. Hot corrosion appeared to have consumed approximately 5 μm of the aluminide on the leading edge of the sectioned airfoil however there were no deep corrosion pits found around the perimeter of this surface (McMordie, 2003). Some coating cracks could also be seen around this same effected area (Nagaraj, 2003). Figure 7 represents a typical stage 1 HPT blade that was coated with SermaLoy J.

Figure 7: Typical SermaLoy J Coated 1st Stage Blade After 7,192 Hours

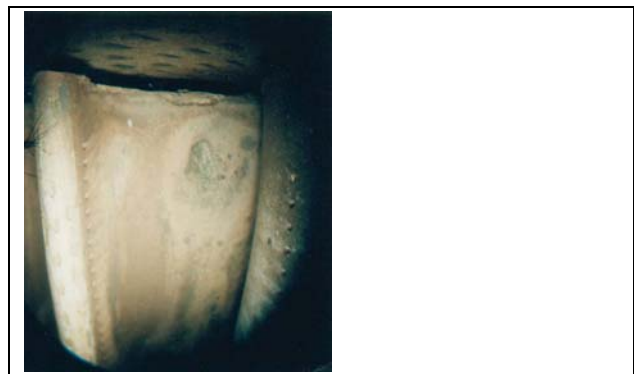
The first engine, on HMAS DARWIN, had a borescope inspection performed, after accumulating 8,689 hours while the most recent engine had 7,192 hours when it was removed from service. Since these two periods are similar, relative to the coating's life span, they will be used for the comparison. In general, it appeared that the coatings gave comparable performances. The Chromalloy PtAl refurbished blades had performed worse in both engines although the performance in the Australian engine seemed better than in the USN engine. Based upon the results of the first rainbow rotor, a statistical analysis placed an expected coating life for PtAl at approximately 12,000 hours of operation where a standard deviation of 1,000 hours produced a 3-sigma lower boundary of 9,000 hours (Driscoll, 2002). This life expectancy was based on the estimation that the coating exceeded maximum serviceable limits at around 10,000 hours and the Navy acceptance criteria would permit the blades to run for an additional 1,800 hours once the exceeded condition was identified. Table 4 represents the coating life values table developed from the first rainbow rotor results. Although the PtAl blades from the USN engine did not perform as well as those from the Australian engine, it is roughly estimated that the blades would fall within the lower boundary predicted for this coating.

Figure 8: Typical Stage 1 PtAl Coated Blade After 8,689 (left) and 7,192 (right) Hours of Operation

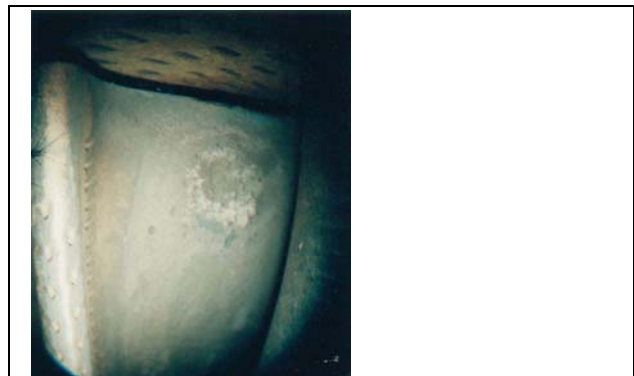
The Australian engine contained refurbished blades with BC-21 coating (CoCrAlY) and a three-step BC-23 coating (CoCrAlHfPt) on new blades while the recent subject engine contained PBC-22 (CoCrAlHf) coating. The BC-22 and BC-23

coatings are considered nearly equivalent, with the BC-23 possibly slightly better; however, not enough to justify the cost differential. It should be noted that the performance of BC-23 is documented on new blades while the results of BC-22 in this rotor were on refurbished blades and as previously noted, the BAJ BC-22 still had approximately 50 μm of coating left on the surface of the airfoil. BC-21 is considered to be less effective than either of the two Hafnium containing coatings (BC-22 / BC-23) and the PtAl coatings are even less effective. The appearances of the three coatings in these two engine tests support this ranking of the overlay coatings.

Figure 9: Typical Stage 1 BC-23 Coated Blade After 8,689 Hours (HMAS DARWIN (left) and BC-22 after 7,192 (right) Hours of Operation (CG-52)

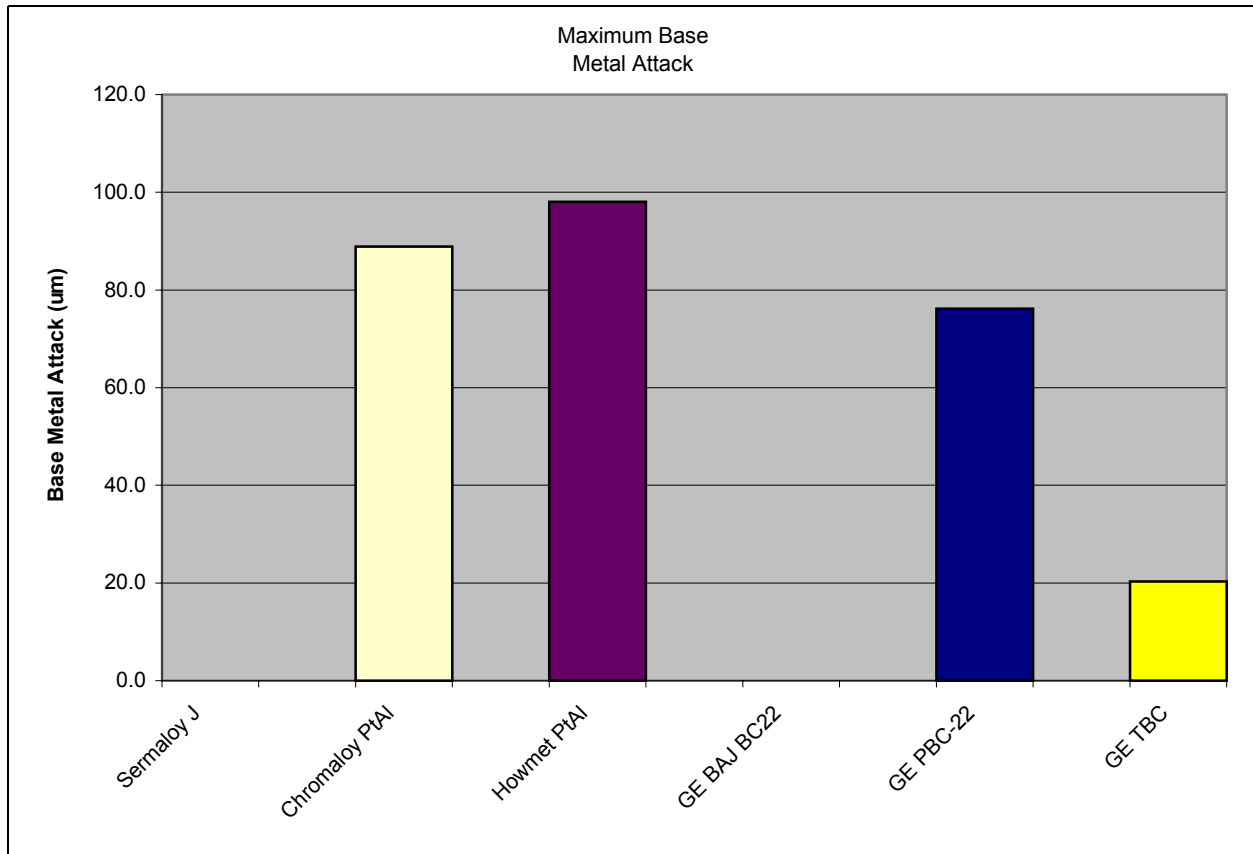
When considering coating performance as a function of substrate attack alone, a simple bar graph can illustrate the overall effectiveness of each coating used in this test. Figure 10 represents a comparison of substrate attack for each coating after 7,192 hours of operation.

Figure 10: Representation Of Depth Of Substrate Attack For Each Coating
