Zagreb earthquake of 22 March 2020 – preliminary report on seismologic aspects and damage to buildings

Research Paper

Zagreb earthquake, post-earthquake building inspections, masonry buildings, damage, historic core, cultural heritage

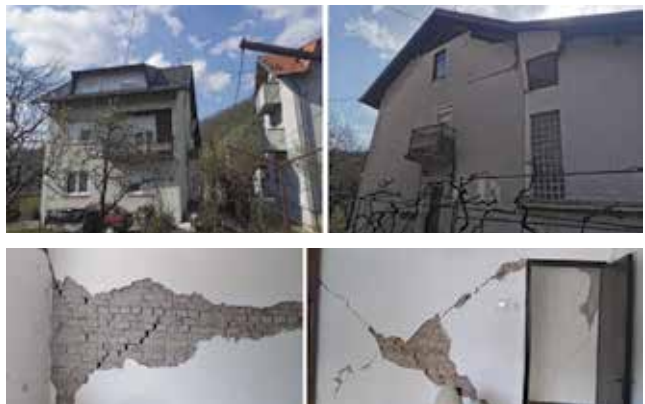
Figures 28 and 29 show frequent damage to houses near the epicentral area. As already pointed out, these are mostly masonry houses without tie beams, but various mixed systems were also encountered because old single storey houses were often subsequently raised by adding a floor.

Figure 29. Damage to houses at LB Dankovec, CD Gornja Dubrava (photo courtesy of Luka Božić and [39])
