# RECTANGULAR RC WALLS UNDER BI-DIRECTIONAL LOADING: RECENT EXPERIMENTAL AND NUMERICAL FINDINGS

ABSTRACT: Following the recent earthquakes in Chile (2010) and New Zealand (2010/2011), peculiar failure modes were observed in Reinforced Concrete (RC) walls. These observations have raised a global concern on the contribution of bi-directional loading to these failure mechanisms. One of the failure modes that could potentially result from bidirectional excitations is out-of-plane shear failure. In this paper an overview of the recent experimental and numerical findings regarding out-of-plane shear failure in RC walls are presented. The numerical study presents the Finite Element (FE) simulation of wall D5-6 from the Grand Chancellor Hotel that failed in shear in the out-of-plane direction in the February 2011 Christchurch earthquake. The main objective of the numerical study was to investigate the reasons for this failure mode. The experimental campaign includes the recent experiments conducted in the Structural Engineering Laboratory of the University of Canterbury. The experimental study included three rectangular slender RC walls designed based on NZS3101: 2006-A3 (2017) for three

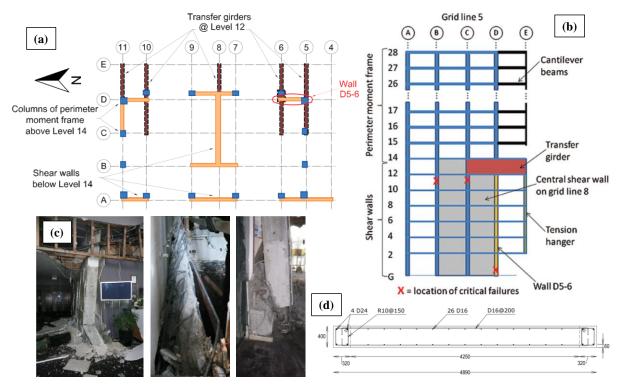
In the short but violent M<sub>W</sub>6.2 Christchurch earthquake on 22 February 2011, the Grand Chancellor Hotel (GCH) building, located in the Central Building District, suffered major structural damage. In particular one of the main shear wall (wall D5-6) failed in a brittle manner at the ground floor level. The building had previously survived the 4 September 2010 and 26 December 2010 earthquakes without apparent significant structural damage and was fully operational when the February event occurred (Dunning Thornton 2011). The 22-storey GCH building was constructed in two phases. The lower 7 (or 14 half-height car park) storey structure, which comprises RC shear walls and cast-in-place flat slabs and columns, was constructed first in 1970s. The upper 15 full-height storey structure, which comprises of perimeter moment frames with a precast floor system, was added subsequently (Kam et al. 2011). The tower was constructed between 1985 and 1988 according to the NZS4203:1984 loading standard and NZS3101:1982 concrete design standard (Elwood 2013). Figure 1 shows the basic information regarding GCH building and wall D5-6 and its final failure. For

Figure 1 (a & b) GCH structural layout sketch plan and elevation along grid line 5 (Elwood 2013), (c) failure mode of wall D5-6 from GCH building in the 2011 NZ earthquake (Dunning Thornton 2011) and (d) details of the wall D 5-6 (Dunning Thornton 2011)

High axial load on the deformed wall acted as vertical shear along the wall and led to the outof-plane shear failure of the wall. Low longitudinal reinforcement ratio and lack of sufficient out-of-plane ties were two of the important parameters that led to the final failure of the wall.

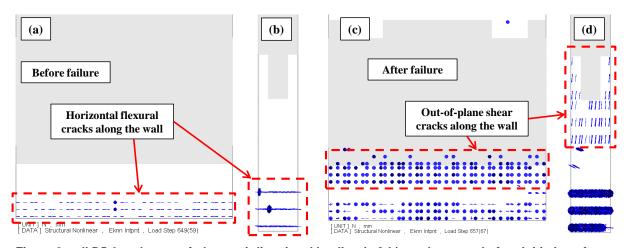
Figure 8 wall D5-6 under out-of-plane uni-directional loading (a & b) crack pattern before initiation of outof-plane shear failure and (c & d) crack pattern after failure (both front and side views)

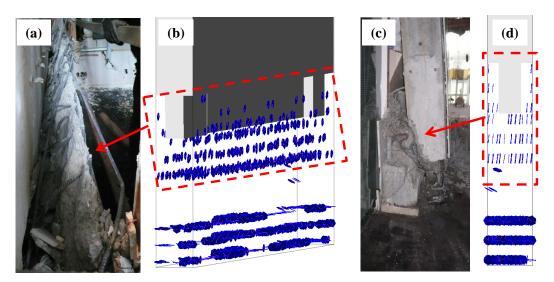
Figure 6 and Figure 7 show the behaviour of the wall under in-plane uni-directional loading before and after failure. As the axial strain and stress contours as well as the crack pattern show, the wall under in-plane loading failed in axial crushing resulted from high axial load and lack of confinement. It should be noted that in Figure 7, cracks are filtered to only show the major cracks and neglect the minor ones. However, when the wall was under out-of-plane loading, it failed in shear in the out-of-plane direction (Figure 8). Out-of-plane shear failure was defined as the point that out-of-plane shear cracks forms along the wall's length. Figure 9 compares the crack pattern resulted from FE analysis with the earthquake observations.

Figure 9 Crack pattern of wall D5-6 under out-of-plane uni-directional loading (a & c) February 2011 earthquake (Dunning Thornton 2011), (b & d) 3D and out-of-plane view of the cracks in DIANA

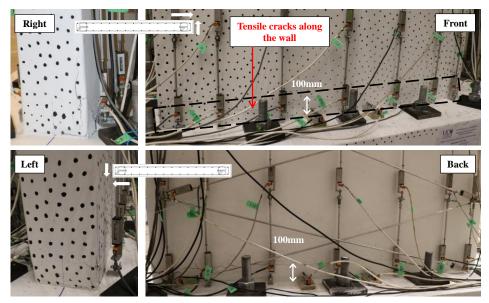
The first sign of cover concrete spalling was observed in the left side from the second cycle of 0.05% in-plane and 0.57% out-of-plane drift ratios. However, there was no sign of vertical splitting in the right side during this drift level. Horizontal tensile cracks on the front and back sides formed along the wall at a height of about 100mm above the base with a length of 1400 and 1100 mm, respectively. Maximum crack width by the end of 0.05% in-plane and 0.57% out-of-plane drift ratios was 0.2mm. There was no sign of residual cracks during this drift level. Vertical splitting in concrete cover increased in the left side and initiated in the right side from the first cycle of 0.1% in-plane and 1.14% out-of-plane drift ratios and penetrated the boundary zone and web (Figure 12). Horizontal tensile cracks formed along the full length of the wall at a height of about 100mm on the front side with a maximum crack width of 0.8mm. On the back face, horizontal tensile cracks formed along the wall with a length of about 1400 mm with a maximum crack width of 0.8 mm. Maximum residual crack width was 0.25 mm during this drift level.

Figure 12 Specimen SP2-ND at 0.1% in-plane and 1.14% out-of-plane drift ratios

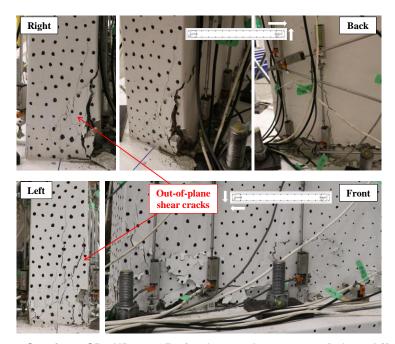
The first sign of out-of-plane shear cracks was observed from the first cycle of 0.15% in-plane and 1.72% out-of-plane drift ratios (Figure 13). During this drift level, the maximum crack width increased significantly to about 3mm. The maximum residual crack width was about 0.8-1mm by the end of 0.15% in-plane and 1.72% out-of-plane drift ratios.

Out-of-plane shear cracks initiated from the first cycle of 0.15% in-plane and 1.72% out-of-plane drift ratios in both left and right sides and developed by the end of the third cycle of this drift level (Figure 13). Consequently the specimen failed in an extremely brittle manner during the first cycle of 0.2% in-plane and 2.29% out-of-plane drift ratios, half way through the first cycle (Figure 14). Failure of the specimen involved a diagonal sliding of about 23mm transverse to the wall from its left side, penetrating almost along the full length of the wall (Figure 15). A lateral deformation of about 23mm was observed in the right hand side of the wall on a length of about 150mm (Figure 15). There was no sign of bar buckling before the

Figure 13 Specimen SP2-ND at 0.15% in-plane and 1.72% out-of-plane drift ratios

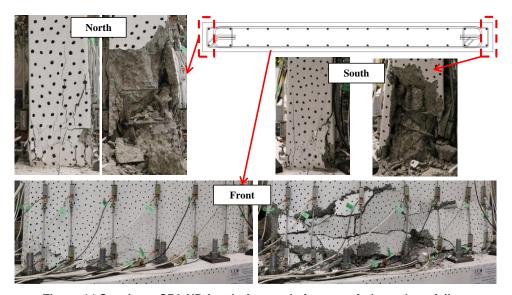
The specimen failed suddenly while applying the first cycle of 0.2% in-plane and 2.29% out-of-plane drift ratios half way through that cycle. Figure 14 shows the specimen just before and after the failure.

Figure 14 Specimen SP2-ND just before and after out-of-plane shear failure

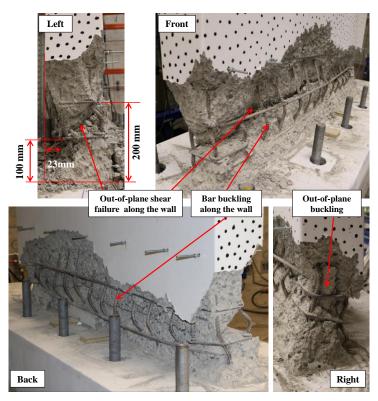
out-of-plane shear failure. However, as can also be seen in Figure 15, all the longitudinal bars along the wall buckled after the failure. Buckling of the longitudinal bars could have been turned into a bar rupture along the wall if the amount of longitudinal bars was less, similar to what happened to the Grand Chancellor Hotel's wall D5-6 (Figure 1). It is worth noting that the longitudinal reinforcement ratio of the specimen SP2-ND was 0.92% while it was 0.452% in the case of wall D5-6. In accordance to what was observed in the numerical study, high axial load on the deformed wall acted as vertical shear along the wall and sheared off the wall while the wall lacked sufficient out-of-plane ties.

Figure 15 SP2-ND failure mode after removing the concrete spalling pieces
