# SEISMIC EXPLORATIONS FOR DEFINING THE DAMAGE TO THE EARTH DAM PISHICA IN THE REPUBLIC OF NORTH MACEDONIA

Blagica Doneva, Marjan Delipetrov, Gorgi Dimov

**ABSTRACT.** The reservoir was built in the middle of the 20<sup>th</sup> century with a total capacity of 750,000 m<sup>3</sup>. The height of the dam from the river terrace is 22 m, the length of the crown is 319 m, and the width of the crown is 6 m. Due to the low resistance of the earth dam and the increase of water level due to heavy rains, the lake has leaked on several occasions, causing floods and environmental disaster in the surrounding settlements. Due to heavy rains and overflow through the dam crown, damage to the downstream slope of the dam has occurred and the overall stability of the dam has been compromised. By controlled discharge of the reservoir it is brought to a stable state and the dam breakage is prevented. At the beginning of 2013, the outflow valves of the dam were opened as a result of heavy rains, with reservoir water flowing to more places and residents of the village and livestock evacuated. At the crown of the dam where there was the largest outflow of water, a gap of about 20 m wide and 3.5-4 m t

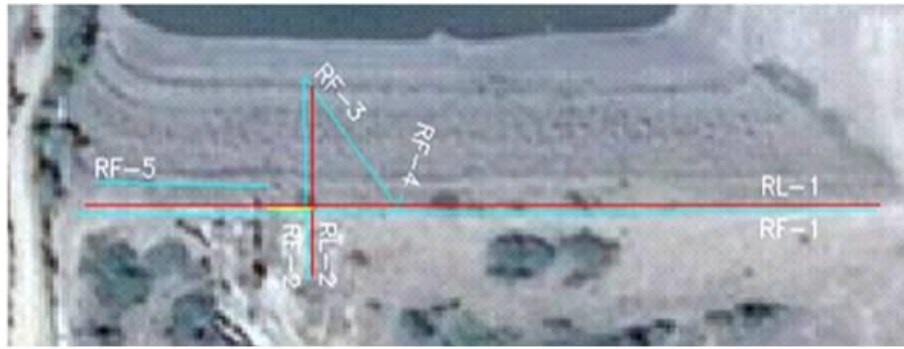
The arrangement of the refractive (RF) and reflective (RL) profiles is shown at the base of the dam (Fig. 1).

Fig. 1. Refractive (RF) and reflective (RL) profiles along and transverse from the dam crown

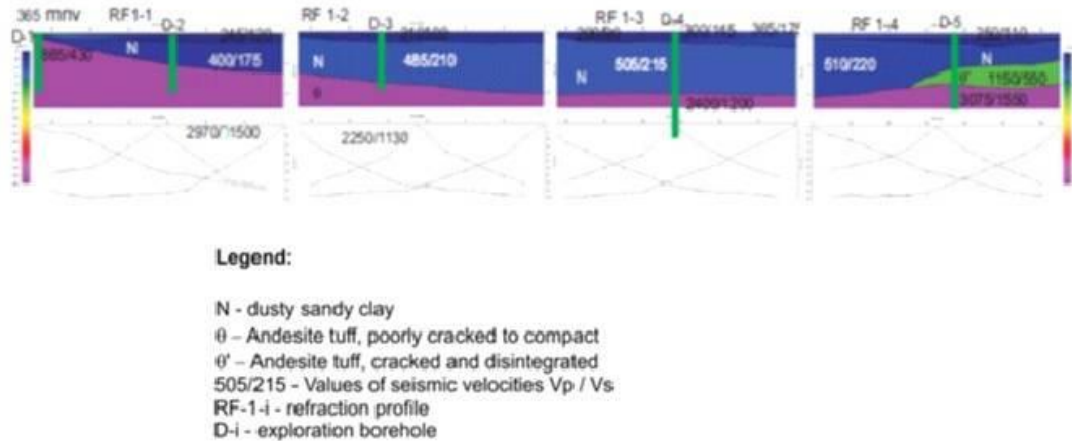
Fig. 2. Seismic refractive profile RF-1 with interpretation

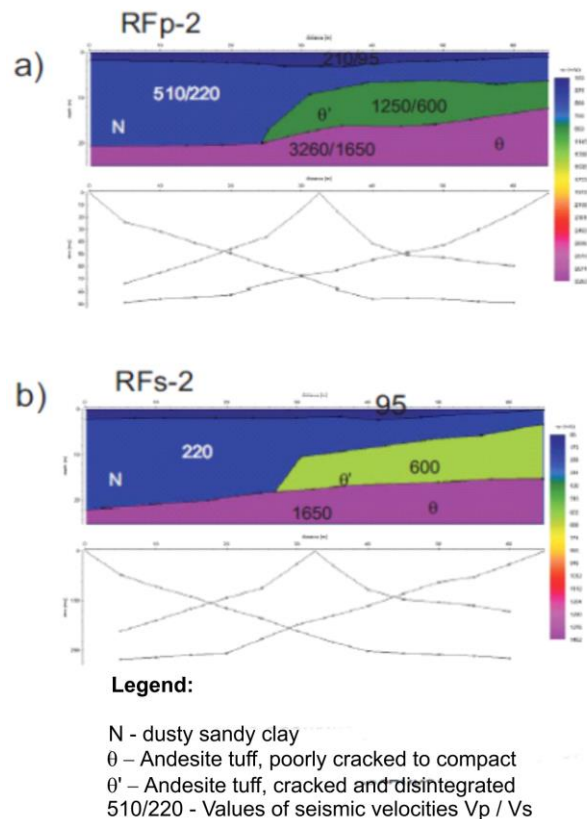
Fig. 3. Seismic refraction profile RF-2 with interpretation a) with P-wave raypaths b) with S-wave raypaths

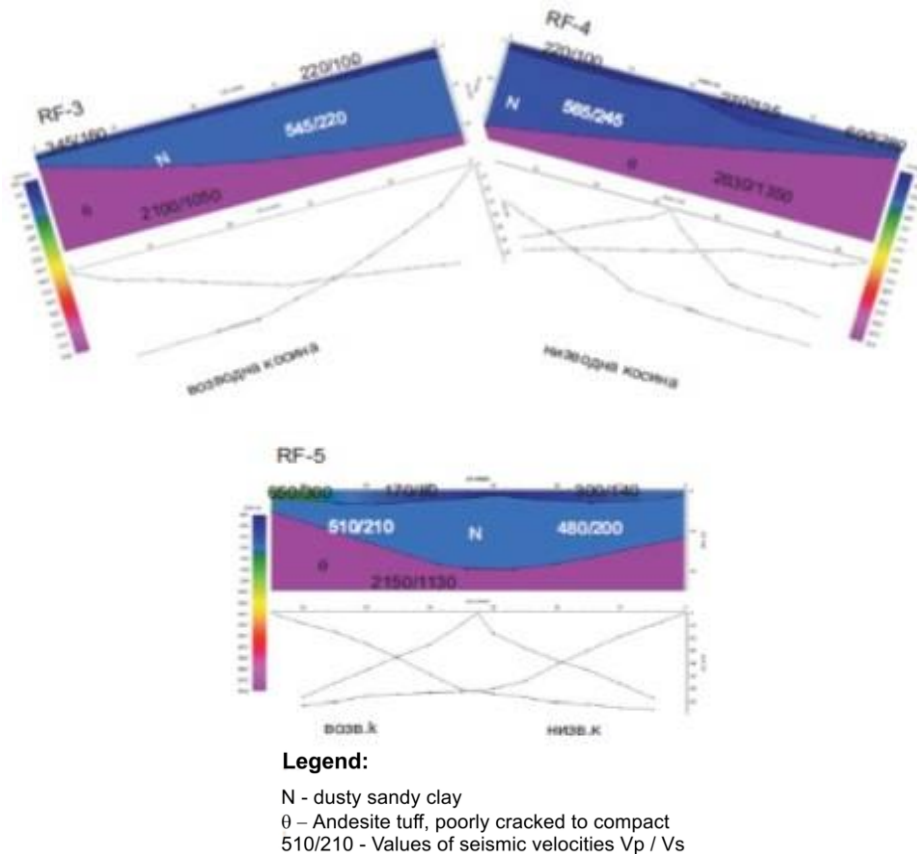
The values of the seismic velocities in the part of the damaged embankment of the dam are of the same order of magnitude as in the other parts of the body. They indicate that the weakened parts of the embankment have been washed away by the water.

Fig. 4. Seismic refraction profile along the slopes of the dam RF-3, RF-4, RF-5 with interpretation

The observed variation of the values of the seismic velocities of the embankment in the body of the dam is a consequence of the uneven compaction of the embedded materials and the changes of the geostatic load which depends on the height and geometric characteristics of the dam (Dragasevic, 1983).

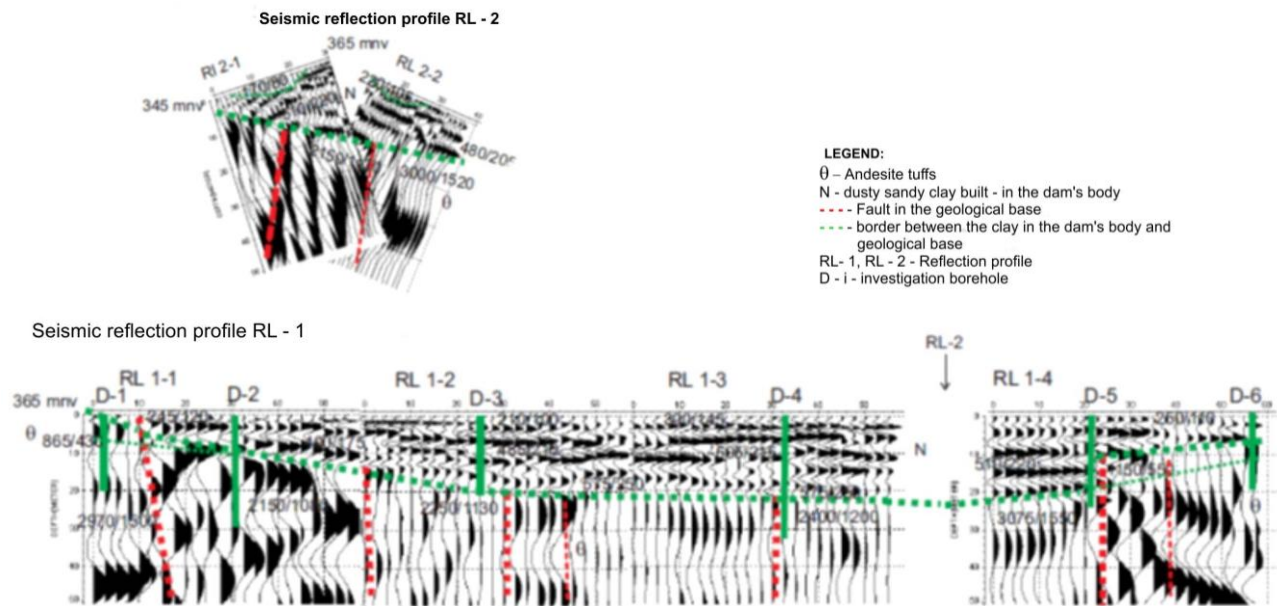
dam (along the crown) of the reflective profile RL-1 and along the cross section in the damaged part of the dam on the reflective profile RL - 2. These surveys determine the height of the dam along its entire length. The withdrawn border was also ascertained with the exploration boreholes.

Tectonic faults and crushed zones have been detected in the geological basis of the dam. Along the dam 7 additional locations have been interpreted. Their directions are approximately determined based on the geomorphological characteristics of the terrain. In the zones of these faults in the geological basis lower values of seismic velocities (25-30%) than the obtained velocities in compact tuffs and significantly smaller amplitudes of reflective waves are measured. However, these dislocations are self-indicating and cannot be classified. To determine them, it is necessary to perform parallel reflective profiles on a wider area of the dam site and other appropriate geo-research methods. (Jakosky, 1963)

The interpreted faults are shown on the reflective profiles RL - 1 and RL - 2 (Figure 5).

Fig. 5. Seismic reflective profile RL-1 and RL-2 with interpretation
