Diagnosing Fouling of Hollow Fibre MF Membranes in Wastewater Reclamation

Long D. Nghiem and Andrea I. Schäfer*

Environmental Engineering, University of Wollongong, NSW, 2522, Australia

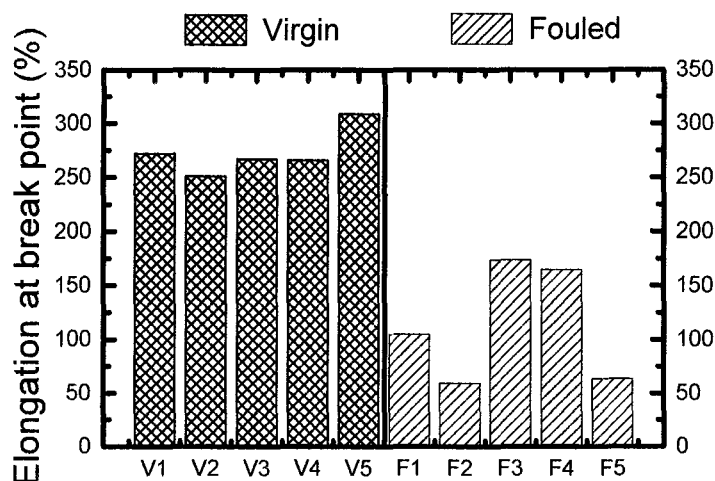
Figure 5: Elongation at break point of the fouled membrane fibres as compared to virgin membrane fibres.

In this case, it appears that the fouled membrane has become more brittle, possibly because the membrane has been allowed to dry prior to testing. This may also be attributed to normal wear and tear during the filtration process and backflush operation. A significant variation in elongation at break point can also be observed for the fouled membrane. However, it is interesting to note that both fouled and virgin membranes have approximately the same young modulus, yield point & elastic profile (data not shown). No clear evidence of material degradation could be observed for the membranes investigated.

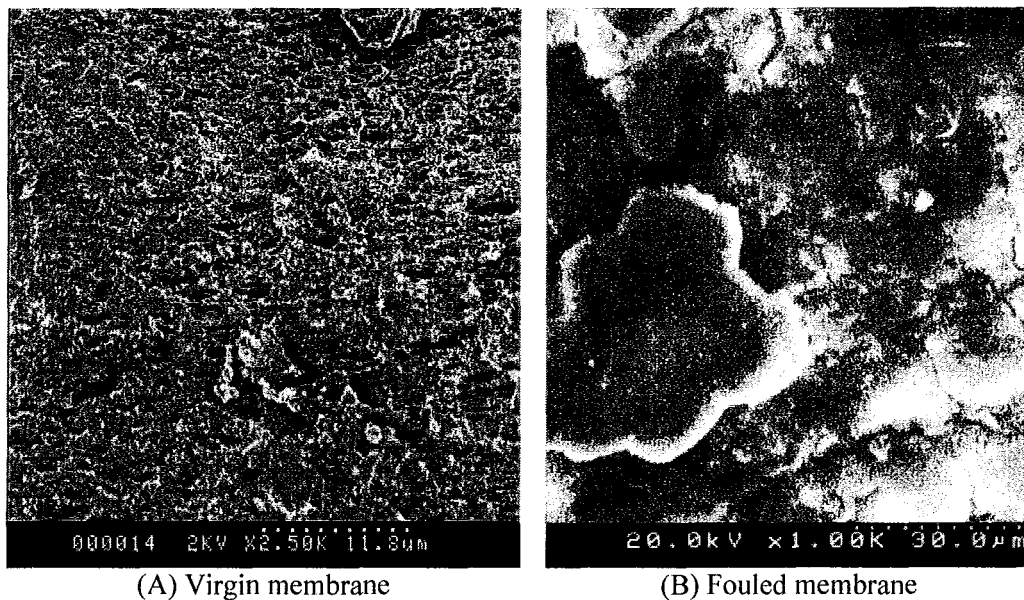
Figure 7: Electron microscopic pictures of a virgin membrane (A) and fouled membrane (B) taken by the FESEM.

The fouling layer morphology is further examined in detail and an electron microscopic picture of the fouling layer is shown in Figure 7. An electron microscopic picture of the clean membrane surface is also presented for comparison purposes. Schäfer *et al.* [1] methodically summarise four distinctive common fouling categories namely scaling/inorganic, organic, colloidal/particulate, and biofouling. There is no evidence of bacteria or fungi on the fouling layer and biofouling is unlikely the main cause in this instance. Figure 7 reveals a firm cake layer on the membrane surface. This cake layer is probably made up of organic matters or colloidal particles or most likely the combination of both. While scaling is uncommon in microfiltration processes and no

evidence of crystallisation can be observed on the fouling layer, it is possible that multivalent cations, for example Ca^{2+} , can act to cement colloidal particles, organic matters, and the membrane surface one another as previously shown in another of our study [10]. This phenomenon has also been exquisitely examined by Li and Elimelech by measuring attractive force between these entities with and without the presence of multivalent cations [11].

particles and organic matter. Complexation and other interactions between multivalent cations, organic matter, and colloidal particles have most likely worsened the fouling process caused by the suspended solids load itself. It is advisable to enhance pre-treatment prior to the MF unit, possibly by applying coagulants, to maintain a low and stable turbidity level in the feed. Chemical cleaning protocol and air backflushing frequency may also need to be modified for an optimal fouling mitigation approach. Monitoring of the feedwater composition over a period of time will provide further insight into the fouling process.

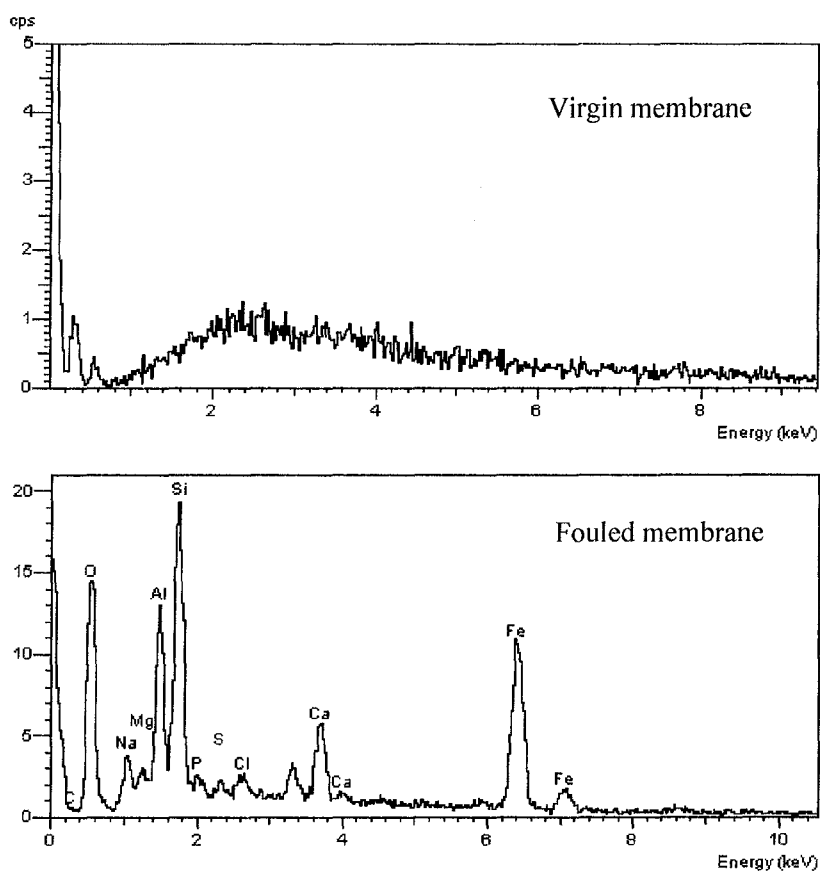
The presence of metallic elements such as iron, aluminium, calcium, and magnesium is clearly evident in the energy dispersive X-ray (EDX) spectrometry graph of the fouling layer as shown in Figure 8. A significant amount of silica can also be observed. Furthermore, Figure 8 reveals a large peak of oxygen and trace amount of other non-metallic elements such as chlorine, sulphur, and phosphate. Such significant amount of oxygen may be attributed to organic matters present in the fouling layer, although it is prudent to note that it can also be from the membrane polymeric material. While a small peak of oxygen can be observed in the EDX spectrometry graph of the virgin membrane, no chlorine, sulphur, or phosphate can be found (see Figure 8).

Figure 8: Energy dispersive X-ray spectrometry of the virgin membrane surface (top) and the foulant layer (bottom). Excitation energy was set at 20 000 kV (note difference in y-axis scale).
